2022 FOX-M ANNUAL NUNAVUT WATER BOARD REPORT

FOR THE NORTH WARNING SYSTEM

Document Number
17.7 NWB-XL-2022 , 30-Mar-2023

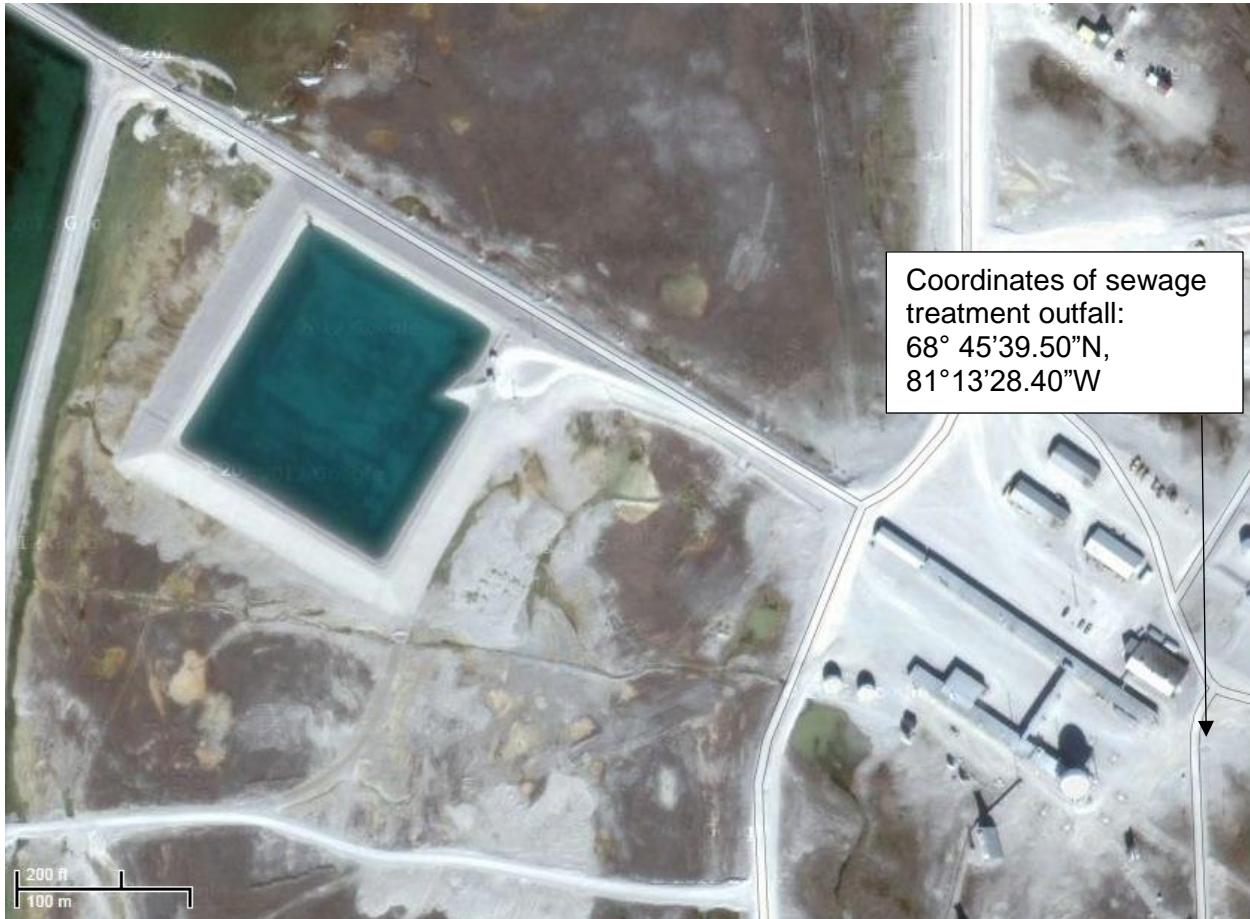
Figure 1: Location and coordinates of sewage treatment outfall: 68° 45'39.50" N, 81°13'28.40" W

The location and coordinates of treated sewage effluent outfall location (FOH-2) is contained in **Annex B**. Sewage sample analytical results and certificates of analysis are contained in **Annex C**.

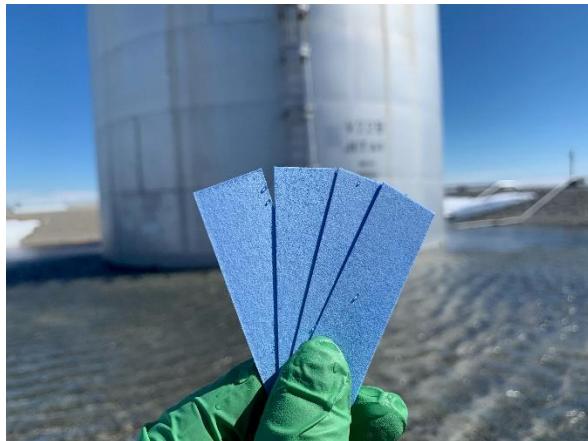
June 17, W22B

The berms at FOX-M were sampled using hydrocarbon test strips as per the approved QA/QC Plan for Berm Water Sampling as stated in the water licence 8BC-FOH1929, PART D, Item 11. The photo log of the hydrocarbon test strips is included below.
