APPENDIX A3 BAY GOOSE DIKE PHOTOGRAPHIC LOG

2017 ANNUAL GEOTECHNICAL INSPECTION
MEADOWBANK GOLD MINE, NUNAVUT

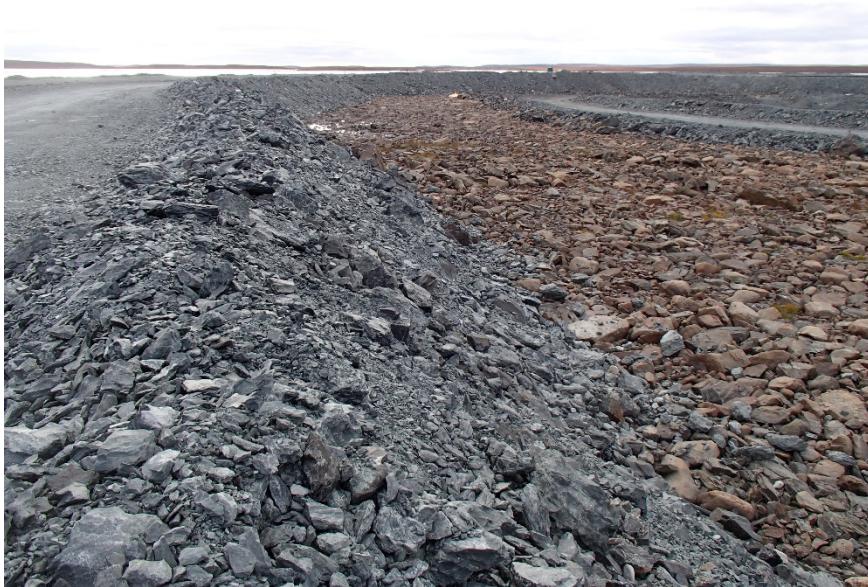
Photograph A3-21 Bay Goose Dike

Description: From approximately Sta. 31+280 on the crest, looking southwest at the downstream slope and the water pond at the downstream toe at Sta. 31+350.

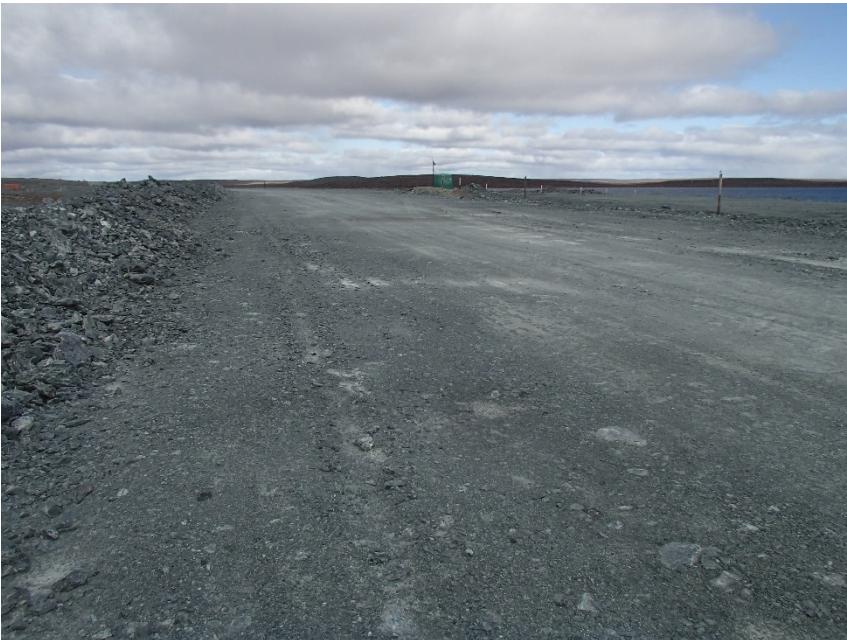
Photograph A3-22 Bay Goose Dike

Description: From approximately Sta. 31+280, looking south at the crest.

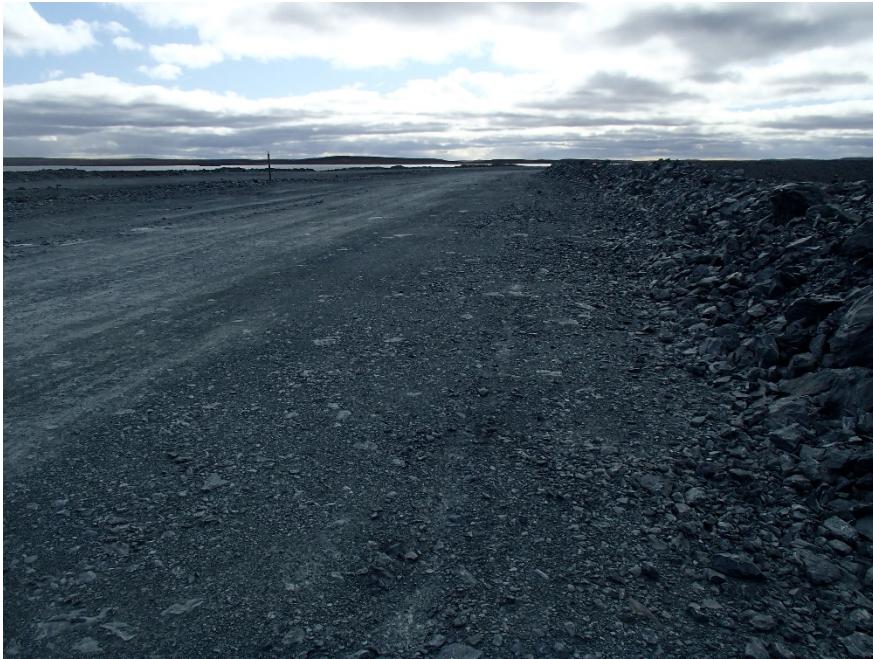
Photograph A3-23 Bay Goose Dike

Description: From approximately Sta. 31+280, looking northeast at the crest.

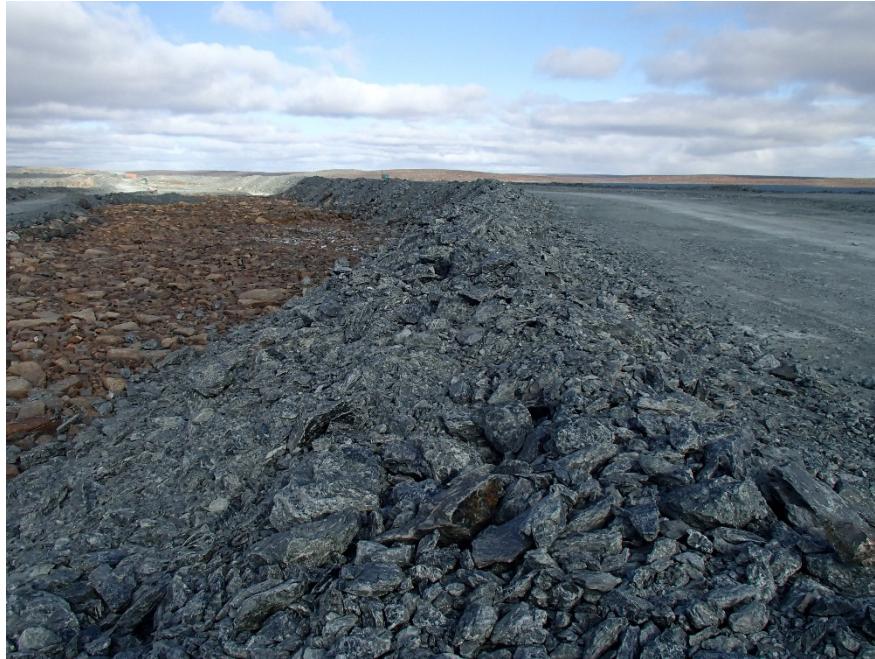
Photograph A3-24 Bay Goose Dike

Description: From approximately Sta. 31+490, looking northeast at the downstream toe and slope.

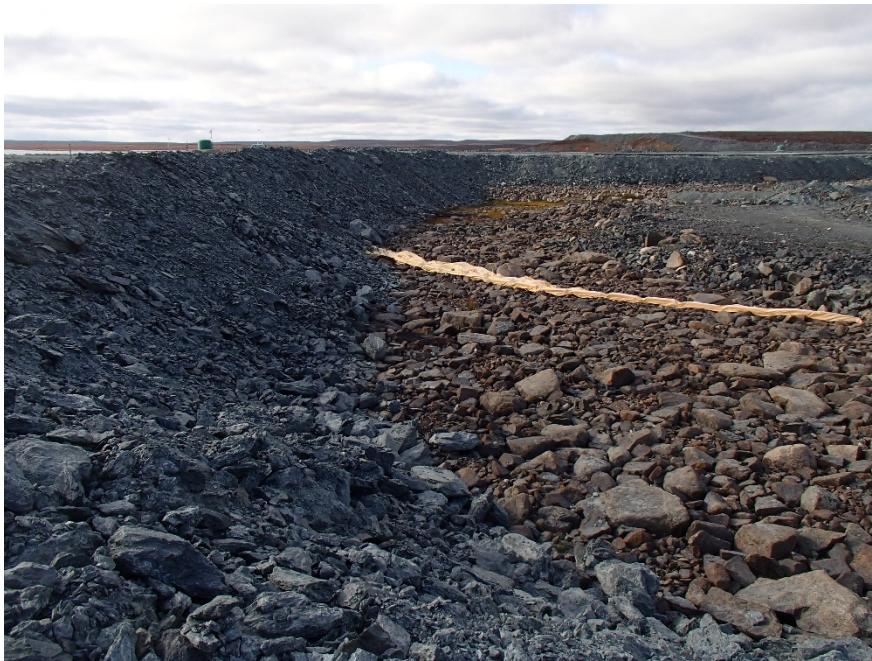
Photograph A3-25 Bay Goose Dike

Description: From approximately Sta. 31+490, looking west toward Channel 3.

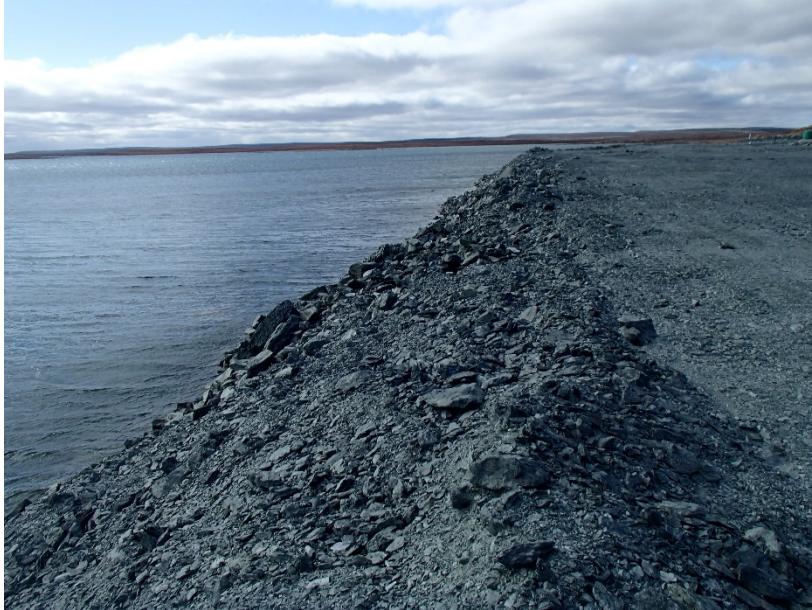
Photograph A3-26 Bay Goose Dike

Description: From approximately Sta. 31+475, looking west at the crest and the upstream slope.

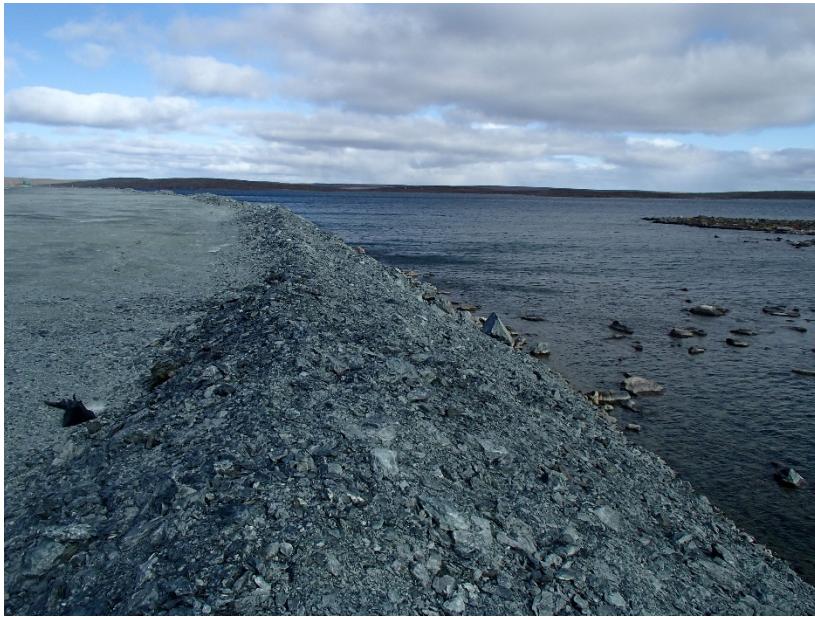
Photograph A3-27 Bay Goose Dike

Description: From approximately Sta. 31+475, looking northeast at the crest and the upstream slope.

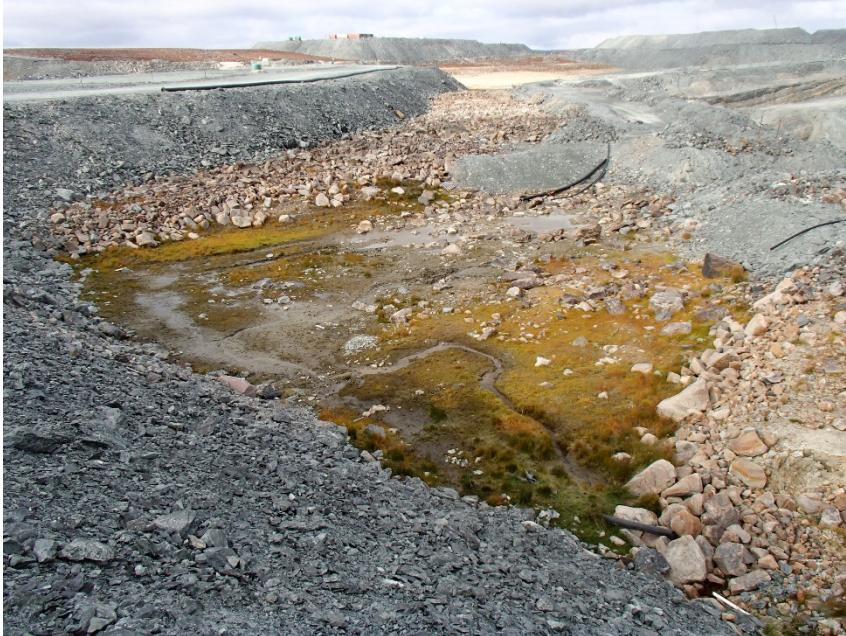
Photograph A3-28 Bay Goose Dike

Description: From approximately Sta. 31+570, looking north toward Channel 3.

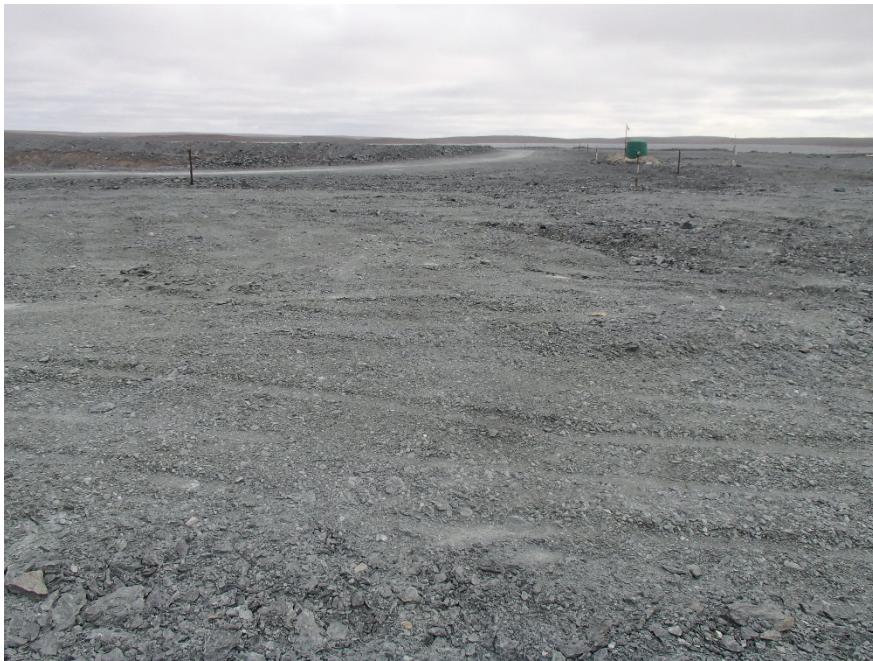
Photograph A3-29 Bay Goose Dike

Description: From approximately Sta. 31+645, looking east at the crest centreline.

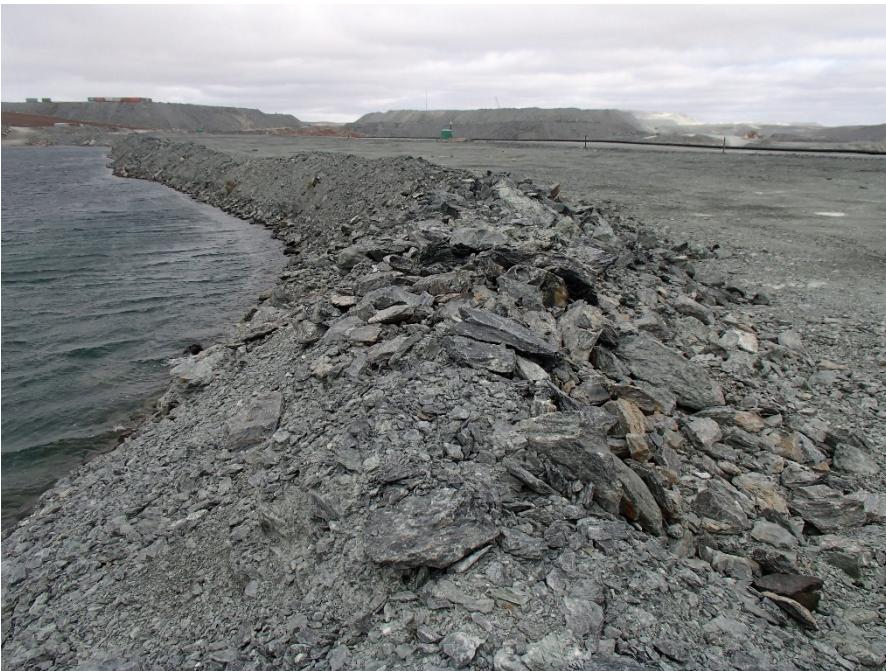
Photograph A3-30 Bay Goose Dike

Description: From approximately Sta. 31+645, looking northwest at the crest and the upstream slope.

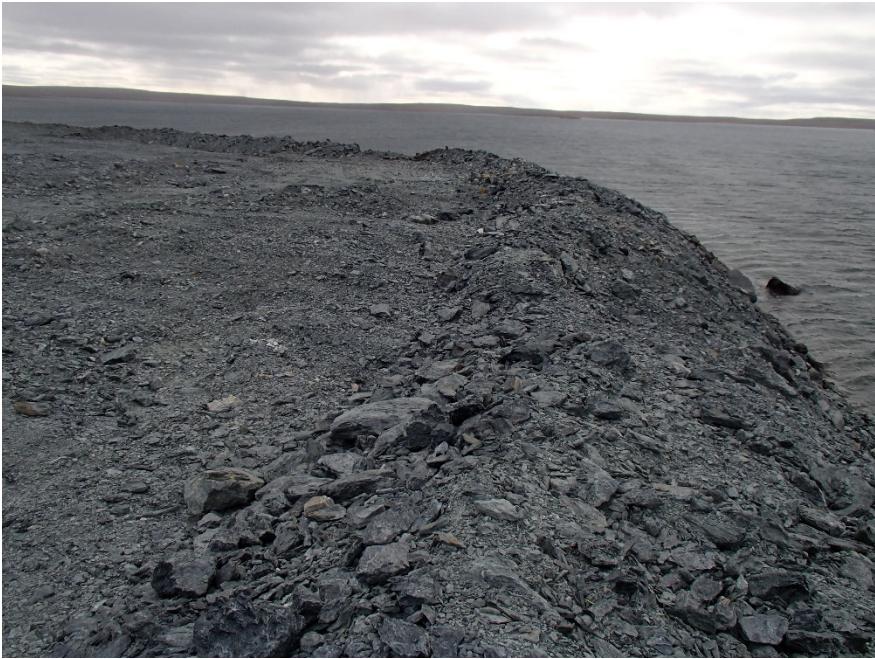
Photograph A3-31 Bay Goose Dike

Description: From approximately Sta. 31+640, looking southeast at the upstream slope.

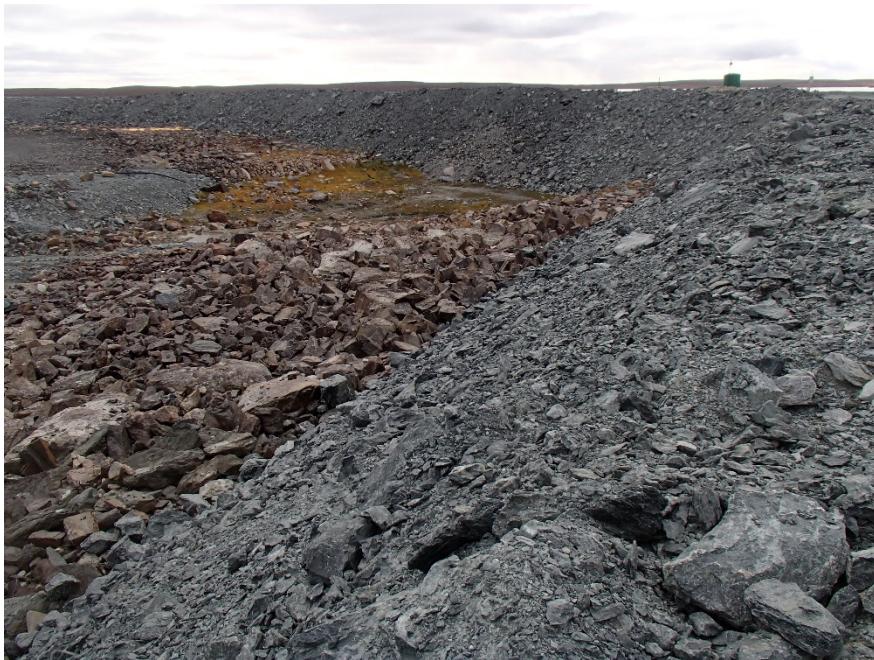
Photograph A3-32 Bay Goose Dike

Description: From the crest at approximately Sta. 31+740. Looking southeast downstream toward Channel 3.

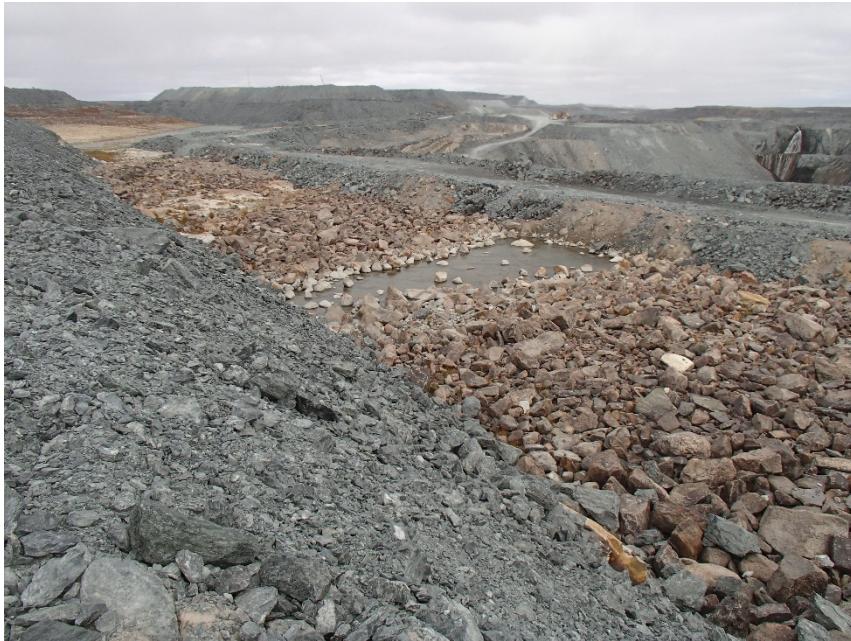
Photograph A3-33 Bay Goose Dike

Description: From the crest at approximately Sta. 31+740, looking north downstream at the water pond at Sta. 31+750.

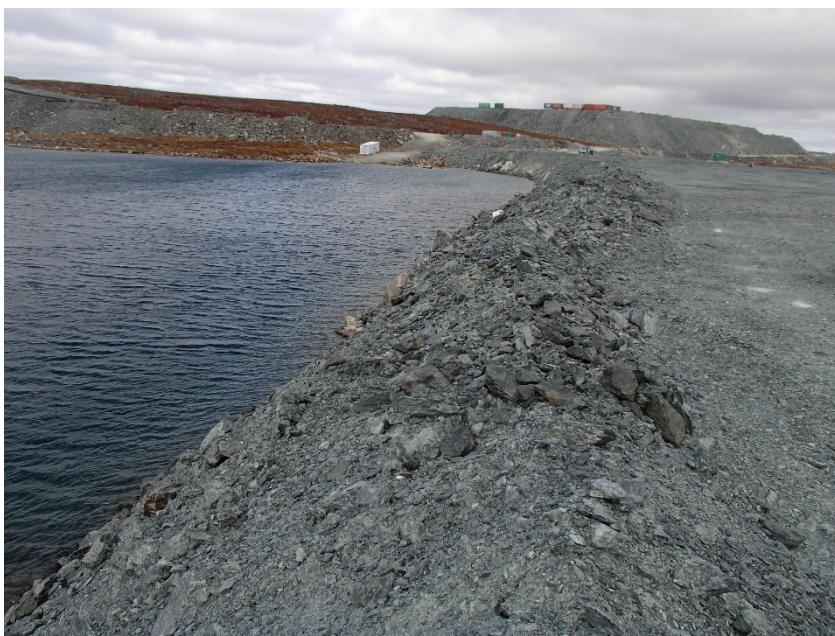
Photograph A3-34 Bay Goose Dike

Description: From approximately Sta. 31+870, looking northwest at the crest and upstream slope.

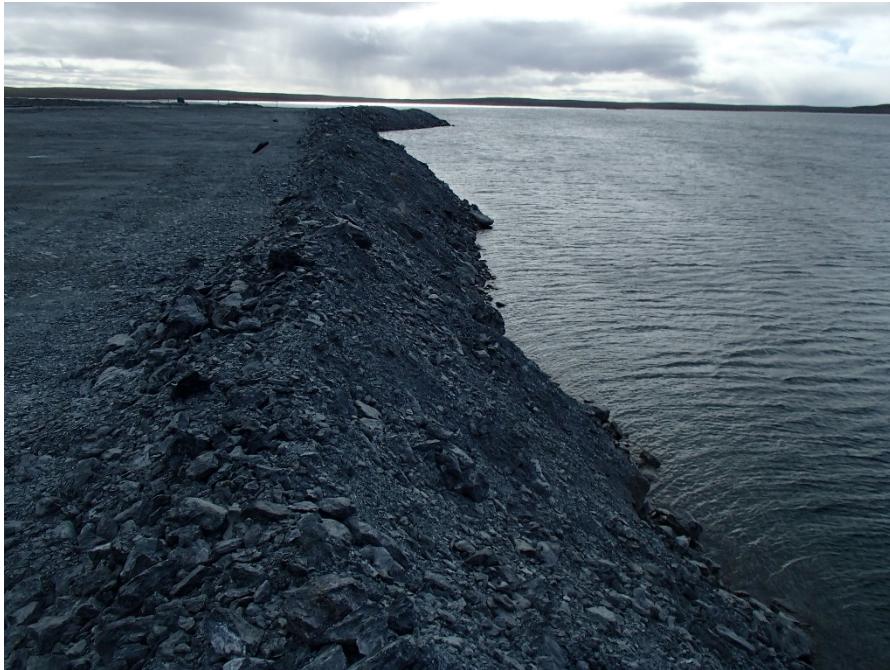
Photograph A3-35 Bay Goose Dike

Description: From approximately Sta. 31+870, looking southeast at the crest and upstream slope.

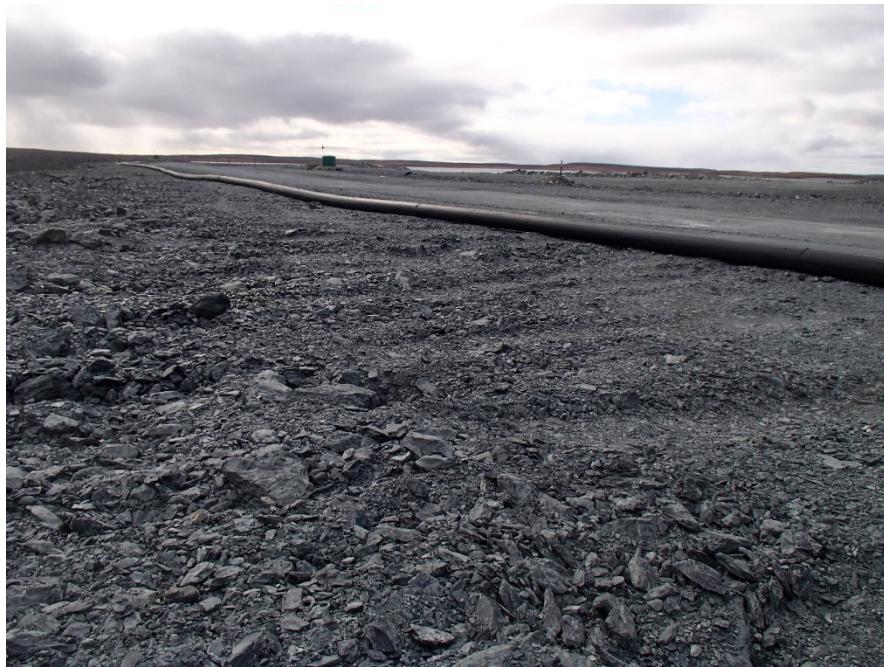
Photograph A3-36 Bay Goose Dike

Description: From approximately Sta. 31+920, looking south at the crest.

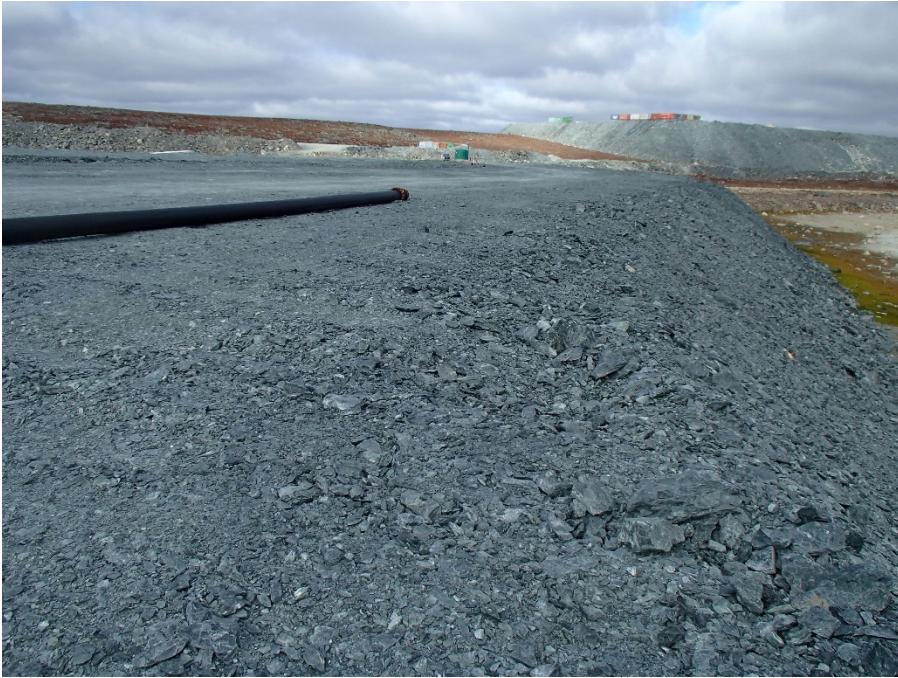
Photograph A3-37 Bay Goose Dike

Description: From approximately Sta. 31+920, looking northwest at the crest.

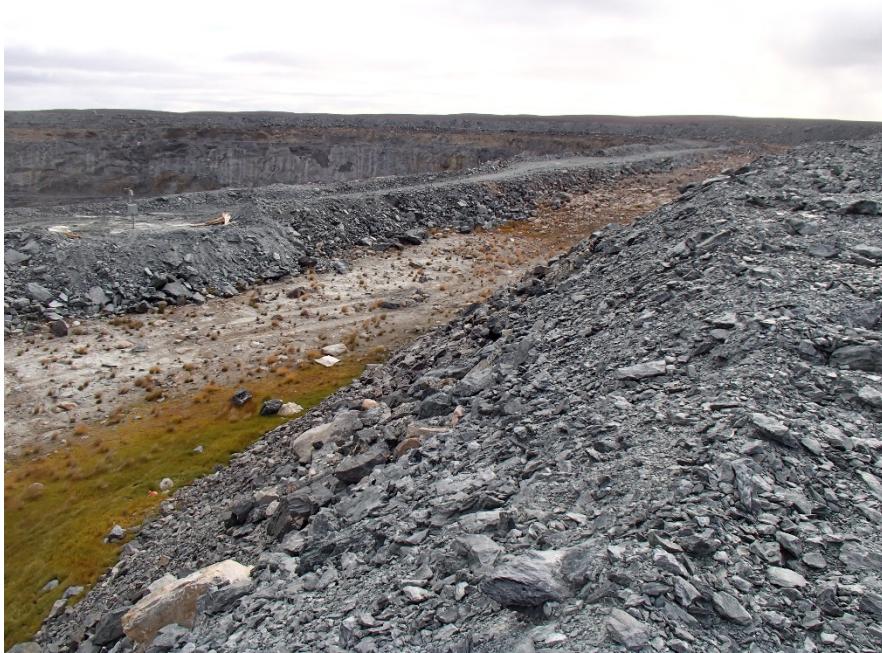
Photograph A3-38 Bay Goose Dike

Description: From approximately Sta. 31+920 on the crest, looking southeast at the downstream slope.

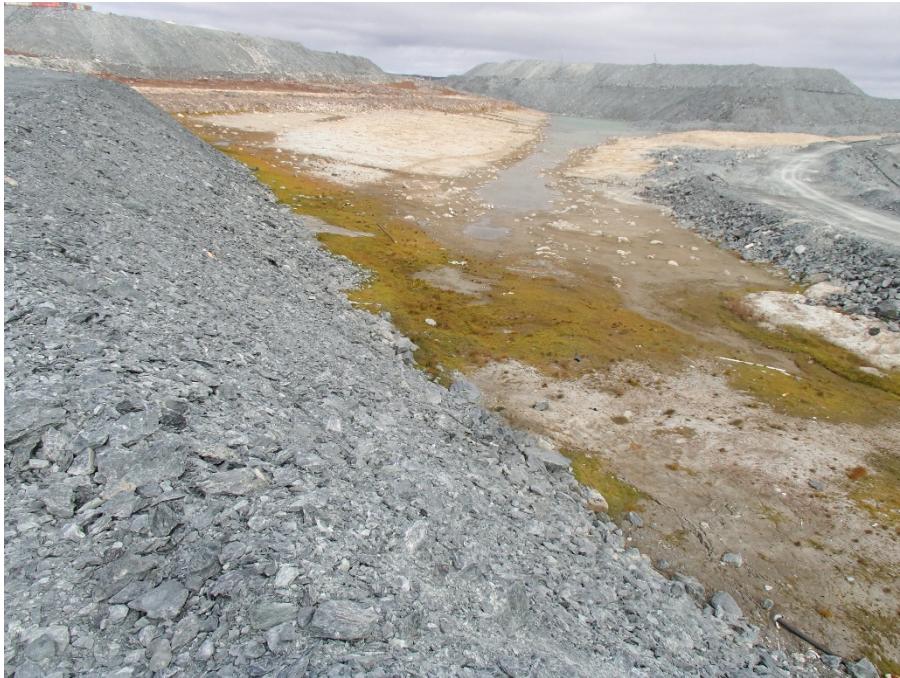
Photograph A3-39 Bay Goose Dike

Description: From about Sta. 31+920 on the crest, looking northwest toward Channel 1 monitoring station.

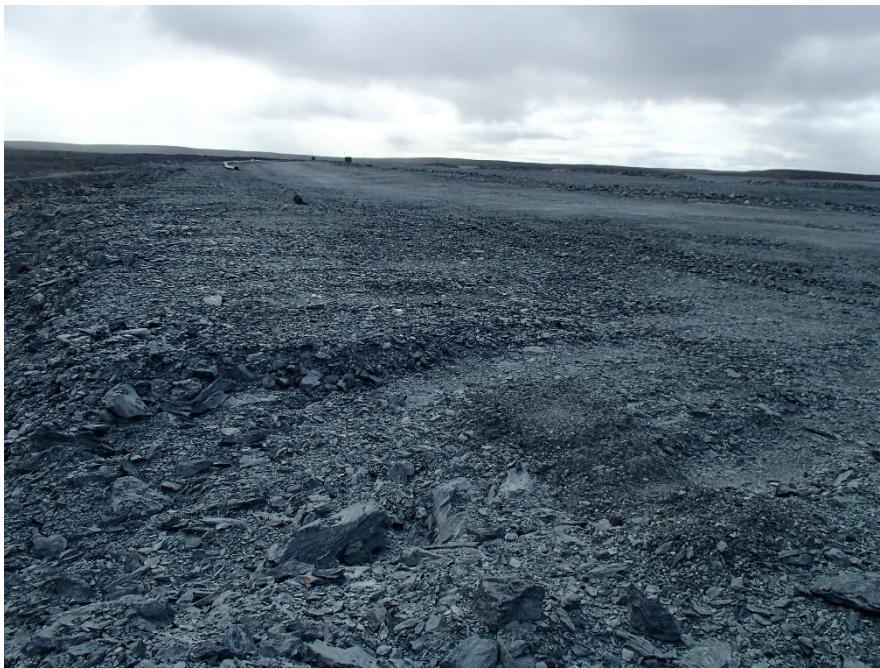
Photograph A3-40 Bay Goose Dike

Description: From approximately Sta. 32+030 looking southeast at the crest.

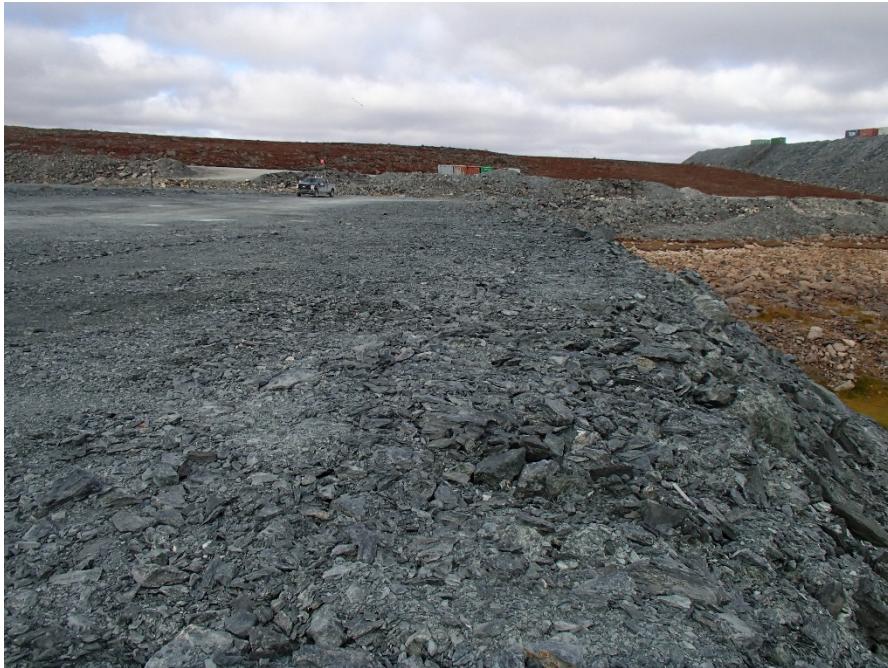
Photograph A3-41 Bay Goose Dike

Description: From approximately Sta. 32+030 looking southwest at the crest.

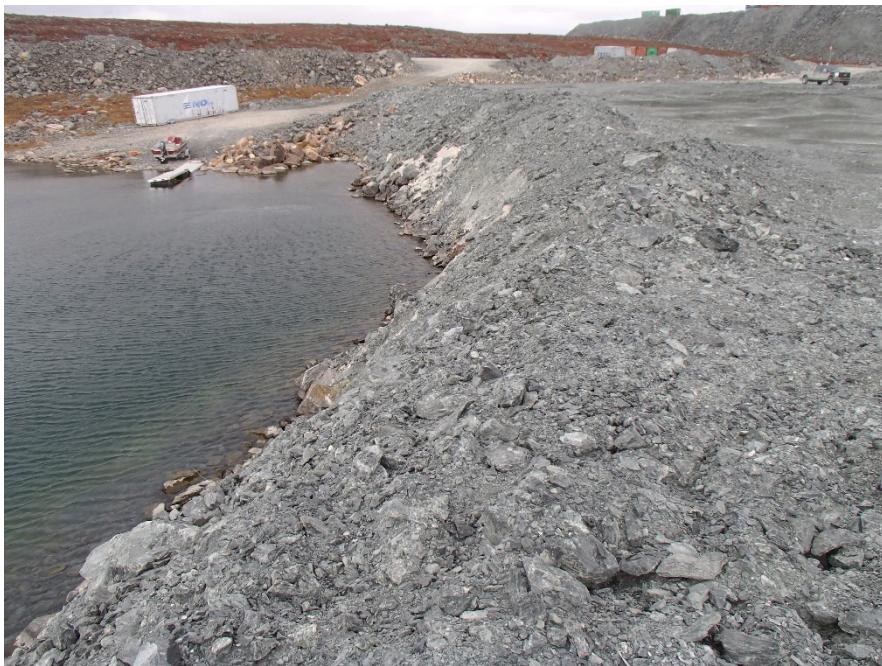
Photograph A3-42 Bay Goose Dike

Description: From approximately Sta. 32+015 (south abutment) looking northwest at the crest and downstream slope.

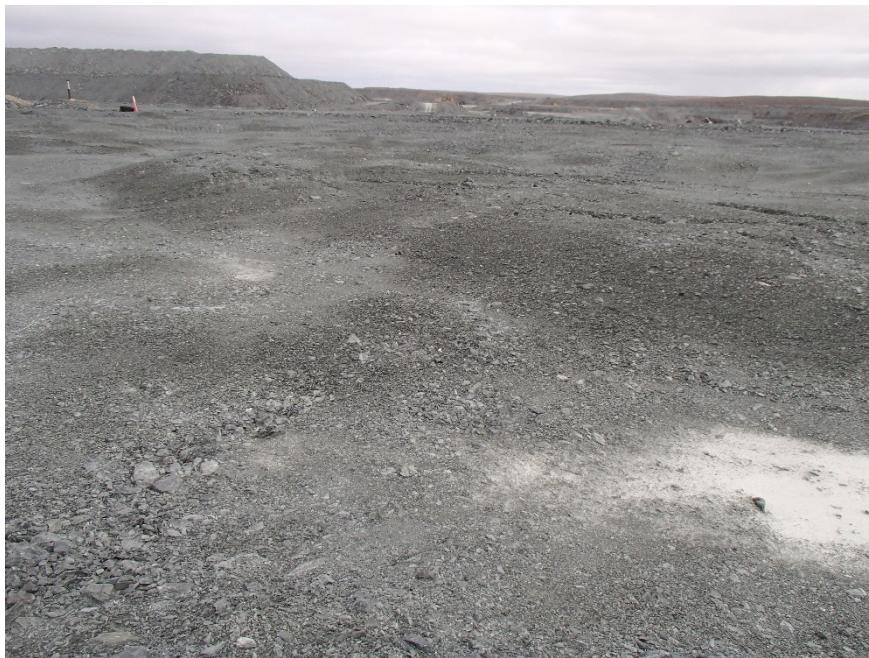
Photograph A3-43 Bay Goose Dike

Description: From approximately Sta. 32+015 (south abutment) looking east at the crest. Presence of high magnitude settlements in the ultramafic cap placed in the winter of 2013.

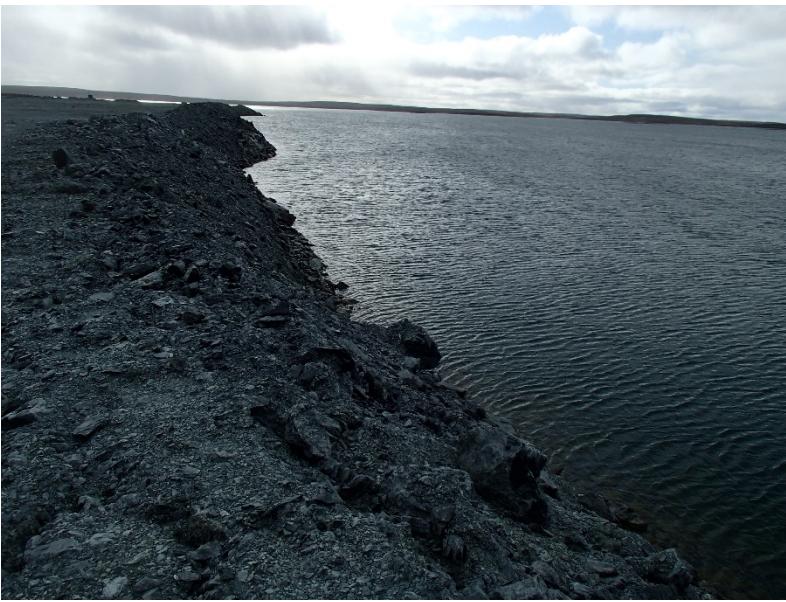
Photograph A3-44 Bay Goose Dike

Description: From approximately Sta. 32+015 (south abutment) looking southeast at the crest and upstream slope.

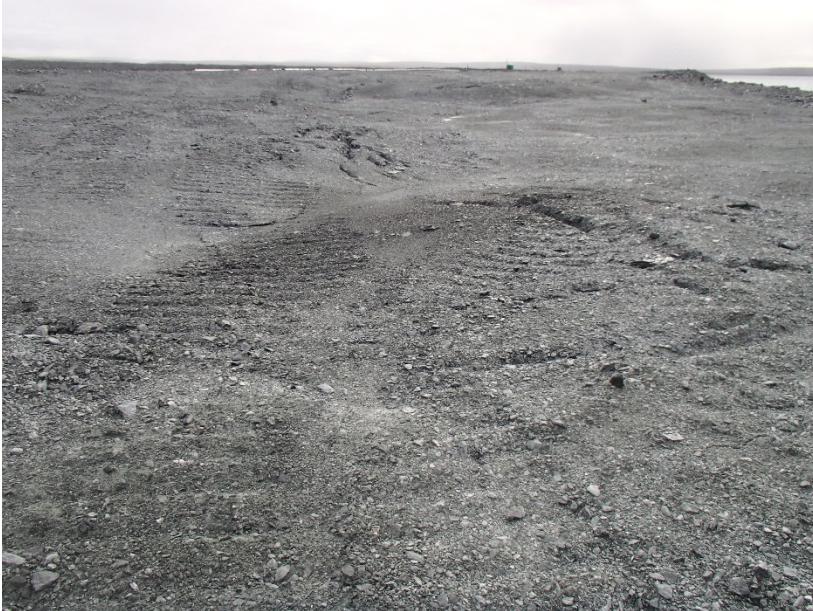
Photograph A3-45 Bay Goose Dike

Description: From approximately Sta. 32+025 (south abutment) looking east at the crest. Zone of high magnitude settlement in the ultramafic cap. The tension cracks seem no longer active.

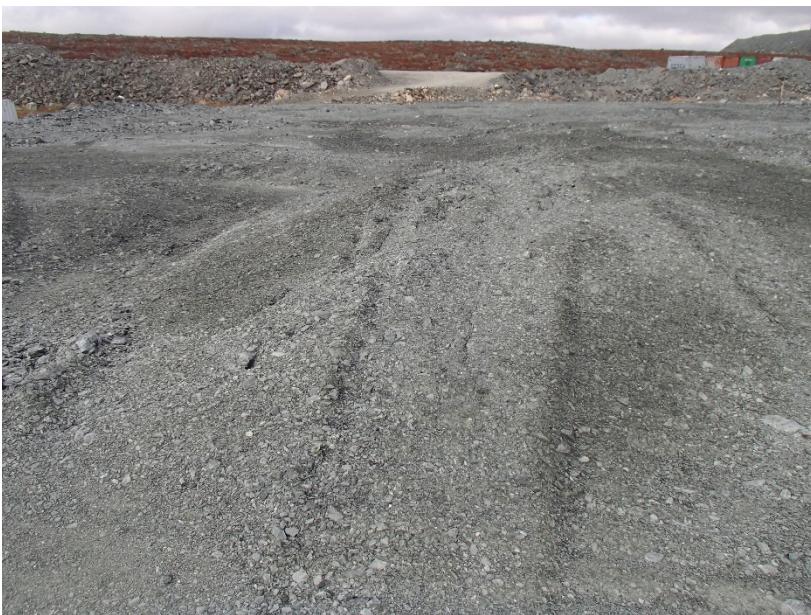
Photograph A3-46 Bay Goose Dike

Description: From approximately Sta. 32+025 (south abutment) looking west at the crest. Zone of high magnitude settlement in the ultramafic cap. The tension cracks seem no longer active.
