**Fish and Fish Habitat Assessment  
of the Niaqunguk (Apex) River,  
Lake Geraldine, and the Lake  
Geraldine Drainage Channel**

*FINAL REPORT*

September 2017

*Prepared by:*  
**Nunami Stantec Limited**  
Rankin Inlet, Nunavut

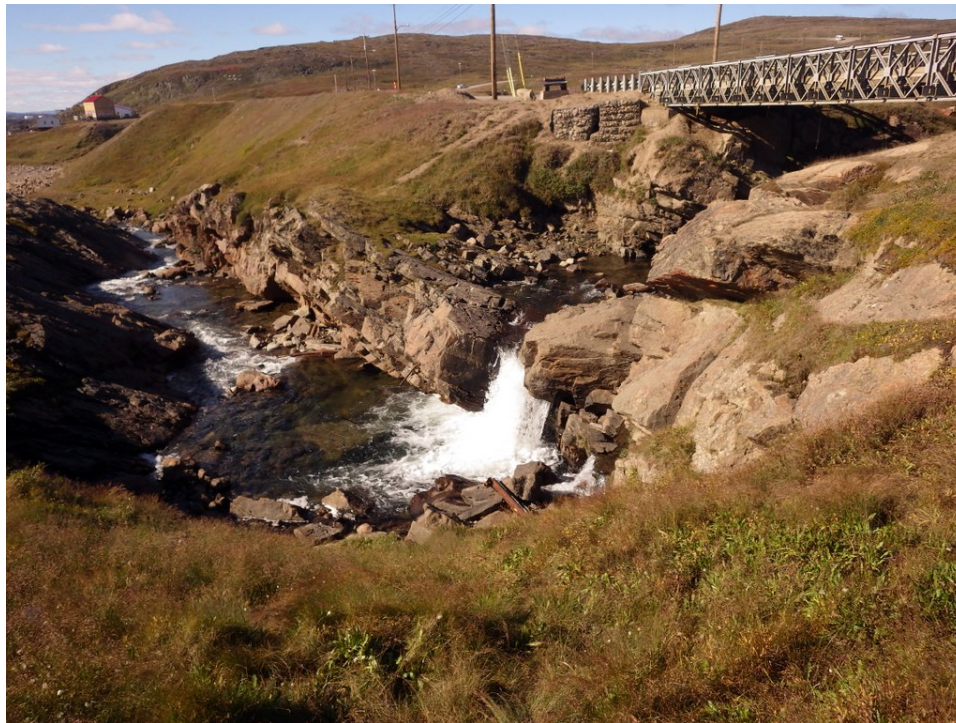
At the mouth of the Apex River, exposed bedrock shelves create a series of waterfalls, the largest being over 2 m in height (Photo 3-2). This waterfall creates a barrier to upstream fish movement at the community of Apex, approximately 350 m upstream from the Koojesse Inlet. The lowest reach assessed, AR-01 (Figure 3-1), is just upstream this waterfall, near the Bypass Road in the community of Apex.

**Photo 3-2 Fish Passage Barrier (Waterfall) at the Community of Apex; Northwest Aspect**

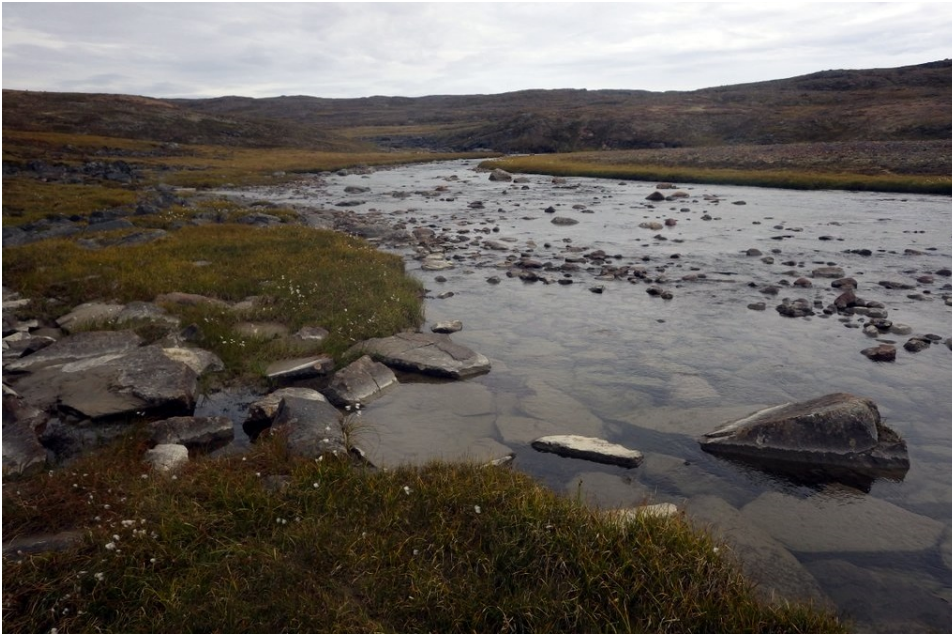
At the upstream end of reach A2, the river flows from a small lake locally known as the “Swimming Lake”. The lake is approximately 35 m wide and 50 m long, with depths exceeding 2 m. Substrates are smaller gravels and cobbles near the lake’s outlet, with cobbles and boulders. The lake has bedrock outcroppings forming cover at the upstream end, and is protected by a valley wall on the east. Habitat in the lake would consist of cover from depth as well as bedrock and boulder structures on the bed and around the edges. Arctic char were observed in the “Swimming Lake” and in the river immediately upstream of the lake.

**Photo 3-8      Reach A2 Looking Upstream Towards the "Swimming Lake"; Northeast Aspect**

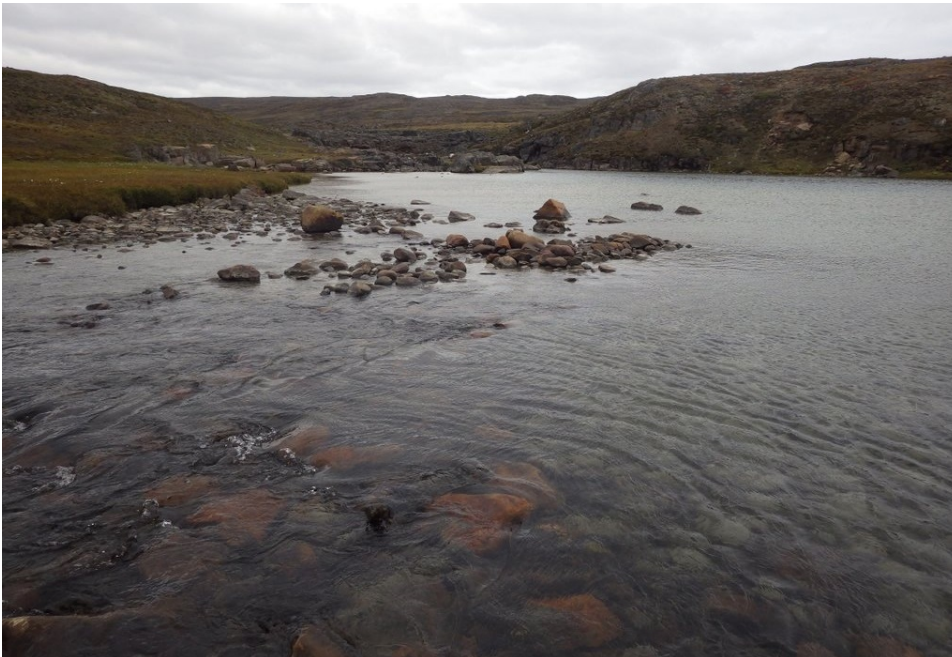
**Photo 3-9      Looking Upstream from Reach A2 into the "Swimming Lake"; Northeast Aspect**

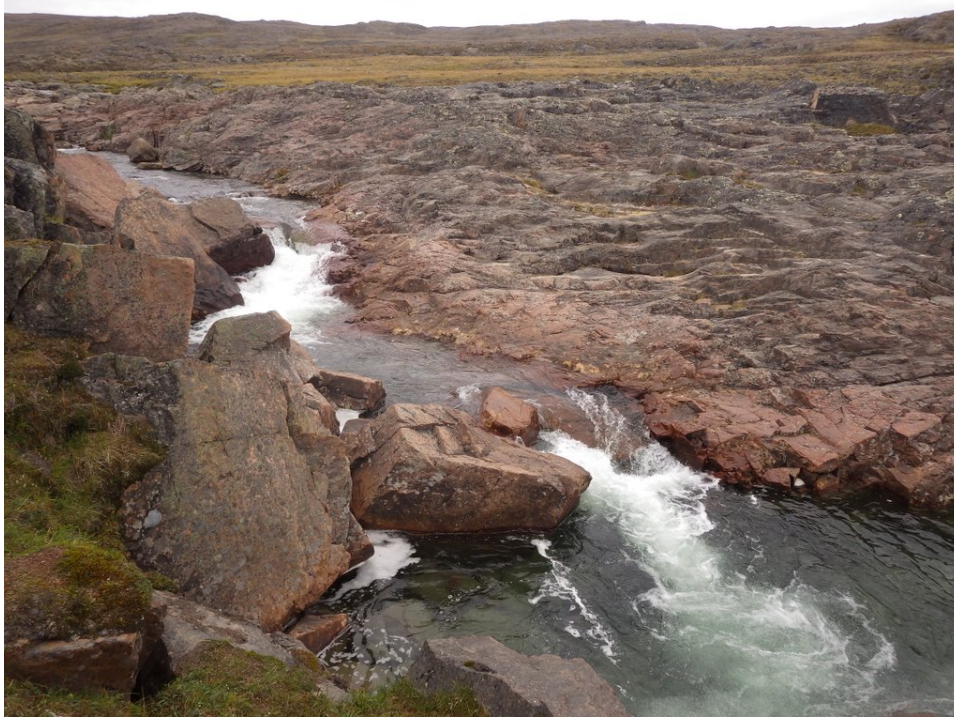
Upstream of the "Swimming Lake", the river is confined in a tighter steep valley with bedrock outcrops creating a series of cascade and rapid sections (Photo 3-10 to Photo 3-12). Substrates are large coarse materials and exposed bedrock. There are a series of cascades forming drops that may limit upstream fish movement, although they do not appear to be high enough to be complete barriers. The presence of scour pools for resting and jumping, small bypass channels, and stepped drops along the edge of the cascade, likely provide passage through the canyons.

NOTE: Fish observed in the pool below the falls

**Photo 3-10 Cascade Upstream of the "Swimming Lake" (19V 526407 m E, 7069344 m N)**

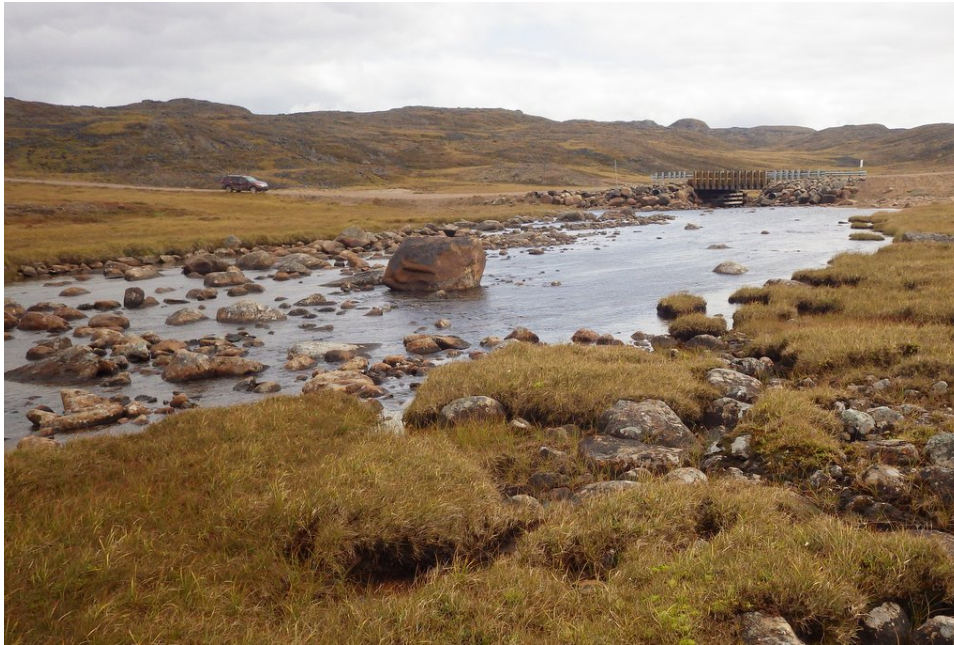
The reach at A1 consists of boulder garden/run habitat along much of the channel length and width, with a narrow riffle zone along the east bank (Photo 3-14). The channel width varies from 25 to 32 m wide, with a wetted width from 22 to 32 m. The channel has depths ranging up to 1.38 m recorded in between large boulders that have a diameter of 1.5 m (Photo 3-15). The dominant substrate is large boulders, followed by cobbles. The banks are stable and vegetated by grasses. Although fish were not captured in this reach it appears that it could provide good fish habitat for fish, with high amounts of cover between the boulders. There are also riffles along the east bank adjacent to steep banks providing cover and potential food production.

**Photo 3-14** Looking Downstream at the Road to Nowhere Bridge from the Mid-Section of Reach A1

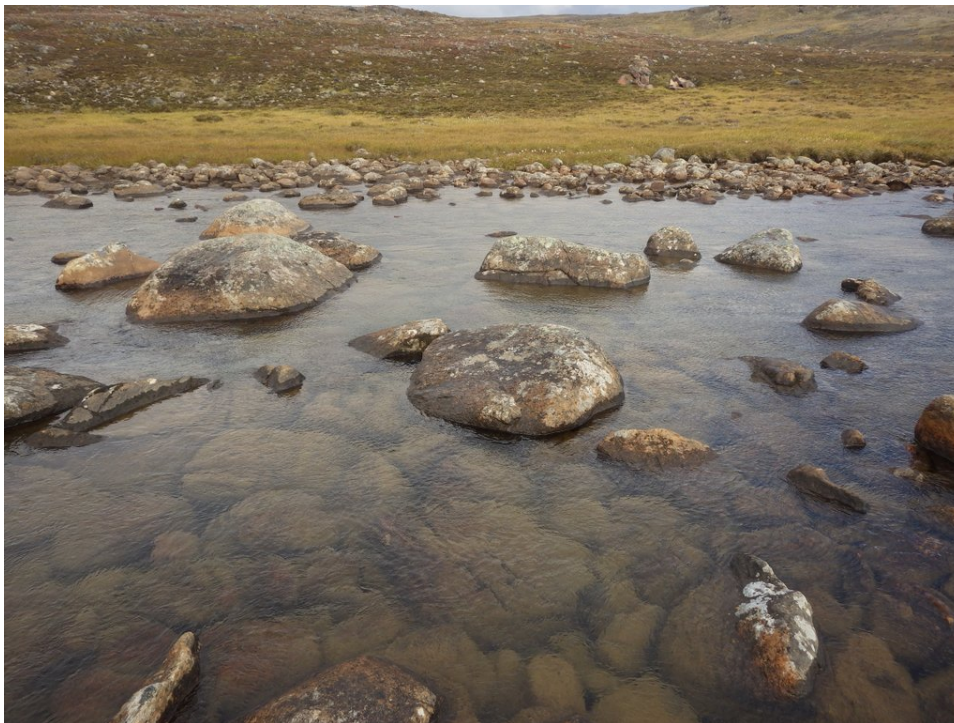
NOTE: Recorded depth at this transect was 1.38 m between the boulders

**Photo 3-15** Mid-Reach of A1 showing the Large Boulders and Deep Interstitial Spaces

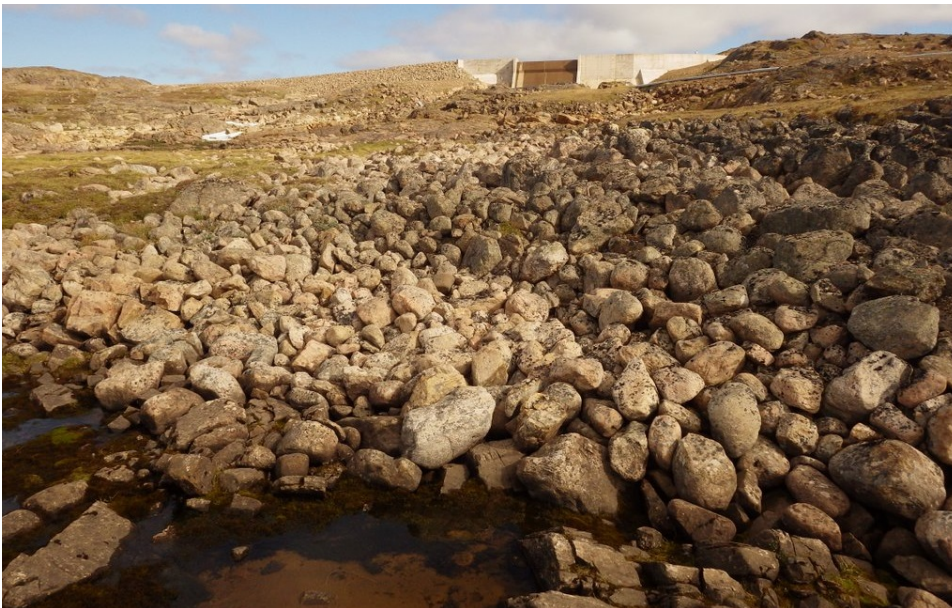
**Photo 3-23 Boulder Field Downstream of Lake Geraldine Dam**

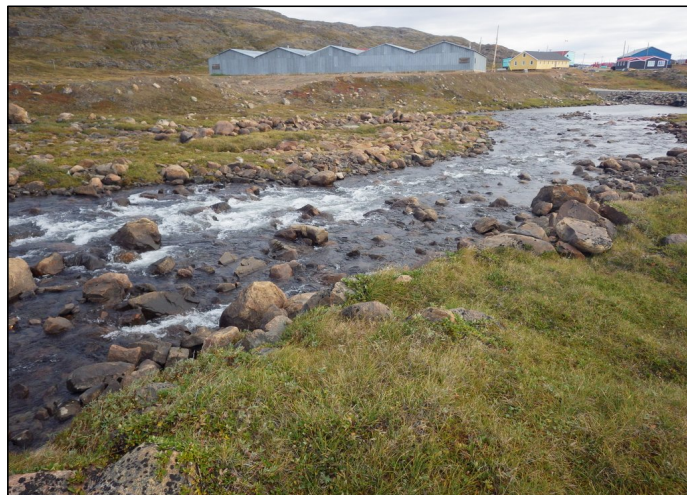
Photo 1: Looking downstream at bottom half of reach. Bypass Road in distance

Downstream end of reach is impounded by the Bypass Road crossing. Steep run with boulder garden at the upstream 2/3 of the reach. Island separating a small channel on the east from the main channel. No fish observed.

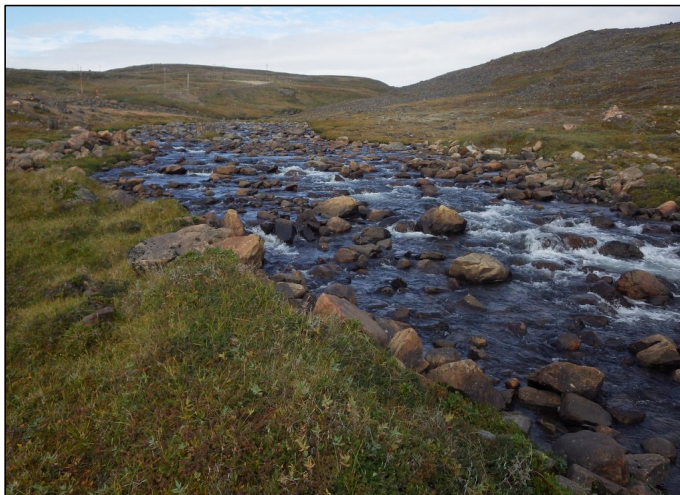
Photo 2: Looking upstream from center of reach.

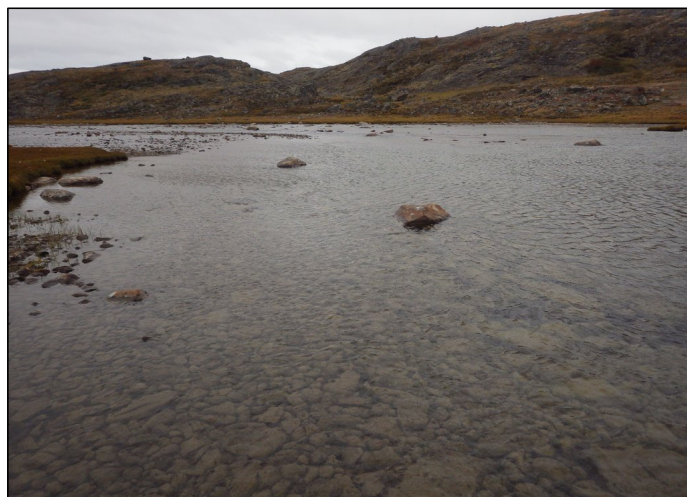
Photo 1: Looking upstream from center of reach AR-02

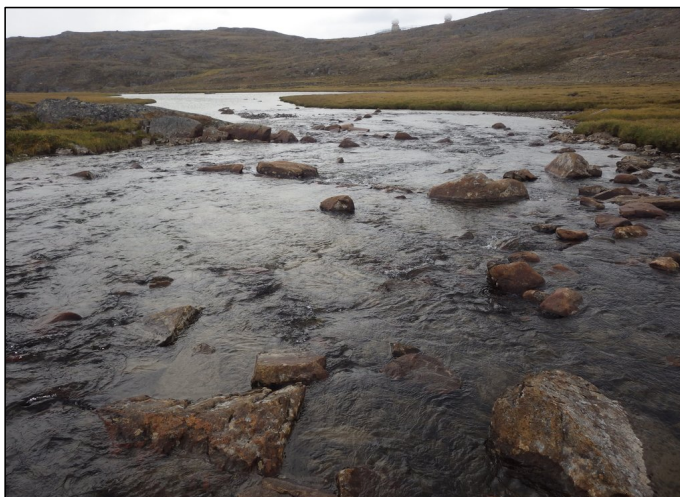
Photo 2: Looking downstream from center of reach AR-02
