Remedial Options Analysis and Remedial Action Plan, Coral Harbour Fossil Creek Bridge Decommissioning and Remediation

Final Report

December 19, 2025

Project No.: 123515435

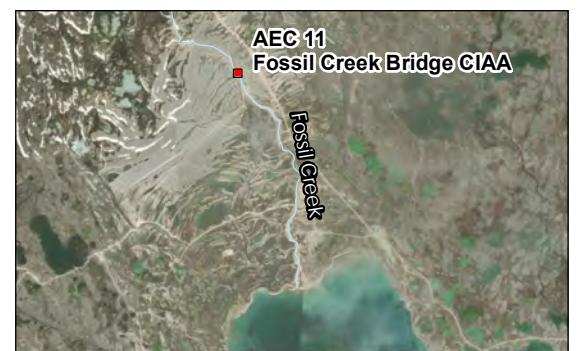
- Estimated Location of Debris Identified During 2025 Supplemental Assessment
- Approximate Location of Buried Timbers
- Estimated Location of Contaminated Soil

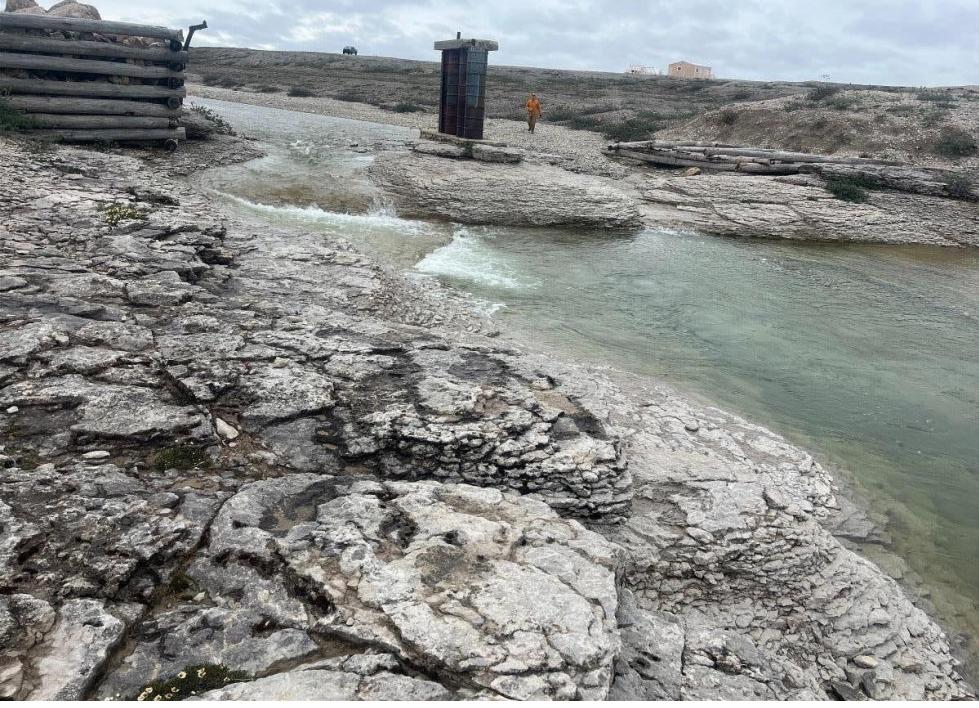
Client: Public Services and Procurement Canada	Project: Coral Harbour Fossil Creek Bridge Remedial Action Plan
Site Name: Fossil Creek Bridge	Site Location: Coral Harbour, NU
Photograph ID: 1	
Photo Location: Fossil Creek Bridge Infrastructure	
Direction: North	
Survey Date: 7/15/2025	
Comments: View of the remaining infrastructure, facing upstream.

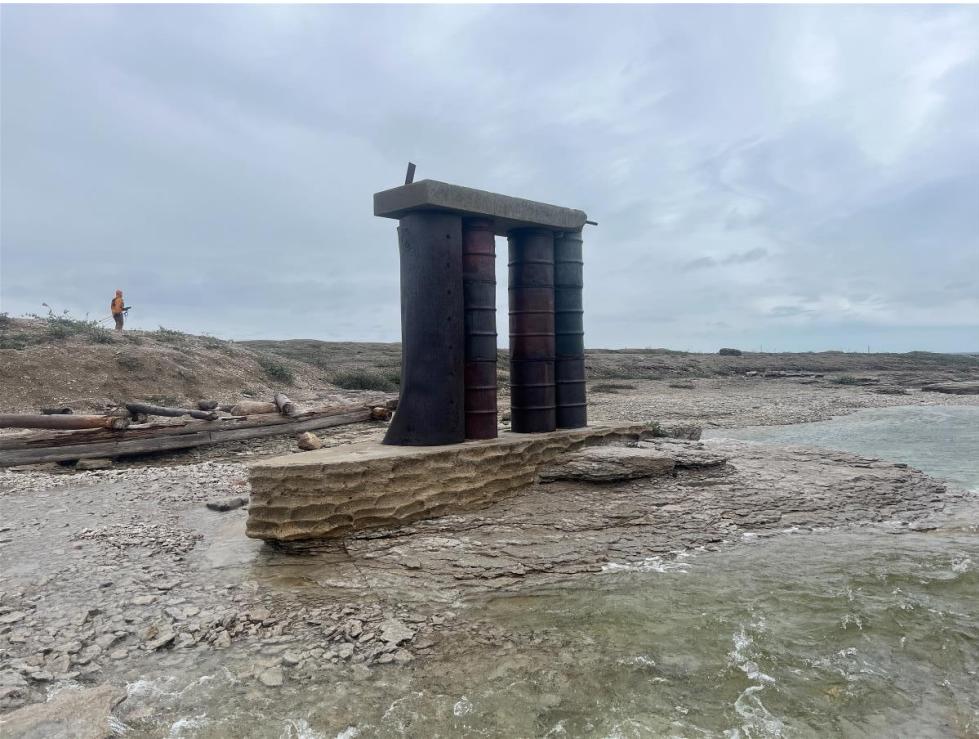
Photograph ID: 2	
Photo Location: Central Pier	
Direction: Southeast	
Survey Date: 7/15/2025	
Comments: View of the central pier infrastructure.

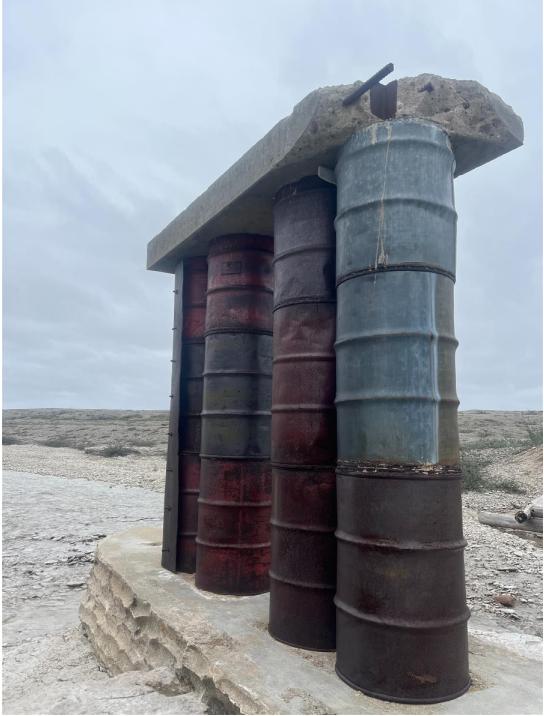
Client: Public Services and Procurement Canada	Project: Coral Harbour Fossil Creek Bridge Remedial Action Plan		
Site Name: Fossil Creek Bridge	Site Location: Coral Harbour, NU		
Photograph ID: 3 Photo Location: Central Pier Direction: North Survey Date: 7/15/2025 Comments: View of the central pier infrastructure.

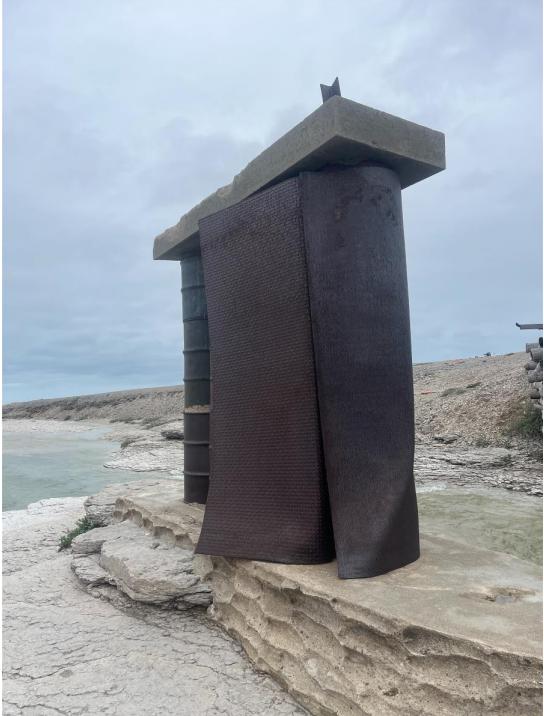
Photograph ID: 4 Photo Location: Central Pier Direction: Southeast Survey Date: 7/15/2025 Comments: View of the central pier infrastructure.

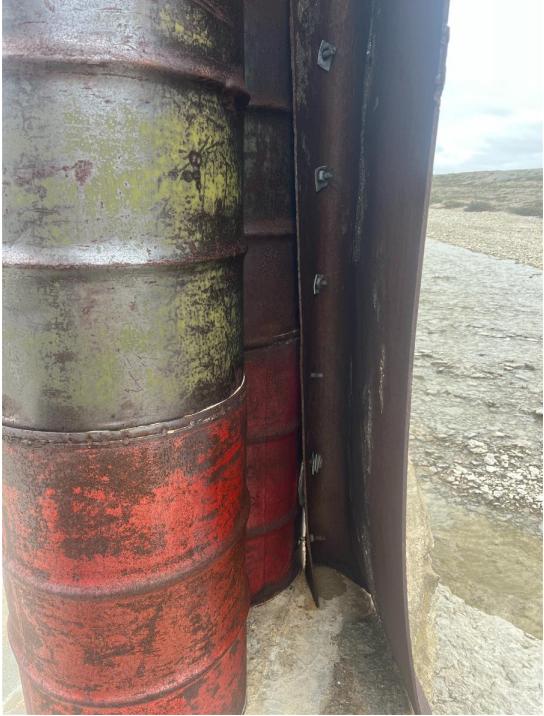
Photo Location:			
Direction:			
Survey Date:			
Comments:			
View of steel plate bolted to central pier.			
Photograph ID: 6

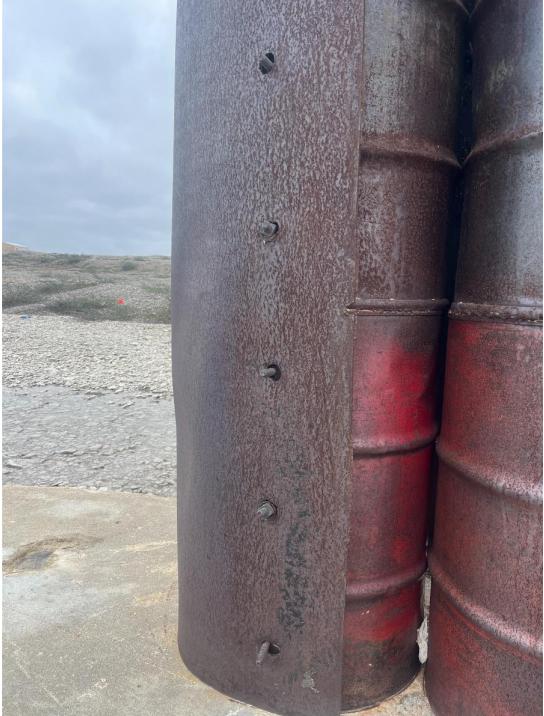
Photo Location:			
Direction:			
Survey Date:			
Comments:			
View of steel plate bolted to central pier.

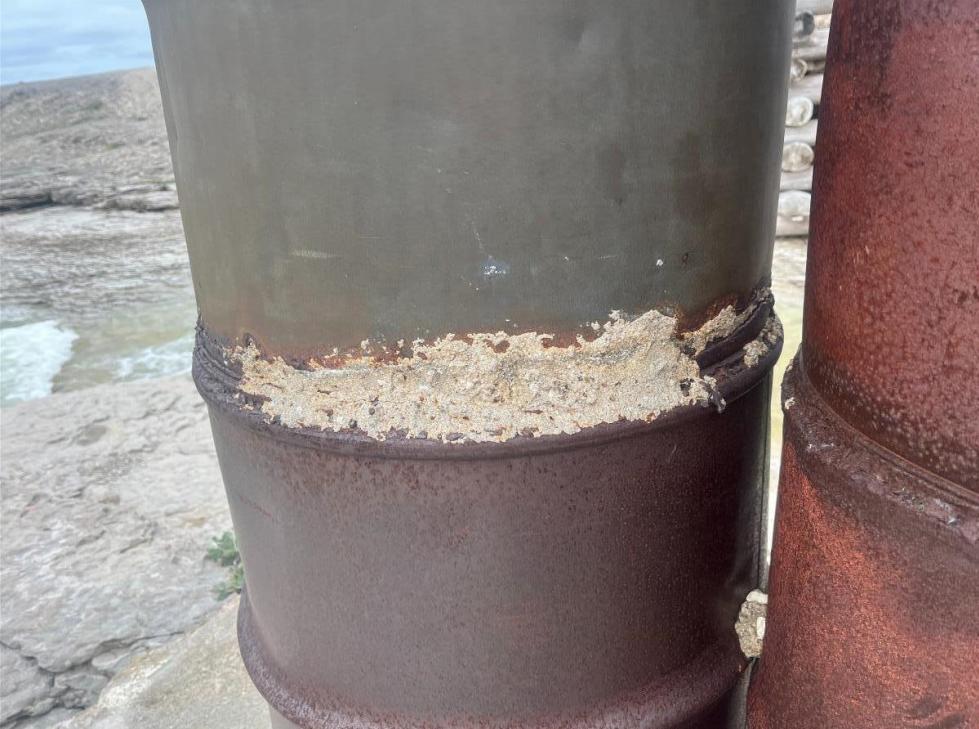
Photo Location: Central Pier			
Direction: Southwest			
Survey Date: 7/15/2025			
Comments: View of concrete in the welded barrel columns.			
Photograph ID: 8

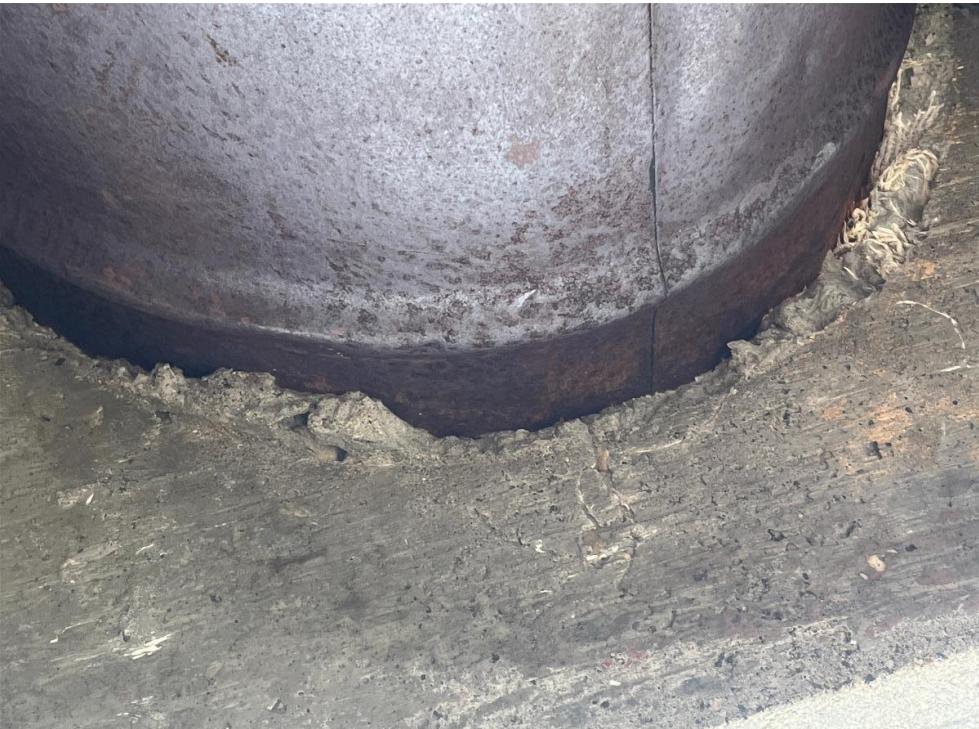
Photo Location: Central Pier			
Direction: Southwest			
Survey Date: 7/15/2025			
Comments: View of bottom of welded barrel column recessed into concrete base.

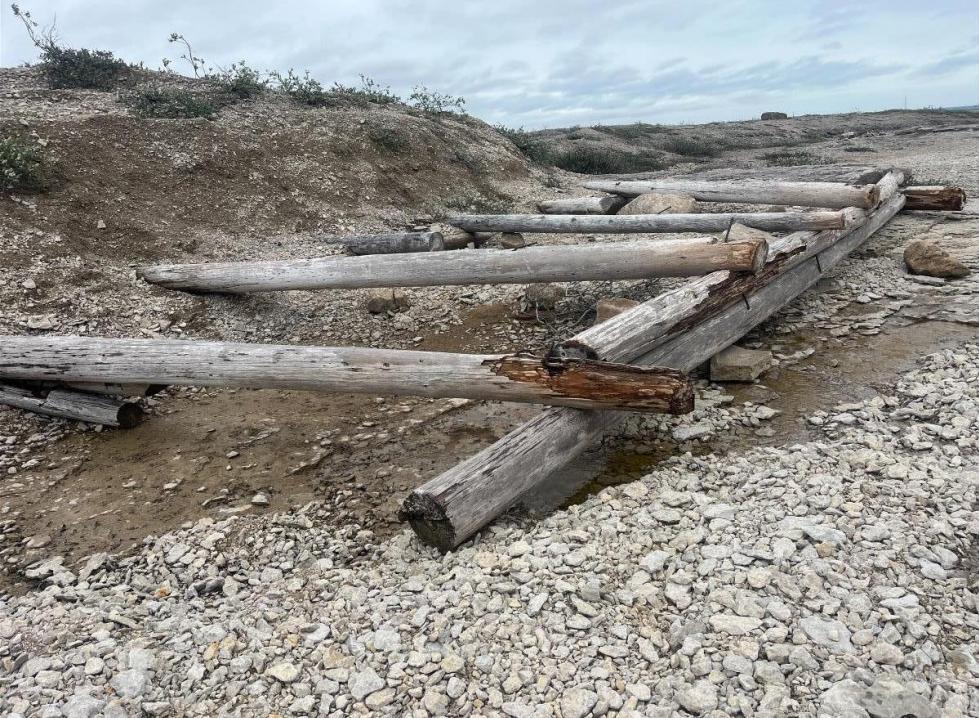
Client: Public Services and Procurement Canada	Project: Coral Harbour Fossil Creek Bridge Remedial Action Plan		
Site Name: Fossil Creek Bridge	Site Location: Coral Harbour, NU		
Photograph ID: 9	Photo Location: Eastern Abutment		
Direction: South	Survey Date: 7/15/2025		
Comments: View of the north side and front of the eastern abutment.

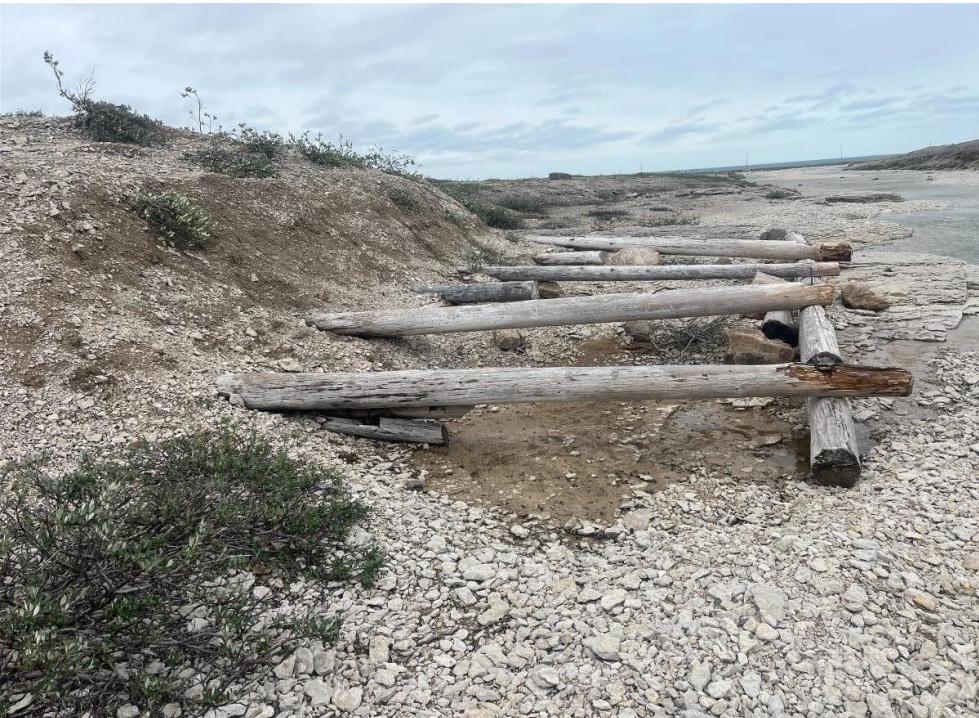
Photograph ID: 10	Photo Location: Eastern Abutment		
Direction: South	Survey Date: 7/15/2025		
Comments: View of the north side of the eastern abutment.

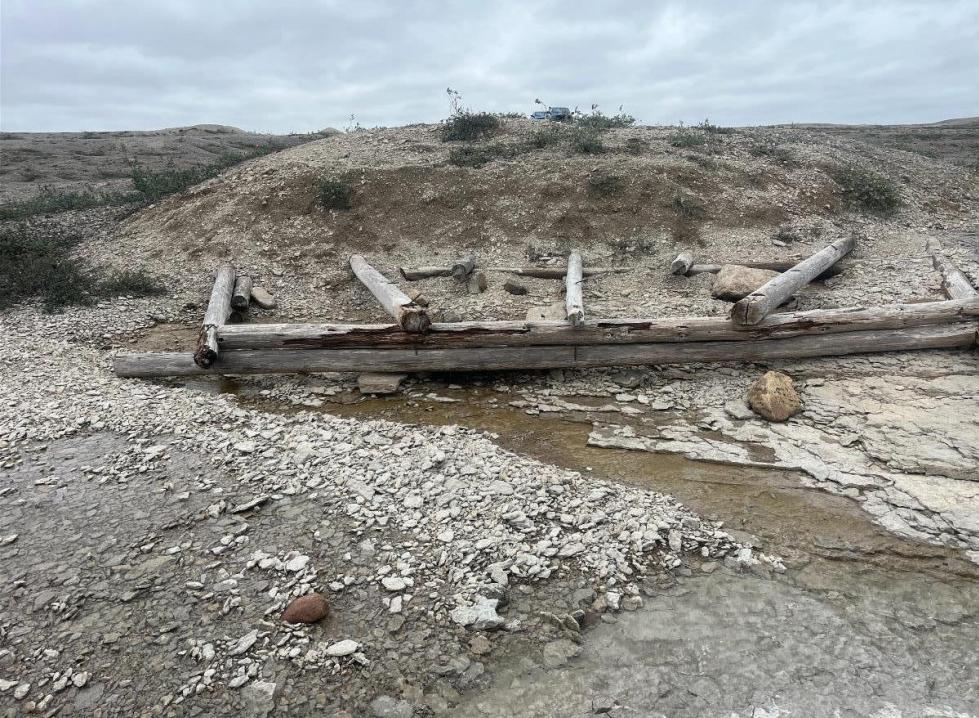
Client: Public Services and Procurement Canada	Project: Coral Harbour Fossil Creek Bridge Remedial Action Plan
Site Name: Fossil Creek Bridge	Site Location: Coral Harbour, NU
Photograph ID: 11	
Photo Location: Eastern Abutment	
Direction: North	
Survey Date: 7/15/2025	
Comments: View of the front side of the eastern abutment.

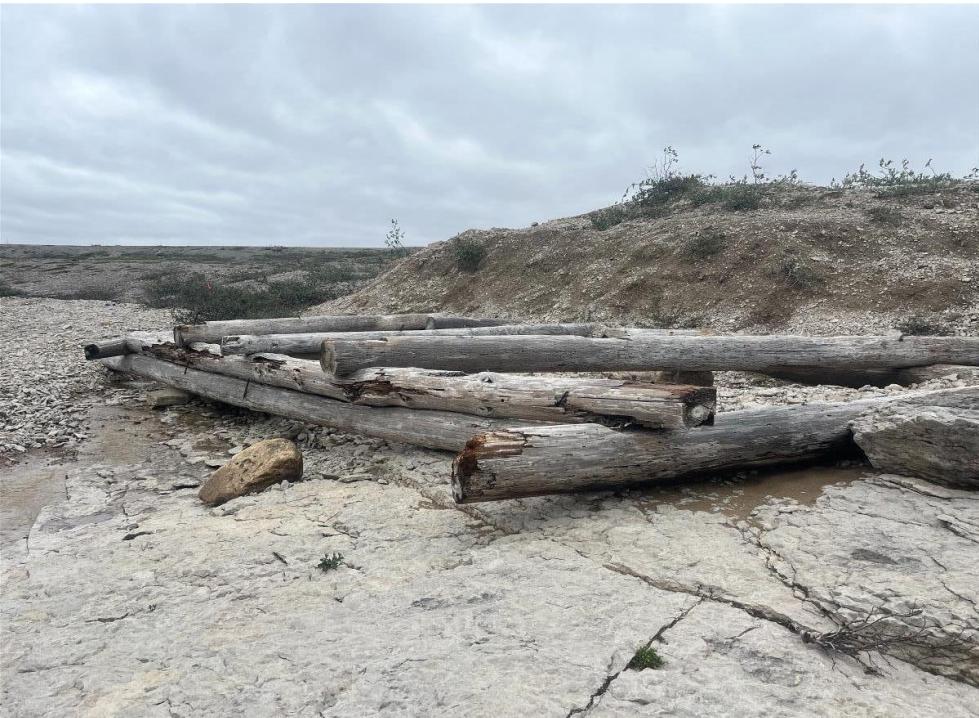
Photograph ID: 12	
Photo Location: Eastern Abutment	
Direction: North	
Survey Date: 7/15/2025	
Comments: View of the south and front side of the eastern abutment.

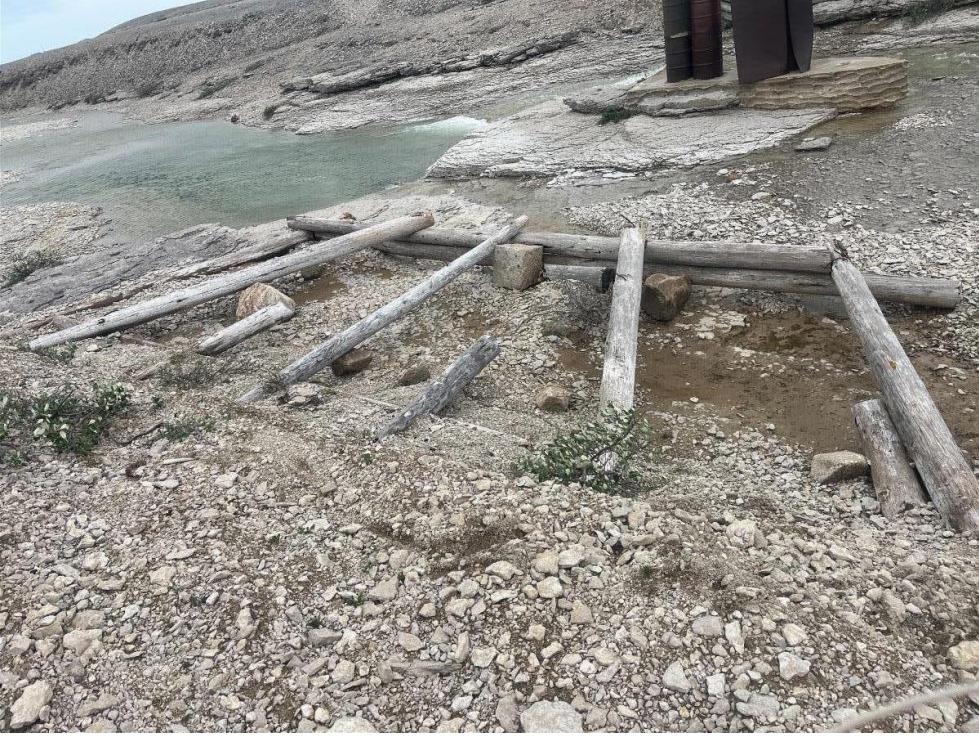
Photo Location: Eastern Abutment			
Direction: Southwest			
Survey Date: 7/15/2025			
Comments: View of the eastern abutment.			
Photograph ID: 14

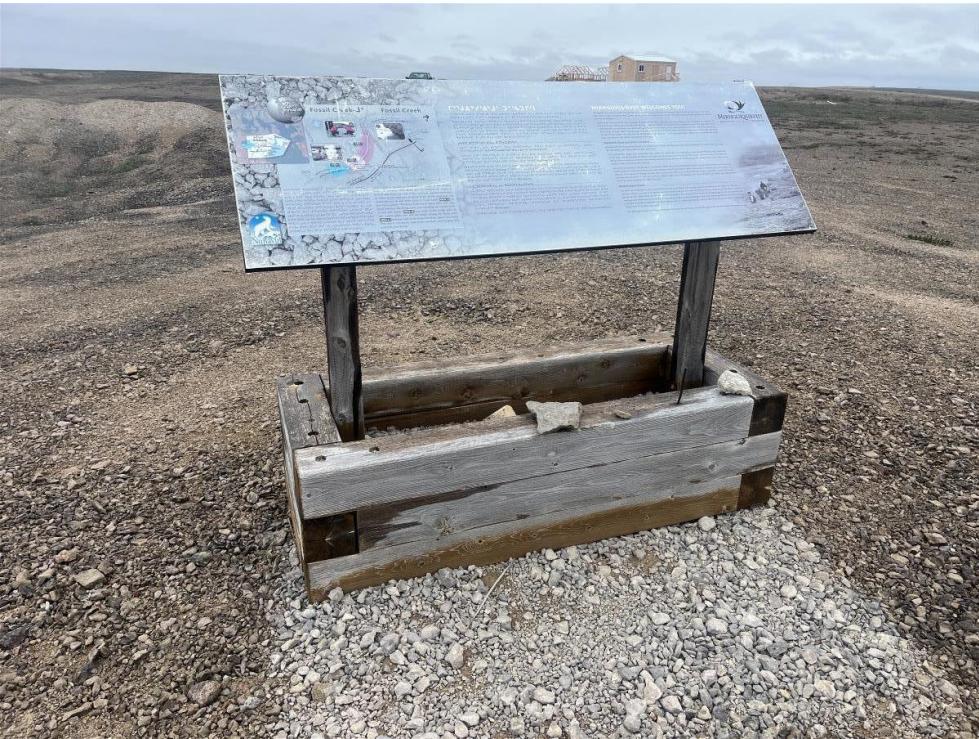
Photo Location: Eastern Abutment			
Direction: North			
Survey Date: 7/15/2025			
Comments: View of the single information placard on the eastern side of Fossil Creek.

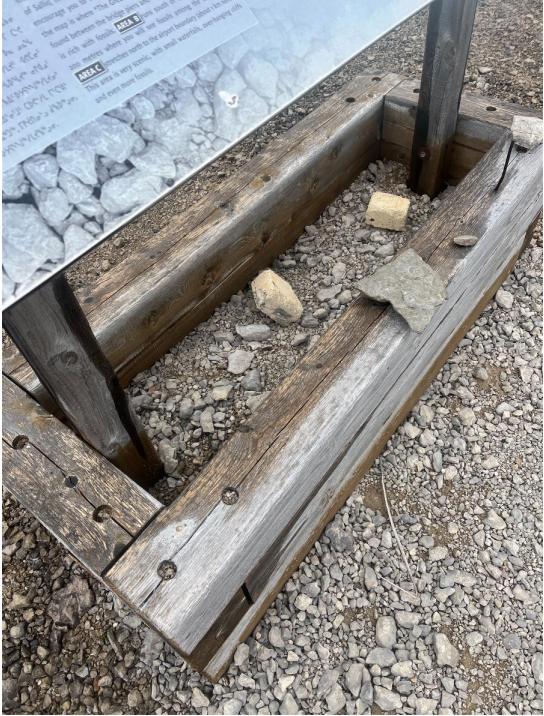
Photo Location: Eastern Abutment			
Direction: North			
Survey Date: 7/15/2025			
Comments: Base of eastern abutment placard, constructed of 4x4 timbers and filled with granular material.			
Photograph ID: 16

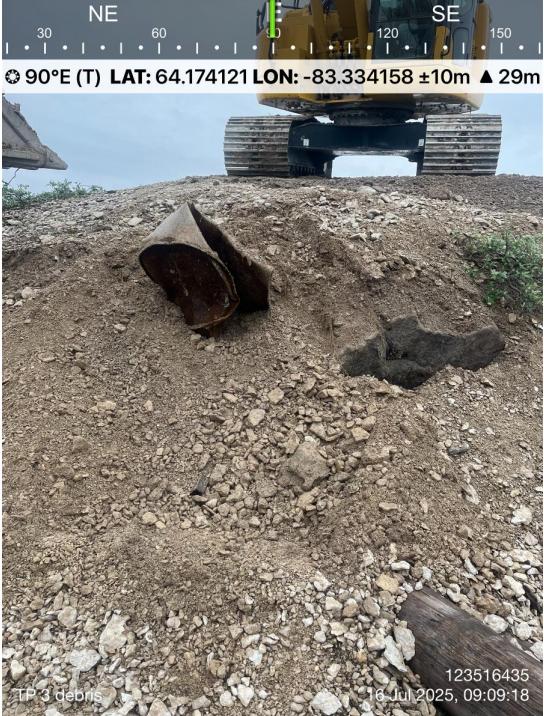
Photo Location: Eastern Abutment			
Direction: East			
Survey Date: 7/16/2025			
Comments: View of crushed, empty drum encountered in TP3 during 2025 SA test pit program.

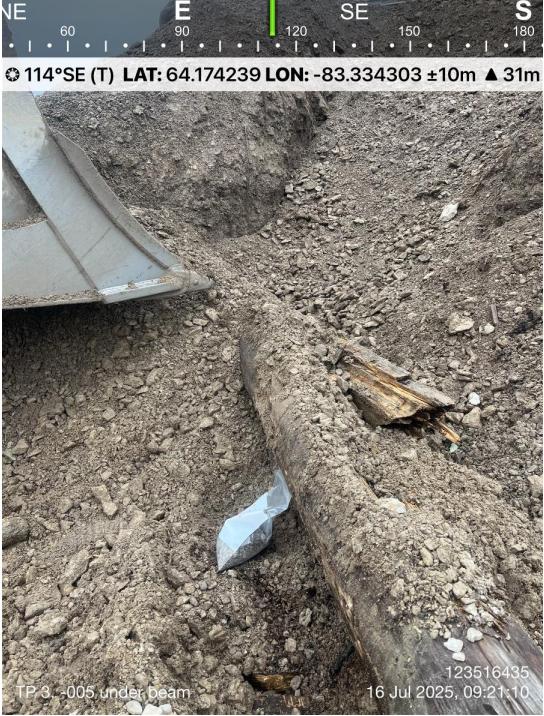
<p>NE 60 90 120 150 180 E SE 120 150 180 S</p> <p>114°SE (T) LAT: 64.174239 LON: -83.334303 ±10m ▲ 31m</p> <p>123516435 TP-3-005 under beam 16 Jul 2025, 09:21:10</p>
Photo Location: Eastern Abutment	
Direction: East	
Survey Date: 7/16/2025	
Comments: View of unearthed timber in TP3 during 2025 SA test pit program.	
Photograph ID: 18

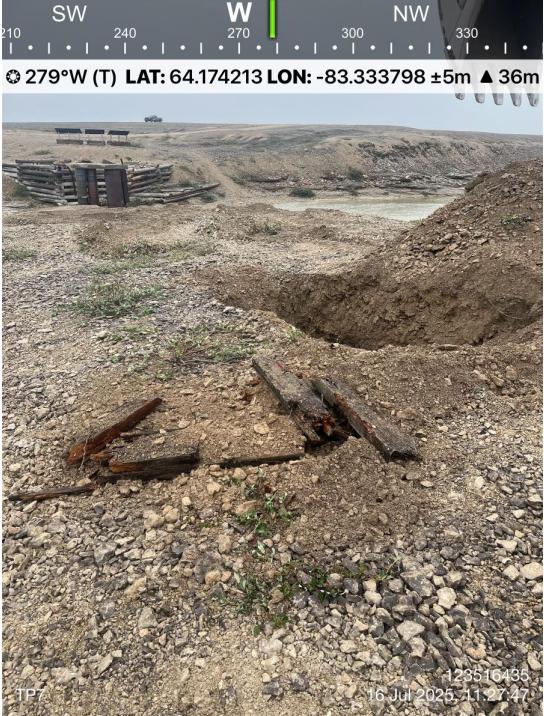
<p>SW 210 240 270 300 330 W NW</p> <p>279°W (T) LAT: 64.174213 LON: -83.333798 ±5m ▲ 36m</p> <p>123516435 TP7 16 Jul 2025, 11:27:47</p>
Photo Location: Eastern Abutment	
Direction: West	
Survey Date: 7/16/2025	
Comments: Hydrocarbon-treated wood debris encountered in TP7 during 2025 SA test pit program.

The estimated 23.8 m^3 of hazardous waste identified at the Site would require off-site disposal in southern Canada and includes the creosote-timbers associated with the bridge, along with the treated wood debris identified in test pits TP7 and TP12 during the 2025 SA.

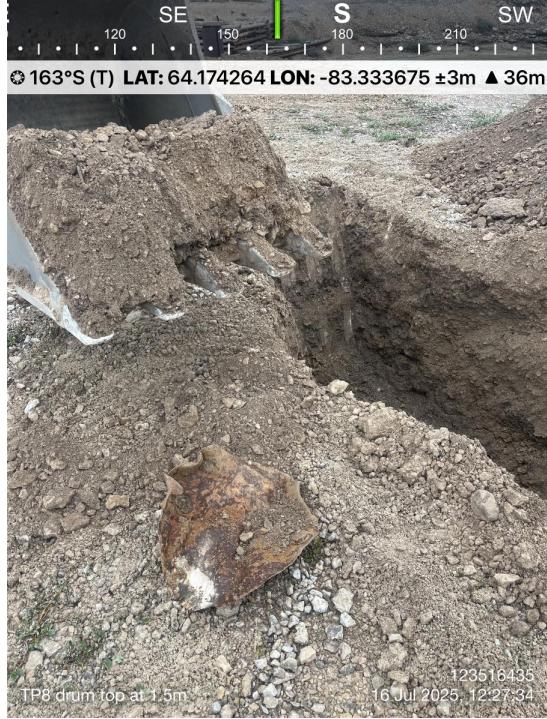
Photo Location: Eastern Abutment			
Direction: South			
Survey Date: 7/16/2025			
Comments: View of drum top encountered in TP8 during 2025 SA test pit program.			
Photograph ID: 20

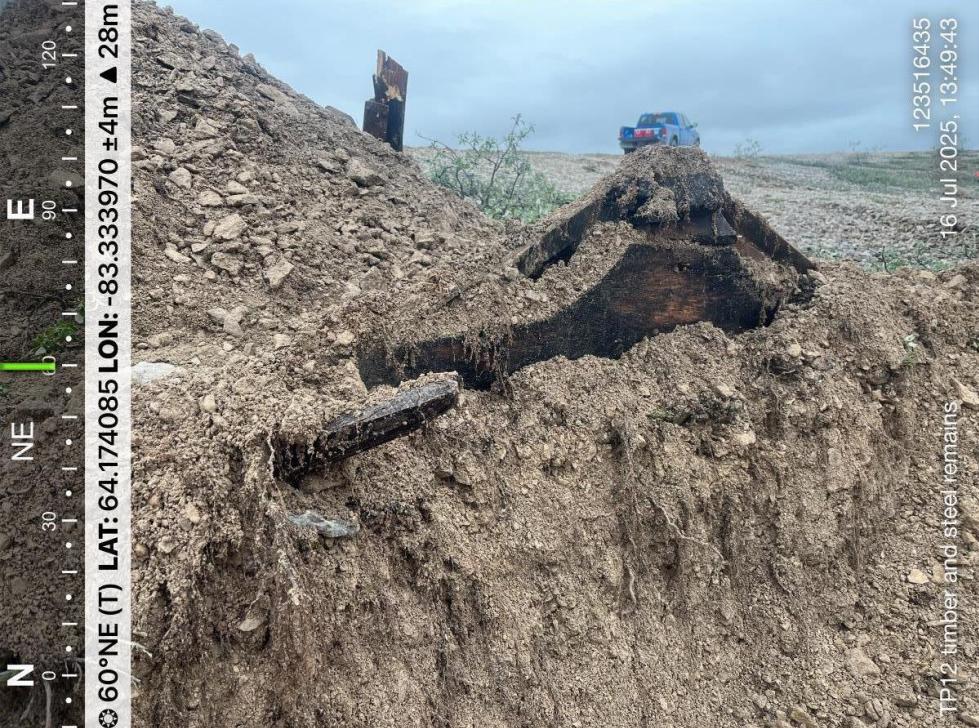
Photo Location: Eastern Abutment			
Direction: Northeast			
Survey Date: 7/16/2025			
Comments: Hydrocarbon-treated wood debris encountered in TP12 during 2025 SA test pit program.

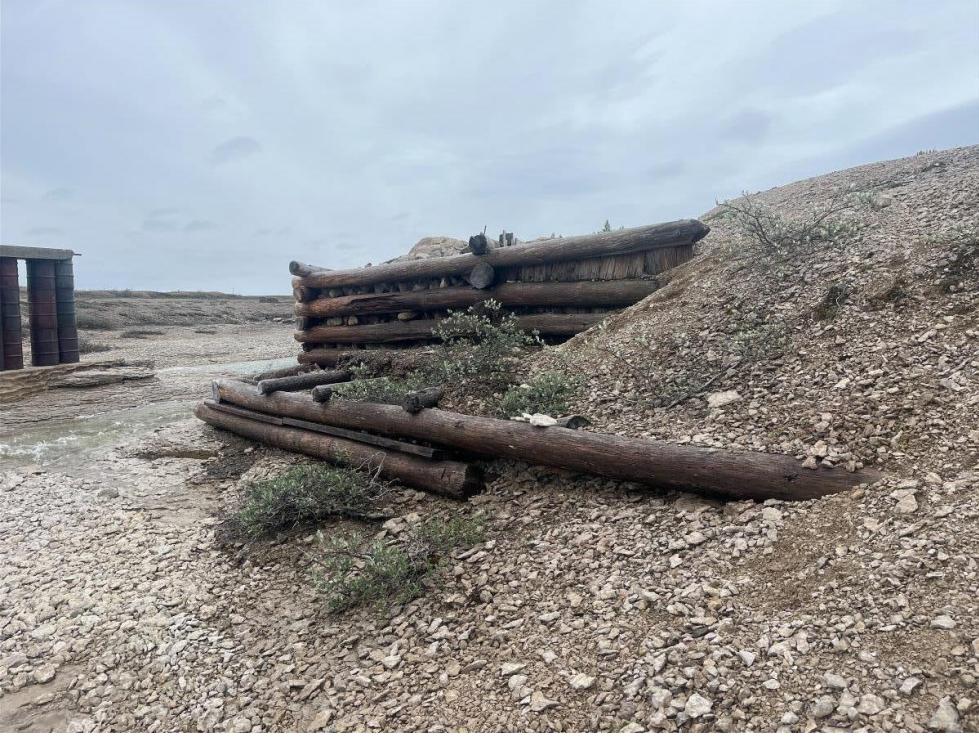
Photograph ID: 22	Photo Location: Western Abutment		
Direction: Southwest	Survey Date: 7/15/2025		
Comments: View of the north side of the western abutment. The mixed hardened tar/rock material is visible in middle of photo.

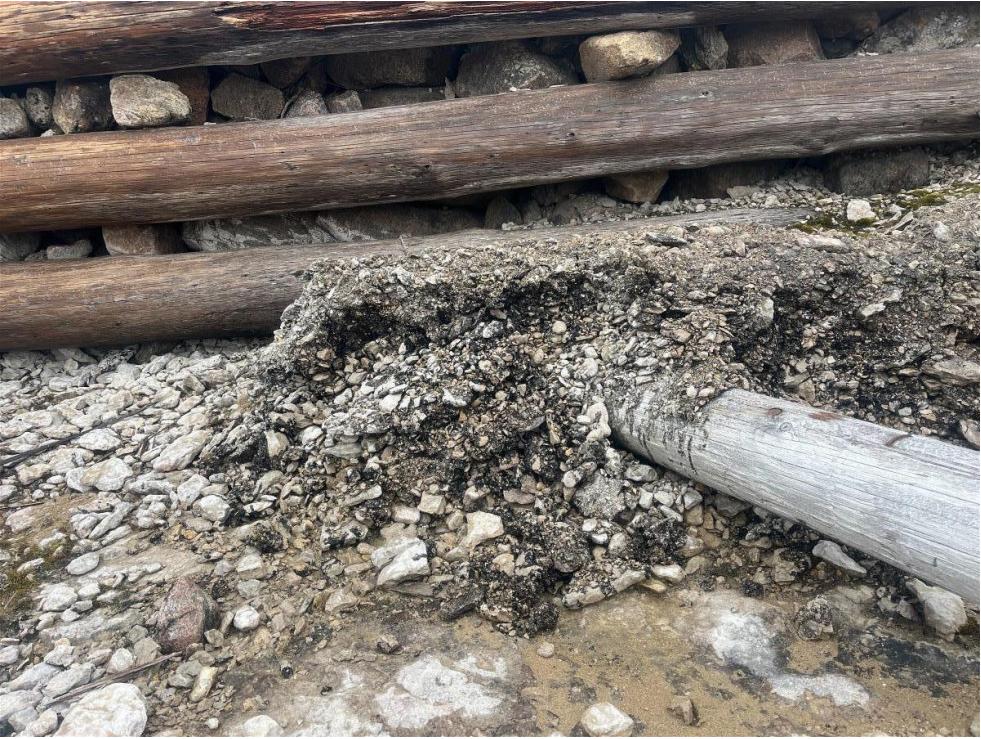
Photo Location: Western Abutment			
Direction: South			
Survey Date: 7/15/2025			
Comments: A closer view of the mixed hardened tar/rock material.			
Photograph ID: 24

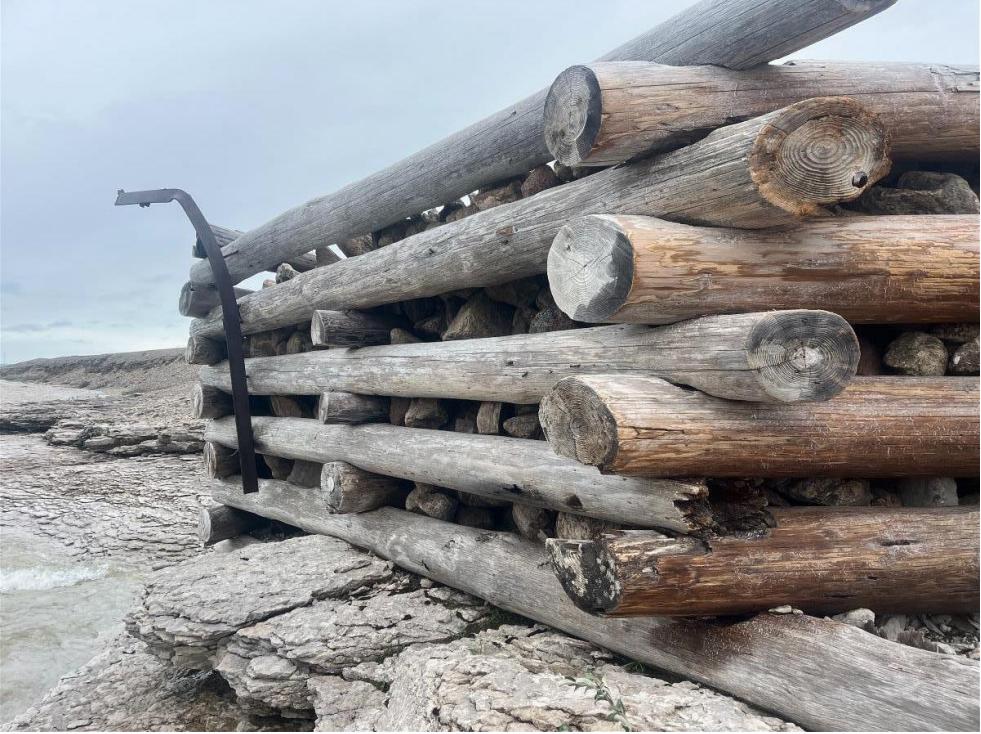
Photo Location: Western Abutment			
Direction: South			
Survey Date: 7/15/2025			
Comments: View of the front side of the western abutment. Bottom timbers are sitting on exposed limestone bedrock.

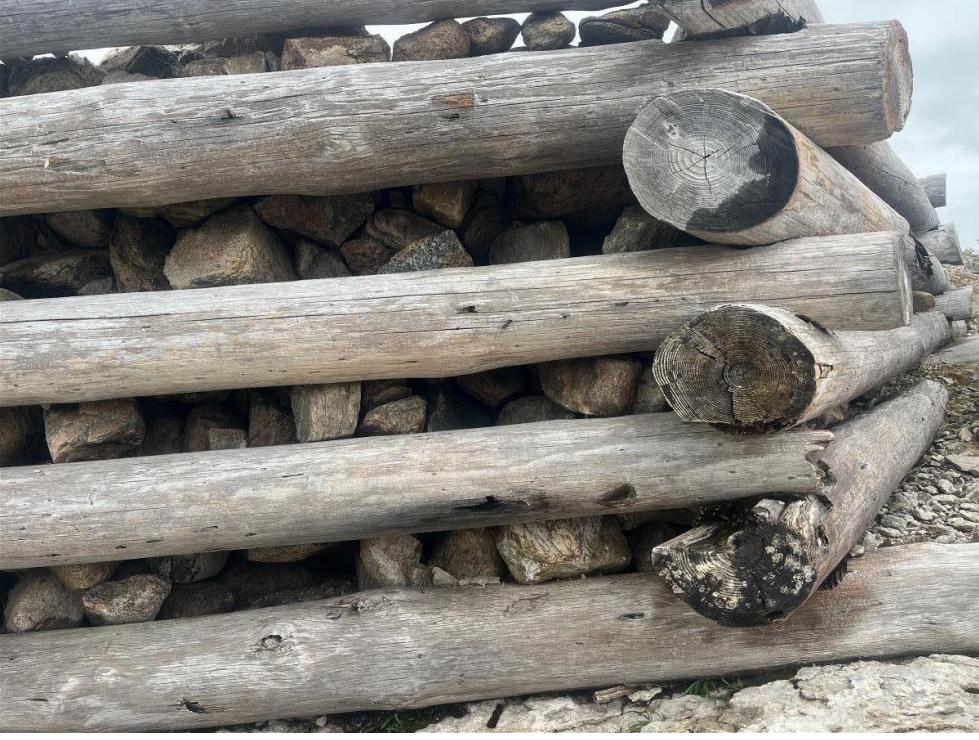
Photograph ID: 26	
Photo Location: Western Abutment	
Direction: East	
Survey Date: 7/15/2025	
Comments: View of the top of the western abutment cribbing. Large boulders are present within the top layer of cribbing fill.

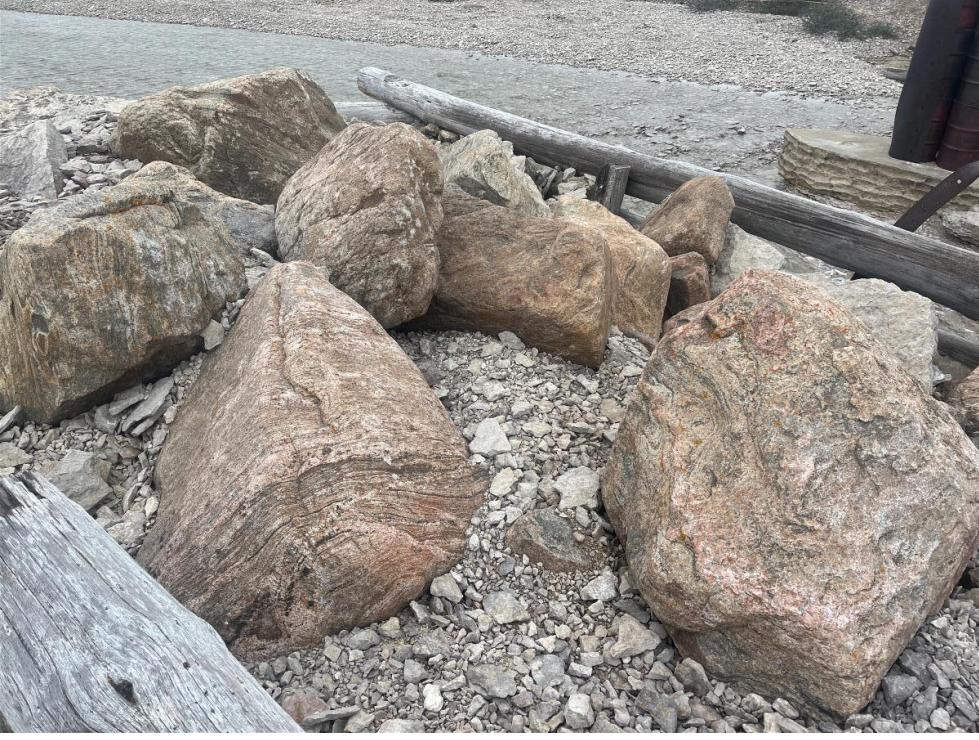
Client: Public Services and Procurement Canada	Project: Coral Harbour Fossil Creek Bridge Remedial Action Plan
Site Name: Fossil Creek Bridge	Site Location: Coral Harbour, NU
Photograph ID: 27	
Photo Location: Western Abutment	
Direction: North	
Survey Date: 7/15/2025	
Comments: View of the top of the western abutment cribbing. Large boulders are present within the top layer of cribbing fill.

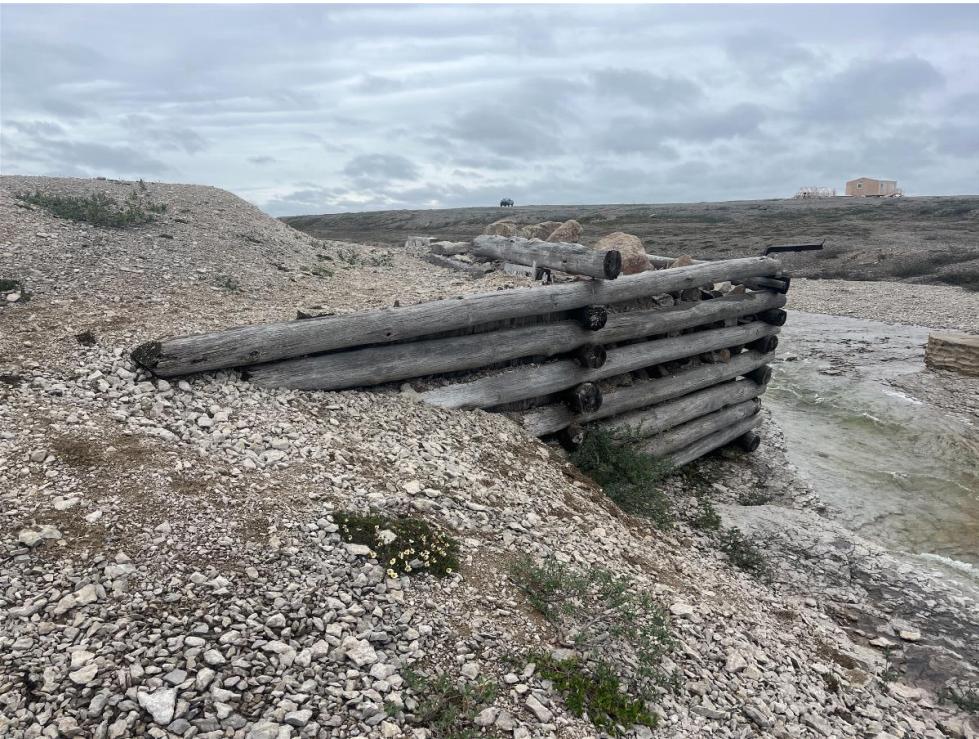
Photograph ID: 28	
Photo Location: Western Abutment	
Direction: North	
Survey Date: 7/15/2025	
Comments: View of the south side of the western abutment.

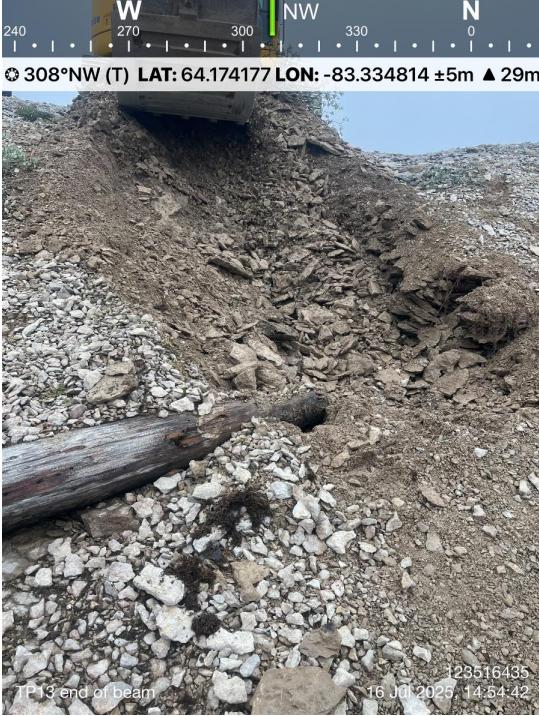
<div style="display: flex; justify-content: space-between; align-items: center;"> W 240 270 300 330 N </div> <p>308°NW (T) LAT: 64.174177 LON: -83.334814 ±5m ▲ 29m</p> <p>TP13 end of beam</p> <p>123516435 16 JUL 2025, 14:54:42</p>		
Photo Location: Western Abutment			
Direction: Northwest			
Survey Date: 7/16/2025			
Comments: End of timber encountered in TP13 during 2025 SA test pit program.			
Photograph ID: 30

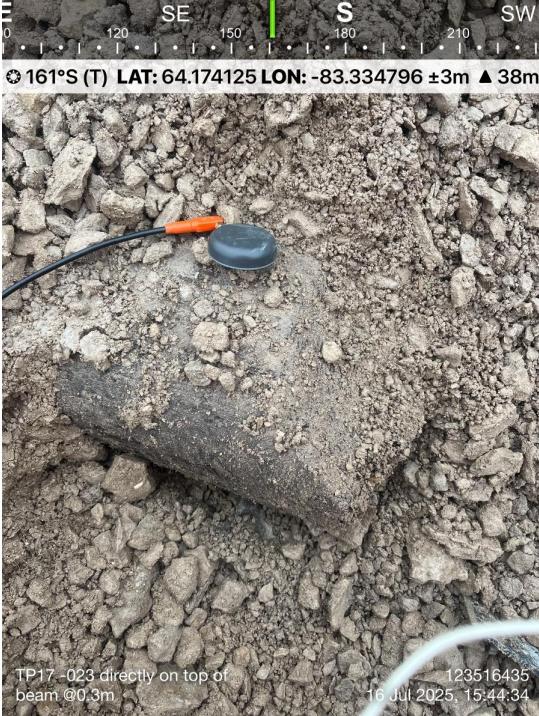
Direction: South			
Survey Date: 7/16/2025			
Comments: End of timber encountered in TP17 during 2025 SA test pit program.

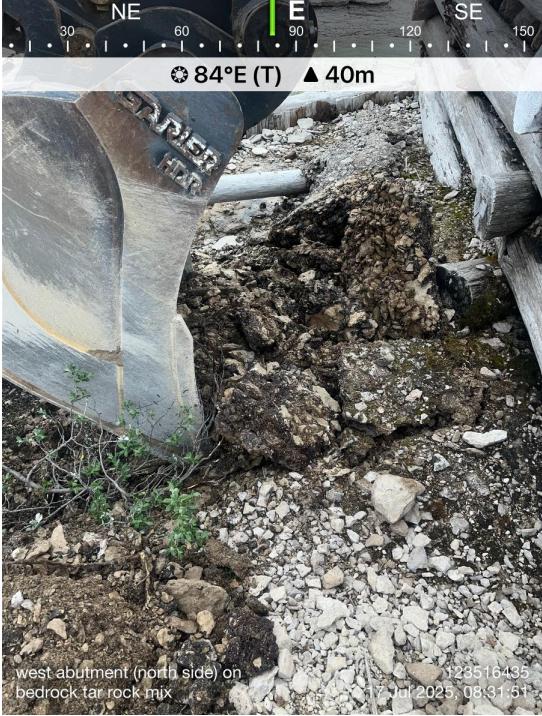
<p>NE E SE 84°E (T) 40m west abutment (north side) on bedrock tar rock mix 17 Jul 2025, 08:31:51</p>
Comments: TP18 being advanced in the mixed hardened tar/rock material during the 2025 SA test pit program.	
Photograph ID: 32

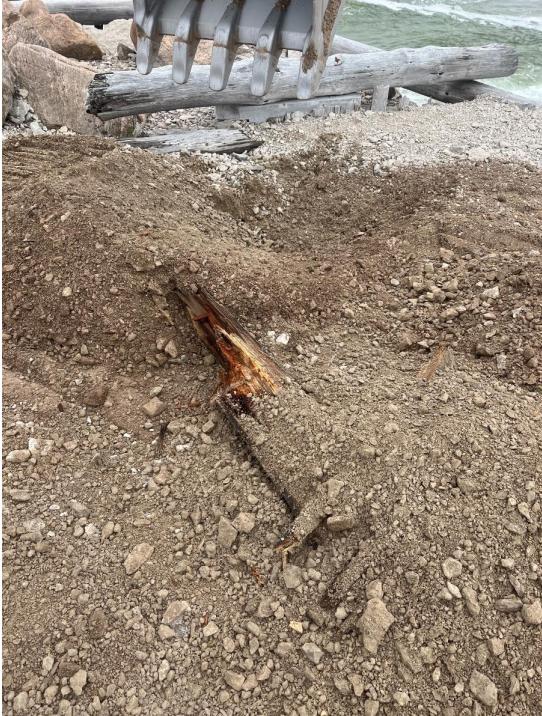
Comments: Buried timber encountered in TP21 during the 2025 SA test pit program.

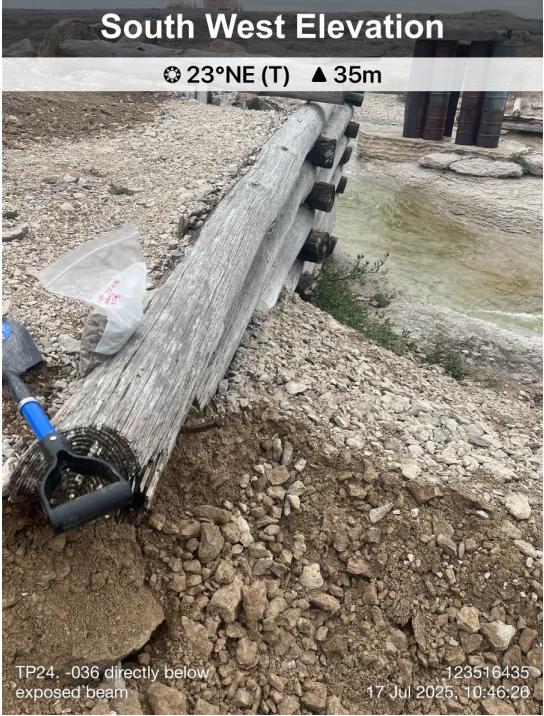
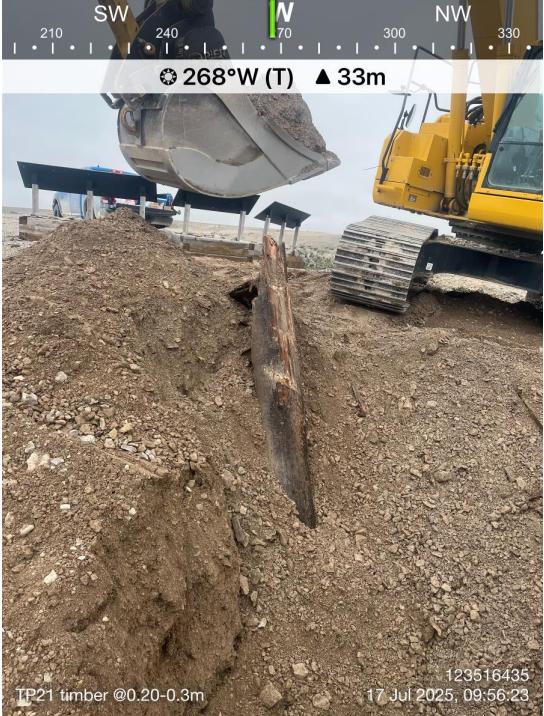
Client:	Public Services and Procurement Canada	Project:	Coral Harbour Fossil Creek Bridge Remedial Action Plan
Site Name:	Fossil Creek Bridge	Site Location:	Coral Harbour, NU
Photograph ID:	33		
Photo Location:	Western Abutment		
Direction:	Northeast		
Survey Date:	7/17/2025		
Comments:	End of timber encountered in TP24 during the 2025 SA test pit program.		
Photograph ID:	34		
Photo Location:	Western Abutment		
Direction:	West		
Survey Date:	7/17/2025		
Comments:	Another view of buried timber encountered in TP21 during the 2025 SA test pit program.		
South West Elevation

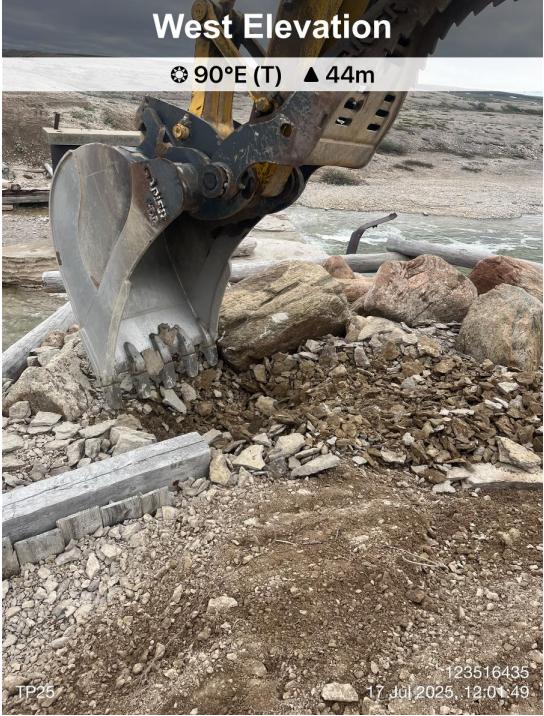
Client: Public Services and Procurement Canada	Project: Coral Harbour Fossil Creek Bridge Remedial Action Plan
Site Name: Fossil Creek Bridge	Site Location: Coral Harbour, NU
Photograph ID: 35	
Photo Location: Western Abutment	
Direction: East	
Survey Date: 7/17/2025	
Comments: TP25 being advanced in the western abutment cribbing fill material.

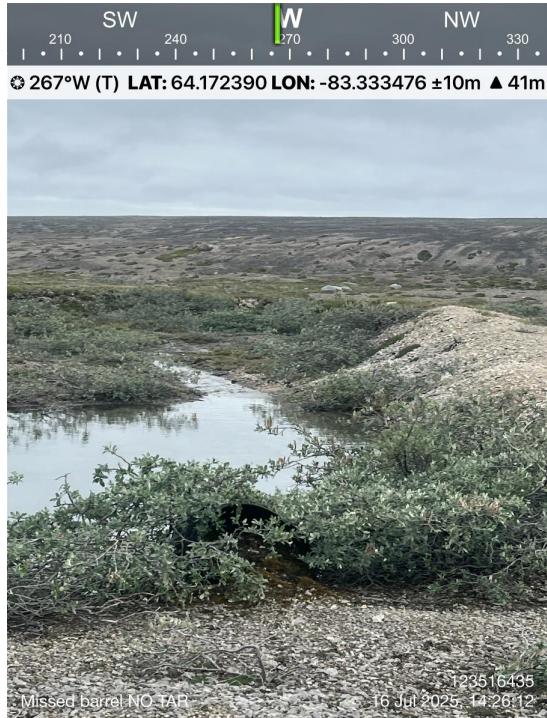
Photo Location: Non-Hazardous Debris			
Direction: West			
Survey Date: 7/16/2025			
Comments: Partially buried empty drum identified on western creek bank, located approximately 200m south of the bridge.

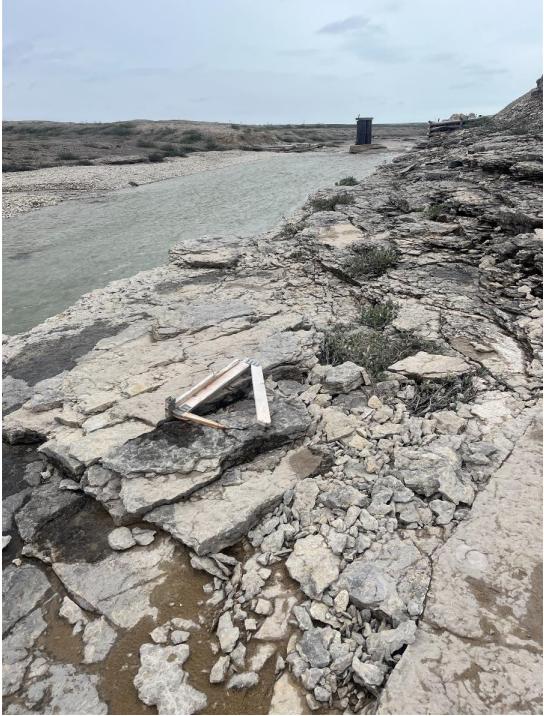
Photo Location: Non-Hazardous Debris			
Direction: Southeast			
Survey Date: 7/15/2025			
Comments: Wooden construction debris identified on western creek bank, located approximately 60m north of the bridge.			
Photograph ID: 40

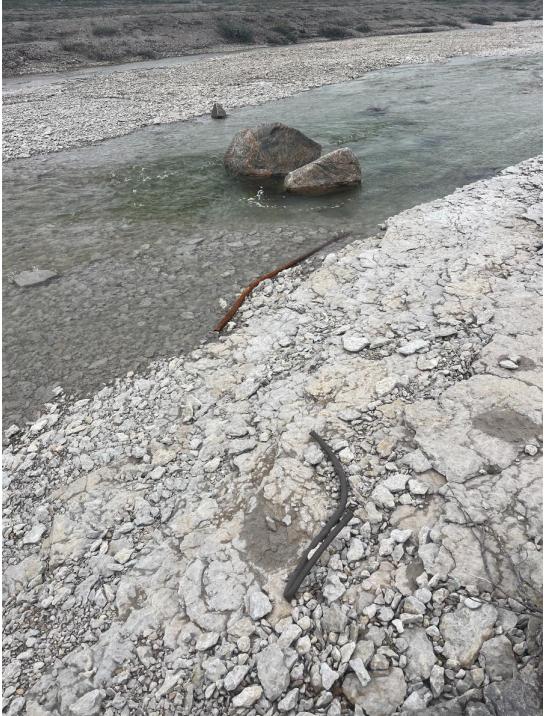
Photo Location: Non-Hazardous Debris			
Direction: East			
Survey Date: 7/15/2025			
Comments: A steel pipe identified in Fossil Creek, located approximately 100m north of the bridge.
