# Addendum

**Re:** **Addendum to Biophysical Impact Assessment – High Displacement Renewable Energy Project:  
Aquatic and Wetland Habitat Surveys**

The Sanikiluaq High Displacement Renewable Energy Demonstration Project (the 'Project') is a wind energy and storage platform tailored for deployment in the remote Hamlet of Sanikiluaq. The project aims to provide clean, affordable, and reliable energy to the community and to reduce diesel reliance for electricity production in the community by at least 50%. The Project will integrate up to ten turbines, e+ micro controller and a containerized Battery Energy Storage System (BESS) within Sanikiluaq's diesel grid to achieve high diesel displacement. The preliminary design is based on 1,000 kW (1 MW) wind energy combined with 500 kWh of battery energy storage. The proposed turbine design has a 50 – 60 meter (m) hub height with a 24 – 36 m rotor diameter.

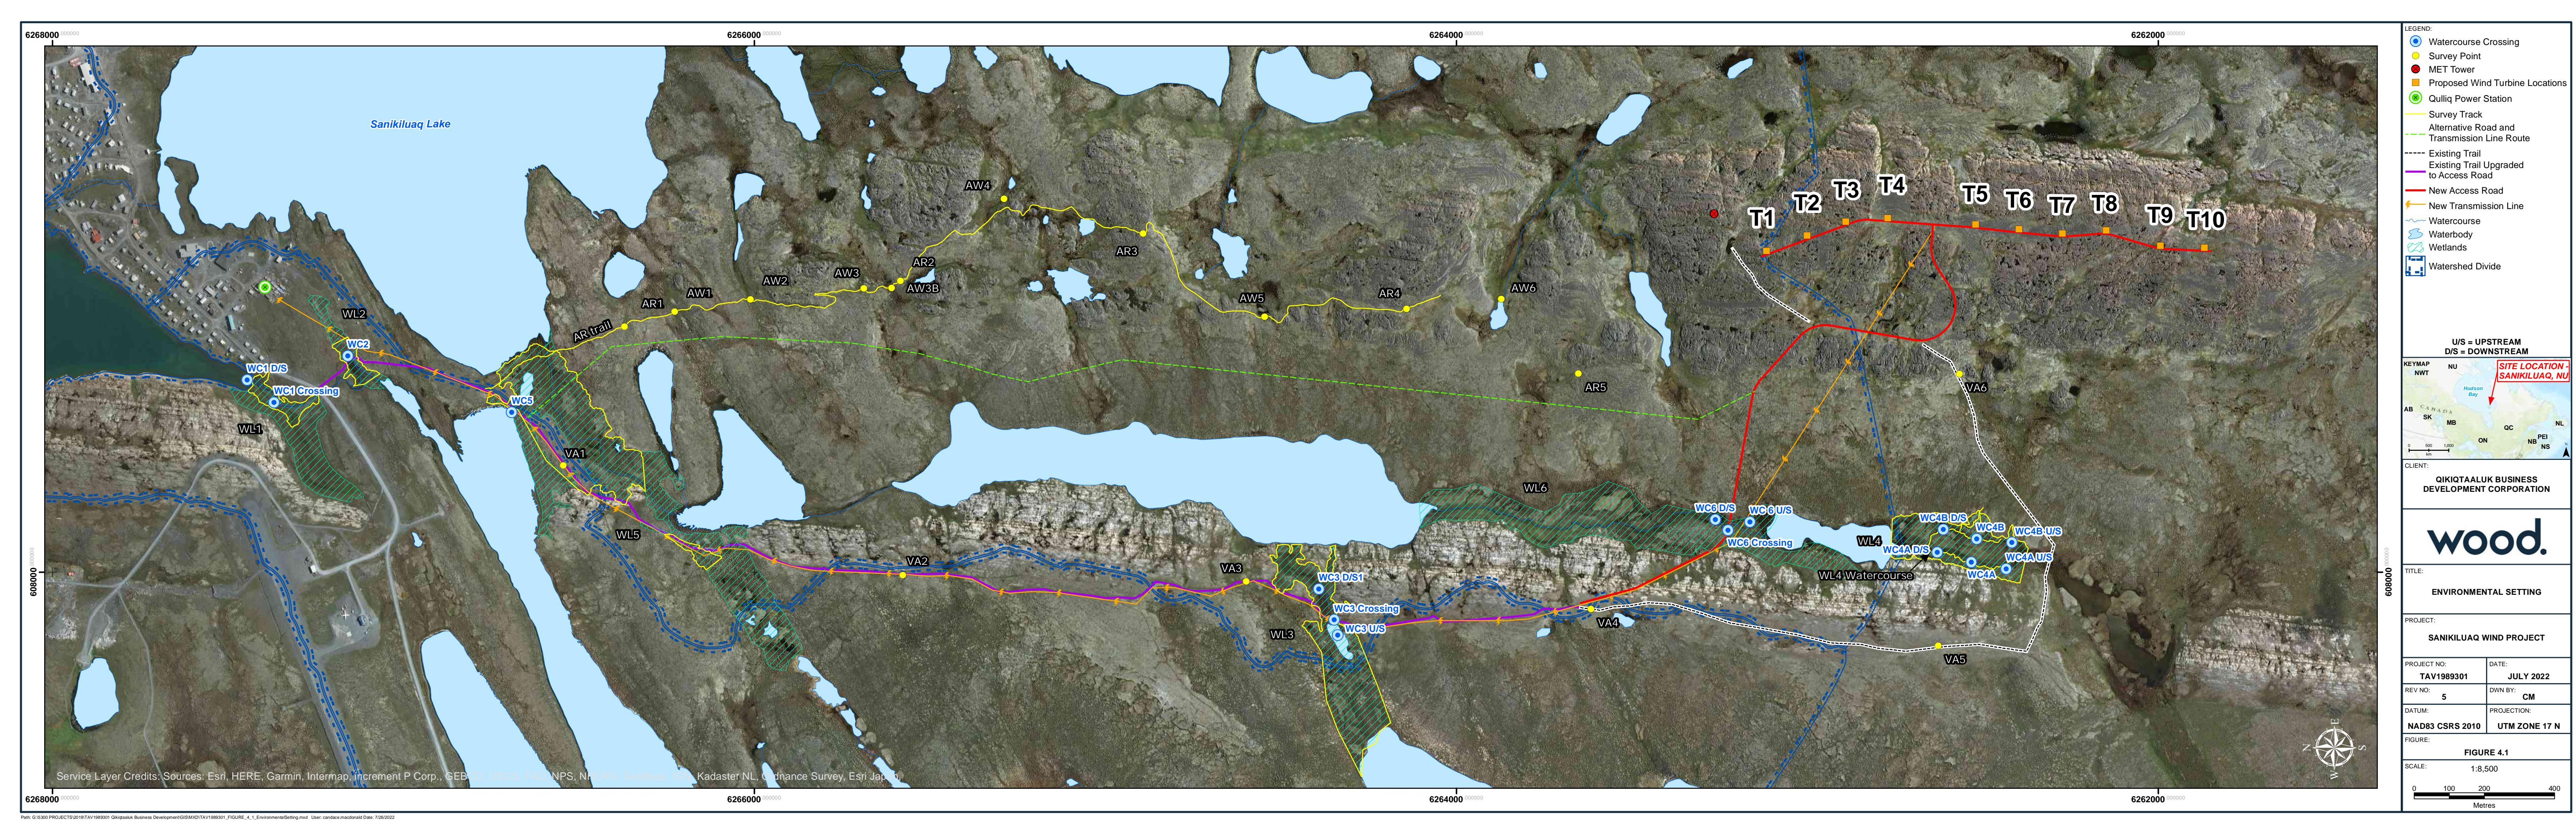
### **Figure**

Wetland resources and applicable regulations are outlined in Section 4.2.3 of the BIA (Wood, 2022). An additional wetland (WL6) was delineated and assessed along the new access road and transmission line (Figure 1, Attachment 1) by an experienced field biologist on 17 June 2022. A representative 1 x 1 m vegetation plot was established in accordance with the August 2021 wetland survey methodologies (Wood, 2022). All identifiable species within the quadrat were noted. The wetland boundary was partially delineated in the field and then extended based on a desktop assessment of aerial imagery (Figure 1, Attachment 1).

An additional watercourse crossing (WC6) was identified at the new access road and the new transmission line (Figure 1, Attachment 1). Wood field staff conducted an aquatic habitat assessment at this new location and revisited all previously assessed watercourse crossings within the project footprint. Water quality parameters were collected at representative crossings as well as selected upstream and downstream locations. Characteristics are provided in Table 2. Photos of watercourse crossings are included in Attachment 2, Photos 1 to 15. Fish community assessments were not conducted but interviews were carried out with local hunters and the HTA office to document recreational or commercial use of the aquatic habitat at the site.
