**Road access to Cape Christian
Fish and fish habitat assessment at stream crossings**

REPORT

Municipality of Clyde River

August 2008

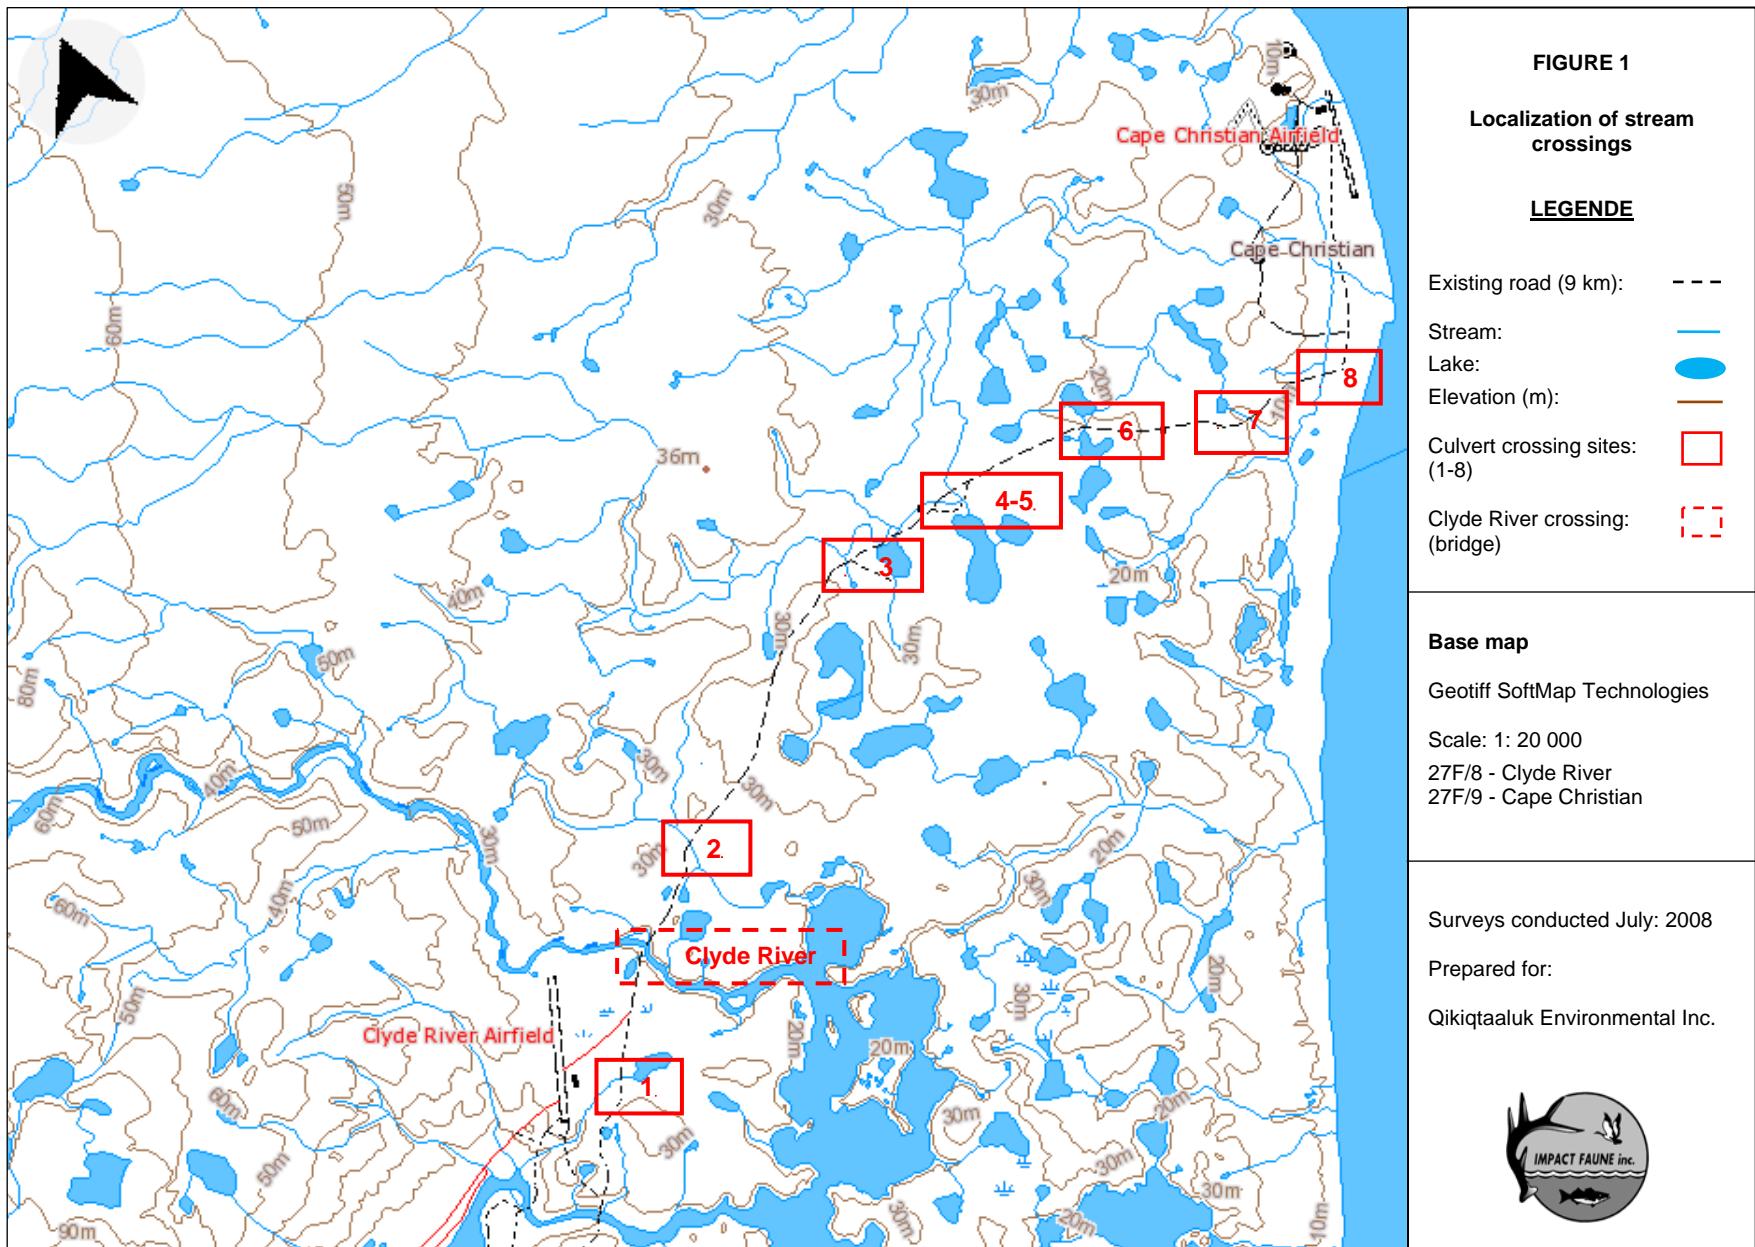
All sites are located along the 16 km existing road, which path appears on 1:20 000 and 1: 50 000 registered topographic maps (Figure 1). Details for the crossings are presented in table 1.

The study streams belong to two distinct watersheds, as sites No. 1, 2 and the Clyde River itself are part of the Clyde River watershed. Sites No. 3 to No. 8 belong to another watershed (unnamed), which outlet is located just south of the Cape Christian airfield (Figure 1).

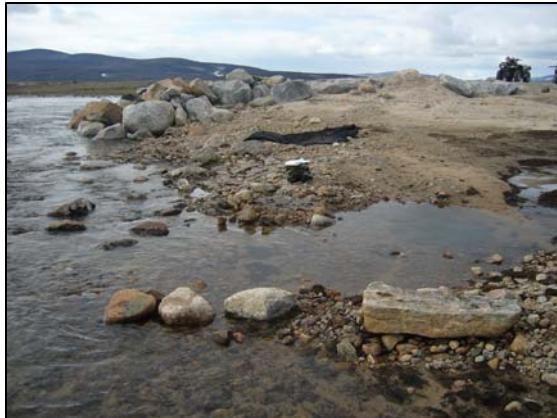
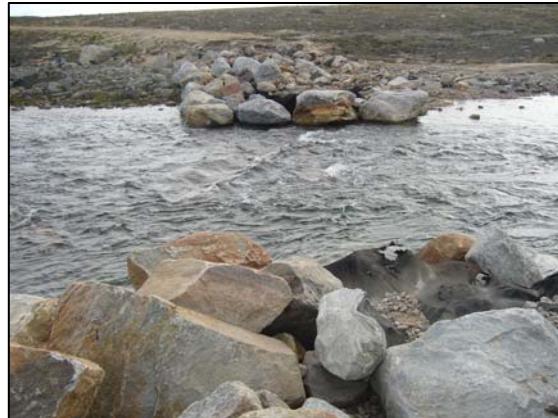
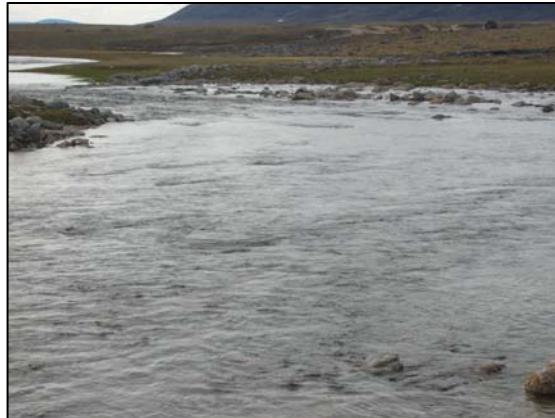
Table 5. Biophysical parameters at the Clyde River crossing site

Site No.	Fish Bearing	Width (m)		Depth (m)	Gradient (%)	Channel morphology	Valley confinement	Flow		Turbidity	Substrate ¹			Cover ²	Habitat quality
		Channel	Wetted					Conditions	Velocity		FNE	INT	LRG		
Clyde River	Yes	40	20	0,70	2,0	Riffle-pool	Unconfined	Permanent	Rapid	Clear	10	50	40	BLD: 90 DPO: 10	Important

Some moderate to good rearing habitat upstream and downstream of the crossing. No critical or important spawning habitat observed downstream.

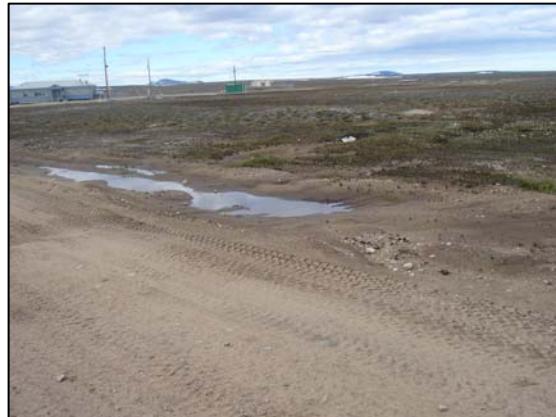
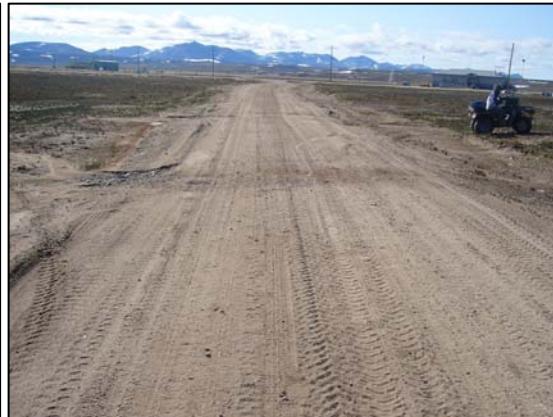
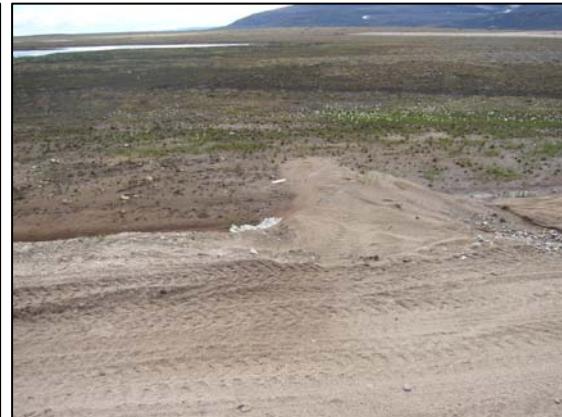
Table 6. Biophysical parameters at crossing site No. 1

Site No.	Fish Bearing	Width (m)		Depth (m)	Gradient (%)	Channel morphology	Valley confinement	Flow		Turbidity	Substrate ¹			Cover ²	Habitat quality
		Channel	Wetted					Conditions	Velocity		FNE	INT	LRG		
1	No	0	0	0	0	NA	NA	NA	NA	NA	NA	NA	NA	NA	None

No channel or water present. Possible surface runoff may occur during snowmelt because the site is location in a terrain depression.

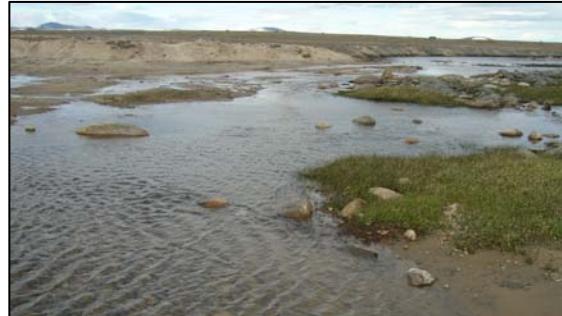
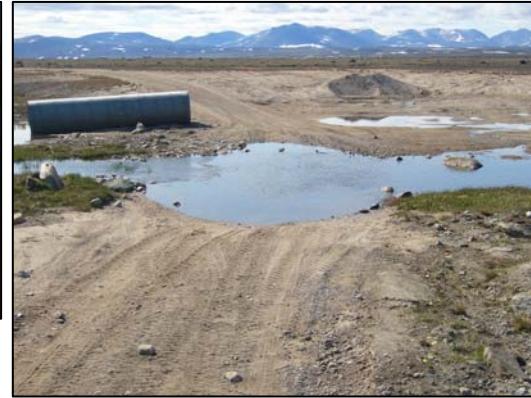
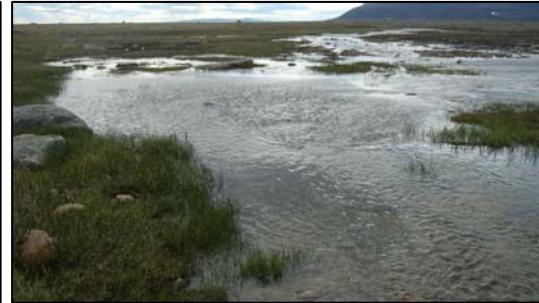
Table 7. Biophysical parameters at crossing site No. 2

Site No.	Fish Bearing	Width (m)		Depth (m)	Gradient (%)	Channel morphology	Valley confinement	Flow		Turbidity	Substrate ¹			Cover ²	Habitat quality
		Channel	Wetted					Conditions	Velocity		FNE	INT	LRG		
2	Yes	31	11	0,10	0,5	Uniform	Unconfined	Permanent	Slow	Clear	40	40	15	ISV: 40 BLD: 60	Marginal

Very wide wetted areas on both side of the crossing, where the channel is not really defined. Channel width at the crossing (10,0 m) is actually narrower than the overall reach surveyed.

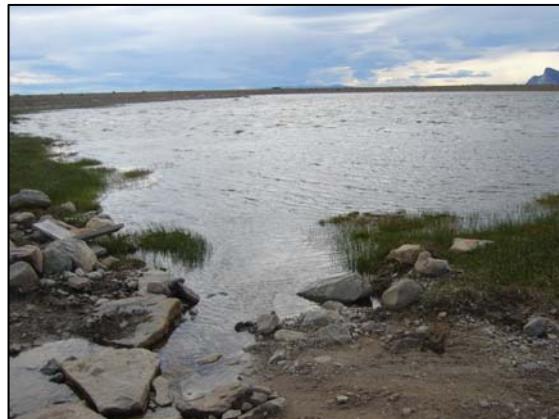
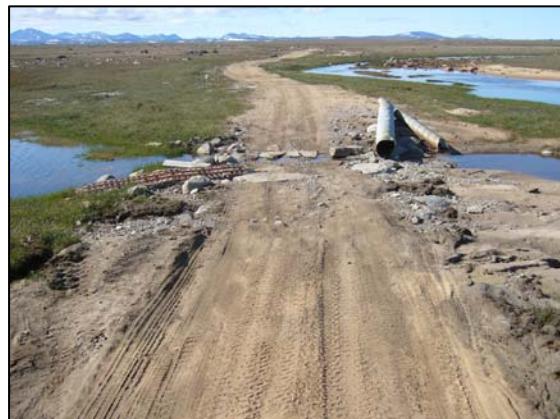
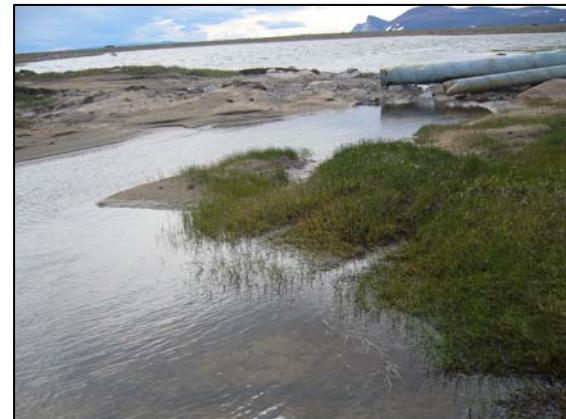
Table 8. Biophysical parameters at crossing site No. 3

Site No.	Fish Bearing	Width (m)		Depth (m)	Gradient (%)	Channel morphology	Valley confinement	Flow		Turbidity	Substrate ¹			Cover ²	Habitat quality
		Channel	Wetted					Conditions	Velocity		FNE	INT	LRG		
3	Yes	12	2	0,20	0,5	Uniform	Unconfined	Permanent	Slow	Clear	85	15		BLD: 100	Marginal

This crossing is located at approximately 10 m downstream of a small lake. Note that the downstream photo view is towards the crossing. Crossing likely represent a barrier to fish passage, at least in low flow conditions. Channel width at the crossing (4,0 m) is actually narrower than the overall reach surveyed.

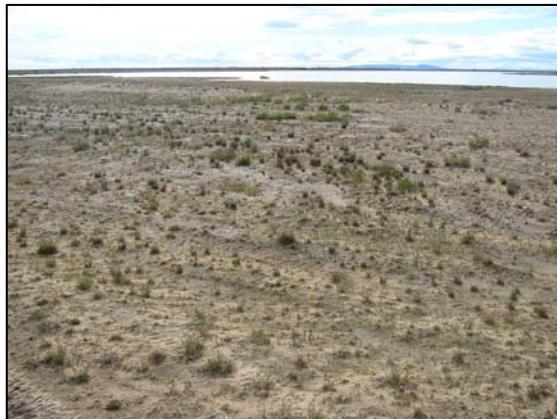
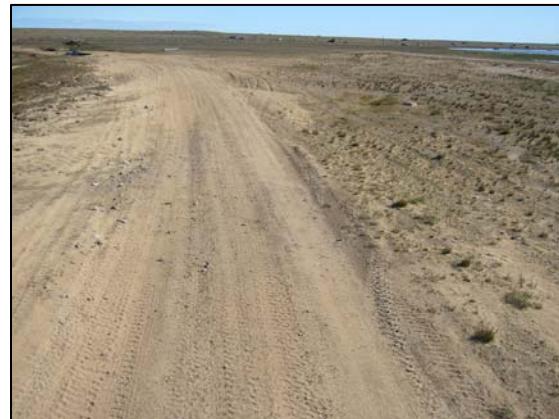
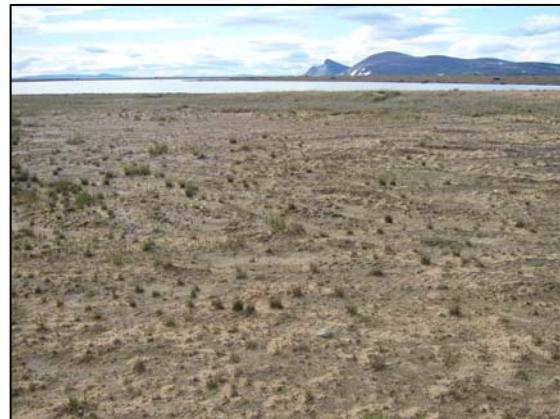
Table 9. Biophysical parameters at crossing site No. 4

Site No.	Fish Bearing	Width (m)		Depth (m)	Gradient (%)	Channel morphology	Valley confinement	Flow		Turbidity	Substrate ¹			Cover ²	Habitat quality
		Channel	Wetted					Conditions	Velocity		FNE	INT	LRG		
4	No	0	0	0	0	NA	NA	NA	NA	NA	NA	NA	NA	NA	None

No channel or water present. Possible surface runoff over road during snowmelt.

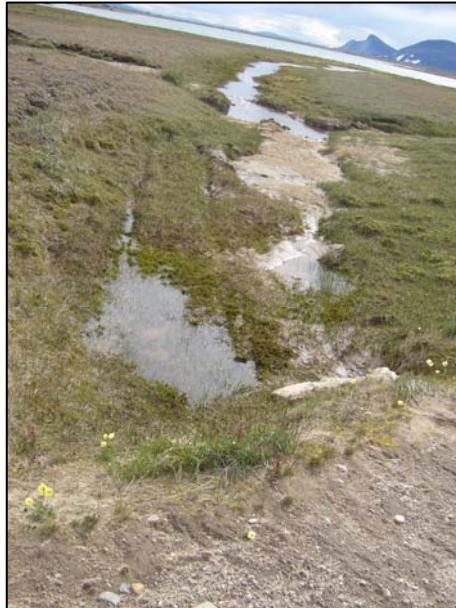
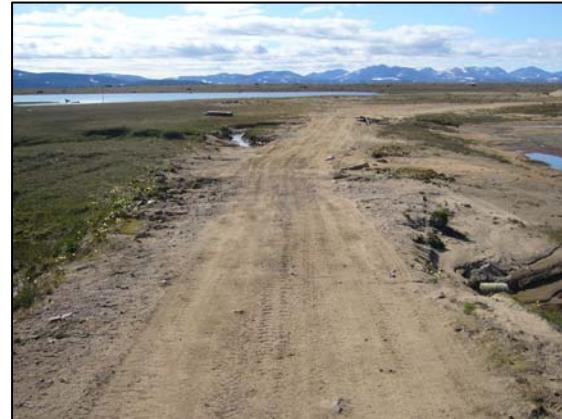
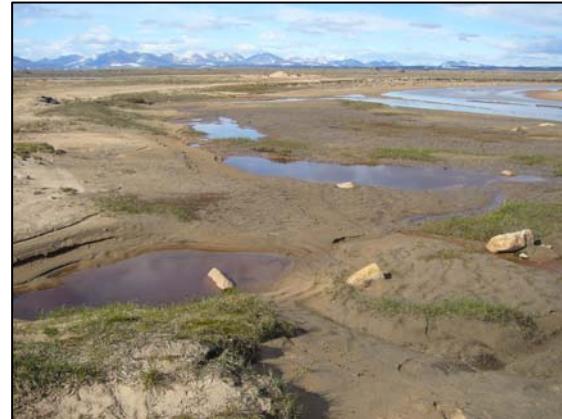
Table 10. Biophysical parameters at crossing site No. 5

Site No.	Fish Bearing	Width (m)		Depth (m)	Gradient (%)	Channel morphology	Valley confinement	Flow		Turbidity	Substrate ¹			Cover ²	Habitat quality
		Channel	Wetted					Conditions	Velocity		FNE	INT	LRG		
5	YES	3	1,5	0,10	0,5	Uniform	Unconfined	Permanent	Slow	Clear	100			DPO, UBK ISV	None

The crossing is located near a small lake (upstream). Fish passage in the downstream section must be occasionally impaired due to the lack of continuous channel, forming isolated water pockets. Habitat quality is considered as none, or marginal at best.

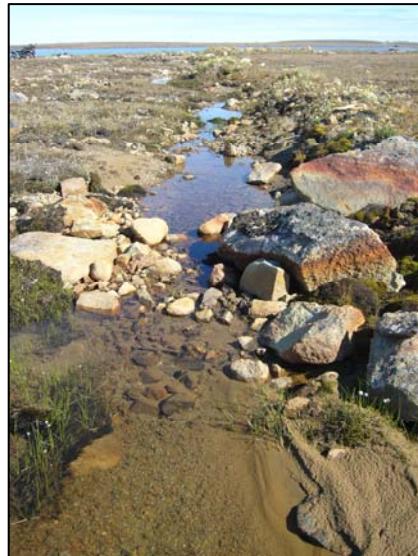
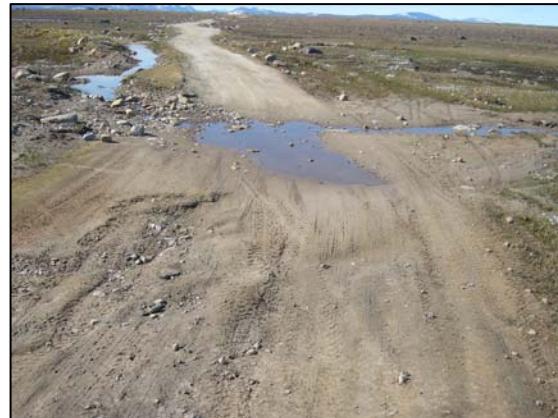
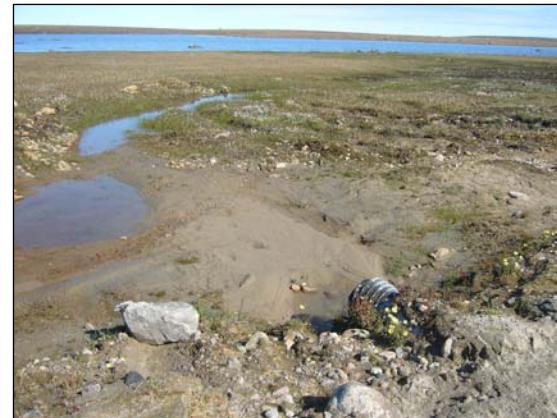
Table 11. Biophysical parameters at crossing site No. 6

Site No.	Fish Bearing	Width (m)		Depth (m)	Gradient (%)	Channel morphology	Valley confinement	Flow		Turbidity	Substrate ¹			Cover ²	Habitat quality
		Channel	Wetted					Conditions	Velocity		FNE	INT	LRG		
6	No	2	0,15	0,05	0,5	Uniform	Unconfined	Intermittent	Slow	Clear	20	40	40	BLD: 100	None

The crossing is located near a small lake (upstream). As an intermittent flow conditions of the stream, reflect that of habitat availability for fish. In other words, fish usage of this stream may be limited to seasonal passage. On the downstream side, a culvert was observed but it appears functional only occasionally. Habitat quality is considered as none, or marginal at best. Crossing likely represent a barrier to fish passage, at least in low flow conditions.

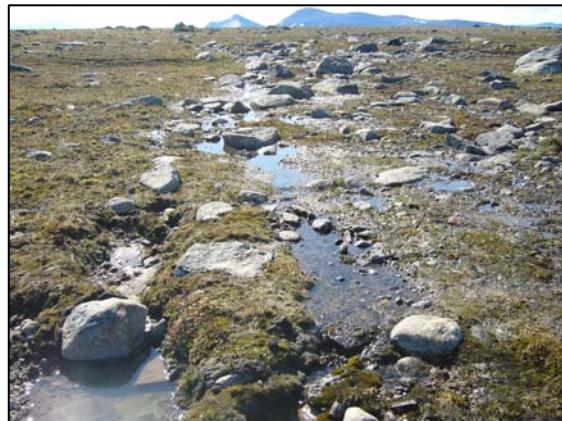
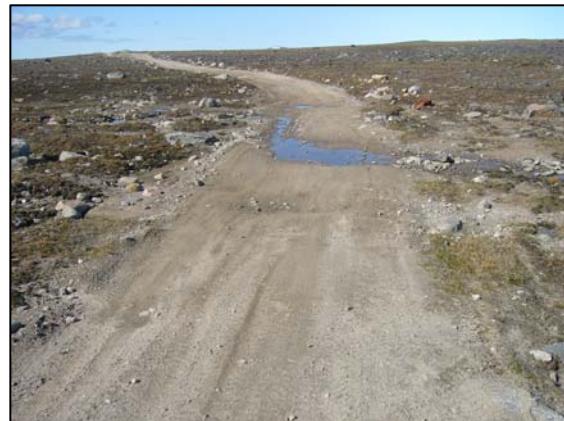
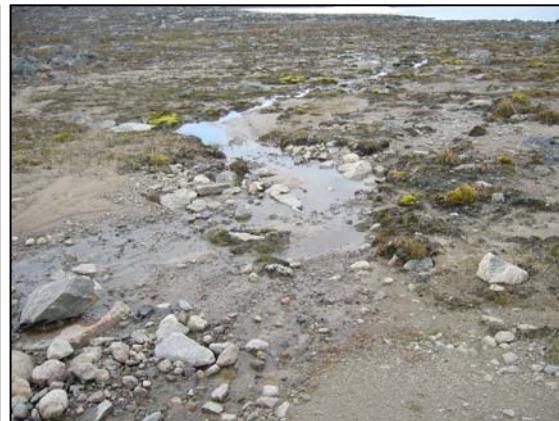
Table 12. Biophysical parameters at crossing site No. 7

Site No.	Fish Bearing	Width (m)		Depth (m)	Gradient (%)	Channel morphology	Valley confinement	Flow		Turbidity	Substrate ¹			Cover ²	Habitat quality
		Channel	Wetted					Conditions	Velocity		FNE	INT	LRG		
7	No	Seepage (alternate surface and underground runoff)		0,02	0,5	NA	Unconfined	Ephemeral		NA	NA	NA	NA	NA	None

No defined channel. The water is limited seepage alternating between surface and underground. No fish presence, passage or habitat even at spring water level.

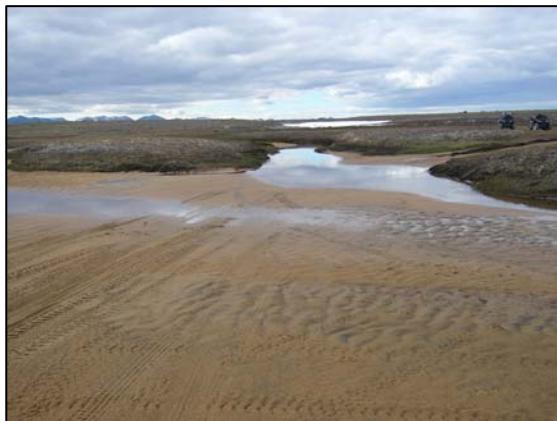
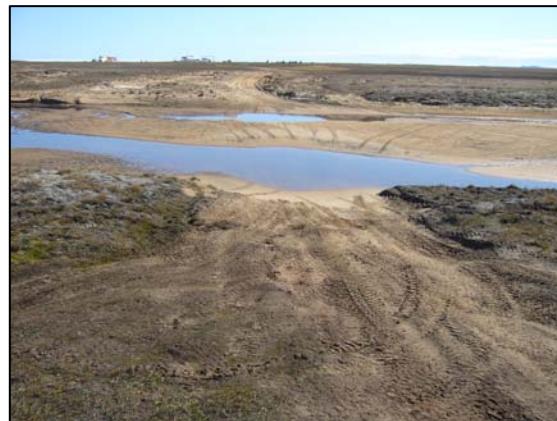
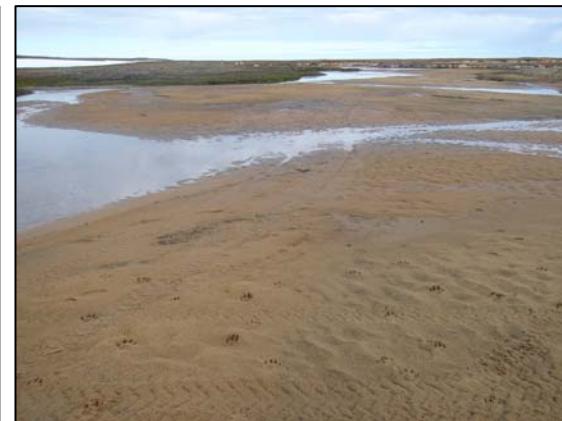
Table 13. Biophysical parameters at crossing site No. 8

Site No.	Fish Bearing	Width (m)		Depth (m)	Gradient (%)	Channel morphology	Valley confinement	Flow		Turbidity	Substrate ¹			Cover ²	Habitat quality
		Channel	Wetted					Conditions	Velocity		FNE	INT	LRG		
8	Yes	29	5	0,15	0,5	Uniform	Unconfined	Permanent	Slow	Clear	100			0	Marginal

Although water level was low at the time of survey, the width of the sand bars and the overall channel setting suggest that spring water volume must be important, although probably not of high velocity. In terms of habitat evaluation, habitat quality is evaluated as marginal, perhaps as "important" at best, because of fish passage to access upper-watershed better habitats.
