Excerpt from letter to Amy Liu entitled, "Summary of Achievements to Improve Creek Crossings between Clyde River and Cape Christian.", dated August 31, 2009, prepared by Philippe Simon (Qikiqtaaluk Logistics Inc.)

Fish habitat compensation

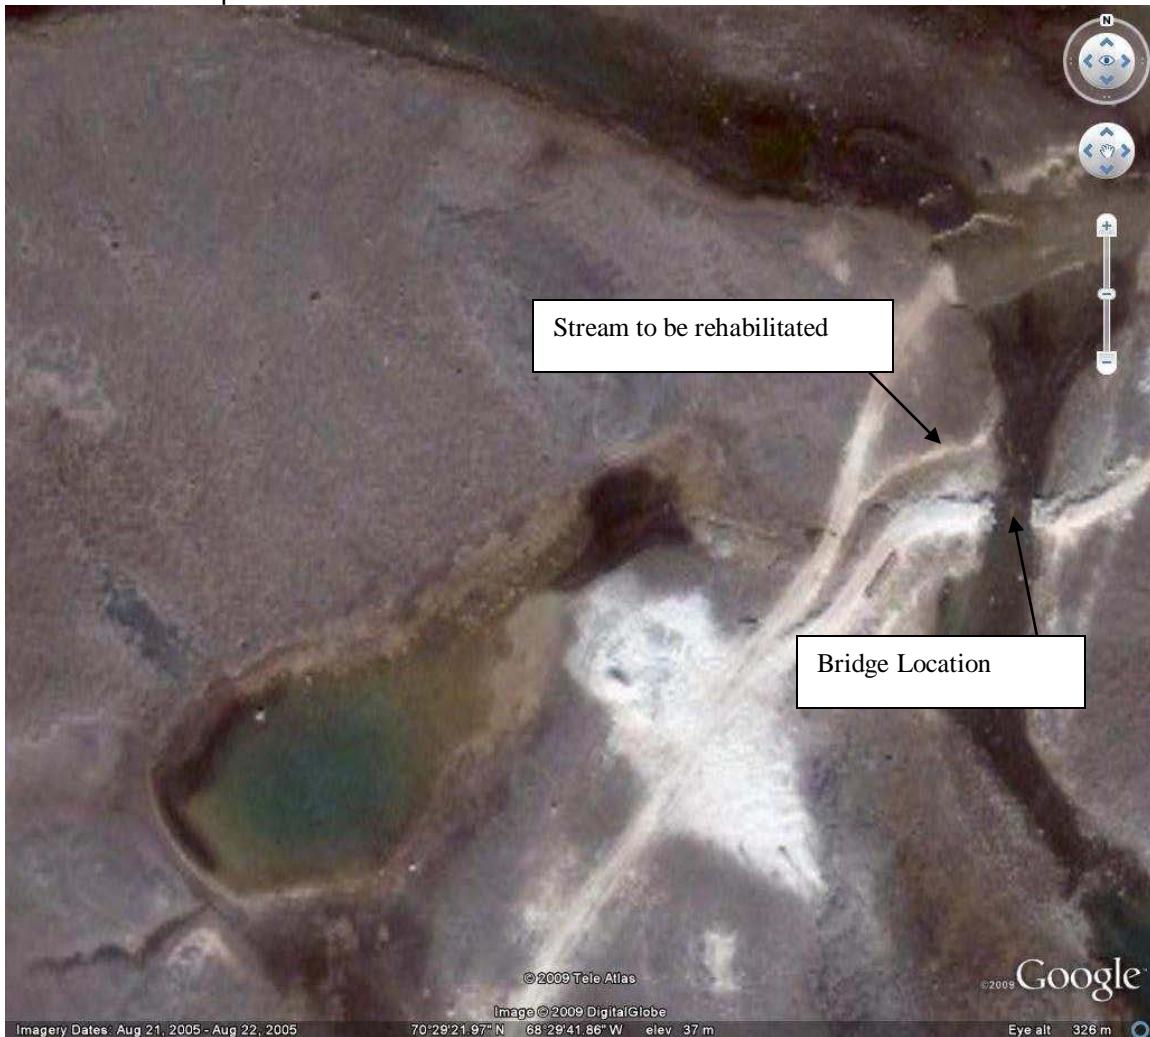
Photo 36: Location of the stream proposed to be rehabilitated

We understand that creek crossing 3a is not authorized. To obtain such an authorization, Qikiqtaaluk Logistics will provide engineer drawings, area of infill, timing and method of construction and habitat to be compensated. As such, it is proposed that a disturbed stream draining into the River Clyde from a small lake close by be restored. Prior to the bridge installation, a 12" culvert was in place in that area. That culvert was removed once the bridge was installed because the road access was re-routed toward the bridge instead of toward the low water level area where residents on Clyde River used to cross with their vehicles. Aerial photo 36 shows the location of the stream and the upstream lake in relation to the River Clyde. The proposed rehabilitation work on that creek would involve the excavation of a shallow channel with smooth slopes on all disturbed areas. The bed of said channel would be filled with rip-rap material and would be built in meanders where possible.
