PROJECT - PROJET		
CAPE CHRISTIAN, NUNAVUT		
© COPYRIGHT QIKIQTAALUK LOGISTICS INC. 2009		
TRADE - METIER	SITING	DATE 2009-03-30
SCALE - ECHELLE		AS SHOWN
SUBJECT - SUJET		
CAPE CHRISTIAN REMEDIATION PROJECT CULVERT INSTALLATION IN FISH BEARING WATERS - CROSSINGS 2 & 9 DETAILS		
PRODUCTION	CONCURRENCE - ASSESSMENT	
DESIGNED ETUDIE	Edward McKyes	
DRAWN DESSINE	Greg Johnson	
CHECKED VERIFIE	Phillippe Simon	
COORDINATION	REVIEWED - REVU	
DWG. NO. - DESSIN NO. QESin 2007 P6-2009-02

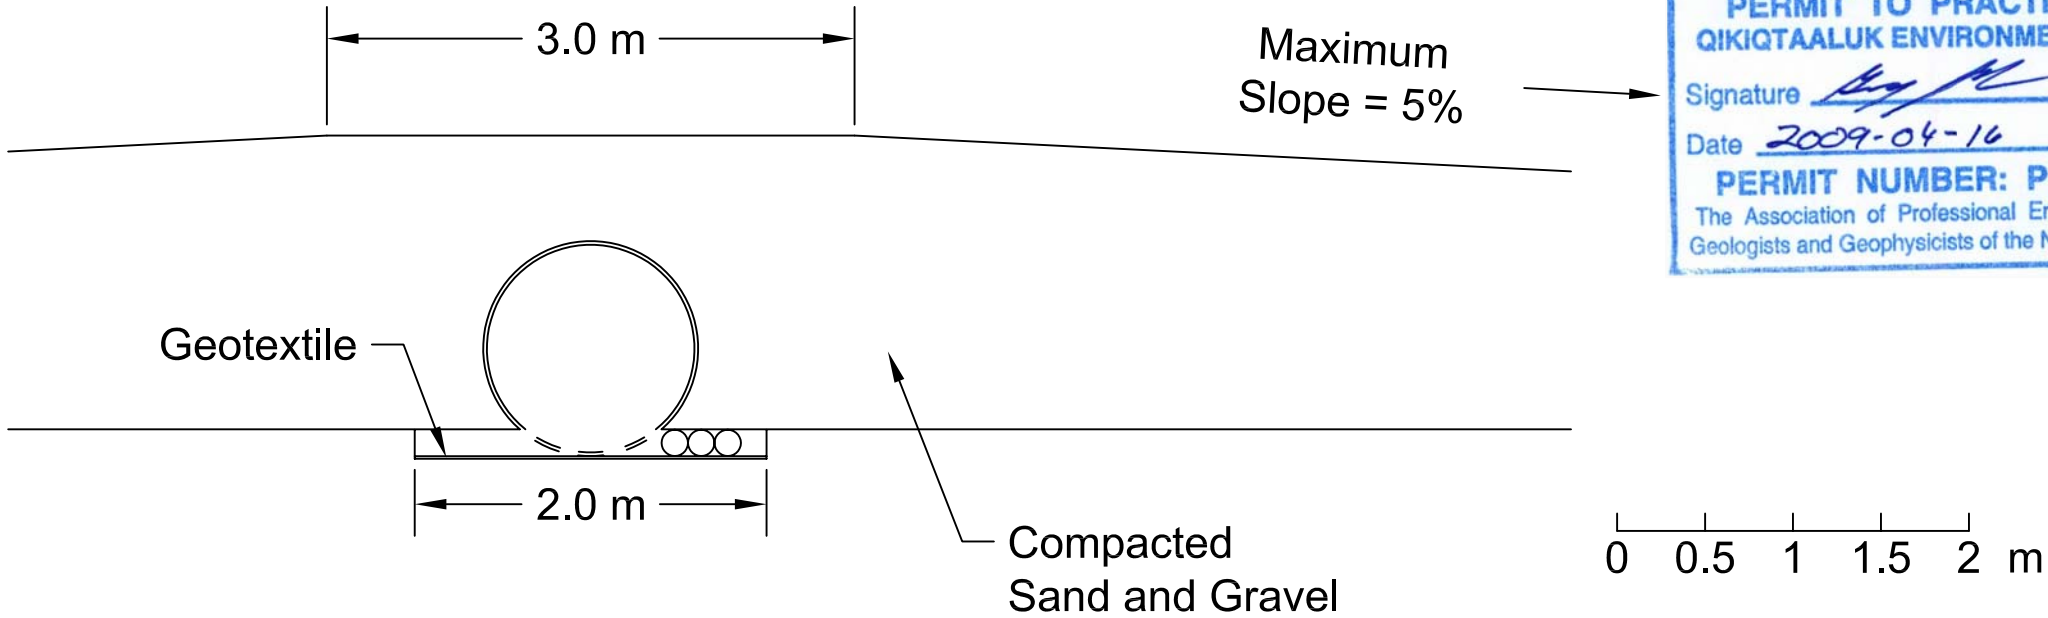
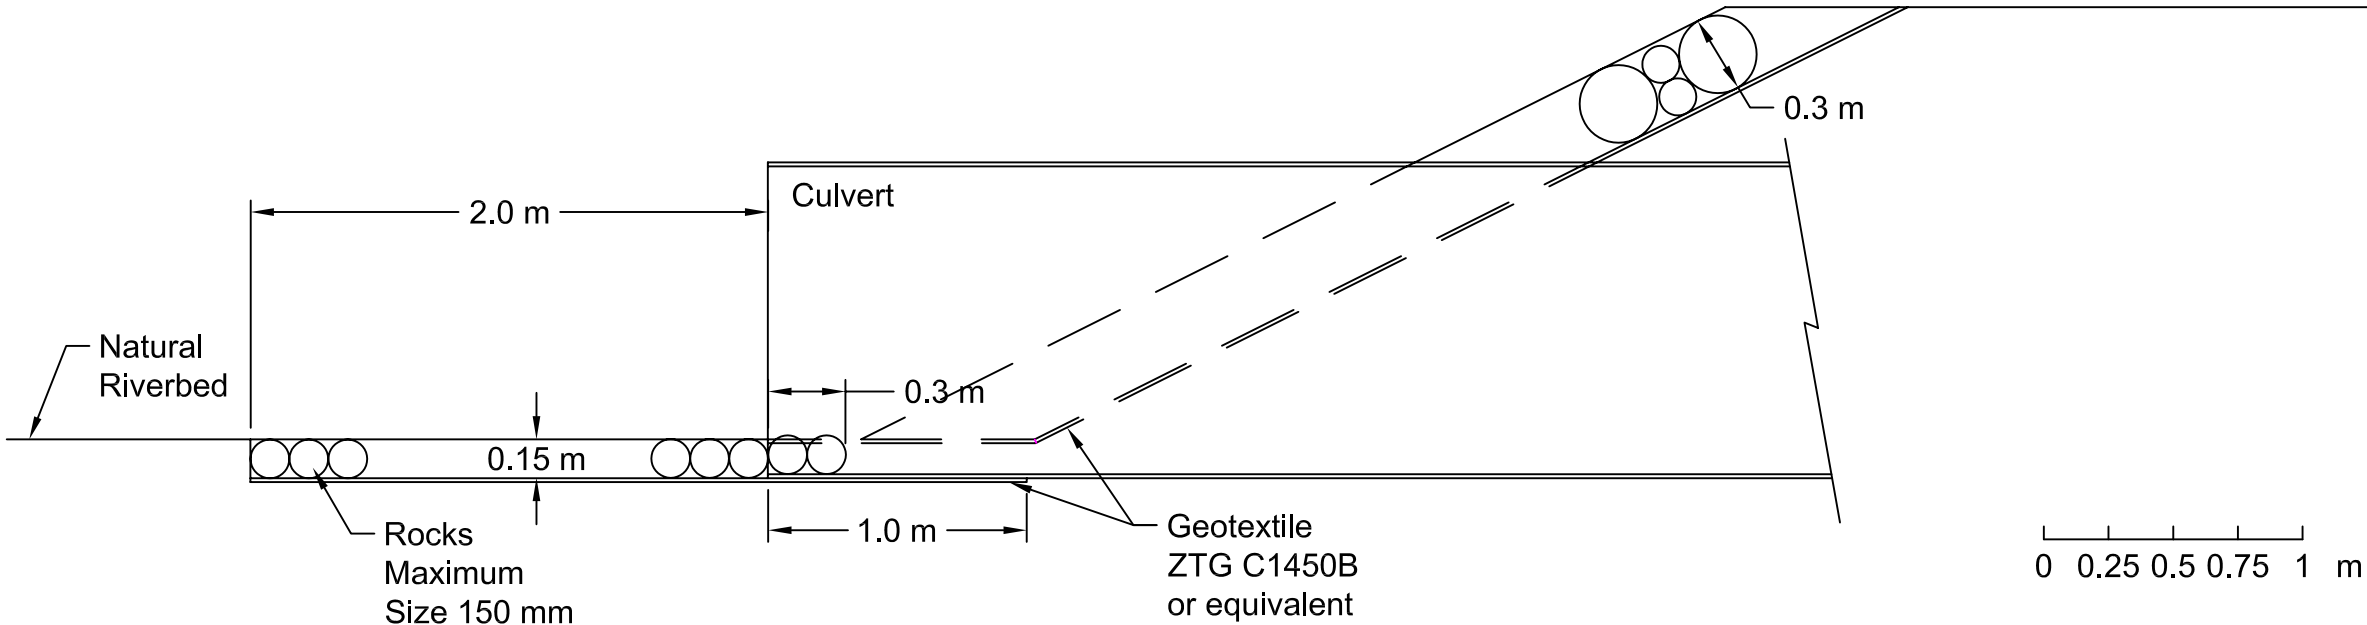
- General Notes:**
1. Stream crossings have not been surveyed and each crossing will have to be field fitted to existing conditions.
 2. All culvert installations should be completed prior to the spring freshet to avoid problems with sedimentation.
 3. All crossings are assumed to be much shallower than the culvert that will be installed, thus the depth of the creek is not shown on the drawings.
 4. All fill material around the culverts must be constructed in lifts of 250 mm of loose material and each lift will be compacted to 95 percent of Maximum Dry Density in accordance with ASTM D698.
 5. Crossing 9 was not part of the fish study, and as such little information is available for the design of the crossing. The design will be adjusted to fit field conditions.
