Dianne River Access Trail

HAMLET OF RANKIN INLET  
RANKIN INLET, NUNAVUT

**Dianne River Access Trail**

**November 30, 2005**

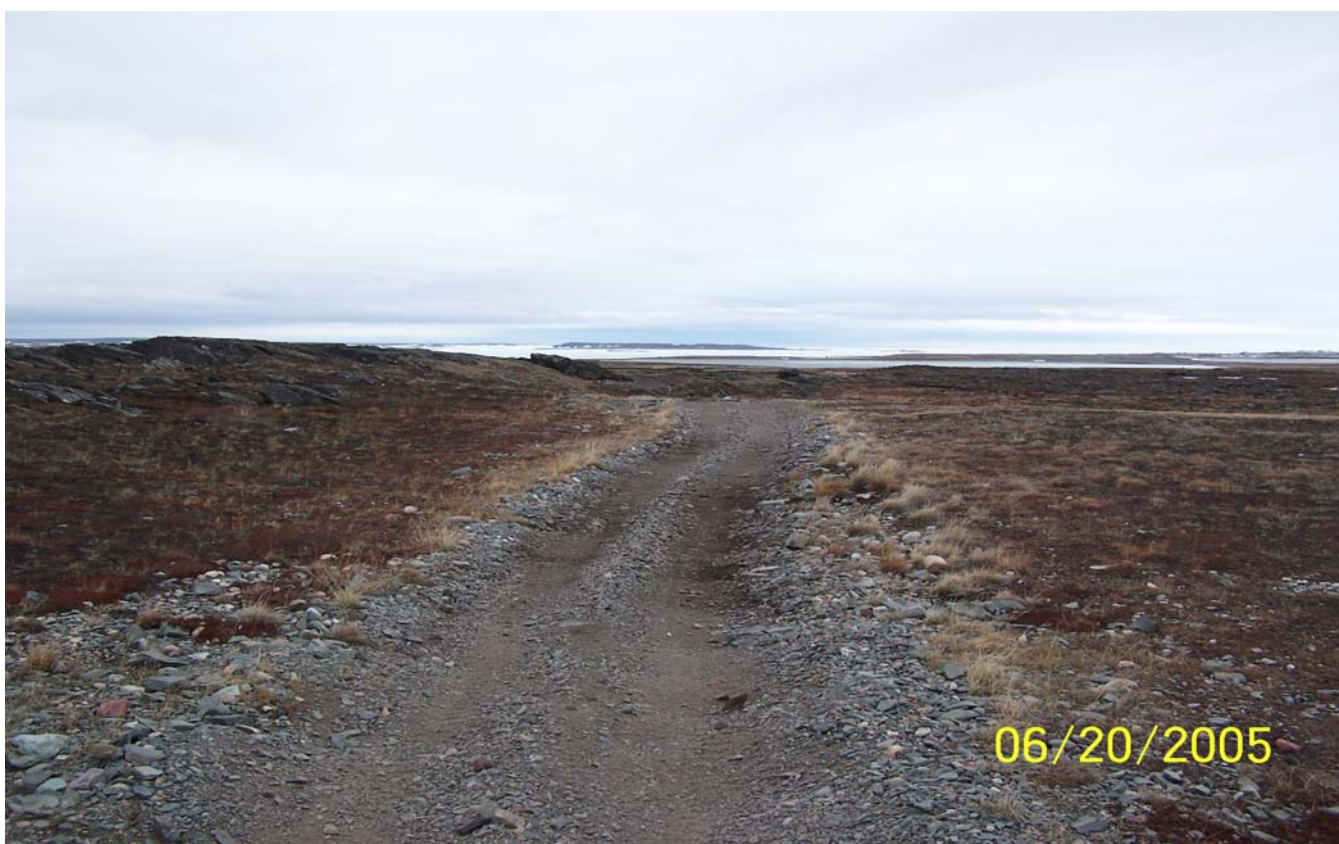
Photo 2- Trail Section located on dry granular soils

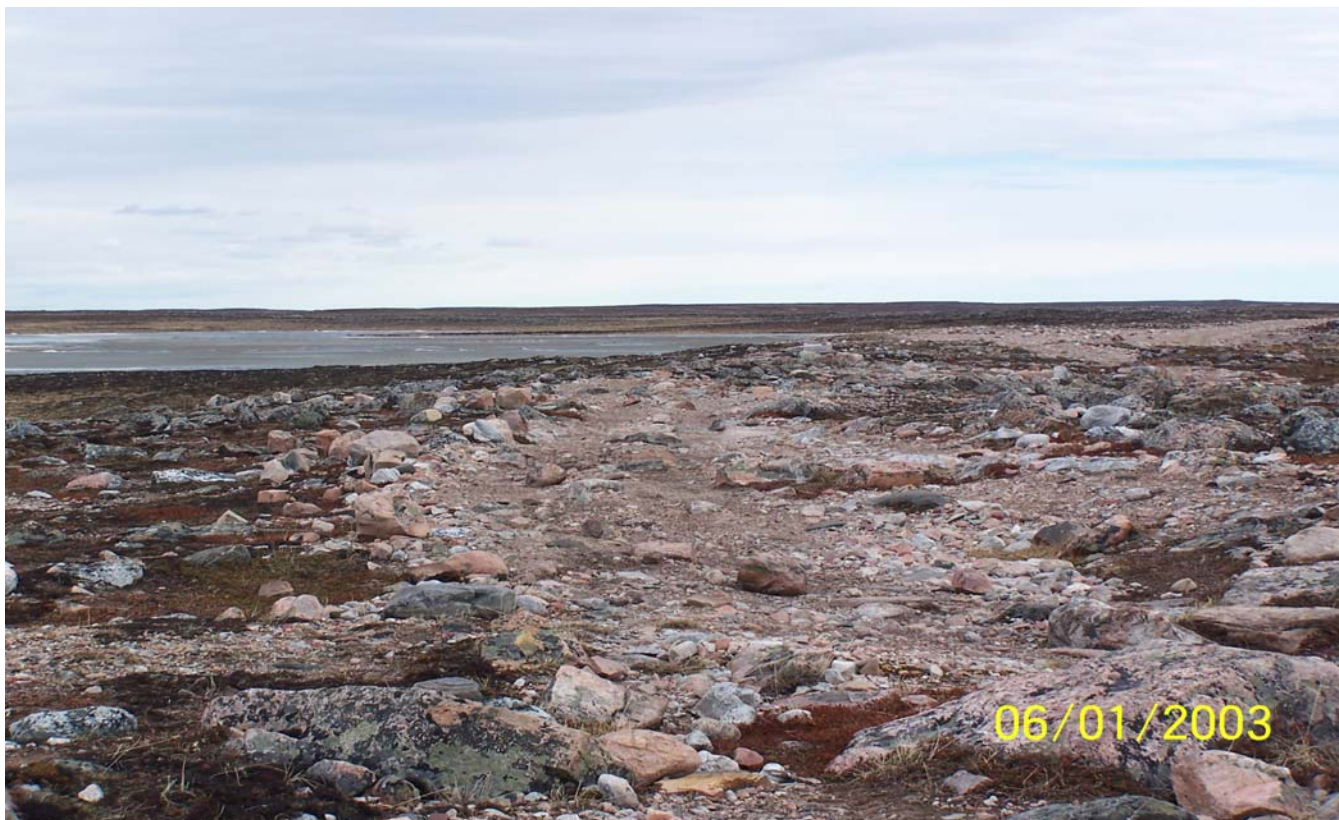
Photo 3- Trail on dry granular soils and large rocks

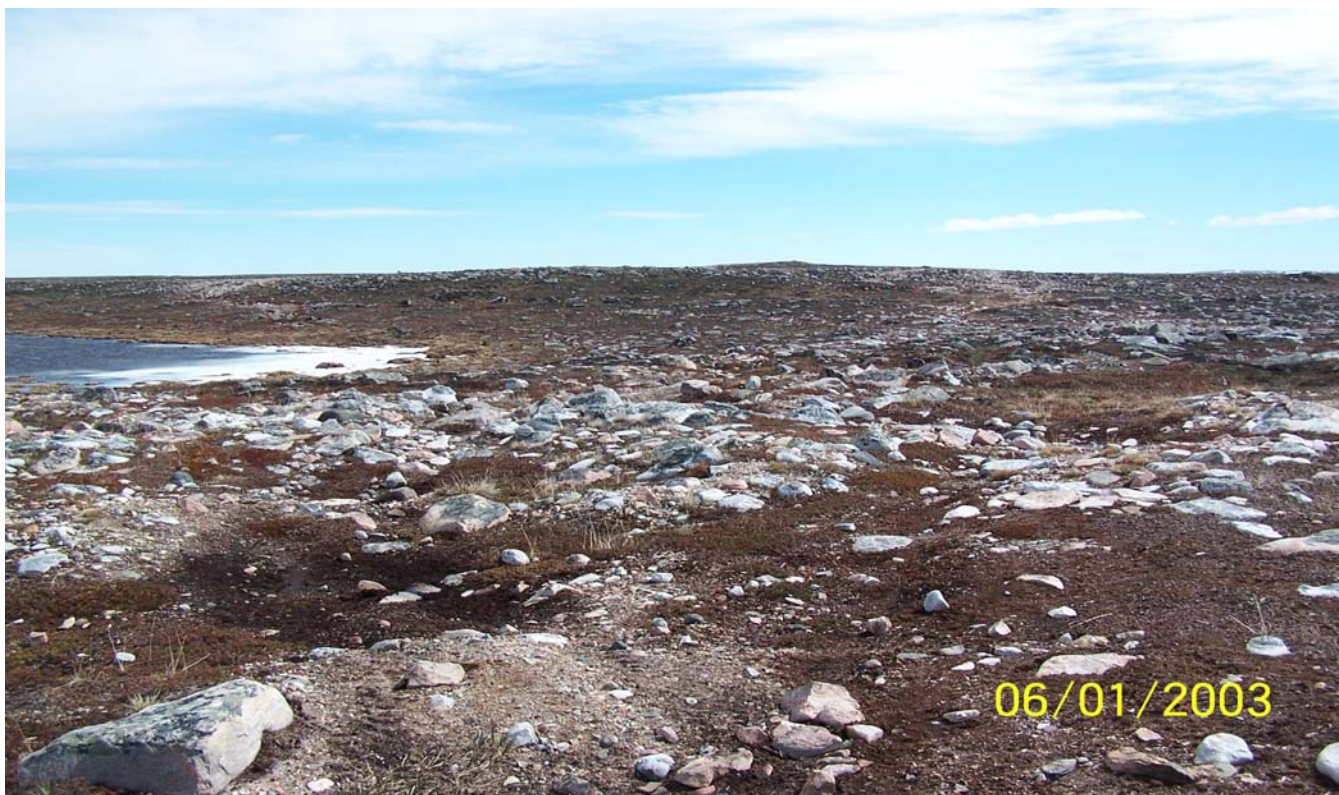
Photo 4 – Trail through rock fields

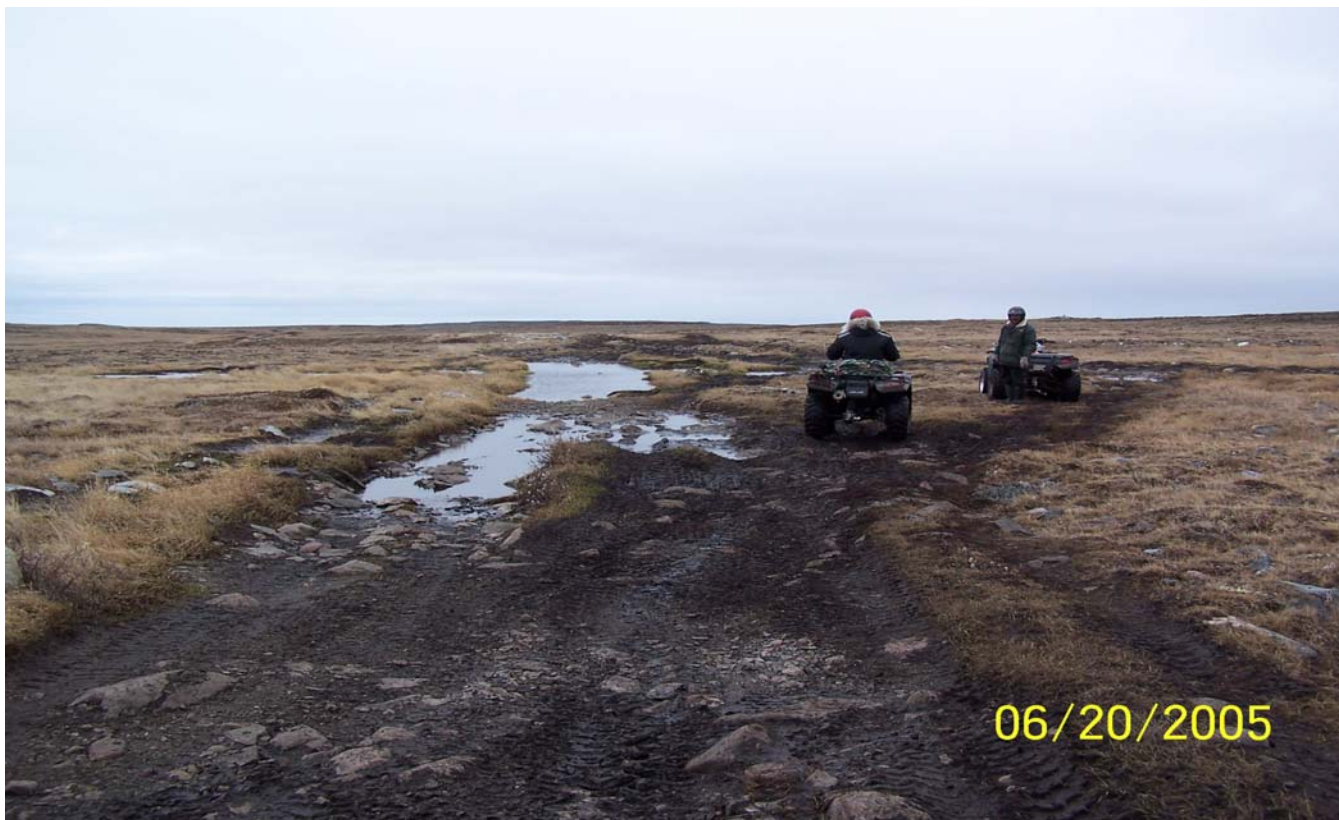
Photo 5 – Trail through fine grained soils, some embedded rocks and standing water

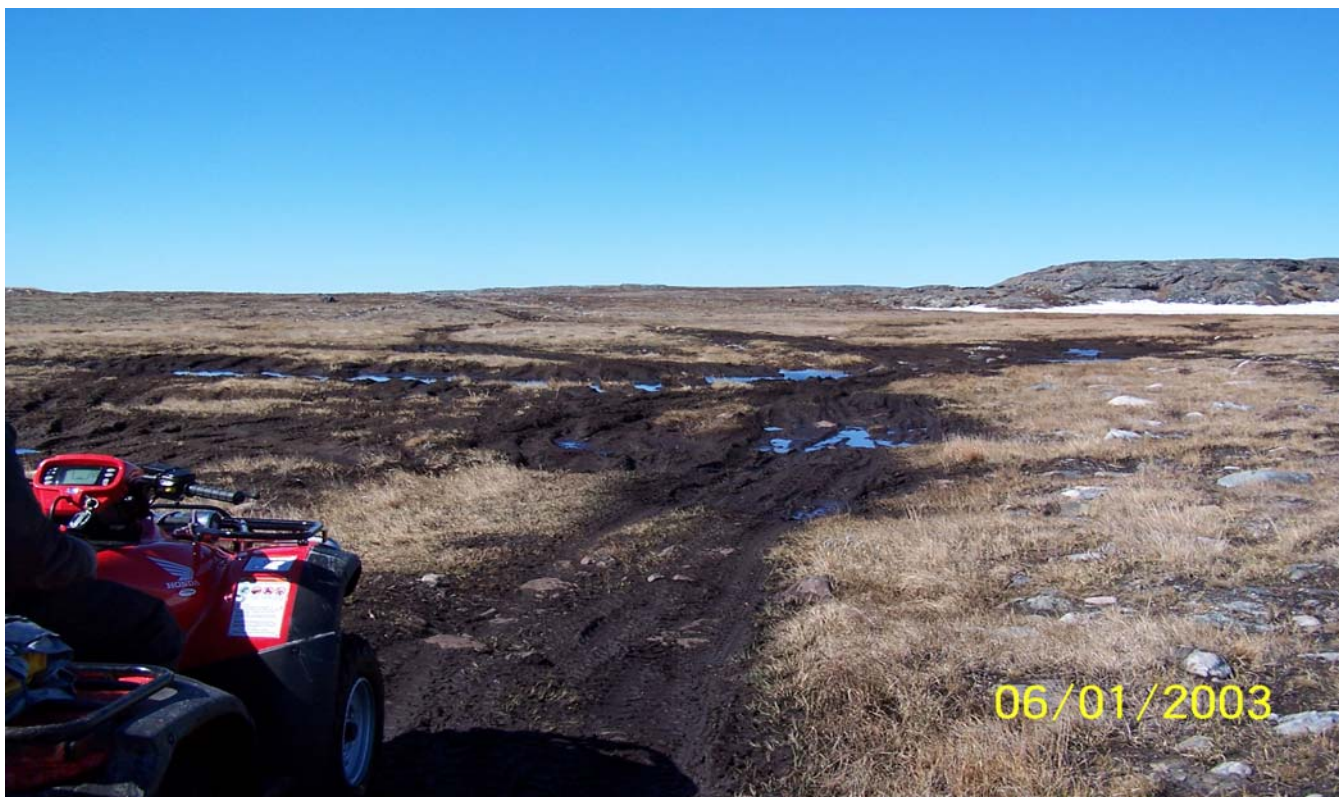
Photo 6 – Wet area in fine grained soils. Note trail widening.

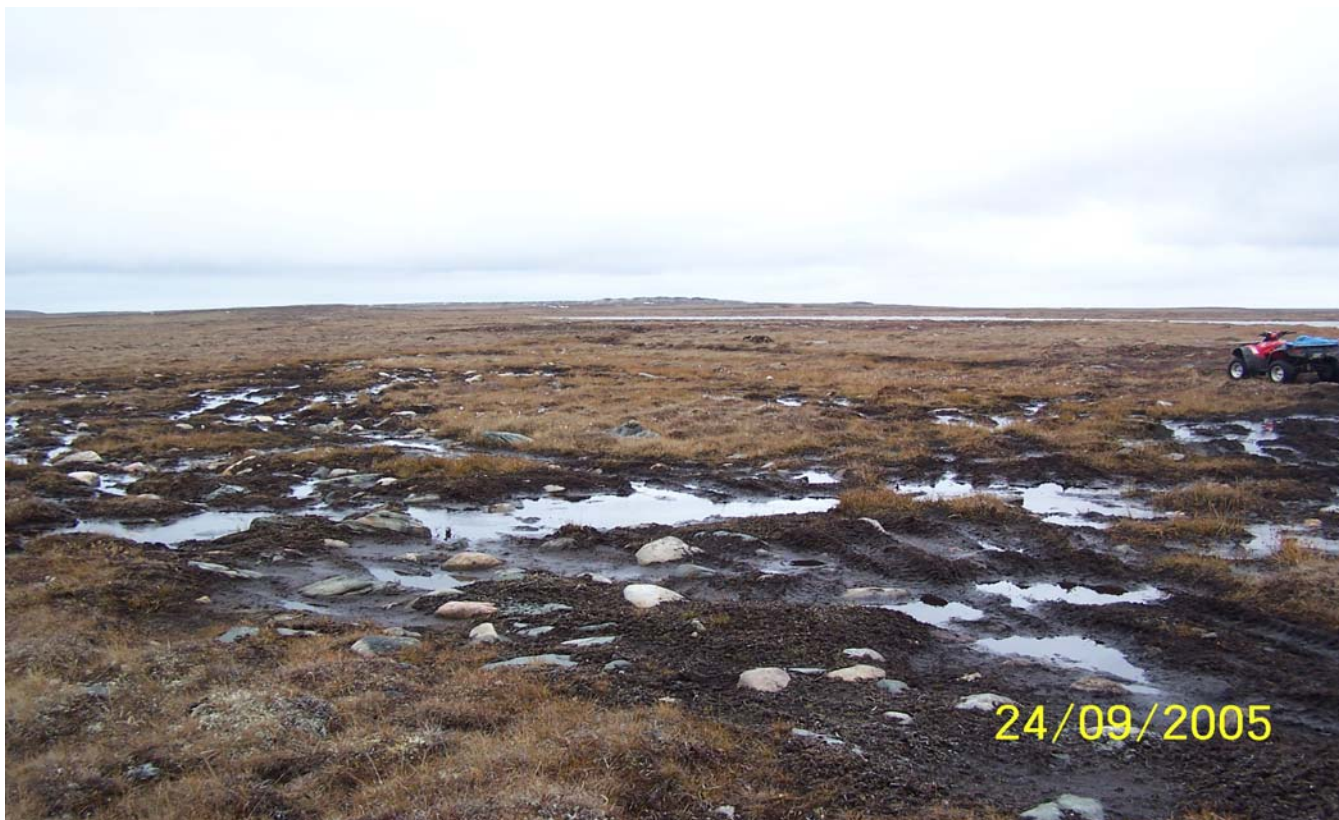
Photo 7 – Widened Trail Crossing at Stream #1

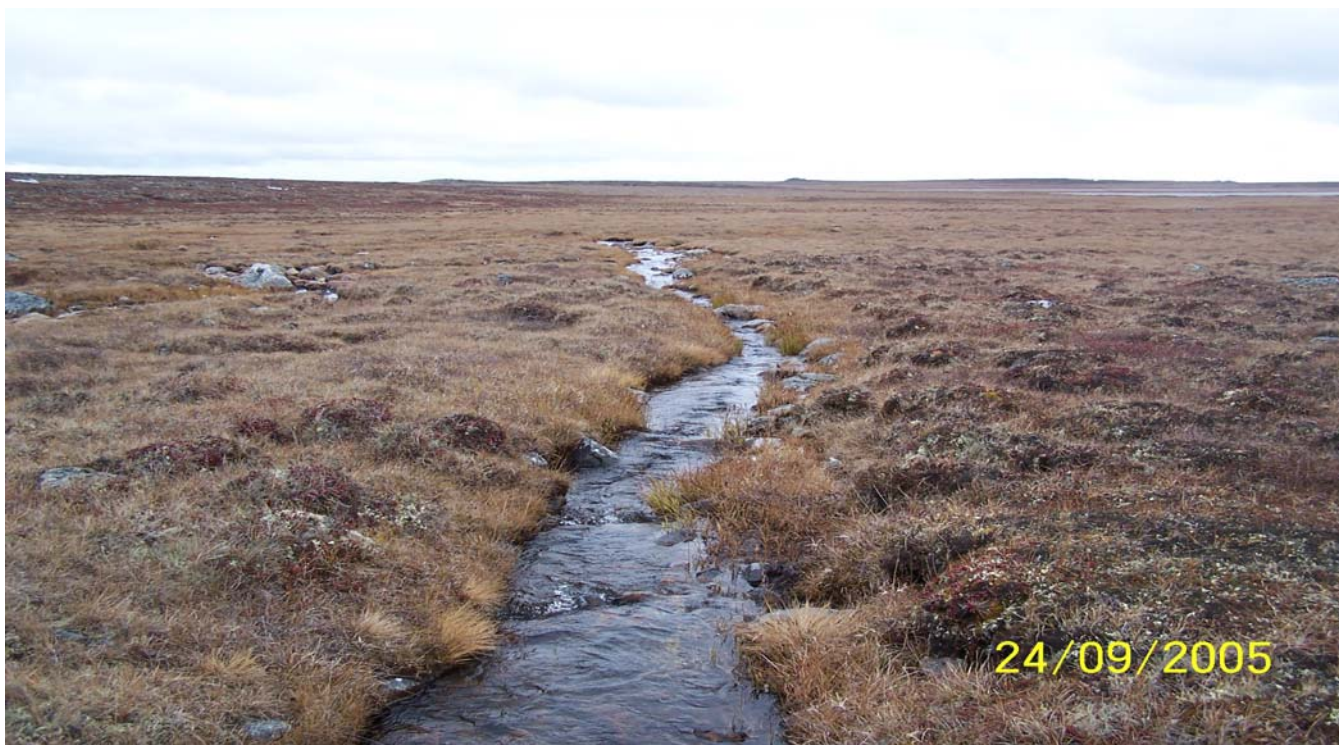
Photo 8 – Undisturbed bank and channel downstream of Stream # 8. Crossing structure to be installed in this location.
