Dianne River Access Trail

HAMLET OF RANKIN INLET
RANKIN INLET, NUNAVUT

November 30, 2005

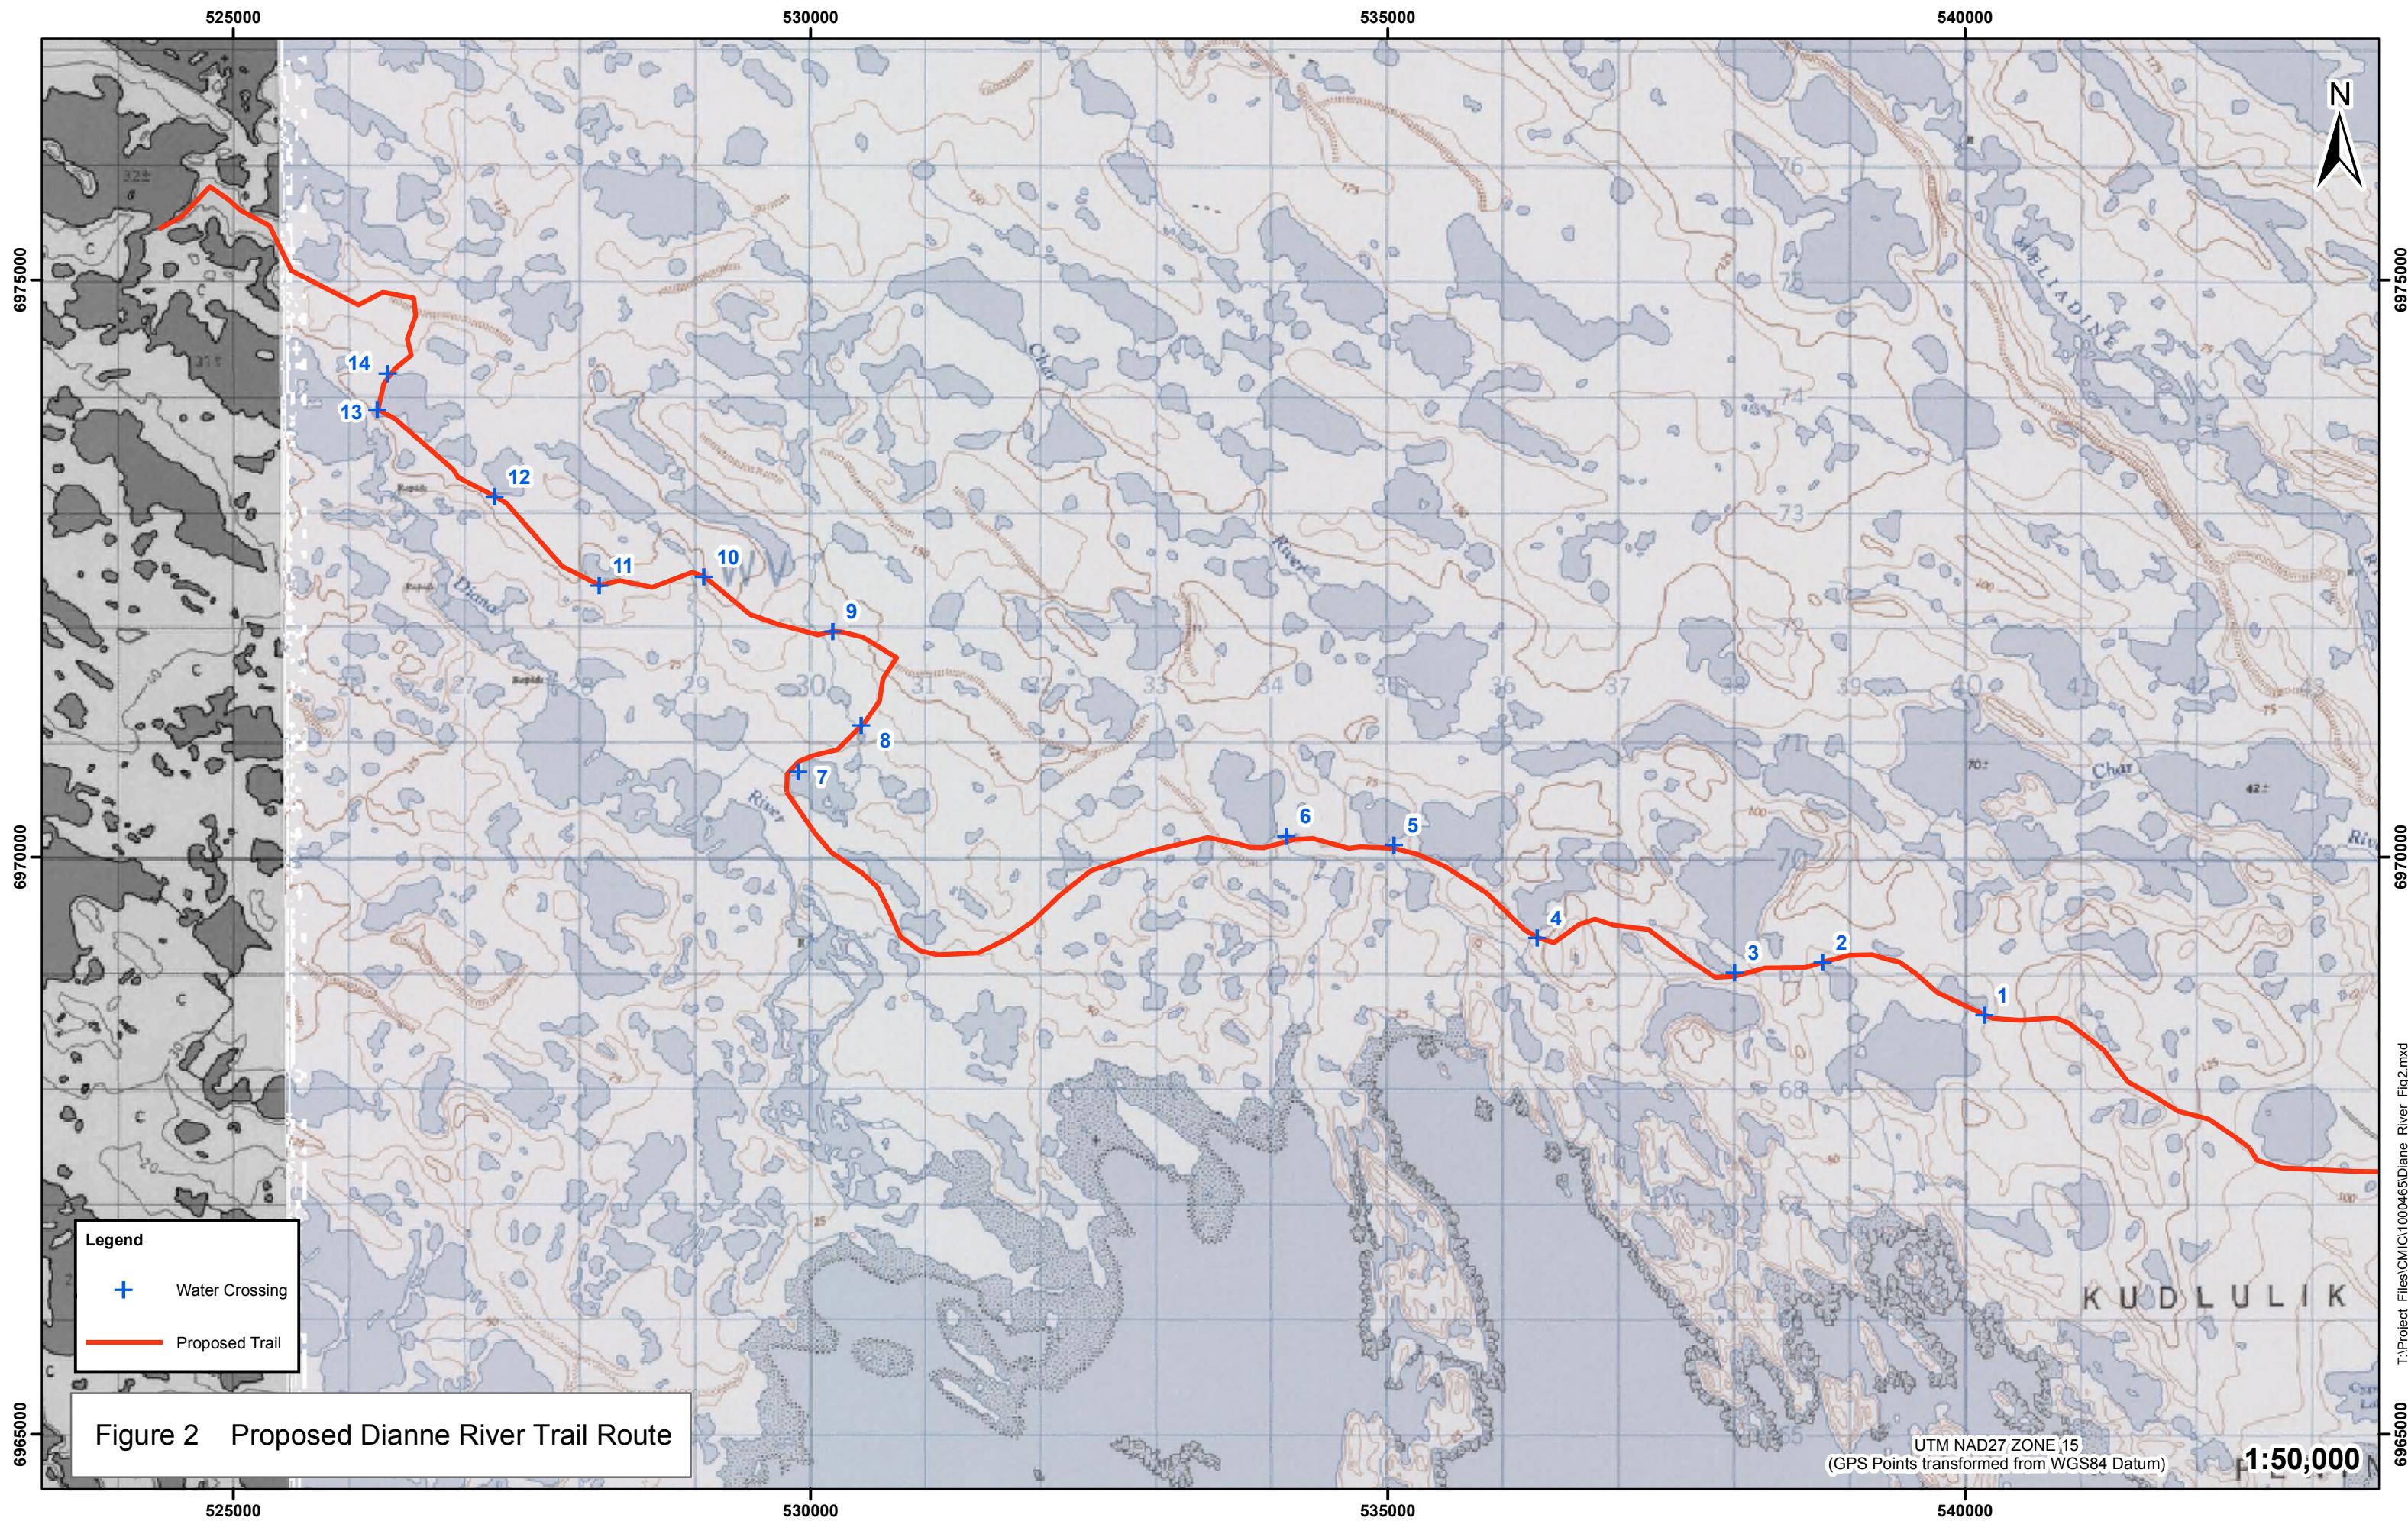
The Hamlet wishes to upgrade the traditional ATV trail between the Hamlet and the Dianne River Narrows. The poor condition of the existing trail discourages many residents from using the trail and accessing traditional fishing areas along the Dianne River. The trail is intended to be upgraded for single lane ATV use during the snow free period. The trail begins on the right side of the community’s “New Dump Access Road” and continues in a westerly direction to a narrowing of the Dianne River (“the Narrows”) which has been a traditional fishing location for the community. The location of the traditional ATV trail is illustrated in Figure 2, **Appendix A**.

Weather conditions were good during the site visit, allowing for inspection of all areas of the trail. Surface water was not frozen and all streams crossed were flowing. GPS waypoints were recorded along the route to enable the route to be plotted and to identify stream locations or where specific improvements and/or mitigation may be required. Figure 2, **Appendix A** illustrates the route of the traditional trail, including any variations confirmed during the field visit.

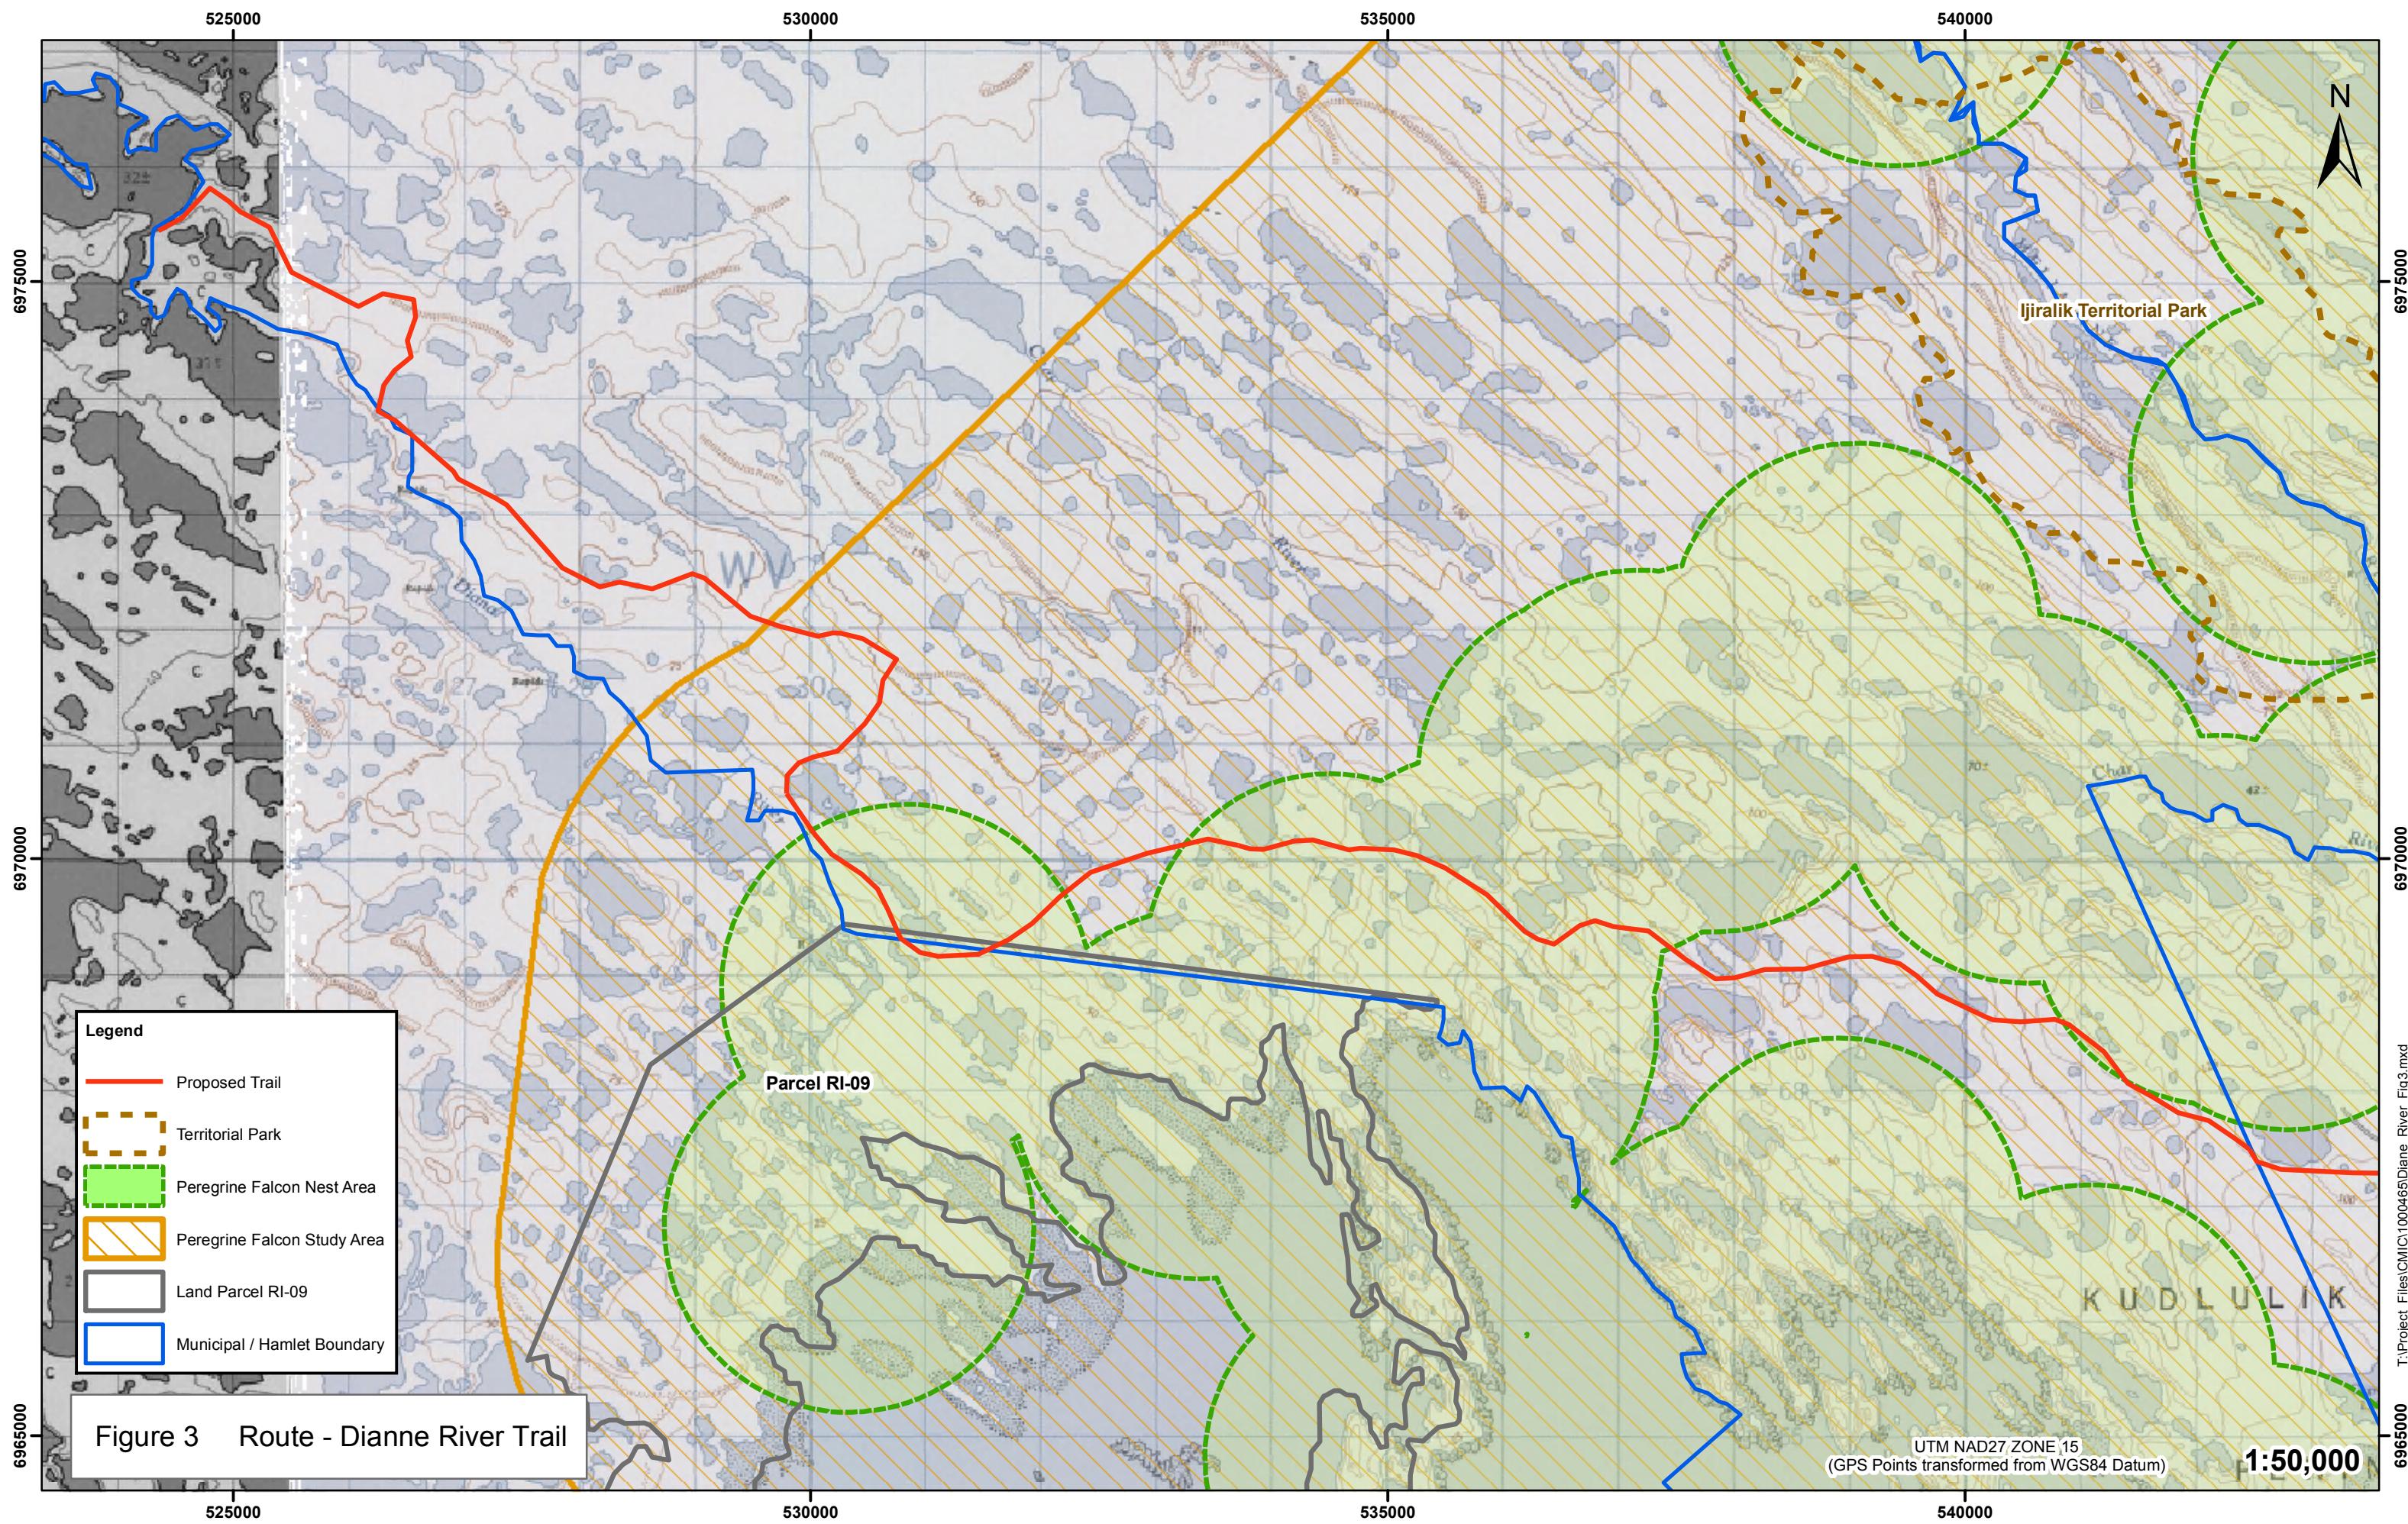
Most of the proposed access trail is located within the Hamlet boundaries. However, as depicted on Figure 3, the area of the trail near the mouth of the Dianne River falls within Inuit Owned Lands (IOL) Parcel RI-09. This IOL parcel is administered by the Lands Division of the Kitikmeot Inuit Association (KIA). An access permit would be required to improve and retain management control of the trail within the IOL parcel. The KIA should be contacted by the Hamlet to initiate the access permit review process.

The DOE has suggested that an area enclosed by a radius of 1.6km from each nest should be considered a sensitive buffer zone (Figure 3, **Appendix A**). The DOE recommends no activity be conducted within these buffer zones when the nests are occupied. Additionally the DOE recommends that the trail route be out of the line of site of the nests and has offered to assist with adjusting the route alignment to achieve this objective.

The existing trail is primarily located within the Hamlet boundaries; however, a short section of the trail near the mouth of the Dianne River is located on Inuit Owned Land (Figure 3, **Appendix A**). Design, construction and operation of the upgraded access trail would be managed by the Hamlet. Construction is expected to occur over a multi-year period. Some degree of operational control over access trail use, as necessary, can be exercised through municipal bylaws.

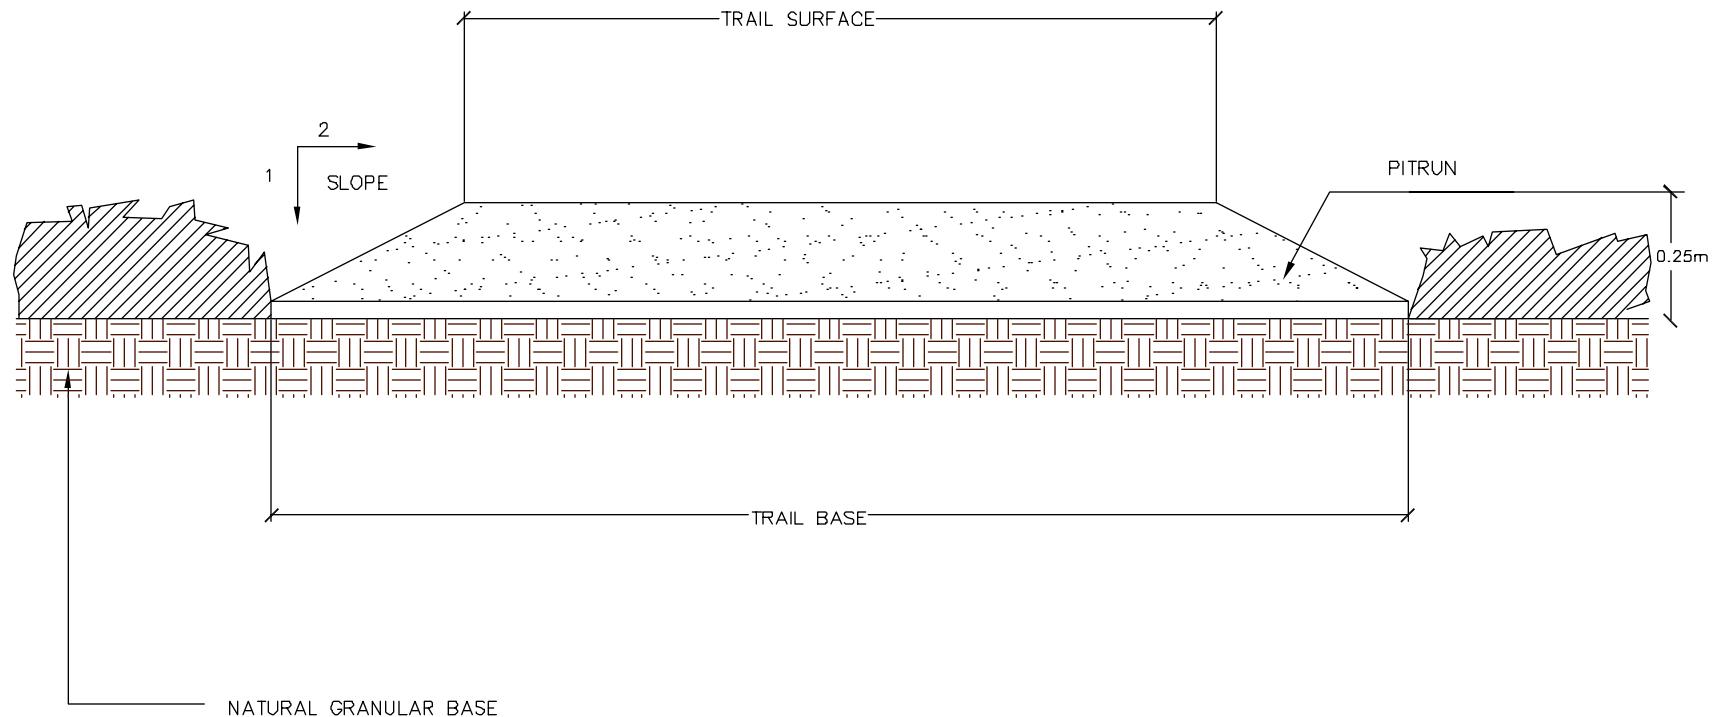
SCALE:	N.T.S.	CLIENT : TITLE : HAMLET OF RANKIN INLET TYPICAL TRAIL CROSS-SECTION DRY GRANULAR BASE	DRAWING NO.
	DATE:	12/07/05		
	DRAWN BY:	LDP		
	APPROVED BY:			
				4

When located on eskers or granular deposits, the access trail would be surfaced by a layer of pit run material to provide strength and define the limits of the access trail as illustrated in Figure 4, **Appendix A**. In some cases it may be beneficial to grade the existing trail flat before applying any additional material so that the trail remains elevated and drains properly.

Within the rock fields it is expected that access trail construction will involve the placement of additional rock to create a relatively flat elevated trail base followed by surfacing with pit run material. The typical cross-section illustrated in Figure 4 can be modified to suit site specific conditions and provide a solid access trail using the minimum amount of imported materials.

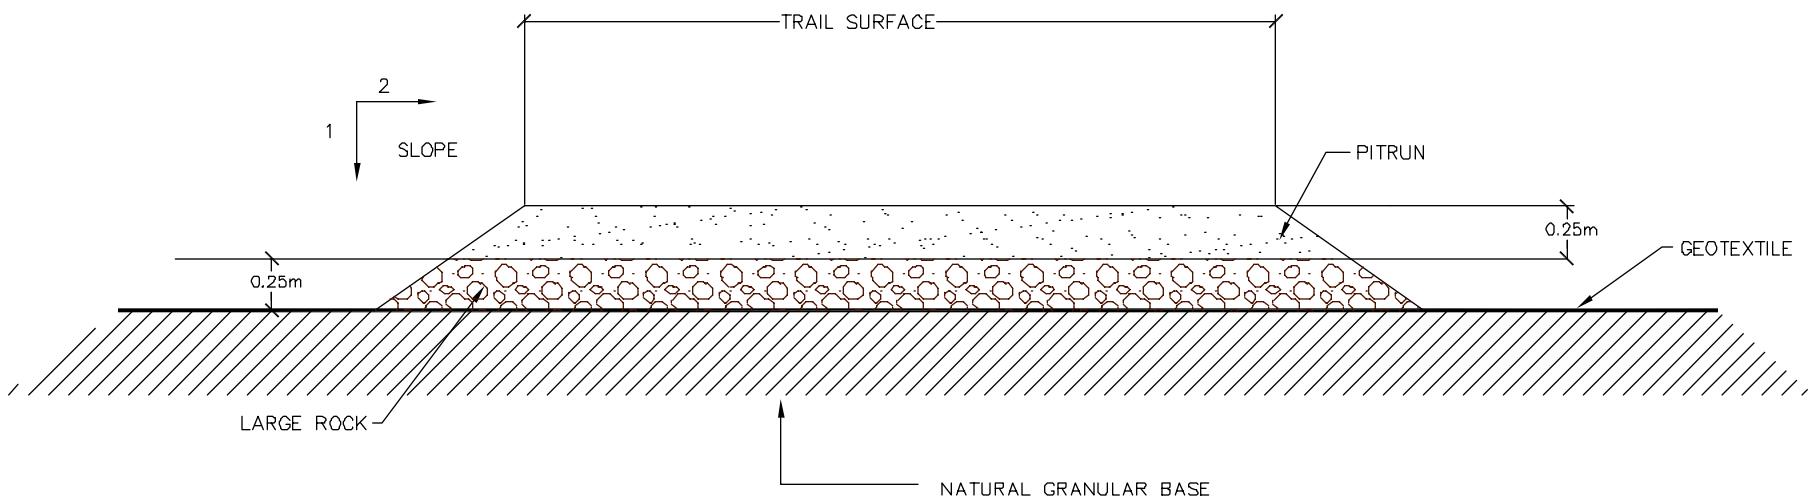
Figure 5 illustrates a typical cross-section for access trails constructed in areas of fine-grained soils. Where the trail is incised below the surrounding grade, a new trail alignment at least 5 metres away should be developed rather than reconstructing the existing trail. Geotextile should be placed on the ground to restrict movement of the granular material into the soil. Rock would be placed on top of the geotextile to form a solid base. The access trail base would be surfaced with pit run material. The depth of fill would vary according to site specific conditions, but would need to be sufficient to maintain traffic above standing water and prevent erosion.

The majority of the access trail is located in areas of fine grained soil material with corresponding high moisture content. Freeze-thaw action in these areas may result in differential settlement and an irregular access trail surface. It is suggested that these areas be covered in a geotextile before placing the granular trail material on top. This method will allow for water to drain, without losing trail material into the soil. The layer of granular trail material will also help insulate the underlying soil, assisting in the development of a solid trail base.
