CONSTRUCTION AND OPERATION OF AN ACCESS ROAD AND BORROW SOURCES AT REPULSE BAY, NU

Environmental Screening

FINAL

March 2011

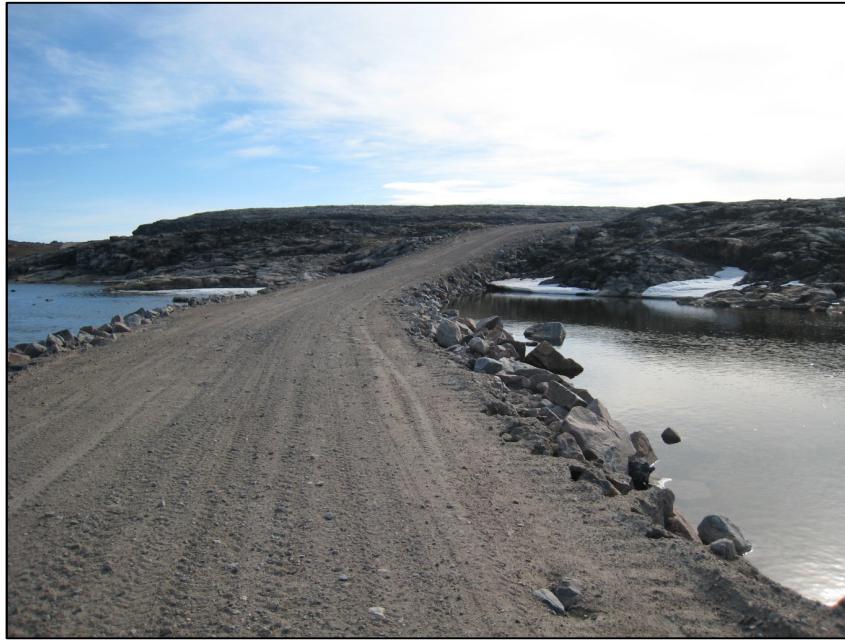
Photo 1: Constructed Cross-1 at km 0+258 across the tidal flat of Tariugaq Inlet in June 2008; west aspect.

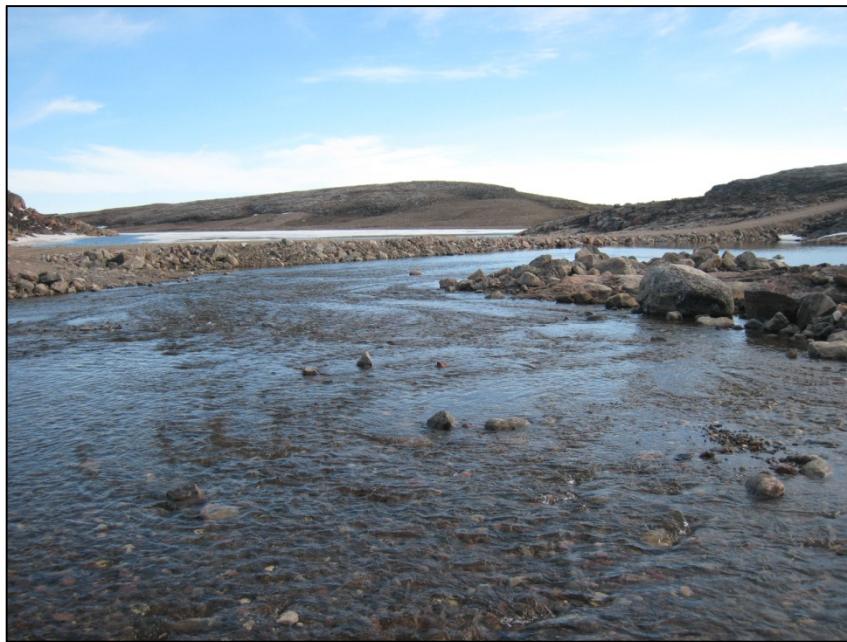
Photo 4: Constructed Cross-1 across the tidal flat of Tariugaq Inlet in June 2008; south aspect.

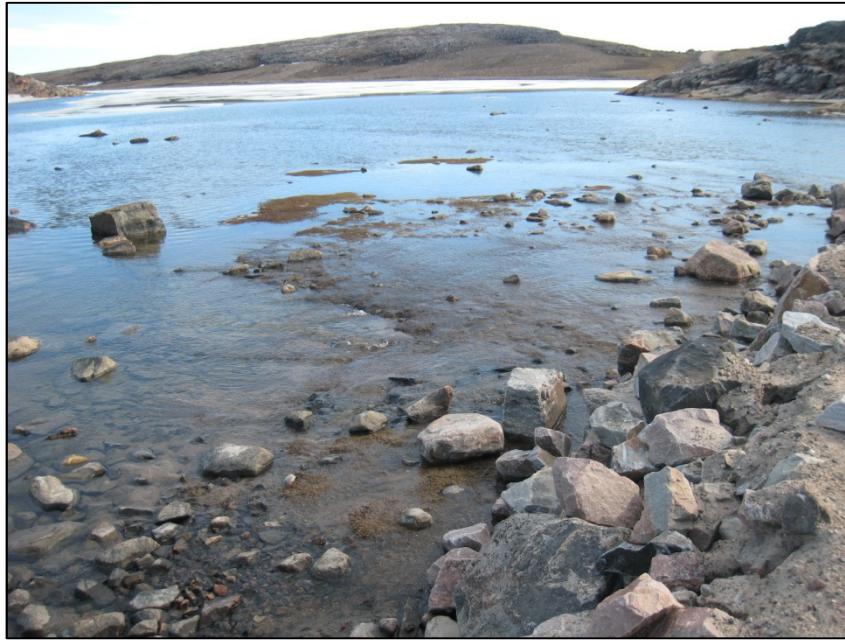
Photo 5: Tariugaq Inlet substrate and large riprap on south shore of Cross-1 in June 2008; south aspect

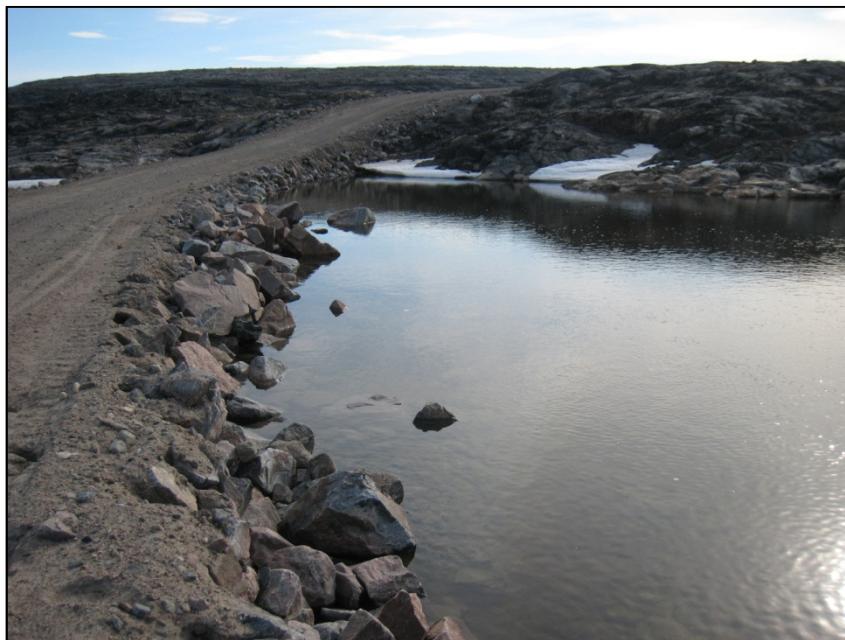
Photo 6: Tariugaq Inlet substrate and large riprap on north shore of Cross-1 in June 2008; west aspect

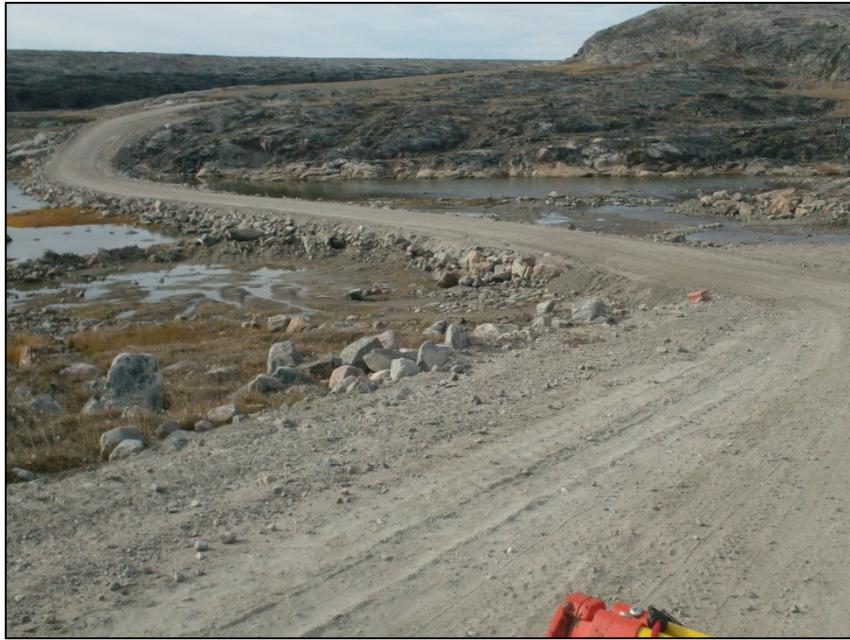
Photo 7: Constructed Cross-1 across Tariugaq Inlet in August 2010; west aspect (FSC 2010).

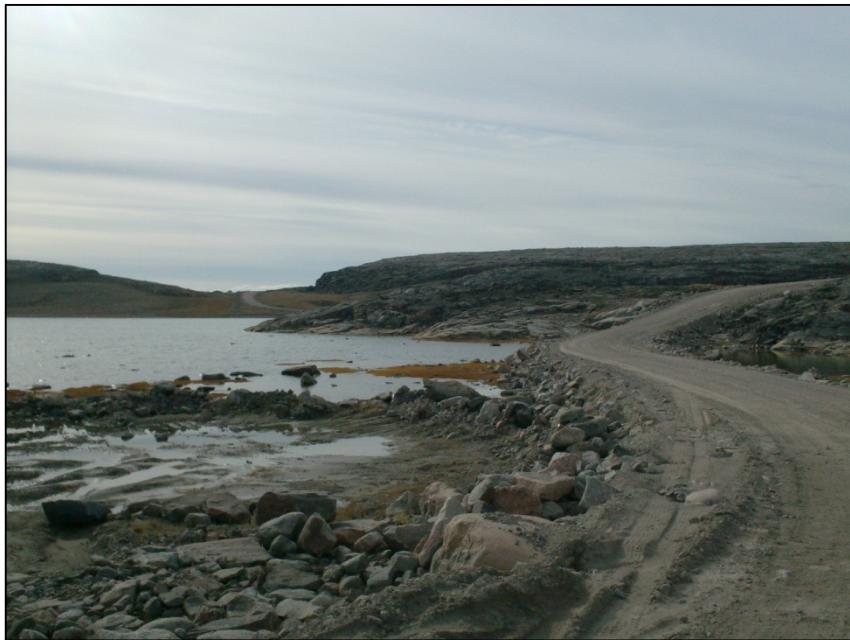
Photo 8: Constructed Cross-1 across Tariugaq Inlet in August 2010; southwest aspect (FSC 2010).

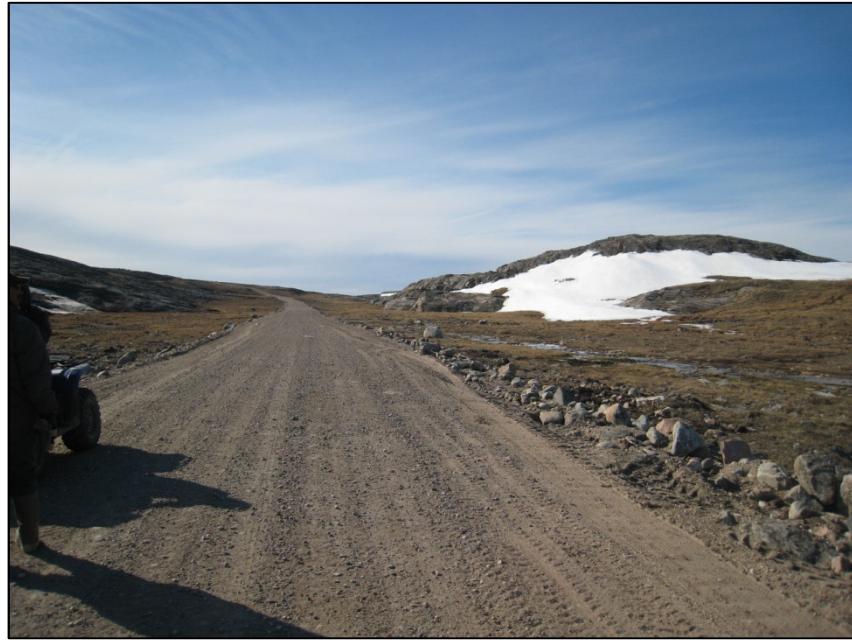
Photo 9: Constructed access road at km 0+980 with typical terrain in June 2008; north aspect.

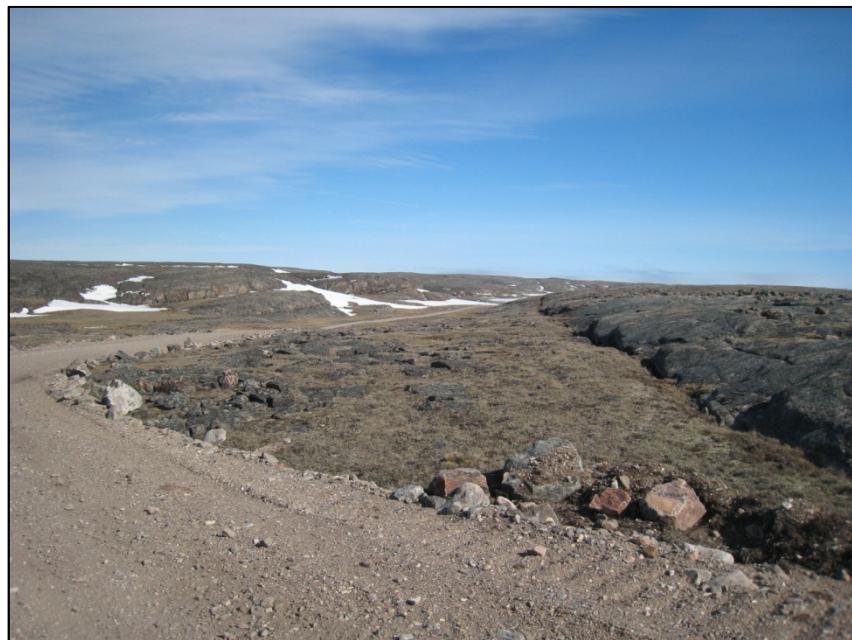
Photo 10: Constructed access road at km 1+720 with typical terrain in June 2008; southeast aspect.

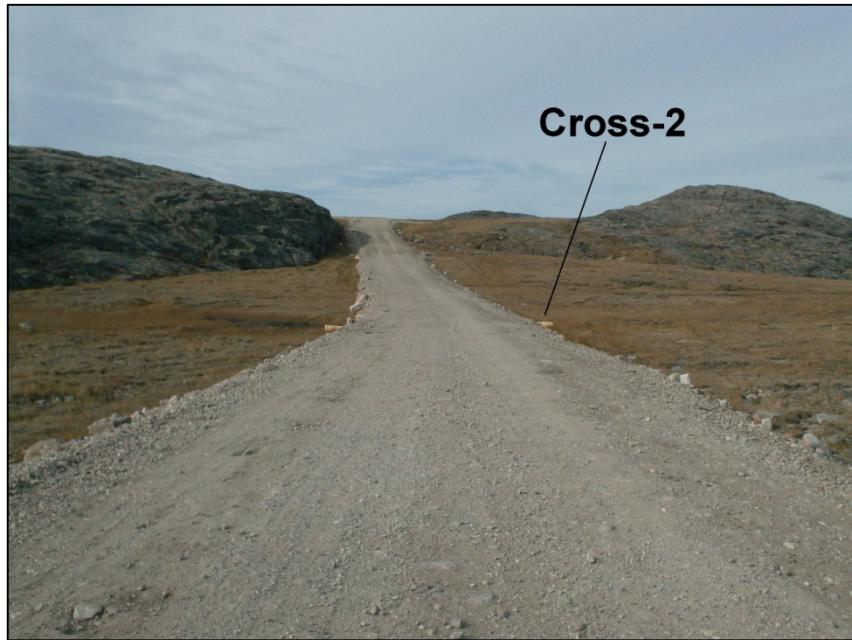
Photo 11: Constructed Cross-2 at km 2+330 in August 2010; northwest aspect (FSC 2010).

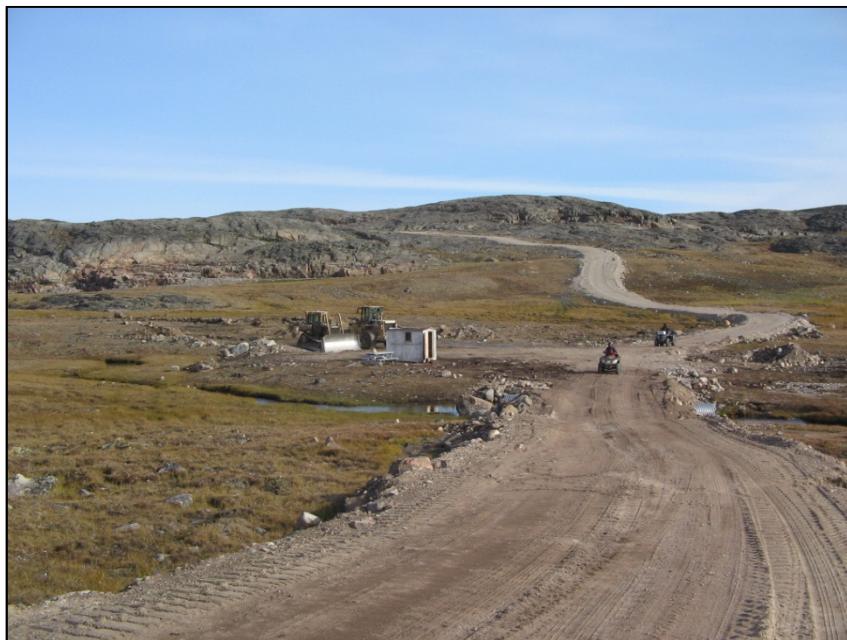
Photo 18: Constructed crossing at Stream #2 and laydown area in September 2010; east aspect (FMA 2010).
