## **Appendix B      Photographs of the Project area**

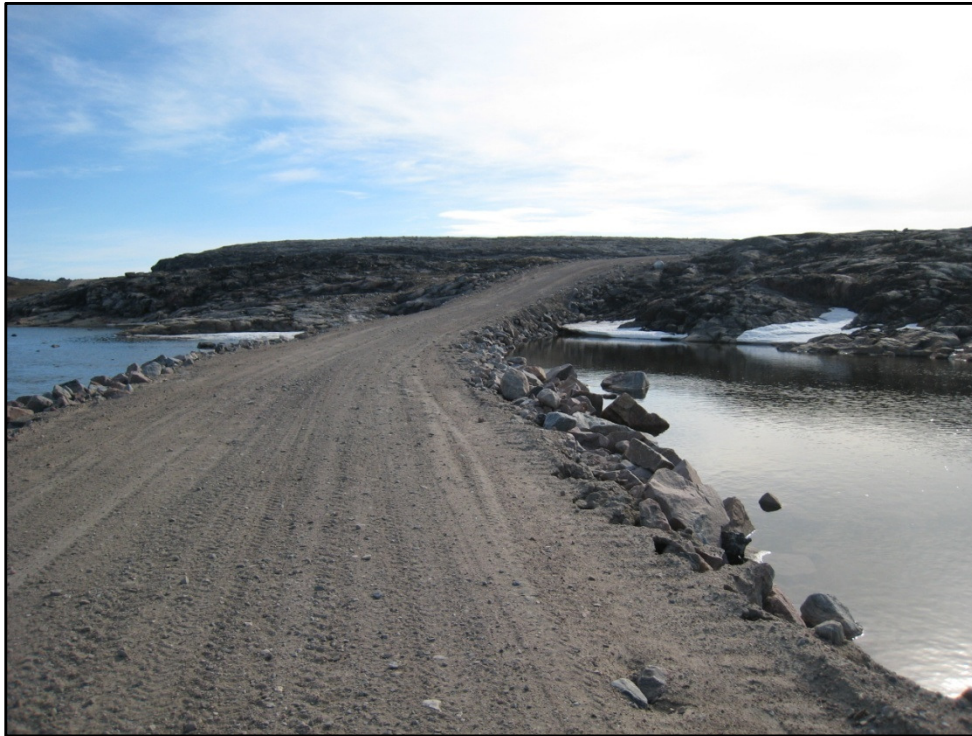
**Photo 1** West aspect of constructed CRS-1 crossing at Km 0 of the North Pole River access road, marine Tariuraq Inlet on the left side of photo and the freshwater lake on the right side; no culverts installed.

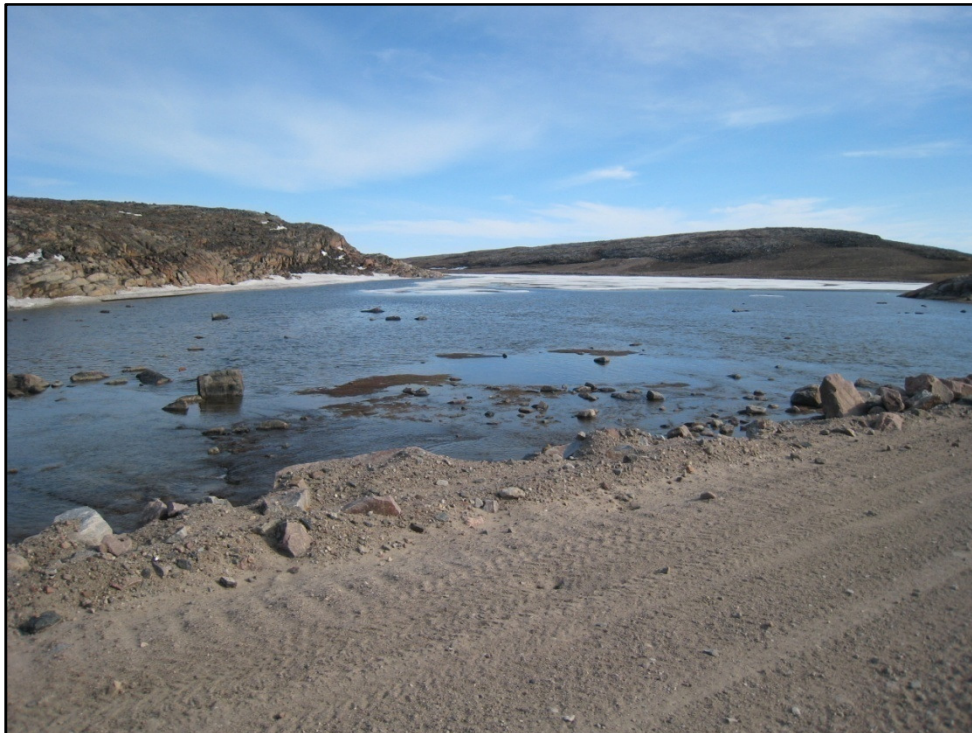
**Photo 2** South aspect from the constructed CRS-1 crossing; marine Tariuraq Inlet in background.

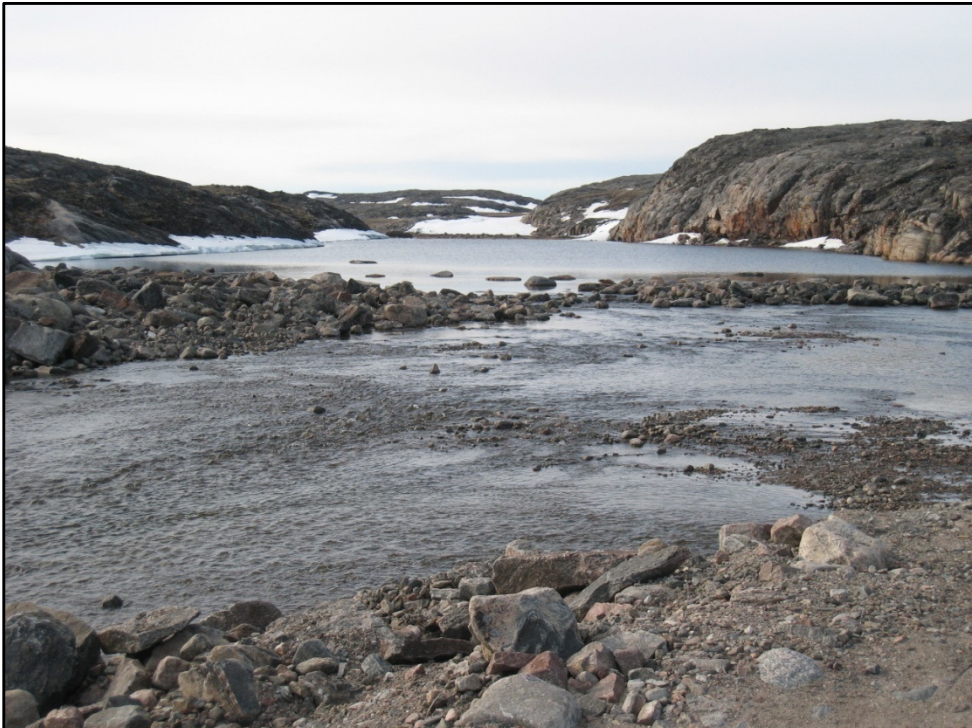
**Photo 3** North aspect from constructed CRS-1 crossing; the freshwater lake in background.

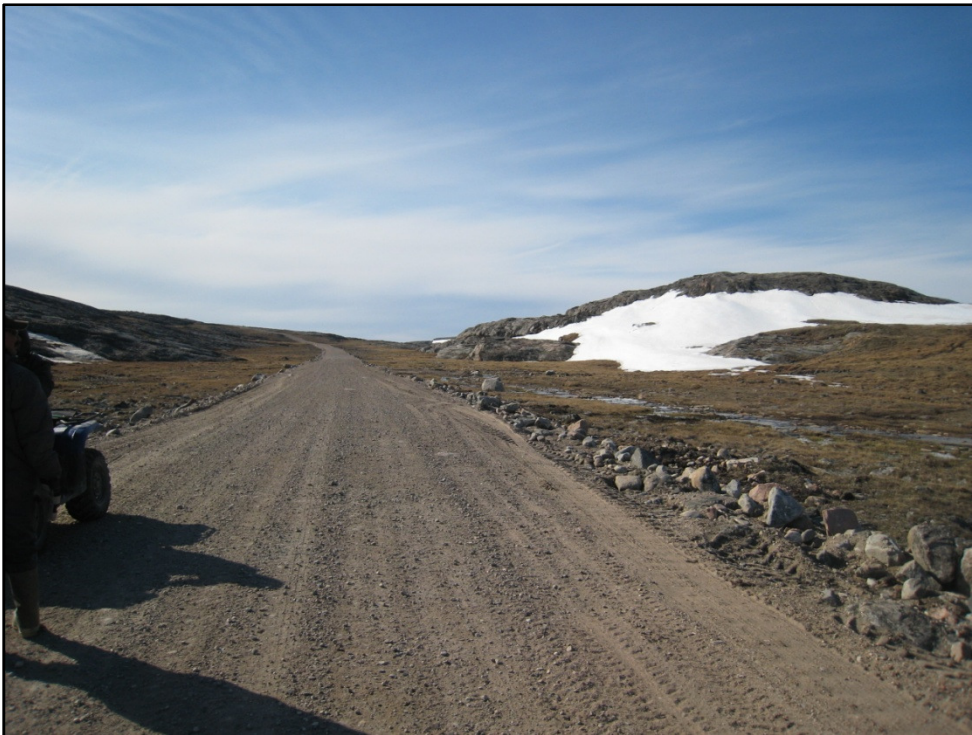
**Photo 4** Km 0.5 of constructed access road, note bedrock ridges and vegetated slopes; north aspect.

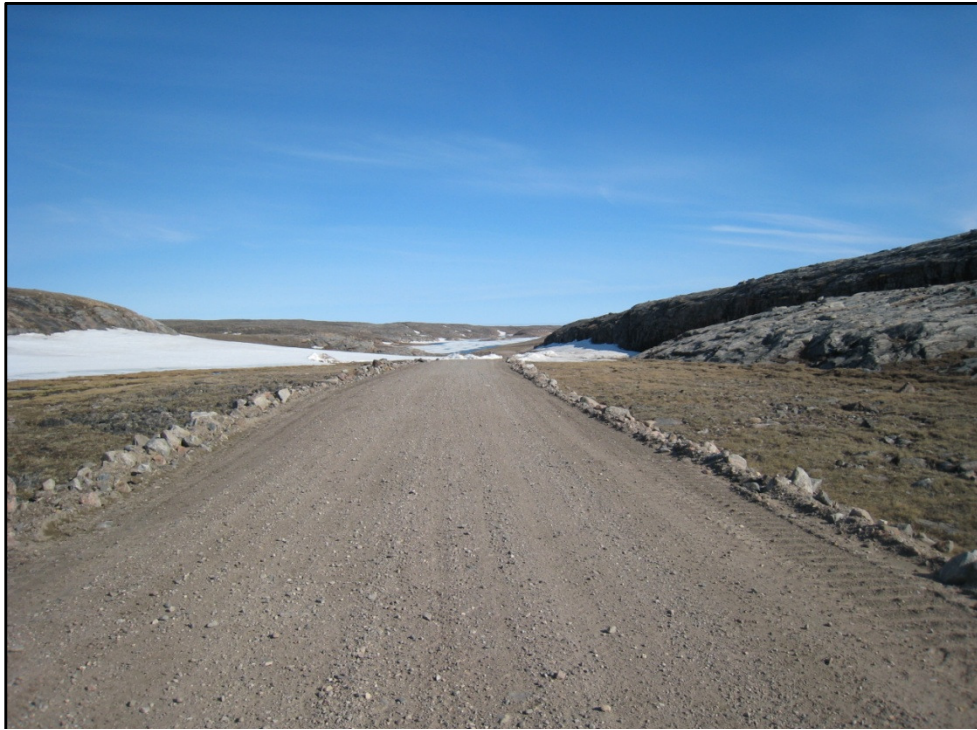
**Photo 5** Km 0.5 of constructed access road, note bedrock ridges on east and west; south aspect with Tariuraq Inlet in far background of photo.

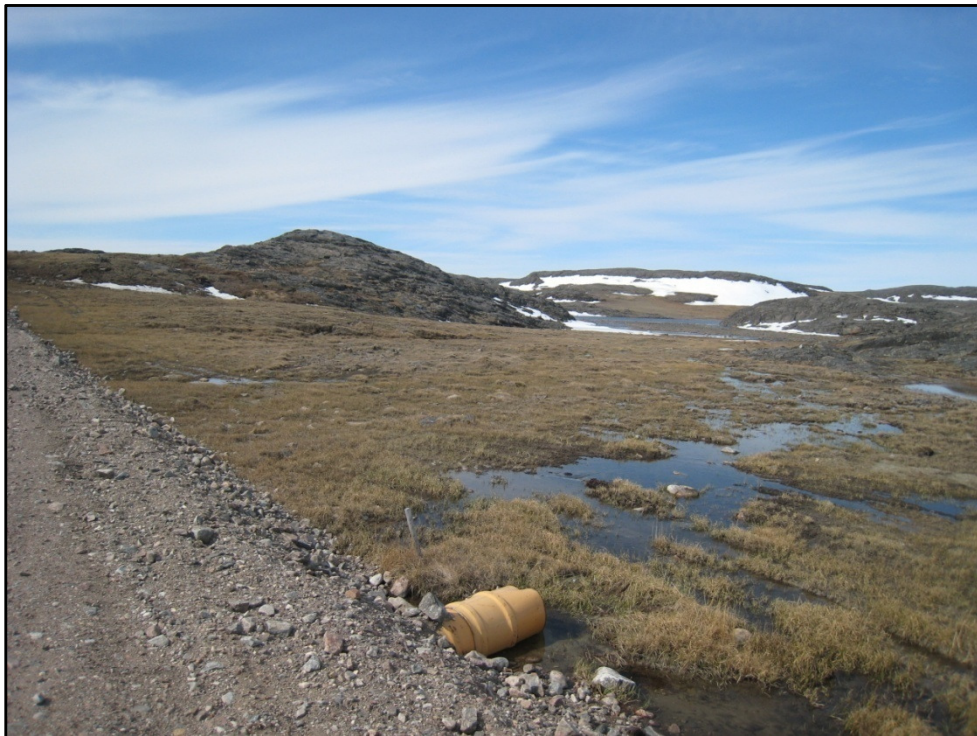
**Photo 6** CRS-2 crossing at Km 1.8 of the constructed access road, north aspect with installed culvert and downstream flow pattern.

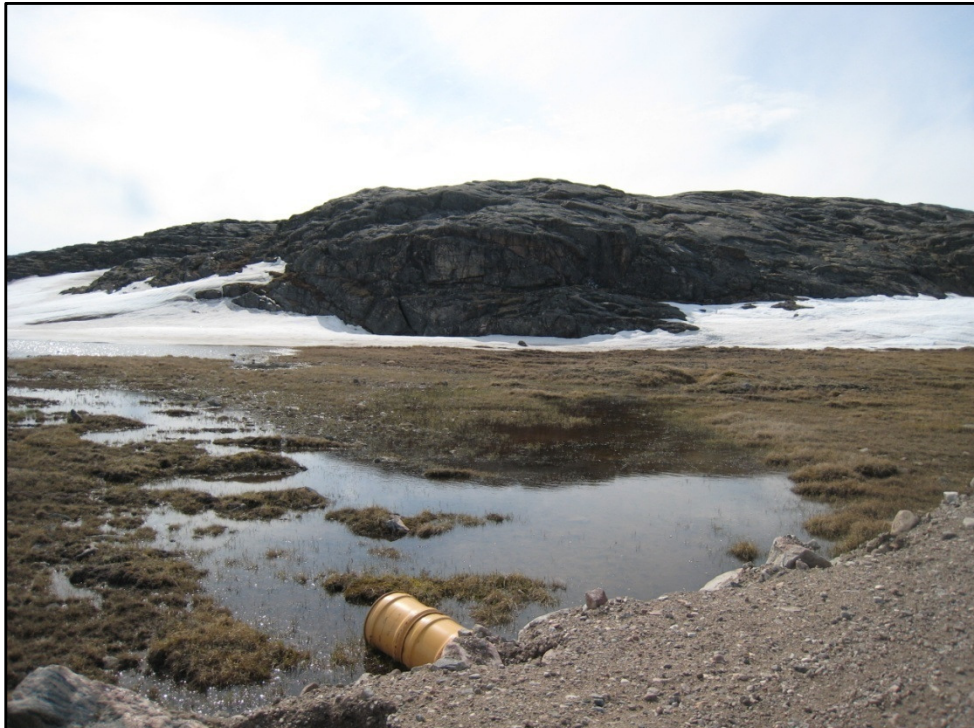
**Photo 7** CRS-2 crossing west aspect with installed culvert and upstream pond flow pattern; upstream water body is confirmed fish-bearing pond.

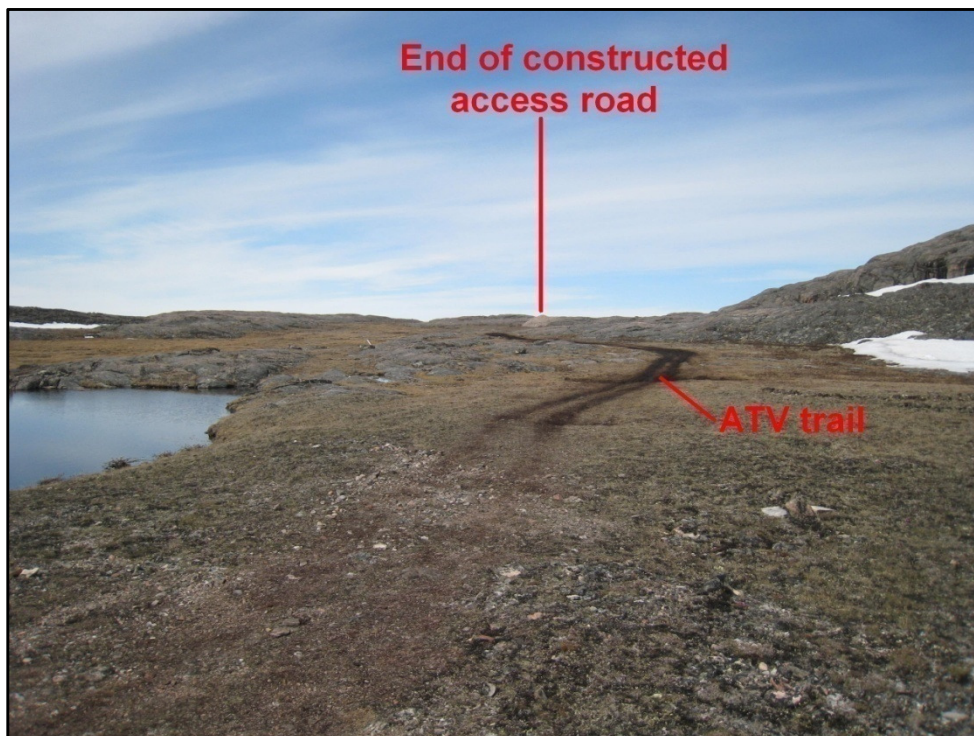
**Photo 8** End of constructed access road with existing ATV trail near Km 2.9 of the proposed route; north aspect.
