GOVERNMENT OF NUNAVUT, DEPARTMENT OF COMMUNITY & GOVERNMENT SERVICES

AIRPORT COMMUNITY ROAD WASHOUT CORAL HARBOUR, NUNAVUT

REPORT

FEBRUARY 2013
ISSUED FOR USE – REVISION I
EBA FILE: C31103058

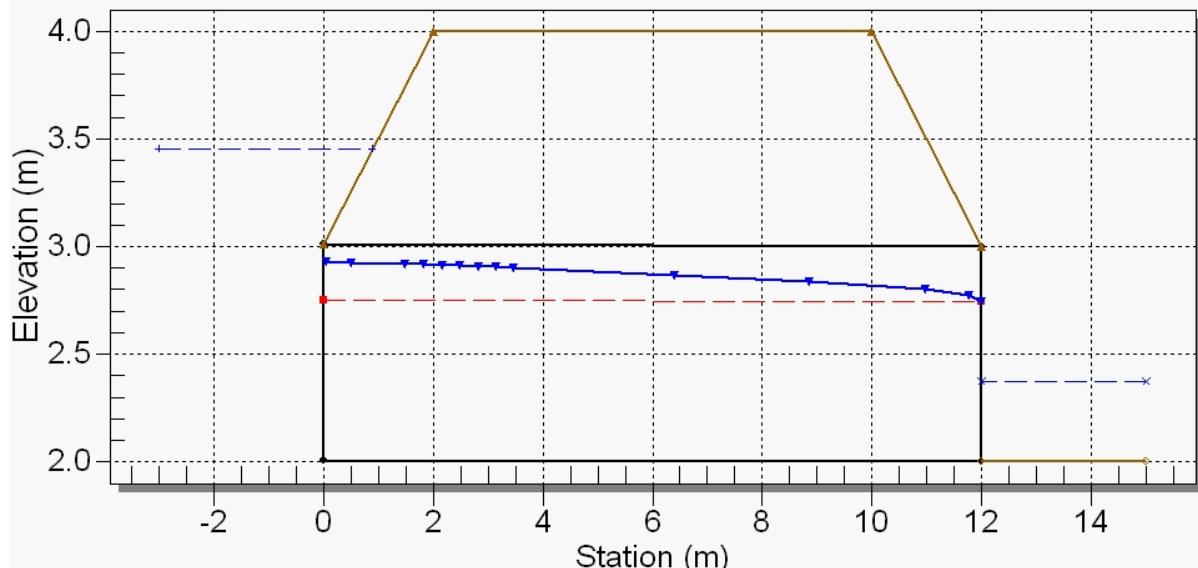
Crossings 1, 2 and 3 located after the cottage junction road (high point) along the Coral Harbour Airport Community Road are single corrugated metal pipe (CMP) structure of 1000 mm diameter. The combined hydraulic capacity of these three culverts is estimated at 5.0 m³/s with headwater elevation at 3.45 m as shown on Figure 3.

Crossing - 1, 2 and 3: Existing Culverts - Hydraulic Analysis, Design Discharge - 5.00 cms

Culvert - Culvert #1 2 and 3: 1000 mm CMP, Culvert Discharge - 5.00 cms

Figure 3: Culvert profile showing headwater and its flow capacity

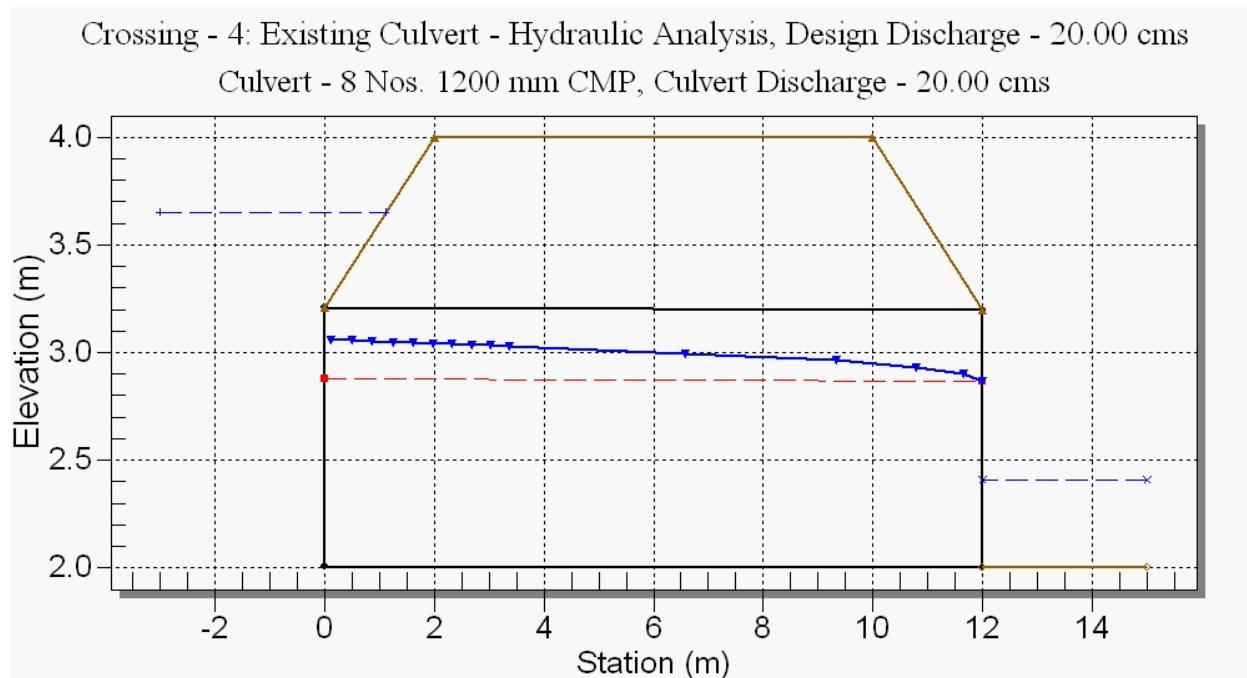
Crossing 4 consists of 8 barrels of 1200 mm CMP installed parallel without any spacing between the pipes. Total hydraulic capacity of these eight culverts is estimated at 20.0 m³/s with a headwater elevation at 3.65 m as shown on Figure 4.

Figure 4: Culvert profile showing headwater and its flow capacity

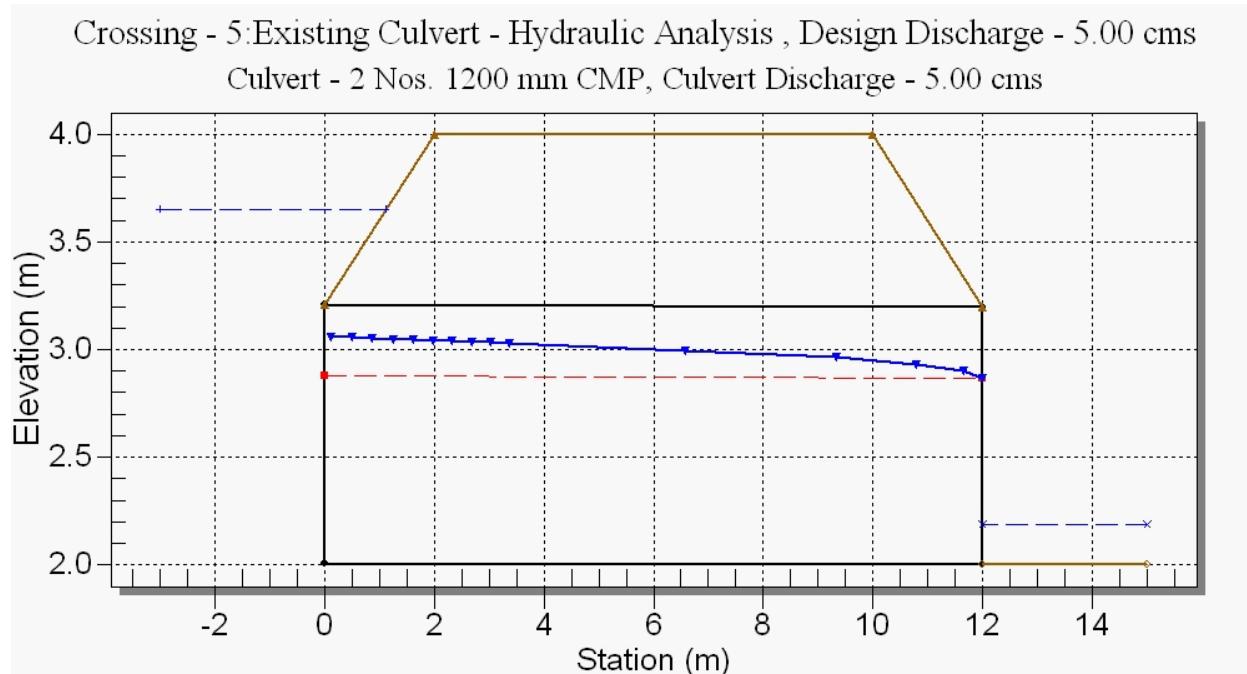
Crossing 5 consists of two parallel barrels of 1200 mm CMP with 1.0 m spacing. Total hydraulic capacity of these three culverts is estimated at 5.0 m³/s with a headwater elevation at 3.65 m as shown on Figure 5.

Figure 5: Culvert profile showing headwater and its flow capacity

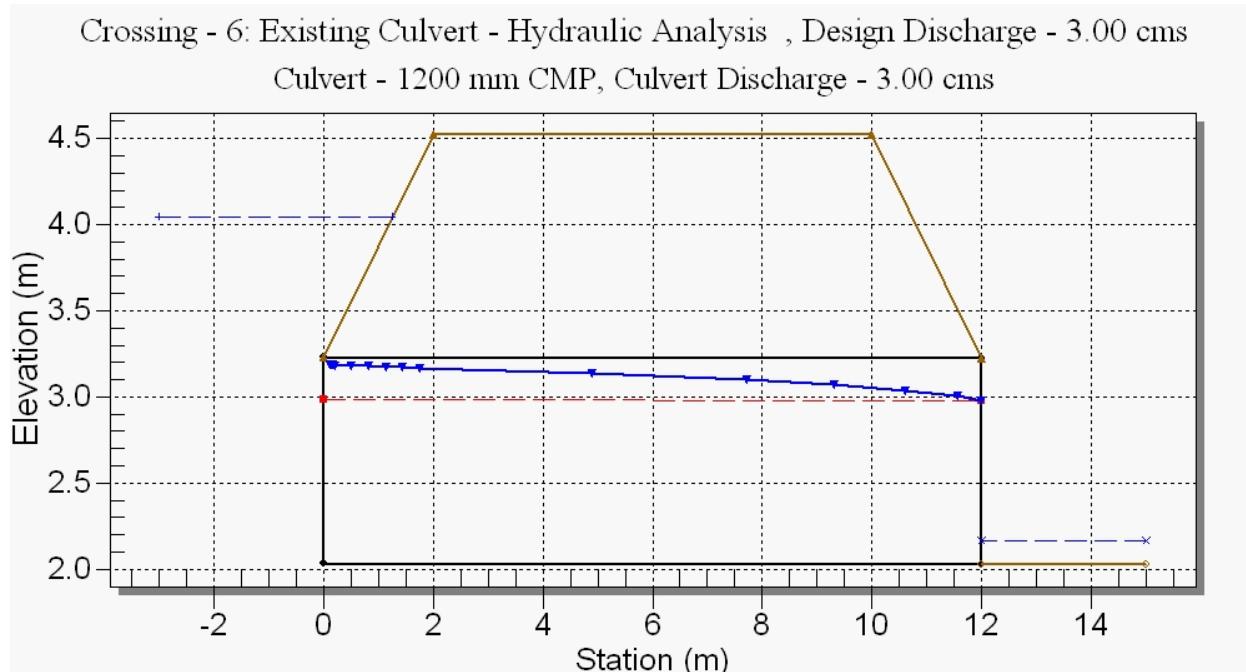
Crossing 6 consists of one barrel of 1200 mm CMP. Total hydraulic capacity of the culvert is estimated at 3.0 m³/s with a headwater elevation at 4.02 m as shown on Figure 6.

Figure 6: Culvert profile showing headwater and its flow capacity

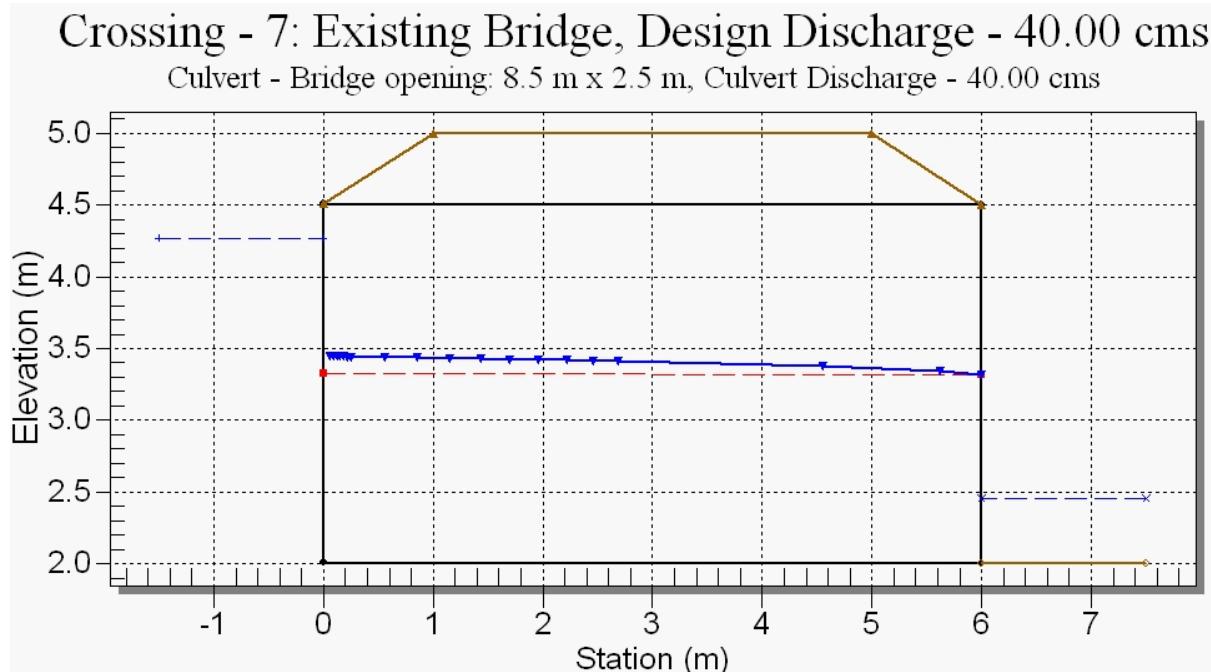
Crossing 7 is the Yellow Bridge with a clear opening of approximately 8.5 m span and 2.5 m rise with rock gabion basket abutments. Road top width is approximately 4.5 m with steel handrail of 0.8 m high. Total hydraulic capacity of the bridge is estimated at 40.0 m³/s with a headwater elevation of 4.2 m and free board of 0.25 m as shown on Figure 7.

Figure 7: Culvert profile showing headwater and its flow capacity

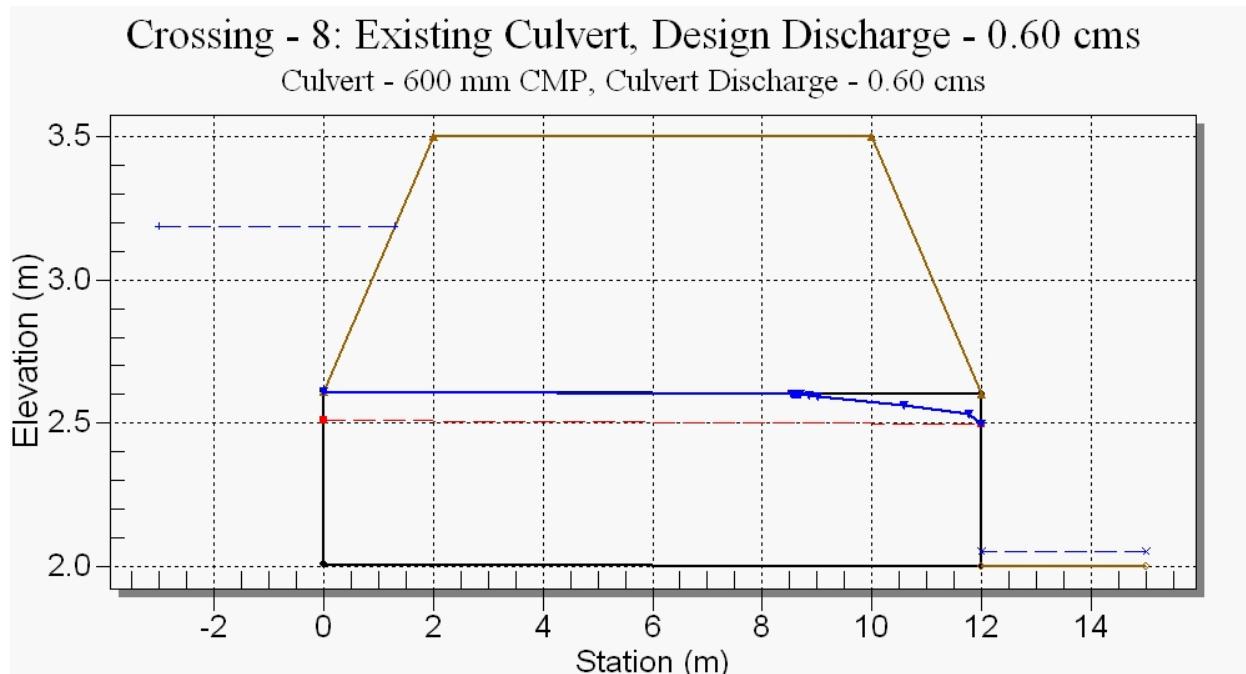
Crossing 8 consists of one barrel of 600 mm CMP. Total hydraulic capacity of the culvert is estimated at 0.6 m³/s with a headwater elevation at 3.2 m as shown on Figure 8.

Figure 8: Culvert profile showing headwater and its flow capacity

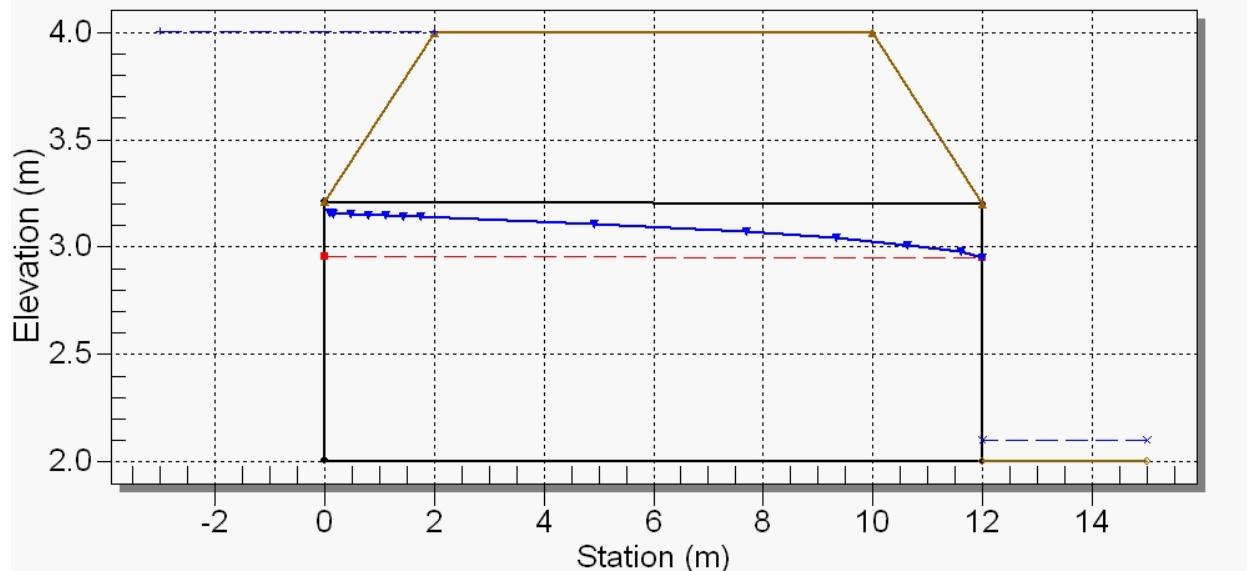
Culvert 9 consists of 1 barrel of 1200 mm CMP. Total hydraulic capacity of the culvert is estimated at less than $3.0 \text{ m}^3/\text{s}$ with a headwater elevation at 4.0 m as shown on Figure 9. Spring flood in June 2012 washed out about 30 m stretch of road on the right side of the culvert as shown on Figure 10.

Crossing - 9: Existing Wash out #1, Design Discharge - 3.00 cms

Culvert - CMP 1000 mm diameter, Culvert Discharge - 2.99 cms

Figure 9: Culvert profile showing headwater and its flow capacity

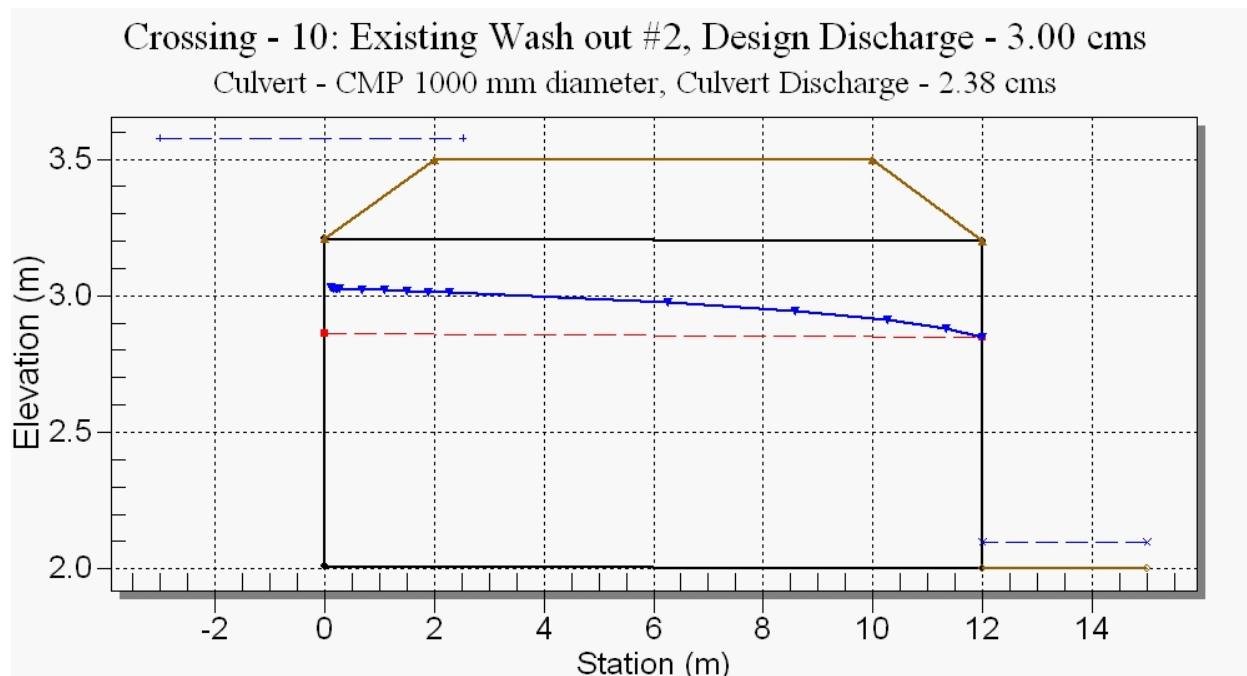
Crossing 10 consists of one barrel of 1200 mm CMP. Total hydraulic capacity of the culvert is estimated at less than 2.4 m³/s with a headwater elevation at 3.5 m as shown on Figure 10. The spring flood in June 2012 washed out about a 50 m stretch of road on the right side of the culvert as shown on Figure 11.

Figure 10: Culvert profile showing headwater and its flow capacity

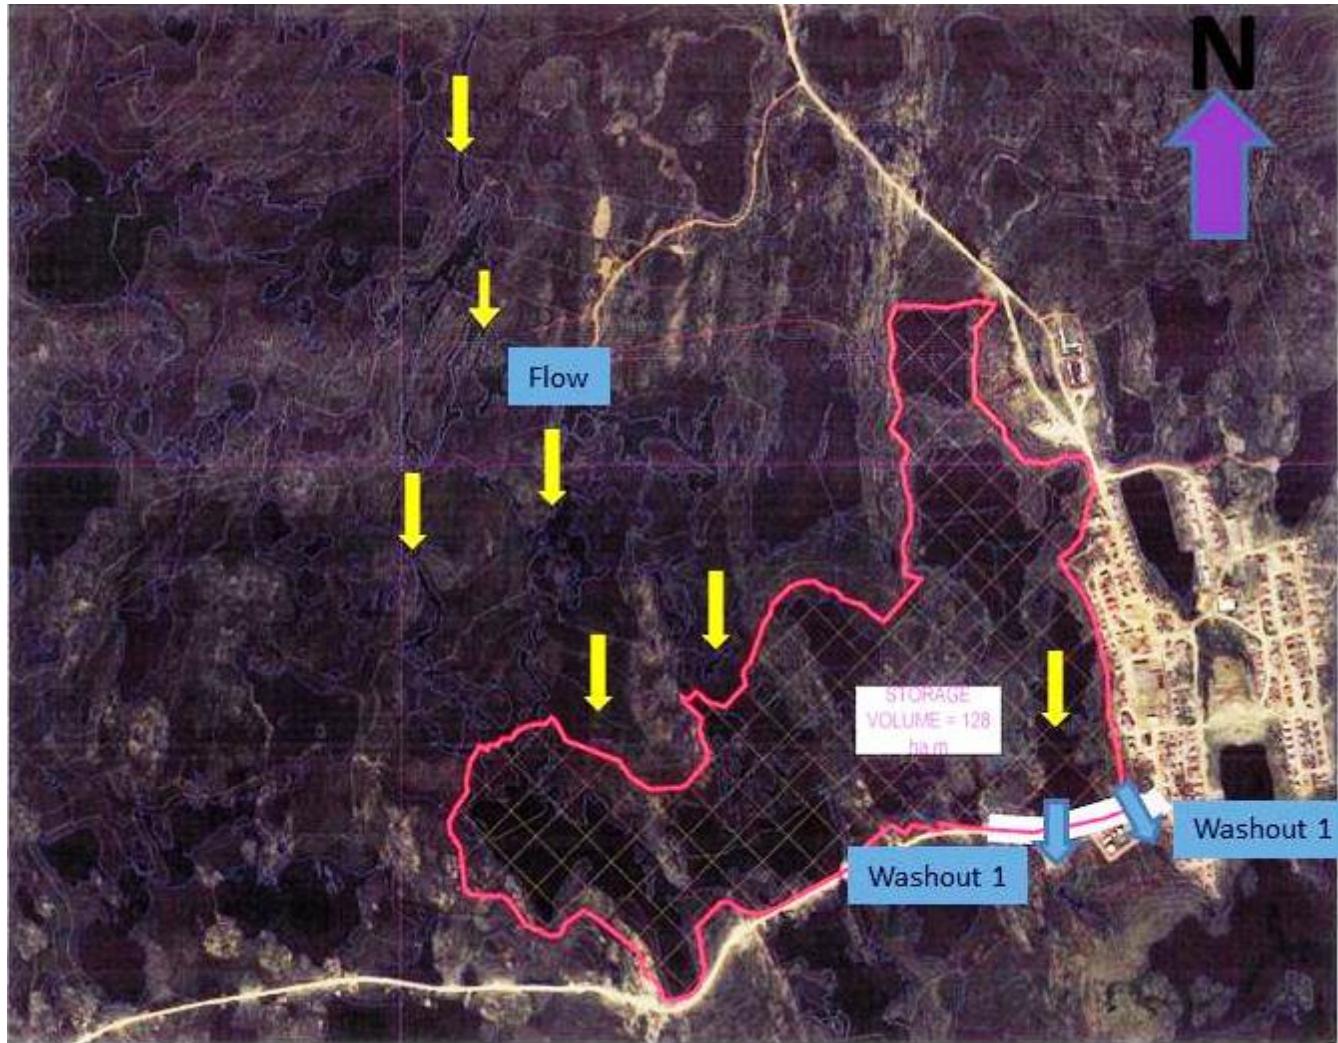
An extreme flood event, such as a combination of rain-on-snow and spring snowmelt event, which produces high runoff volume with the 85% frozen ground condition, was considered for this analysis. The existing road is about 3 km long between the high point and the entrance of the Coral Harbour Hamlet, and acts as a weir during the peak snow melt and rain condition. This condition creates a ponding area of up to 128 ha upstream of the road, and generates 128 ha-m storage volume because of the limited hydraulic

capacities of the culverts and bridge structures along the road as shown on Figure 11. The ponding will not typically over-top under the design snowmelt and or rain-on-snow events alone. Hydrologic and hydraulics analysis using XP SWMM model is given below.

Figure 11: Ponding area during spring flooding.

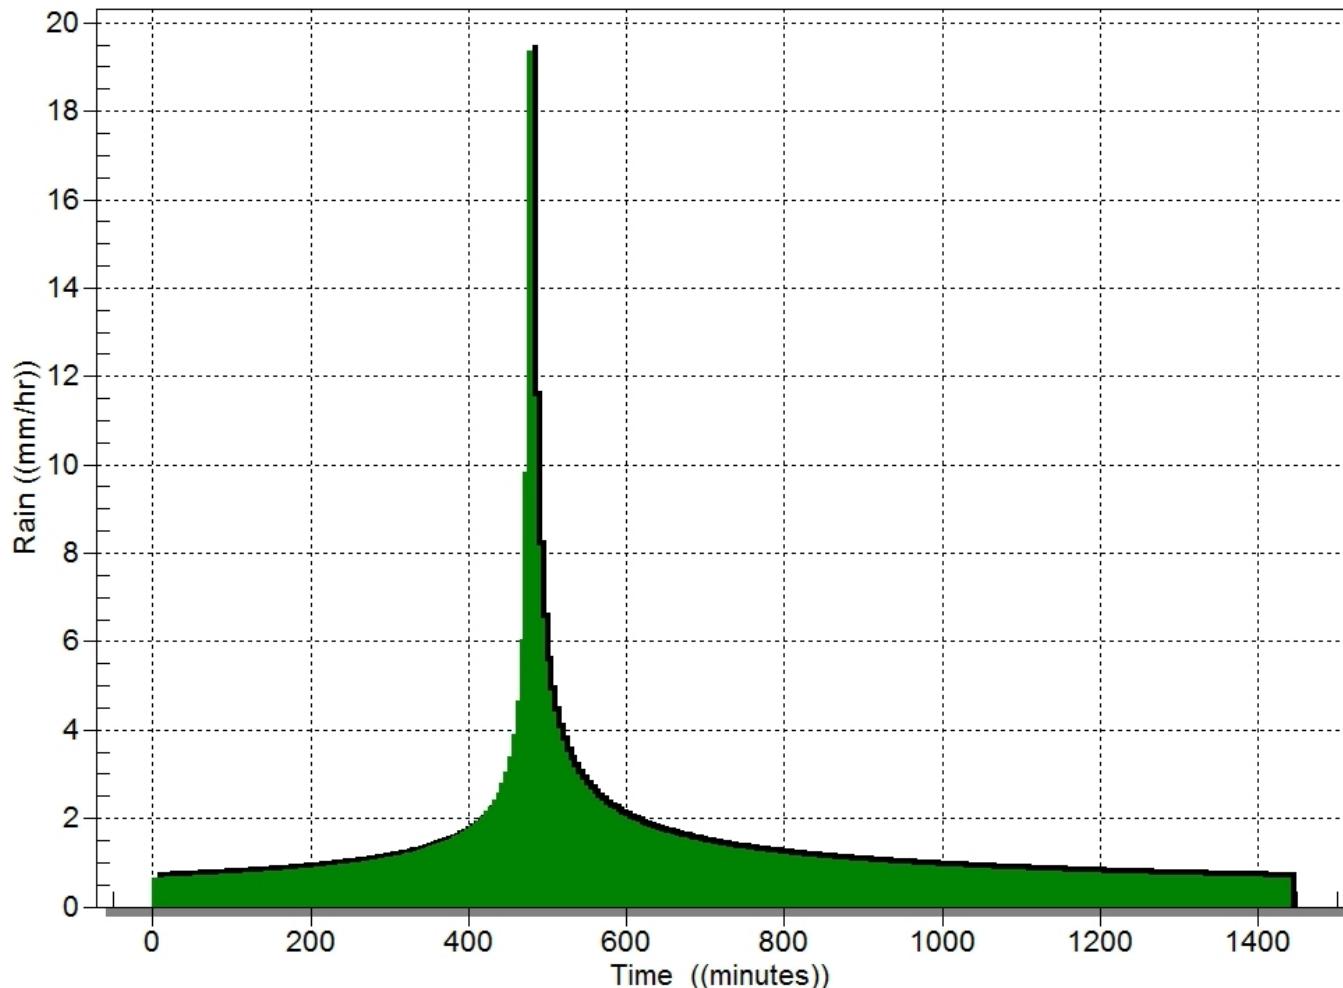
10 Year Chicago Storm
Coral Harbour, Nunavut

Figure 12: Hyetograph for the 10 year Chicago storm event, Coral Harbor, Nunavut

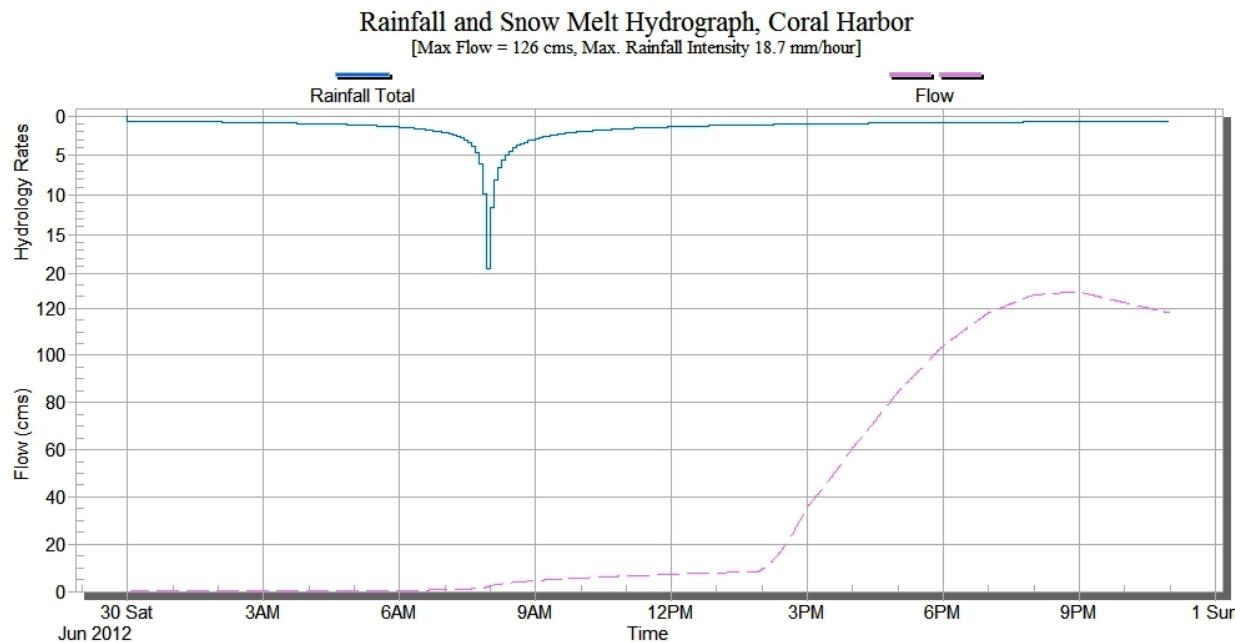
The estimated peak flow of 126 m³/s was obtained from XP SWMM model based on a combination of the 10-year storm event with storm duration 24 hours and the snowmelt with respect to the maximum recorded temperature of 23°C. The Hyetograph and combined hydrograph obtained from the XP SWMM model run is shown on Figure 13.

Figure 13: Hyetograph (10 year storm event, 24 hours duration) and Hydrograph from XP SWMM model run during snow melt.

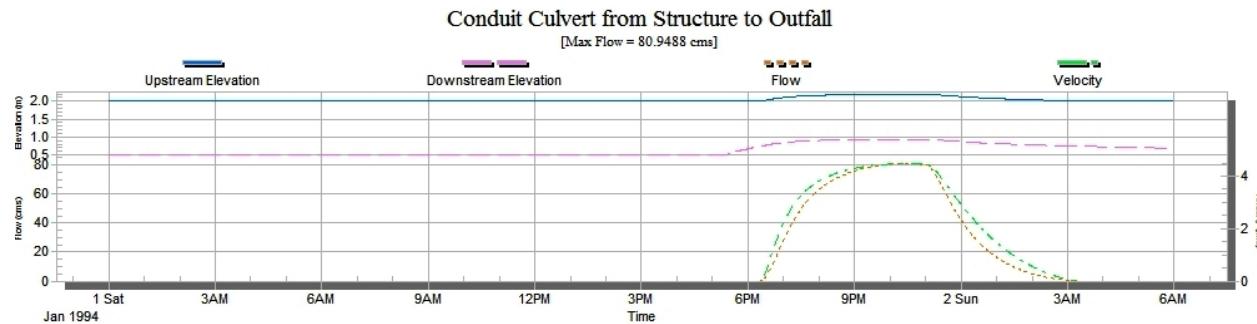
Total peak flow obtained from the watershed is separated into two components as culvert flow and bridge flow as shown on Figures 14 and 15.

Figure 14: Hydraulics characteristics of the culvert during snow melt and rainfall.

The existing culverts and bridge structures can handle $73.6 \text{ m}^3/\text{s}$ and the remaining flow of $52.4 \text{ m}^3/\text{s}$ will be handled by proposed hydraulic structures at Crossings 9 and 10, respectively as discussed in Section 4.4.

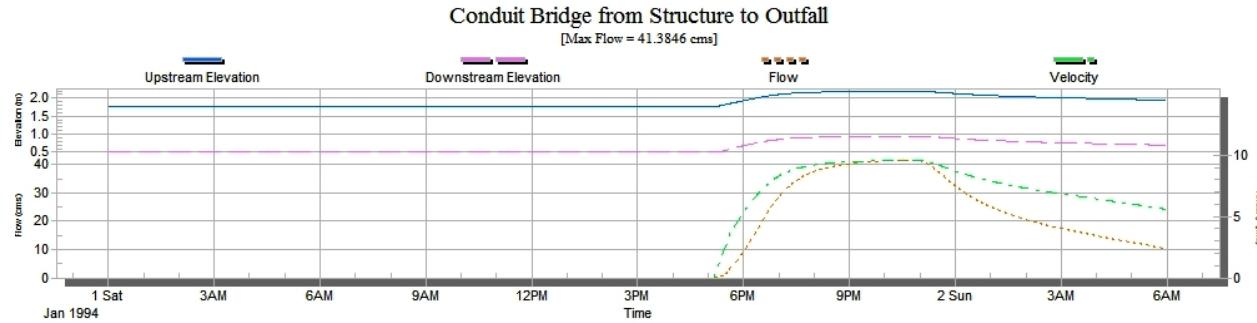
Figure 15: Hydraulics characteristics of the bridge during snow melt and rainfall.

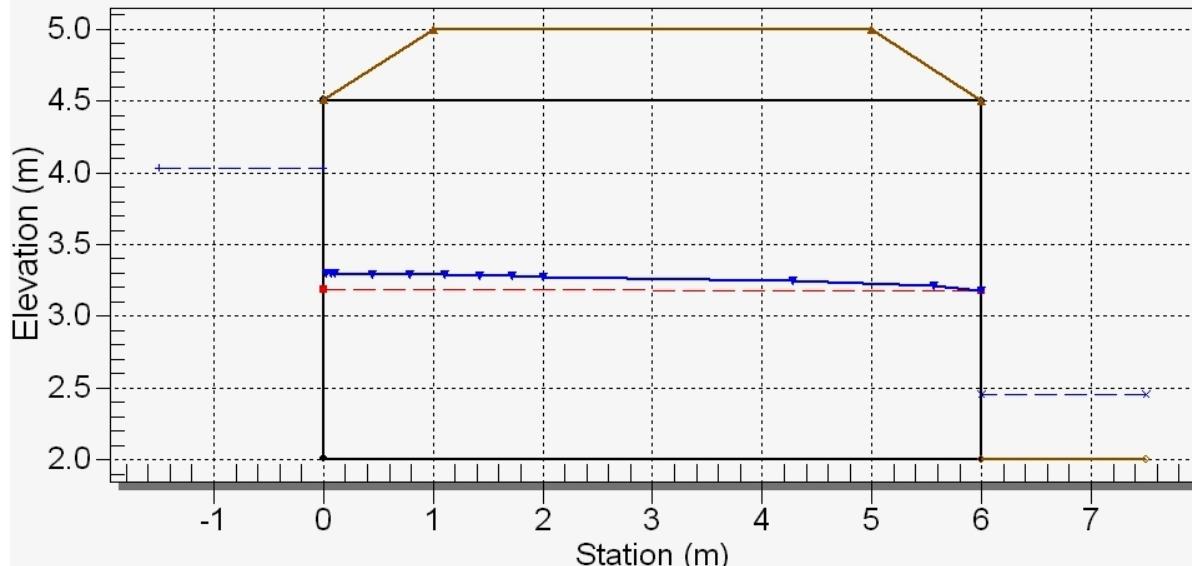
Option 1 provides a combination of bridge and culvert structures at Washouts 1 and 2, respectively. The proposed bridge structure at Crossing 9 is similar to the existing yellow bridge with hydraulic capacity of 40 m³/s and a free board of 0.5 m during spring flooding condition as shown on Figure 16.

Crossing - Washout #1: Bridge, Design Discharge - 40.00 cms

Culvert - Bridge opening: 10.0 m x 2.5 m (Option 1), Culvert Discharge - 40.00 cms

Figure 16: Bridge option at washout 1 location.

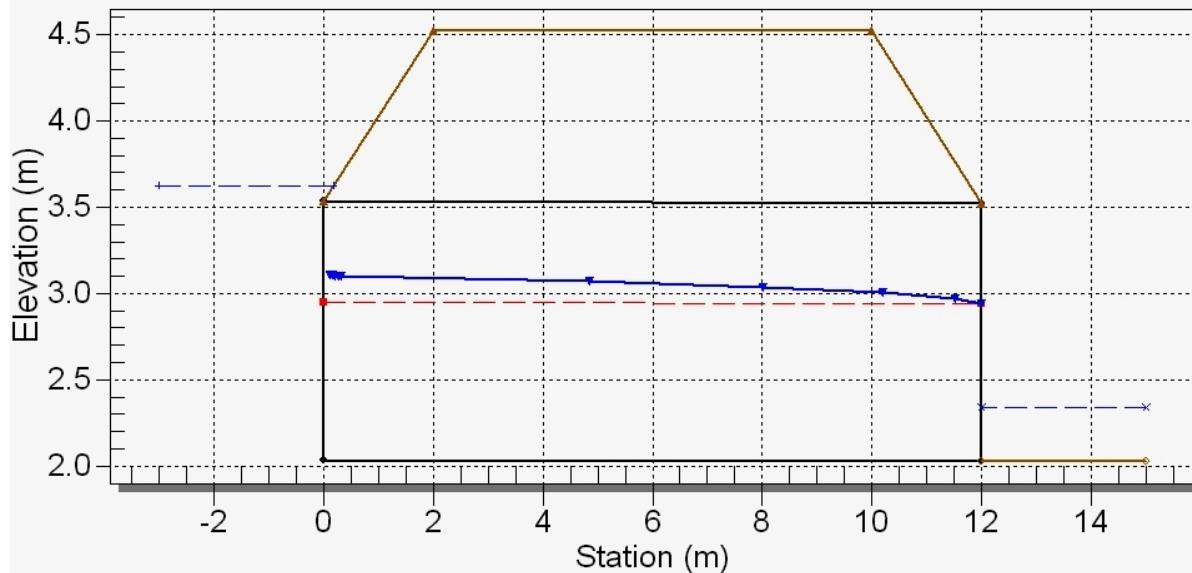
The proposed culvert structure at Crossing 10 is the corrugated metal pipe (CMP) of 1500 mm diameter. Four barrels of these CMP can handle $12.5 \text{ m}^3/\text{s}$ flows with a headwater of 1.6 m as shown on Figure 17. The culvert length is 12 m and sloped at 0.1%. Rip-rap protection is required at both inlet and outlet of the structure.

Crossing - Washout #2: Culvert - 4 Nos 1500 mm dia., Design Discharge - 12.50 cms

Culvert - Option 1: CMP Culvert, Culvert Discharge - 12.50 cms

Figure 17: Bridge option at Washout 1 location.

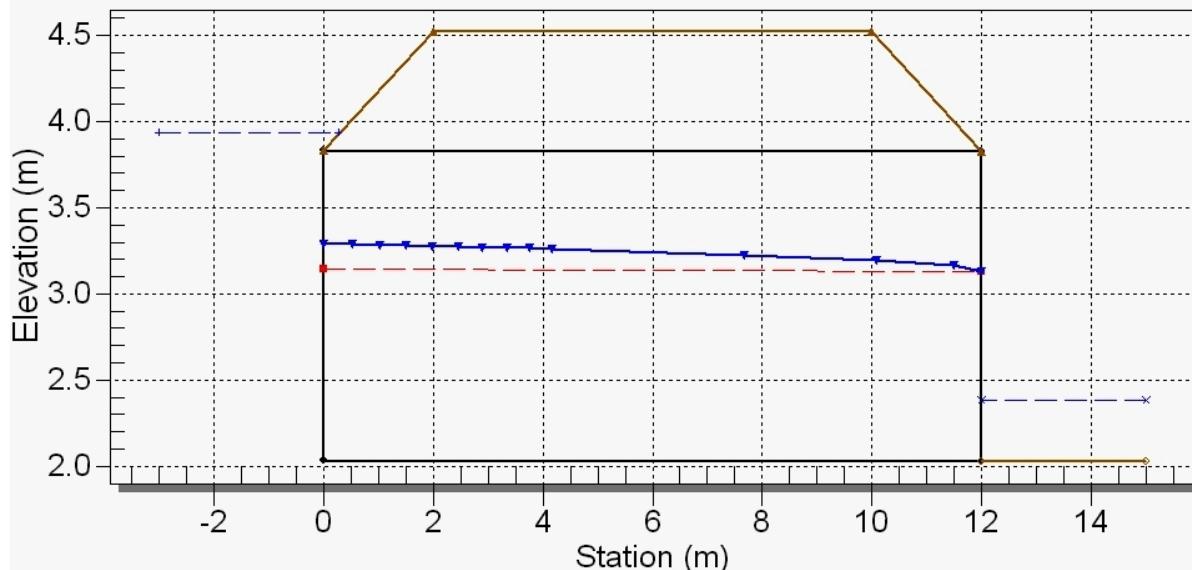
Hydraulic structure for Option 2 is a concrete box culvert of opening size 2400 mm span and 1800 mm rise. Total flow of 52.4 m³/s is distributed equally to both Crossing 9 (Washout 1) and Crossing 10 Washout 2. Therefore, each crossing needs three barrels of concrete box section of 2400 mm x1800 mm which can handle 26.2 m³/s flows at headwater 1.95 m as shown on Figures 18 and 19. The culvert length is 12 m and sloped at 0.1%. Rip-rap protection is required at both inlet and outlet of the structure.

Crossing - Wash out #1, Design Discharge - 26.20 cms

Culvert - Option 2:Concrete Box Culvert: 2400 mm x 1800mm, Culvert Discharge - 26.20 cms

Figure 18: Bridge option at Washout 1 location.

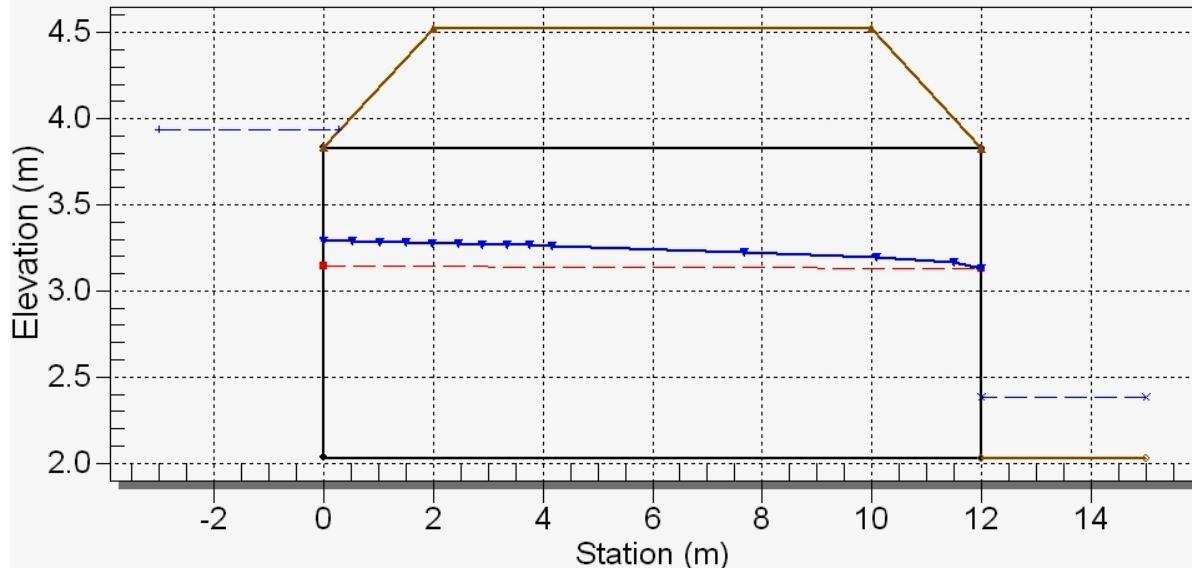
Crossing - Wash out #2 , Design Discharge - 26.20 cms

Culvert - Option 2: Concrete Box Culvert: 2400 mm x 1800mm, Culvert Discharge - 26.20 cms

Figure 19: Bridge option at washout 1 location.

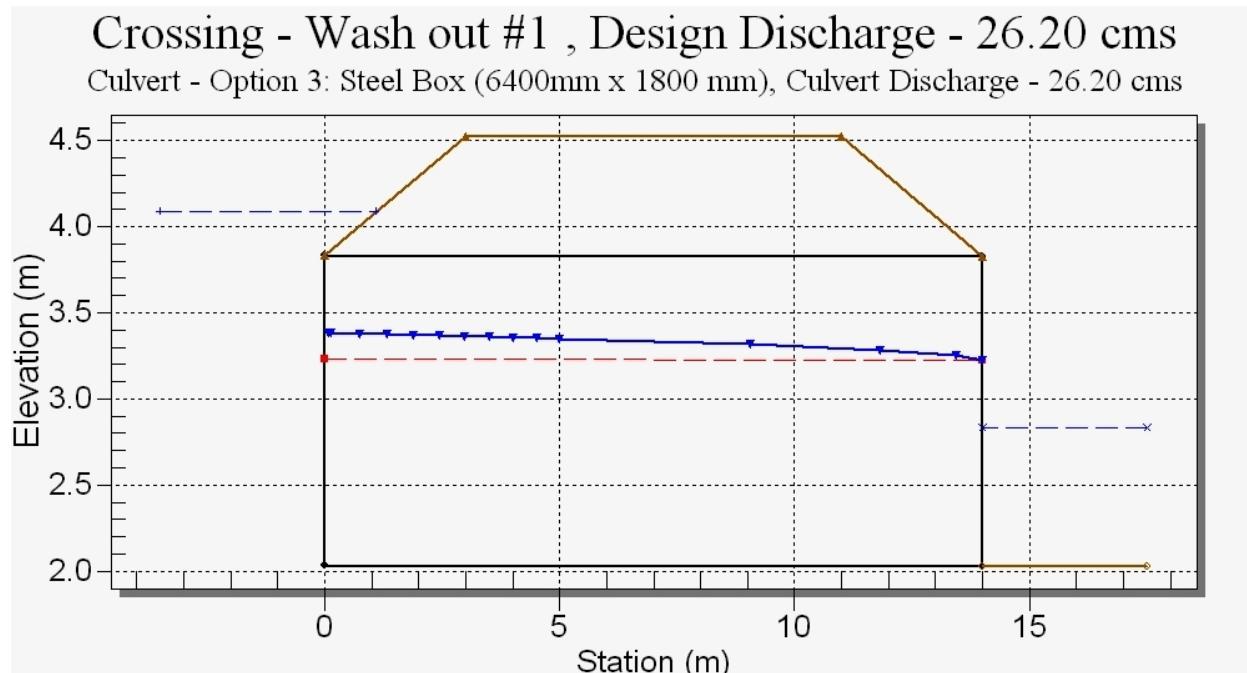
Hydraulic structure for Option 3 is a steel box culvert of opening size 6400 mm span and 1800 mm rise. Total flow of 52.4 m³/s is distributed equally to both Crossing 9 (Washout 1) and Crossing 10 (Washout 2). Therefore, each crossing with a single steel box section of 6400 mm by 1800 mm can handle 26.2 m³/s flows at headwater 2.1 m as shown on Figures 20 and 21. The culvert length is 14 m and sloped at 0.1%. Rip-rap protection is required at both inlet and outlet of the structure.

Figure 20: Bridge option at Washout 1 location.

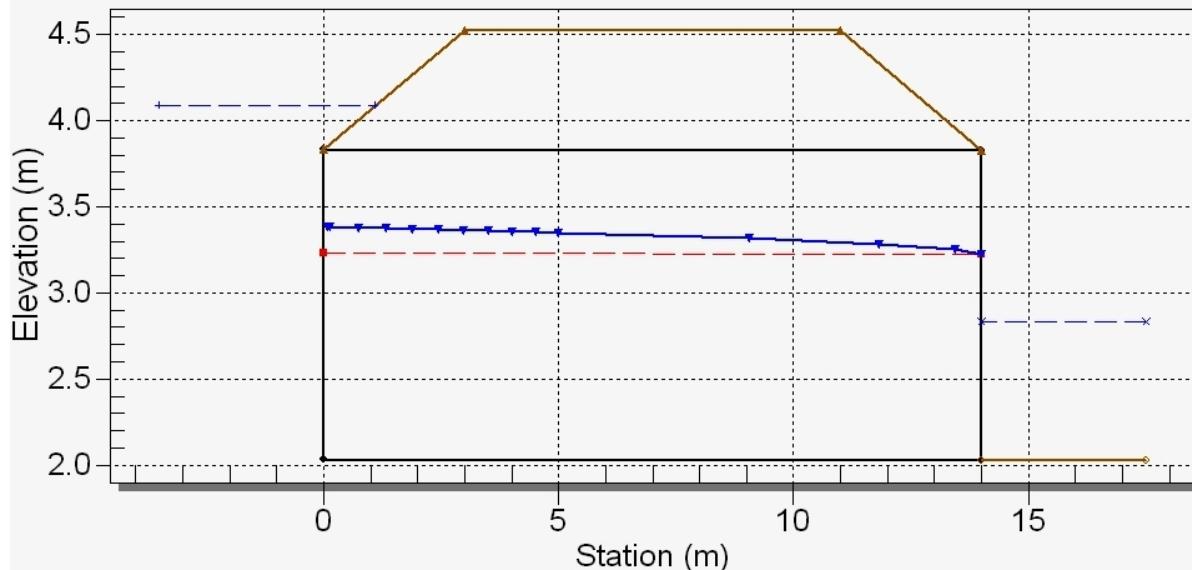
Crossing - Wash out #2, Design Discharge - 26.20 cms

Culvert - Option 3: Steel Box (6400mm x 1800 mm), Culvert Discharge - 26.20 cms

Figure 21: Bridge option at Washout 1 location.
