During the week of June 30<sup>th</sup>, 2012 the mayor of the Hamlet of Coral Harbour reported to GCS that the water level in the lakes around the Airport Road at the entrance to the hamlet was rising at an alarming rate. This was due to a fast spring melt and moderate rain for over two weeks..

### AIRPORT TO TOWN ROUTE LOCATION (AIRPHOTO ANALYSIS ASSOCIATES 1971)

ROUTE LOCATION

CORAL HARBOUR AREA

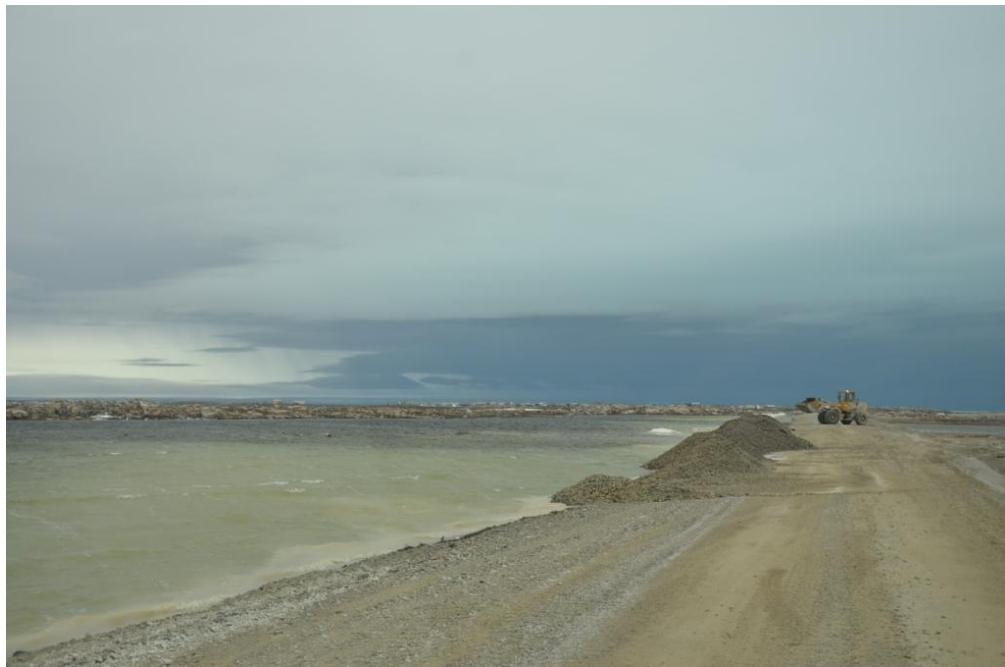
The hamlet mobilized equipment belonging to airports and local dump trucks.

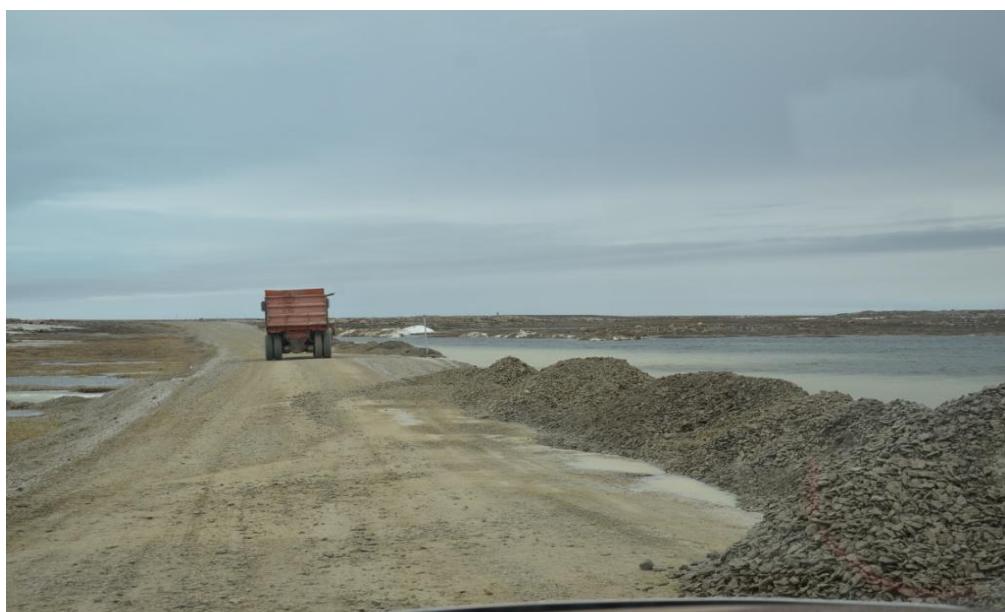
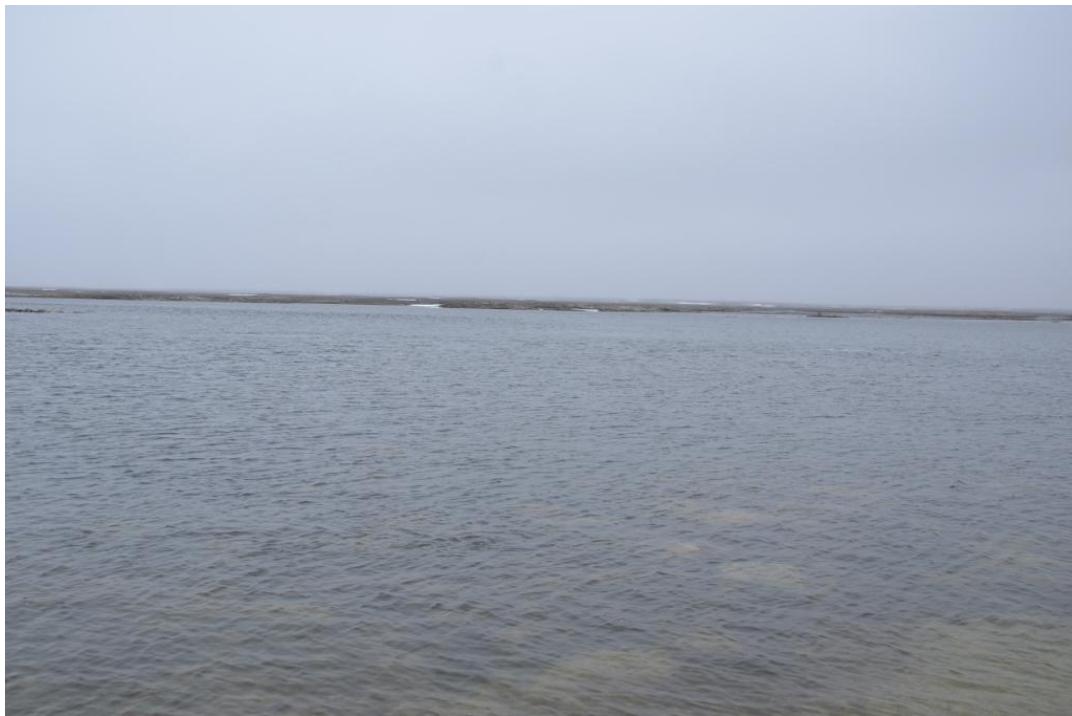
The hamlet proceeded to place fill along the Airport Road to help prevent it from washing out.

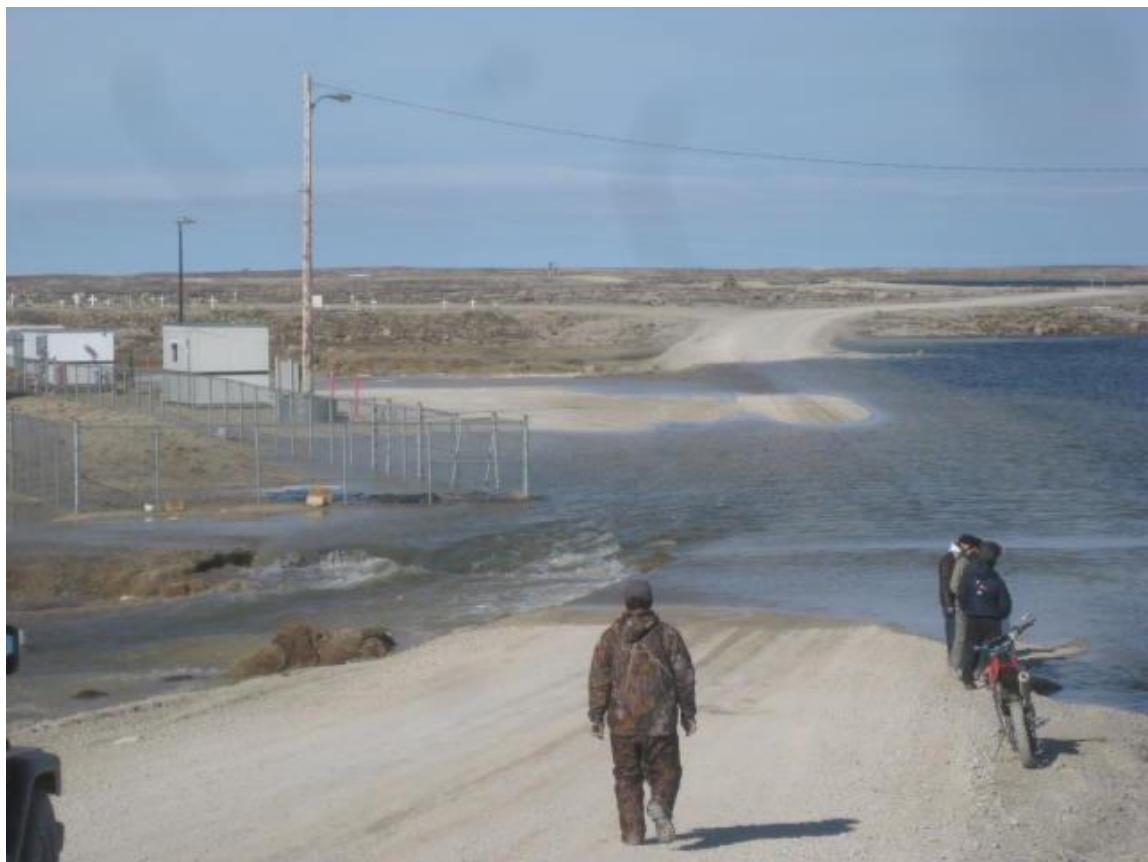
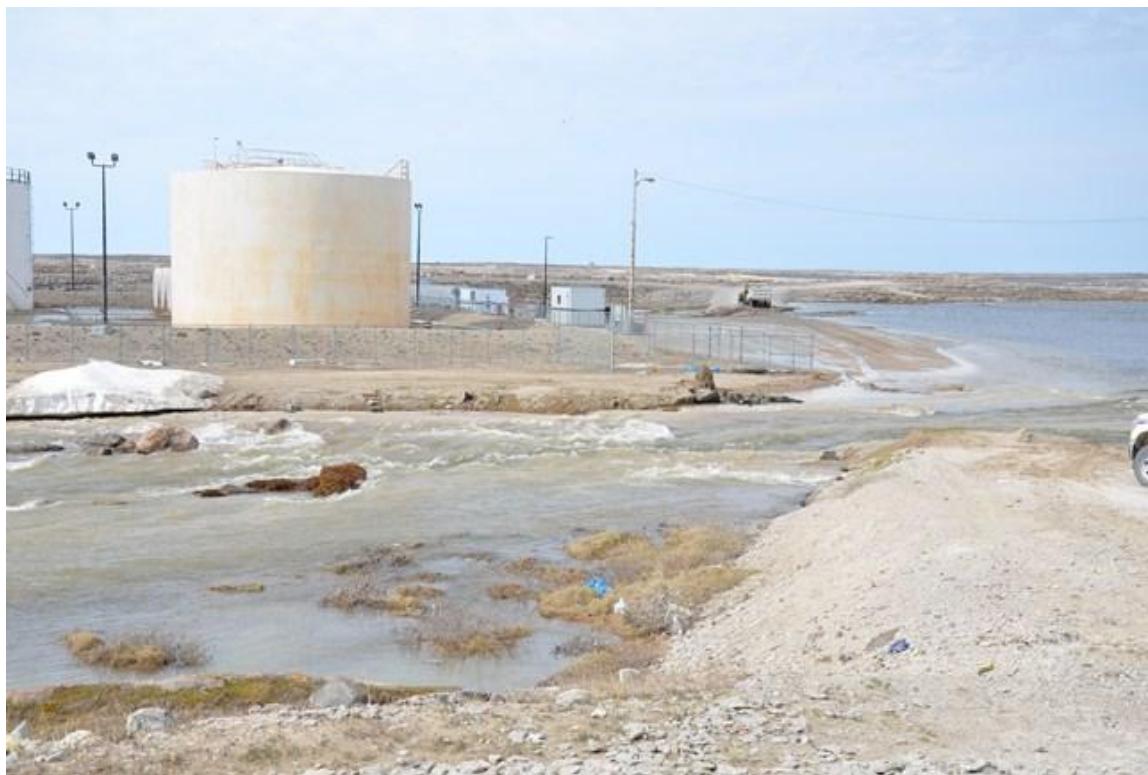
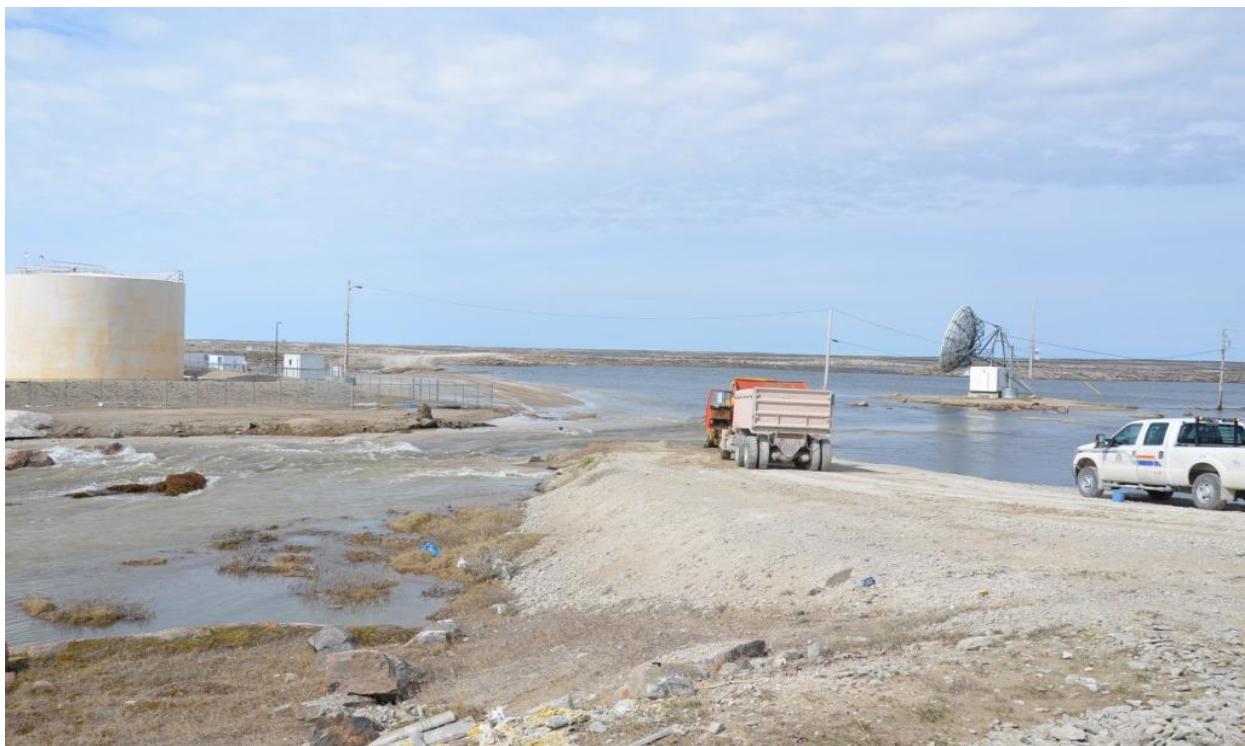
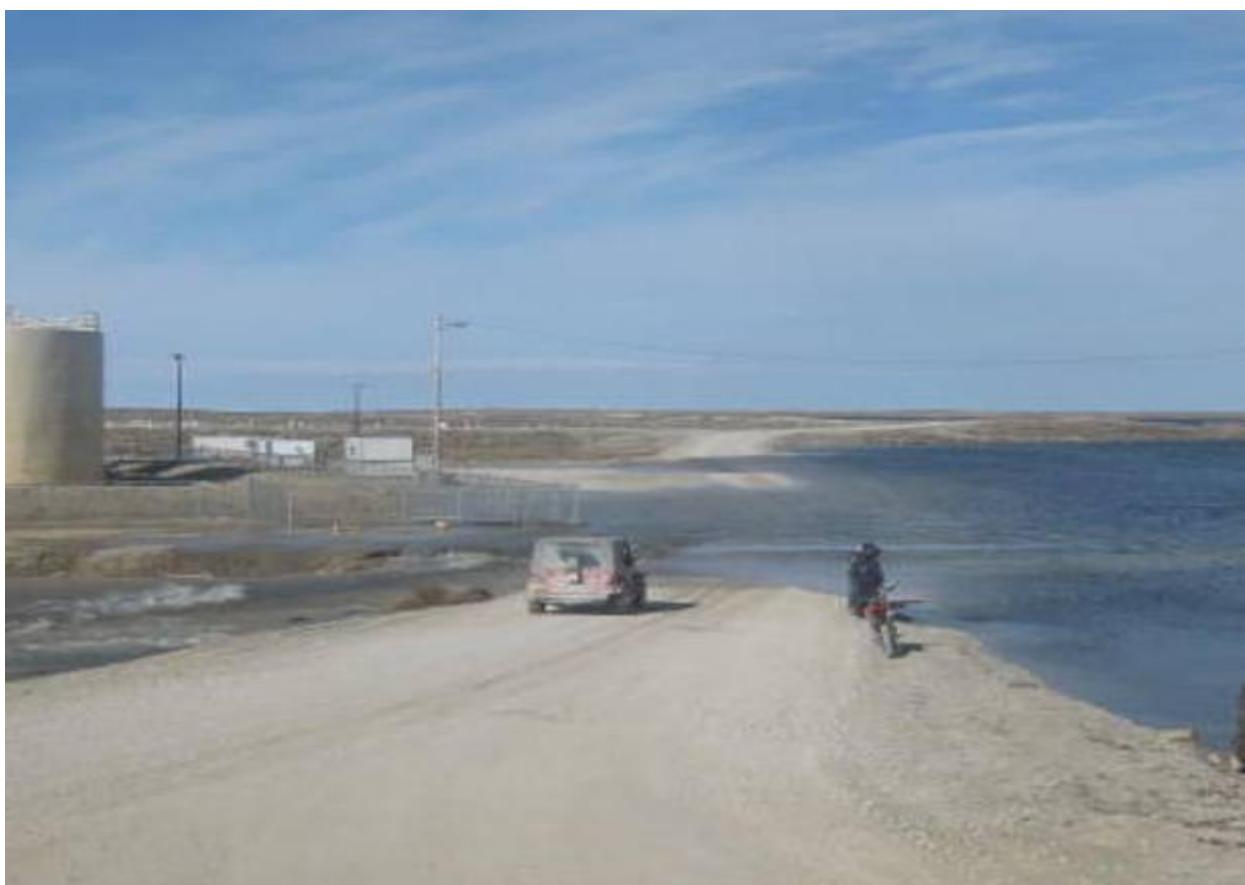
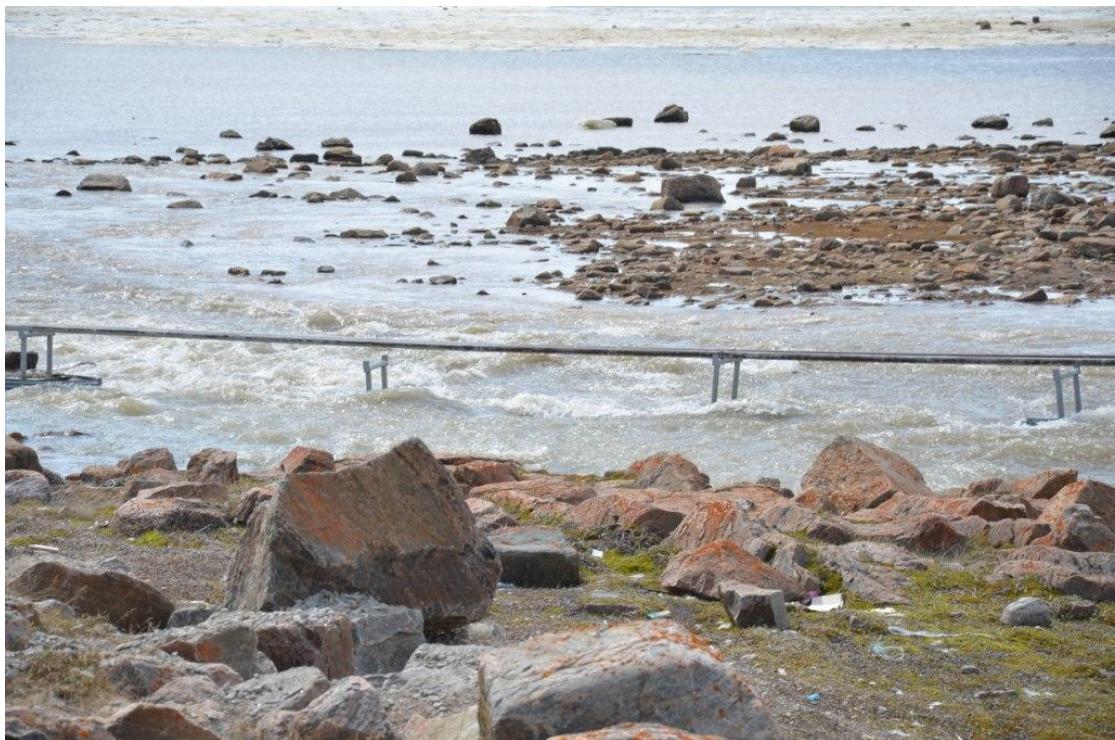
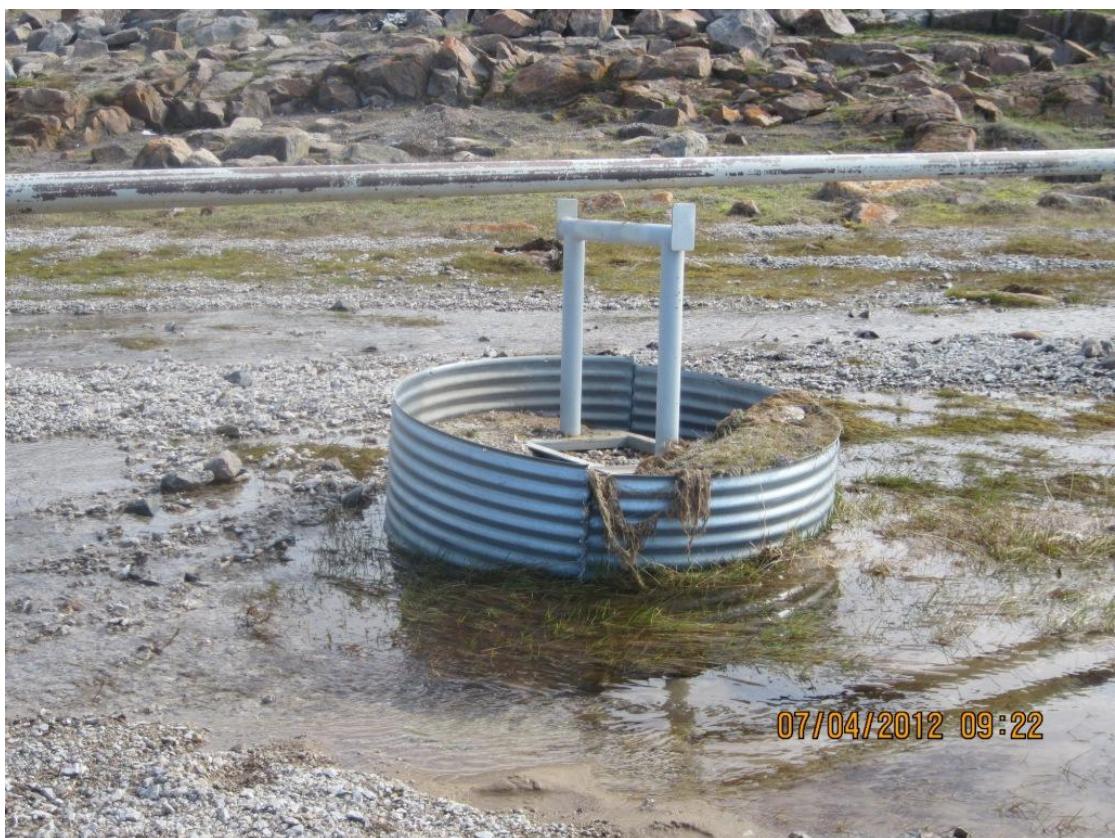
The water overflowed in to the wetlands area and flowed down stream to the lowest elevation which is near the Fuel Storage Facility. Two 1000mm Ø CMP culverts are located across the Airport Road in this area. These culverts could not handle the excessive water run-off and the existing road washed out in two areas on both sides of the existing Fuel Storage Facility tank farm. The washout also caused damage to the Fuel Storage Facility's re-supply Pipeline.

The following are some pictures of the damage and the amount of water in the area. The hamlet has completed temporary repairs and the road to the airport is open. Water levels have receded to normal seasonal levels.

The hamlet mobilized equipment and installed culverts and gravel fill to repair the areas that washed out. The Road to the Airport was closed for about a week while repairs were done.

According to the mayor this has happen four times in the last 6 or 7 years. The hamlet is seeking financial assistance from the GN to raise this road by a meter and install additional culverts or to consider installing a bridge to prevent this from happening again in the future.

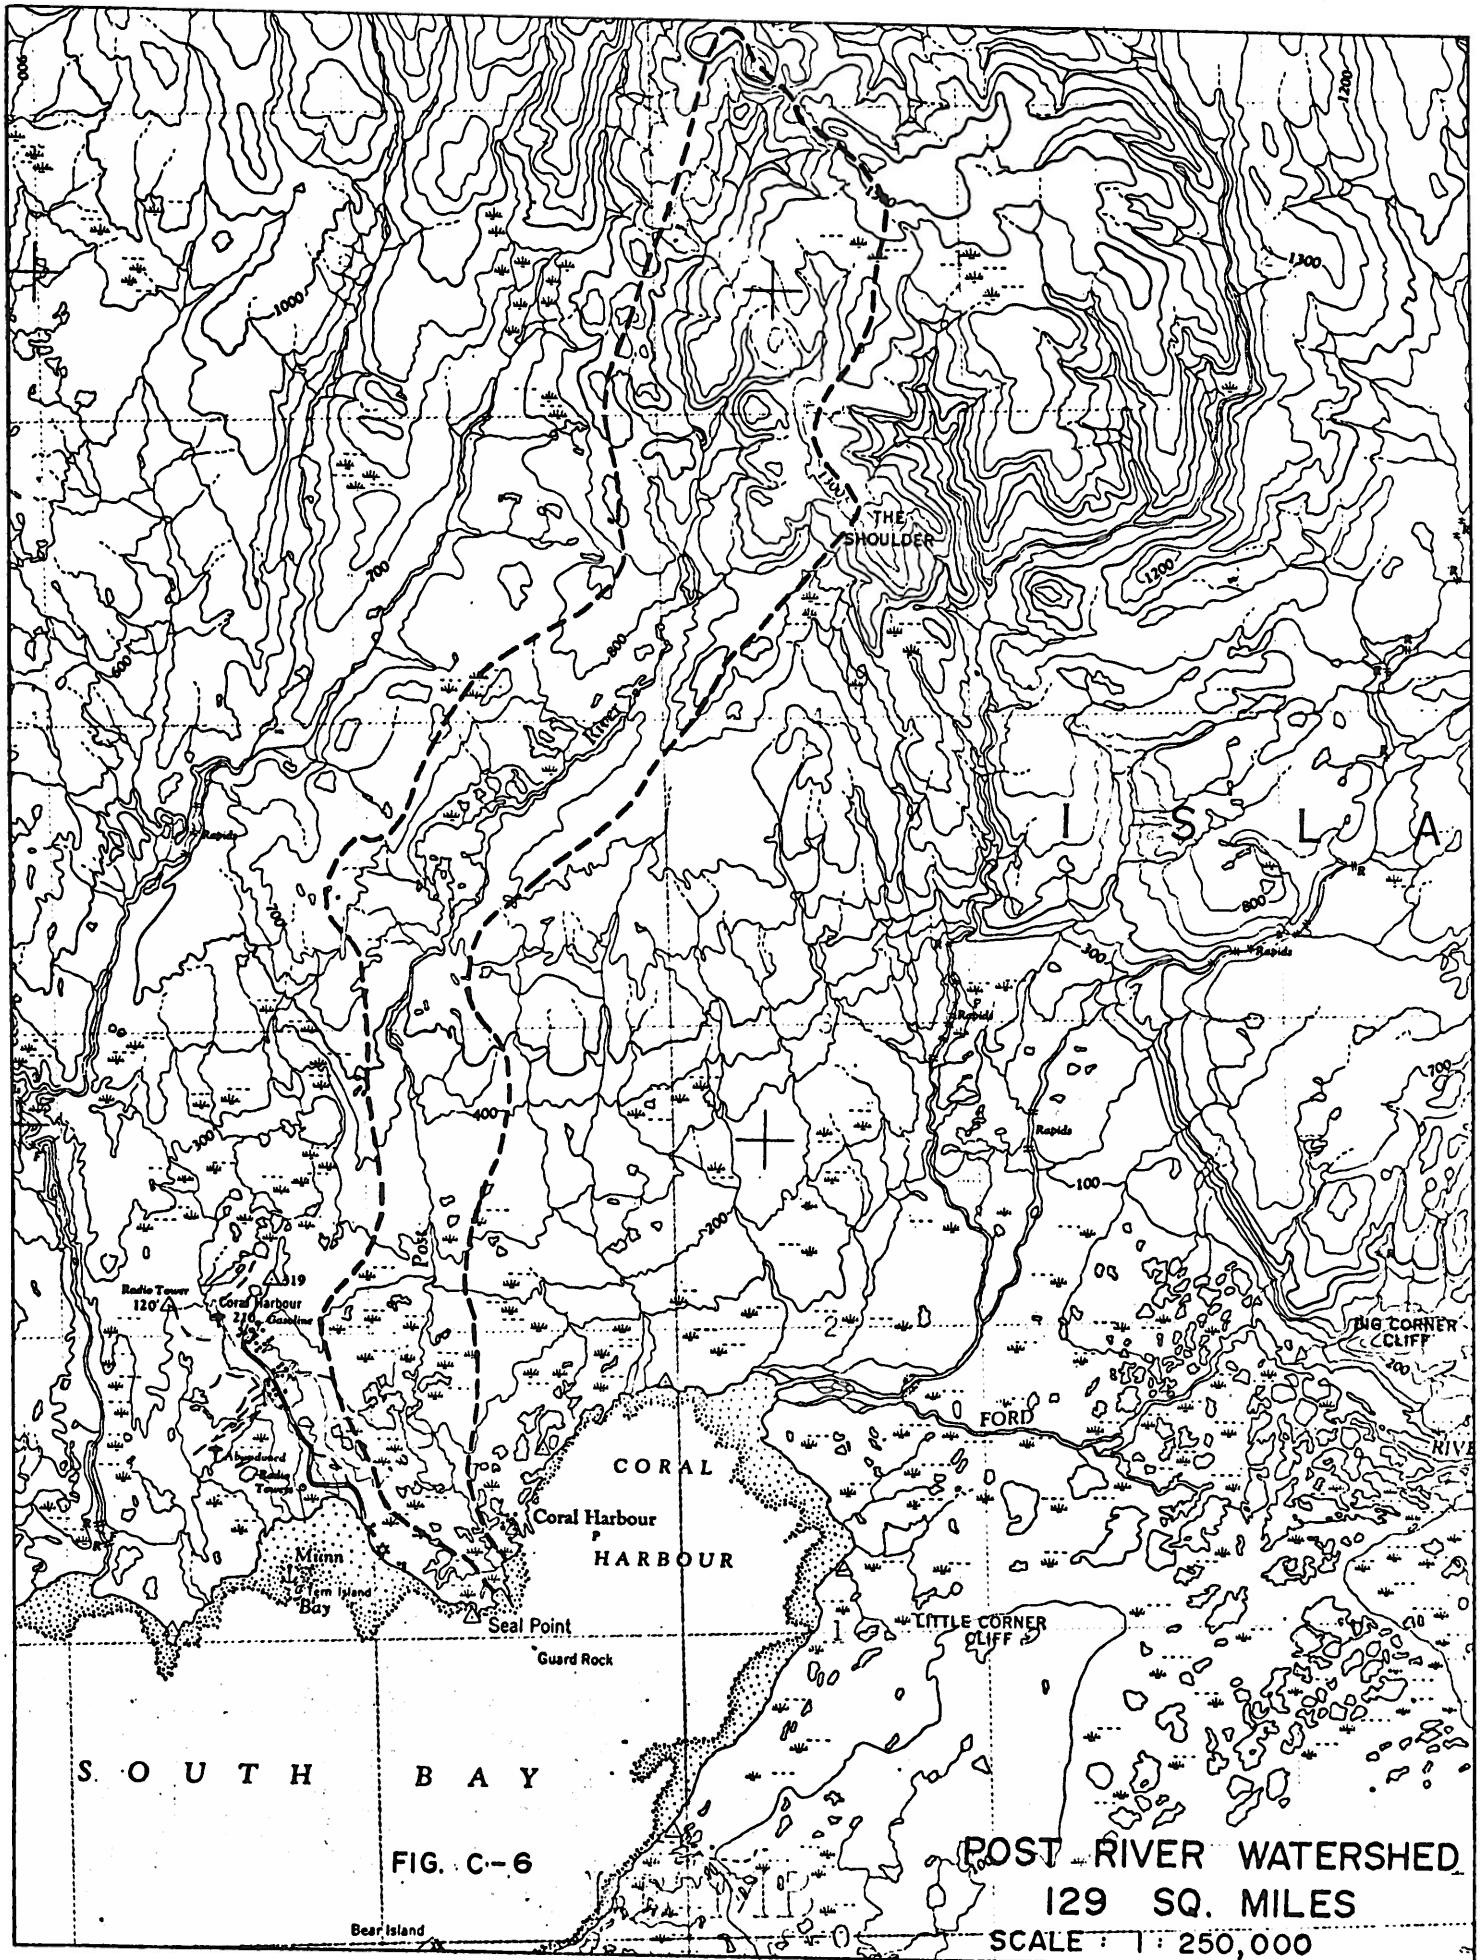
The Post River has a watershed of 129 square miles (Figure C-6). The total precipitation on this watershed is 67,000 acre ft. per year. Although calculated annual lake evaporation is 10" and water surplus is 0. It is unlikely that losses due to evaporation and evapo-transpiration are greater than 10 percent.

The Post River watershed has a southerly aspect Figure C-6. Melting can be expected to occur rather rapidly. The figure of 0.10 inches of snow melt per degree-day appears to be a valid estimate. The maximum accumulation of thawing degree days for the first 30 days of the thawing season is listed in the meteorological records as 309 for June 8, 1956. This is an average of 10 degree-days per day. At this rate the 4.9" (water equivalent of snow) would melt in about 5 days. (1 in/day). Peak discharge for snowmelt for the previous triangular hydrograph formulae assuming an excess of 4.0" (0.9" of basin storage) would be:
