SUPPLEMENTAL INFORMATION REPORT

Coral Harbour Airport Community Road Washout Rehabilitaion Project, NU

ISSUED FOR USE
DECEMBER 10, 2015

FILE NO.: 704-V13203282-01.001

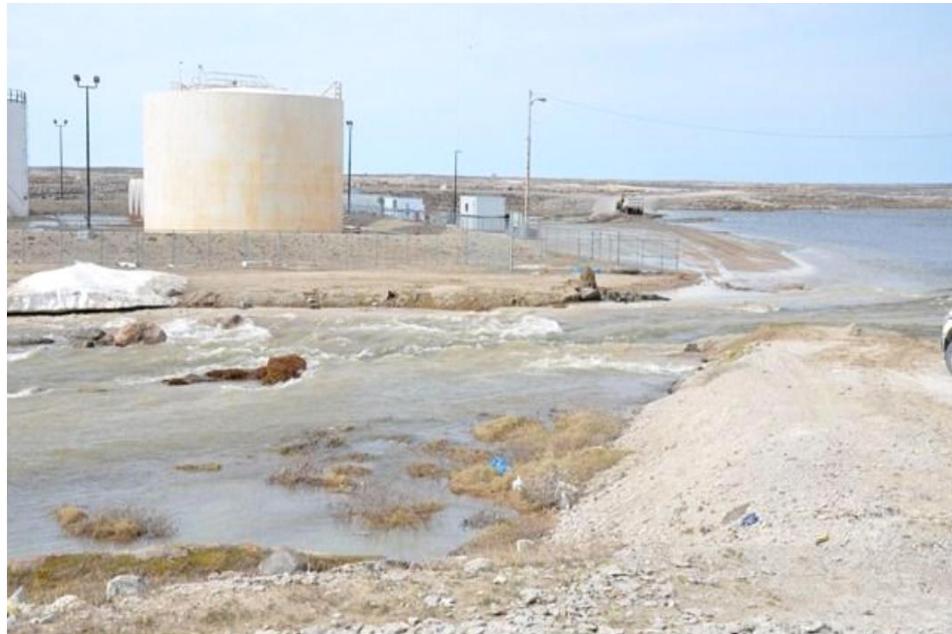
Photo 1: June 2012 washout

The water overflowed in to the wetlands area and flowed down stream to the lowest elevation which is near the Fuel Storage Facility. Two 1,000 mm diameter CMP culverts are located across the Airport Road in this area. These culverts could not handle the excessive water run-off and the existing road washed out in two areas on both sides of the existing Fuel Storage Facility tank farm. The washout also caused damage to the Fuel Storage Facility's re-supply Pipeline.

The Hamlet mobilized equipment and installed culverts and gravel fill to repair the areas that washed out. The road to the Airport was closed for about a week while repairs were done.

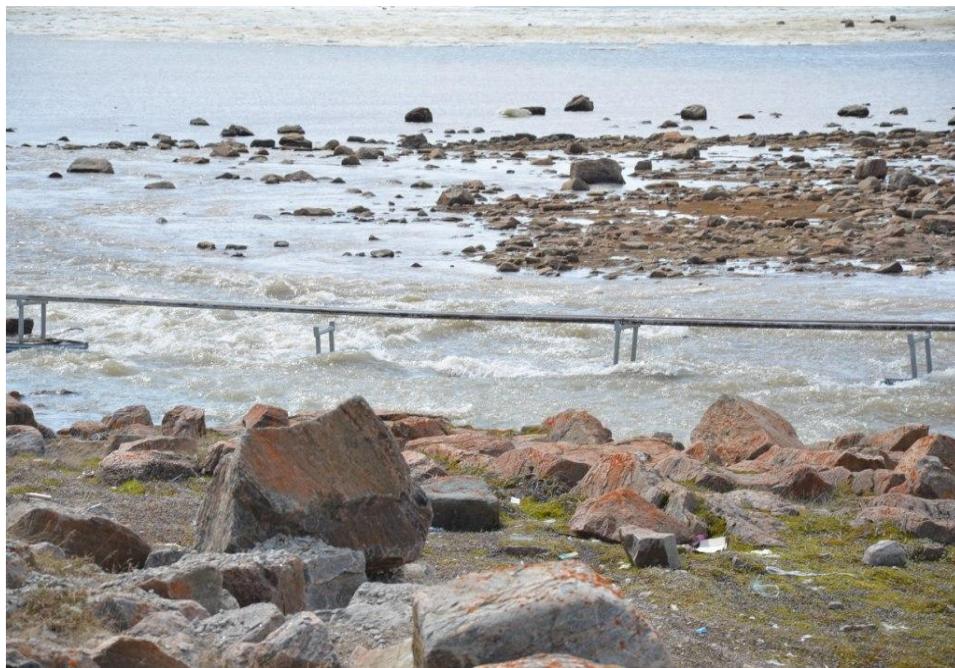
Photo 2: June 2012 impact of washout on Community Fuel Line

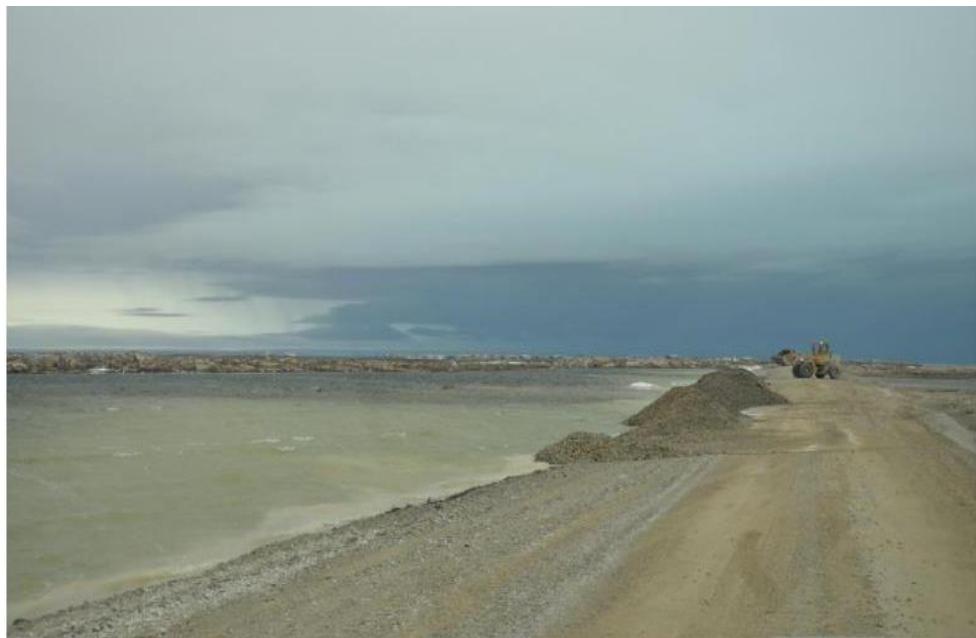
Photo 3: Fill placement along the Airport Road to help prevent it from washing out

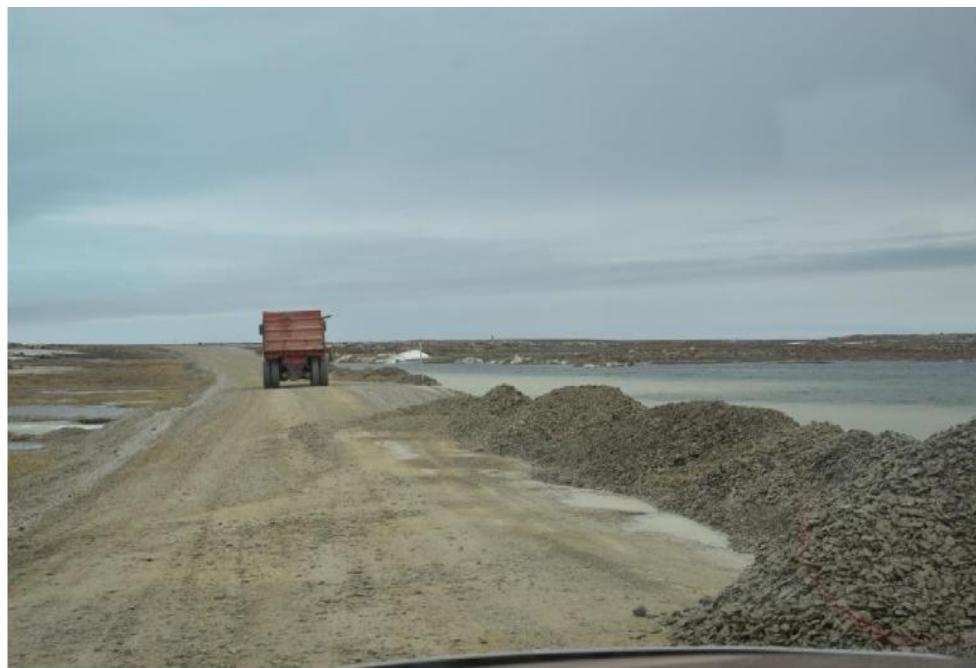
Photo 4: Fill placement along the Airport Road to help prevent it from washing out

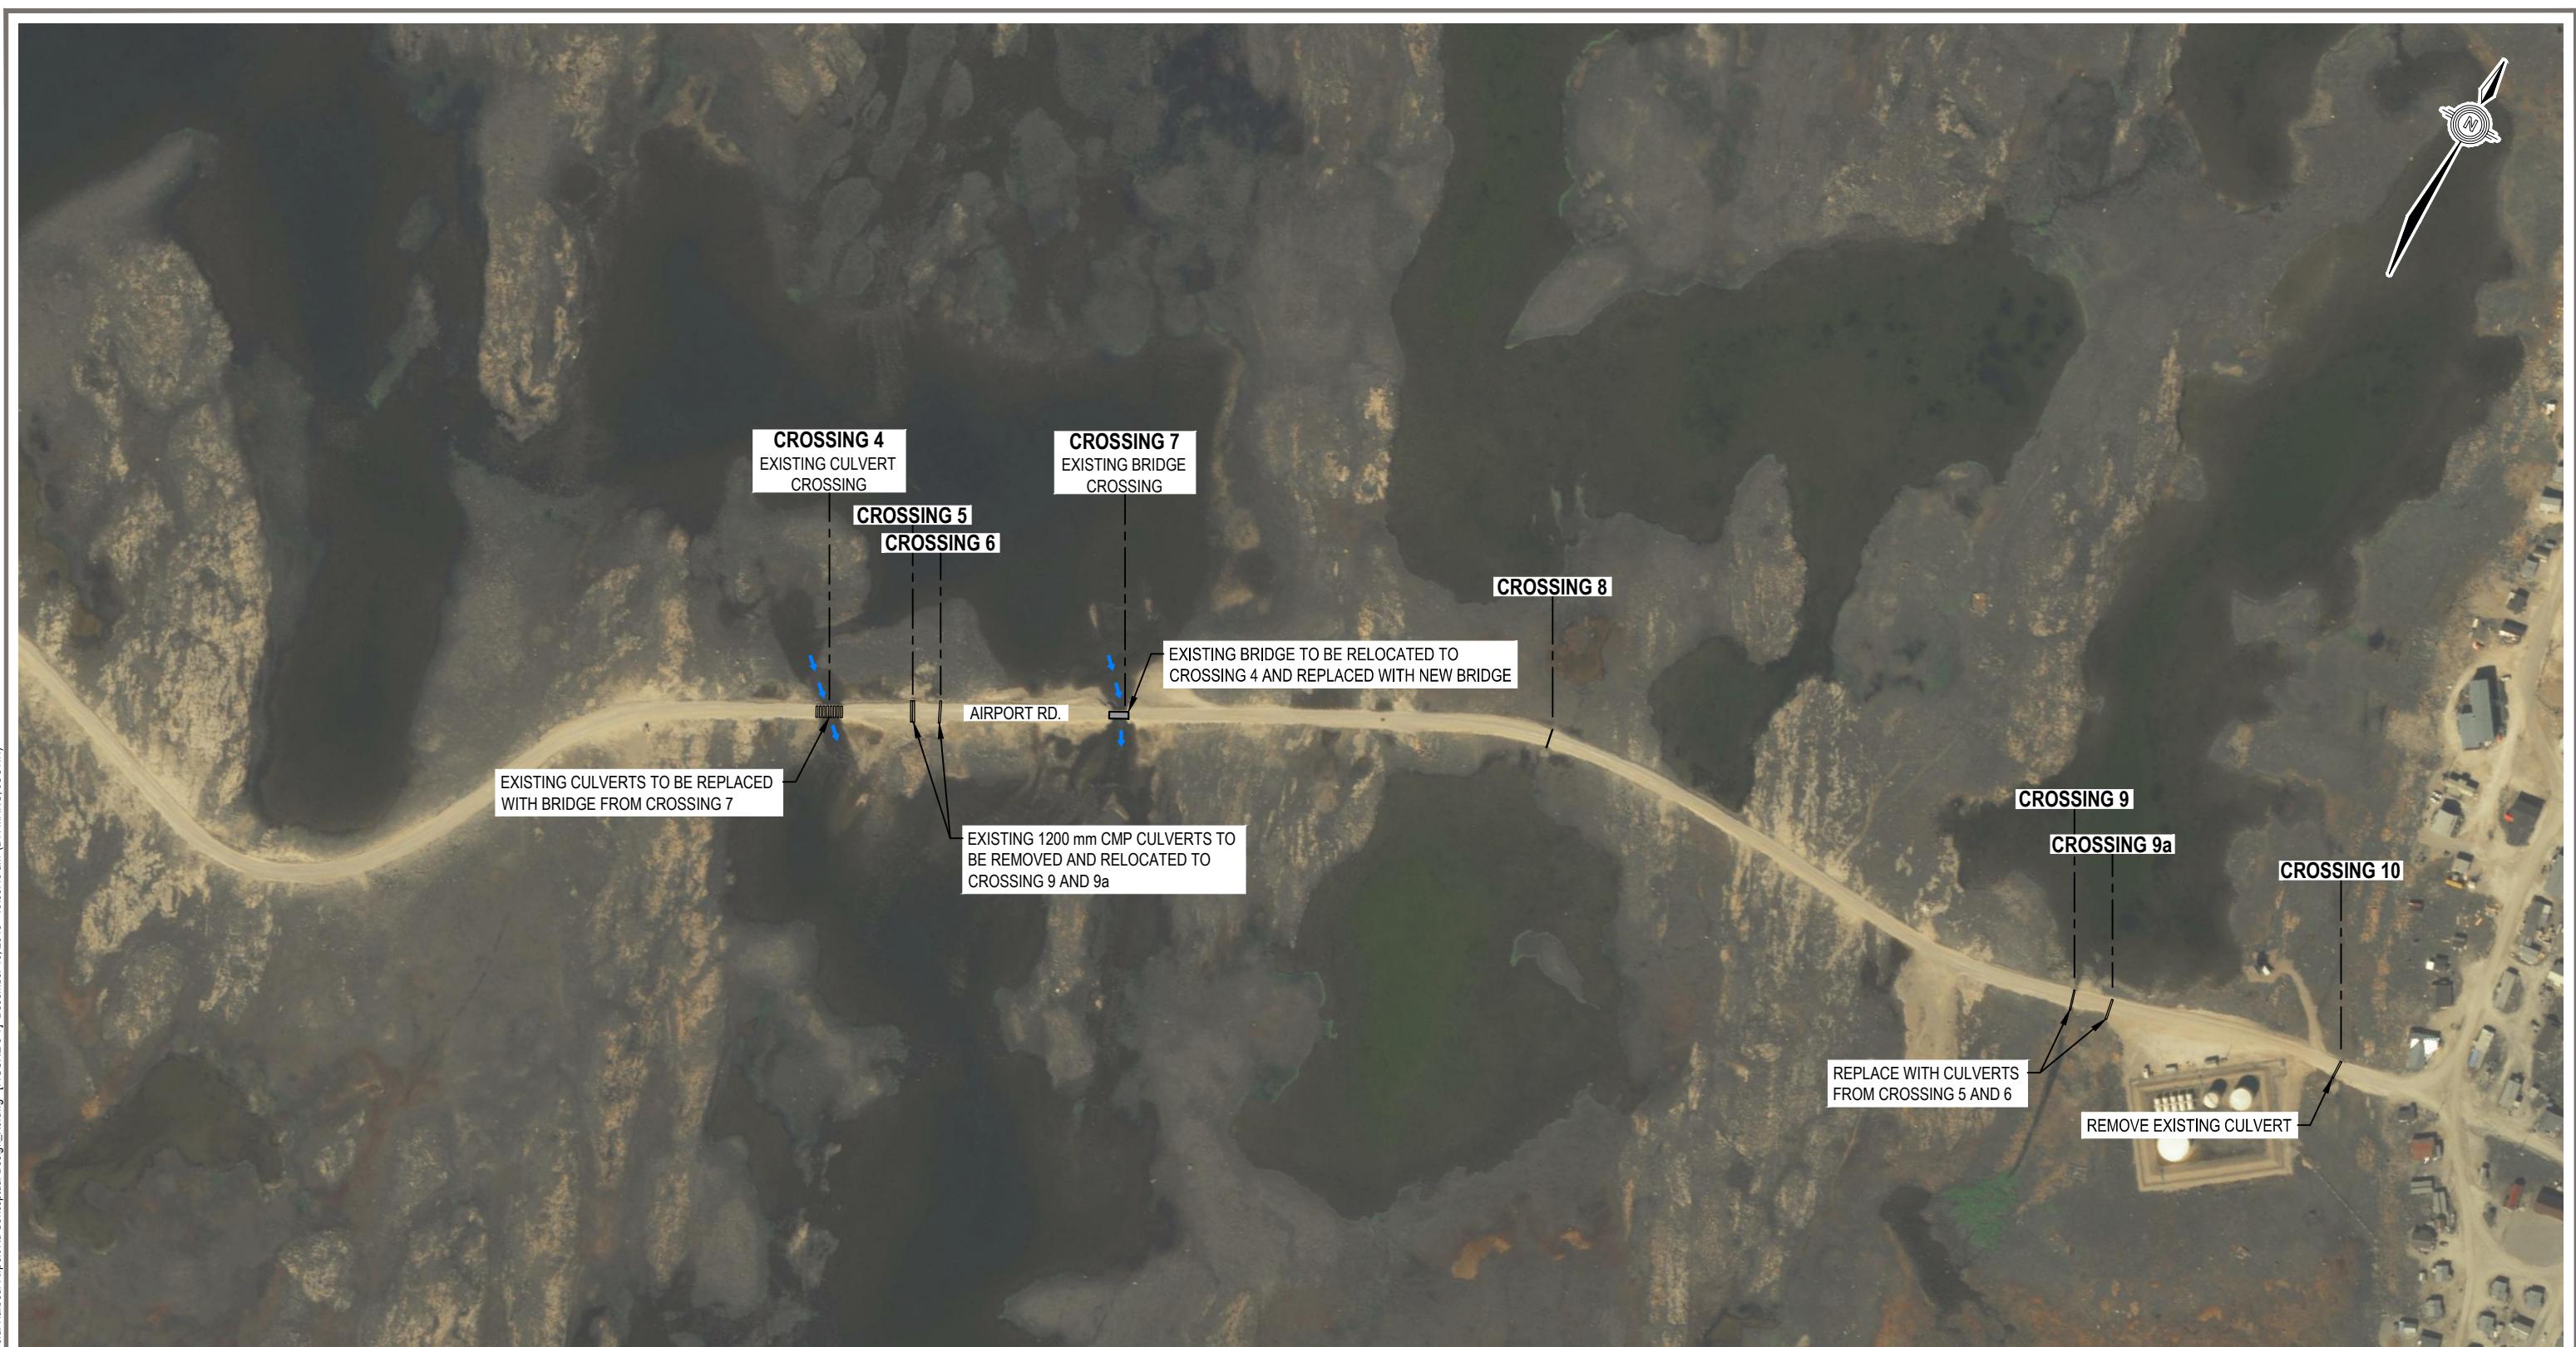
AIRPORT RD. WASHOUT REHABILITATION CORAL HARBOUR, NU				
CORAL HARBOUR AIRPORT COMMUNITY ROAD STREAM/DRAINAGE CROSSING REHABILITATION PROGRAM SITES				
PROJECT NO.	OFFICE	DES	CKD	REV
V13203282	VANC	RH	0	DRAWING

Figure 3-1 shows the locations of the proposed stream/drainage crossings that will be rehabilitated or replaced. It should be noted that all of these proposed undertakings and indeed the entire road is located within the Municipal Boundaries of Coral Harbour as shown in Figure 3-2.

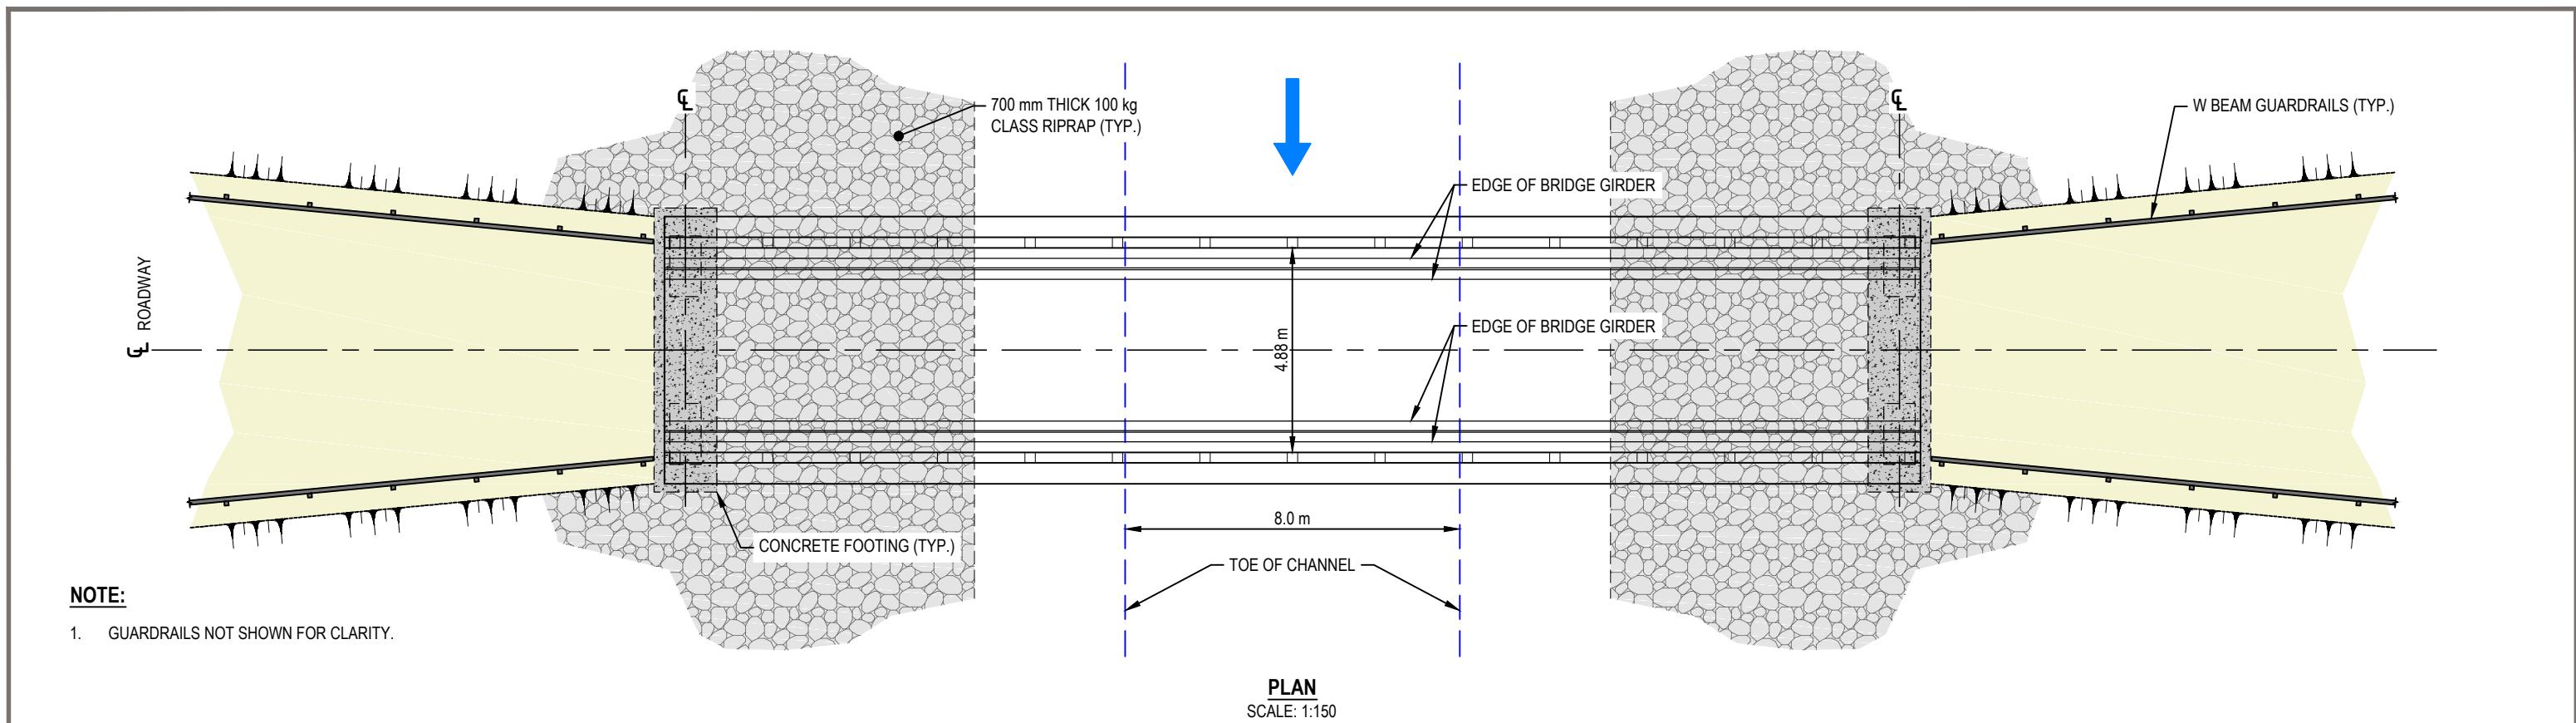
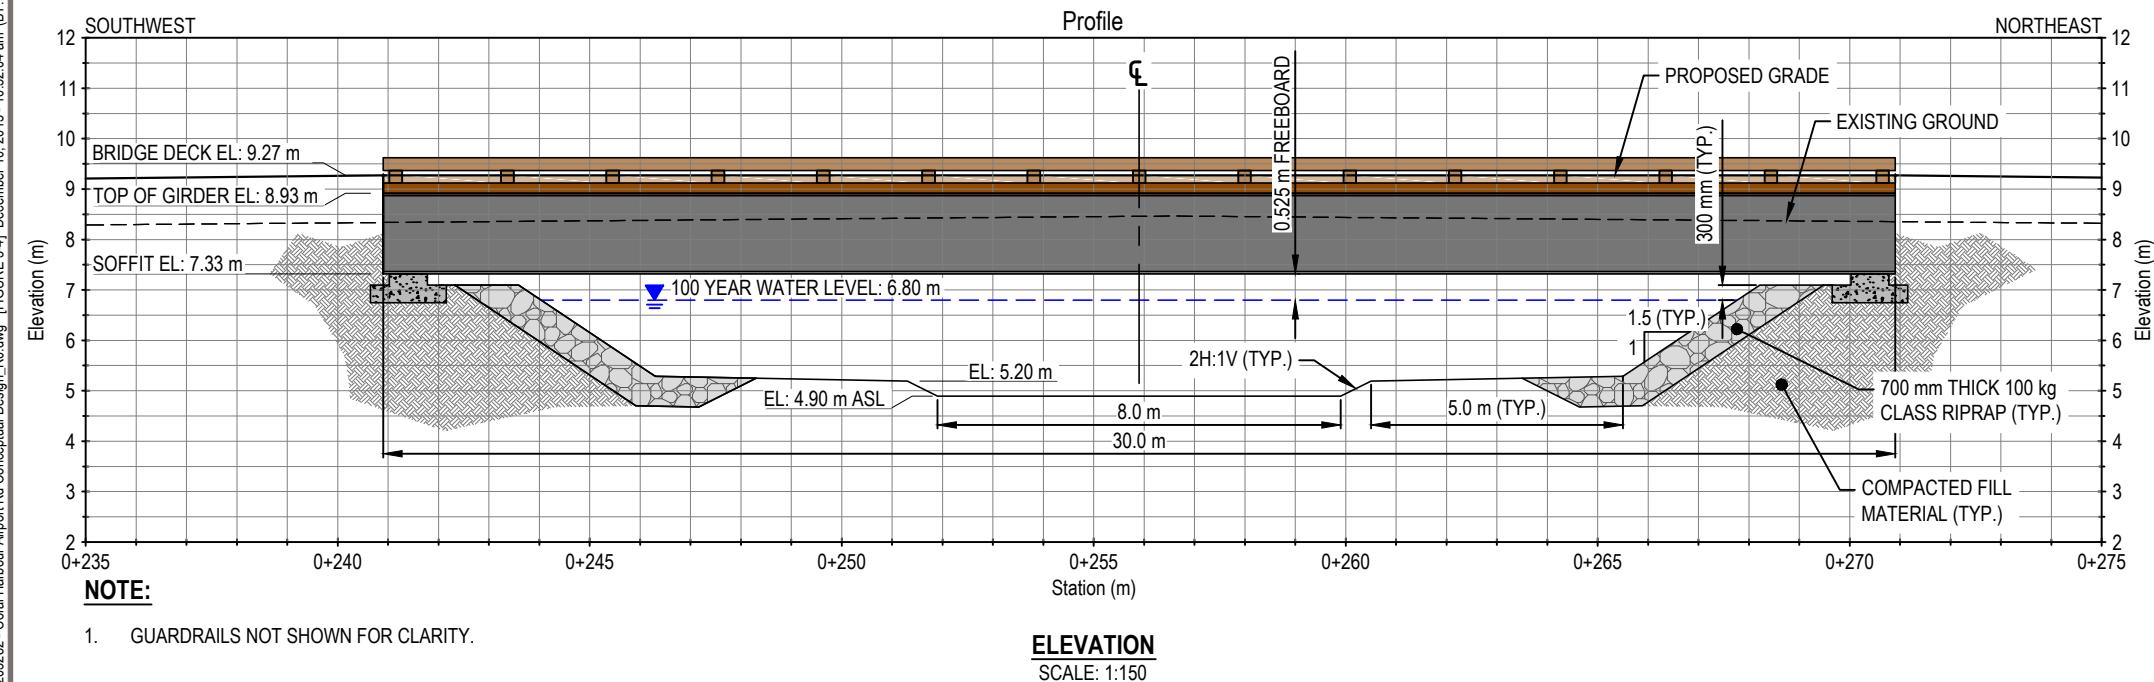
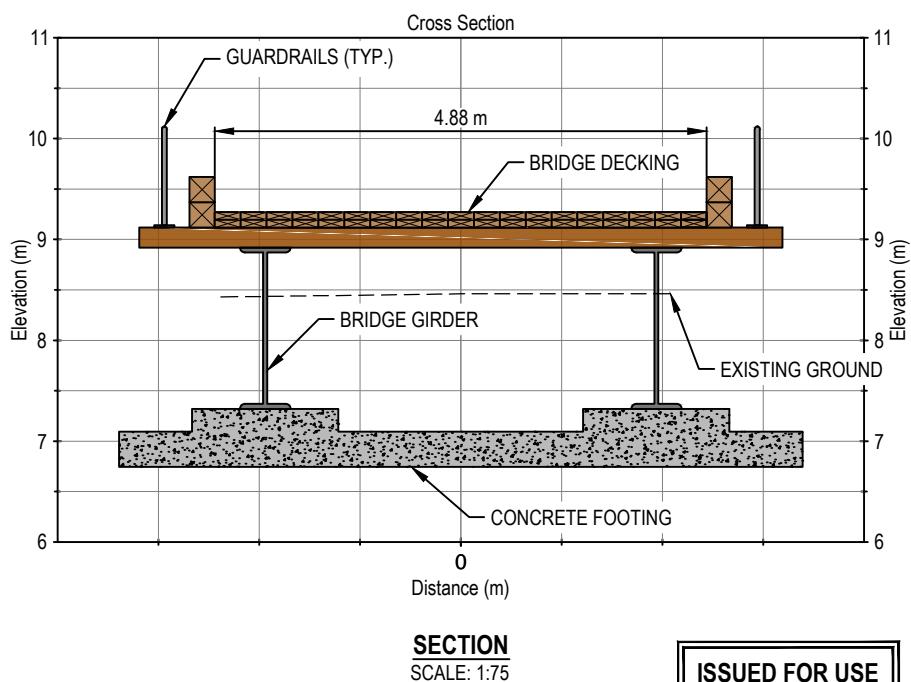
PROJECT NO.	OFFICE	DES	CKD	REV	DRAWING
VANC	MAN	DNM	DNM	0	Figure 3-4
December 1, 2015	SHEET No. of	DWN	APP	STATUS	-

1. These drawings represent a conceptual design. Actual dimensions, elevations and materials may vary.

CROSSING 7
BRIDGE DESIGN (NEW BRIDGE)

- Construction of a new, 30 m long bridge at Crossing #7, founded on a pre-cast concrete sill and protected by an earth-filled abutment protected by rip-rap;

Under design flow conditions, we estimate that Crossing #7 would convey 69 m³/s while Crossing #4 would convey the remaining 25 m³/s. The corresponding upstream water level during this event would be approximately 6.8 masl, reducing the risk of the Post River spilling into the East Basin.

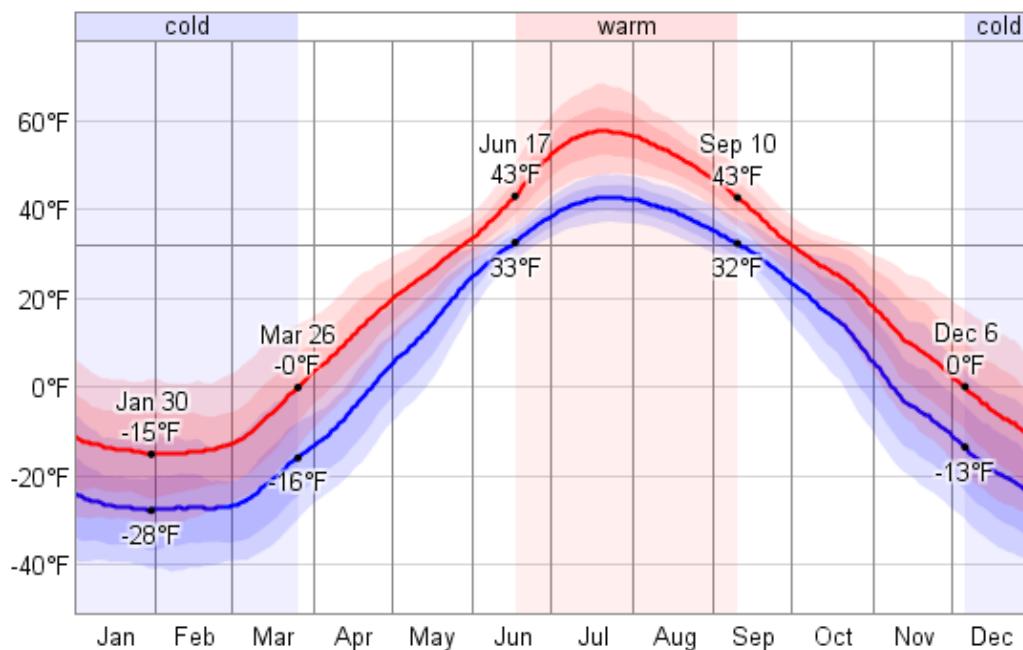
Figure 4-1: Daily High and Low Temperature at Coral Harbour Airport, NU

Notes: The daily average low (blue) and high (red) temperature with percentile bands (inner band from 25th to 75th percentile, outer band from 10th to 90th percentile).

The snow-free season typically lasts from about mid-June to mid-September, with an average daily high temperature above 6.1°C (43°F). The warmest days of the year typically occur in July and early August, with an average high of 14.4°C (58°F) and low of 6.1°C (43°F), as shown in Figure 4-1.

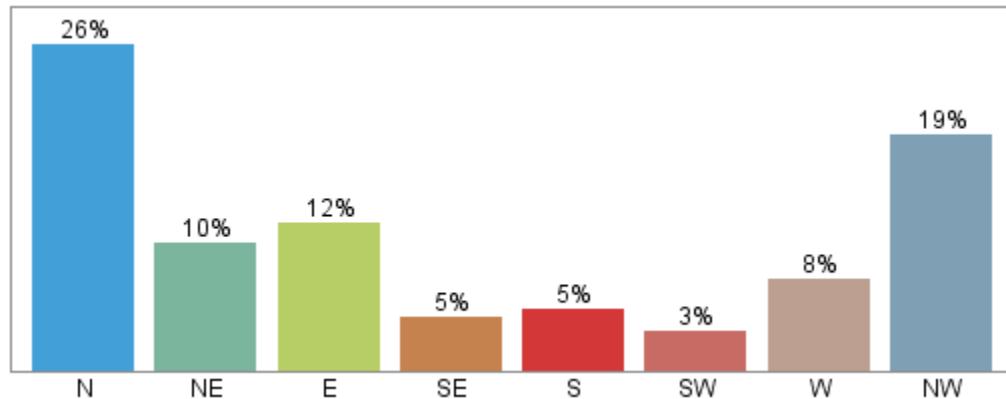
Figure 4-2: Annual Average Wind Directions at Coral Harbour Airport, NU

Notes: The fraction of time spent with the wind blowing from the various directions over the entire year. Values do not sum to 100% because the wind direction is undefined when the wind speed is zero.

Over the course of the year typical wind speeds in the Coral Harbour area vary from 0 km/h to 32.2 km/h, rarely exceeding 54.7 km/h. Winds occur most frequently from the north (26% of the time), followed by winds from the north west (19% of the time), east (12% of the time), and north east (10% of the time). Winds occur least often from the south west (3% of the time) and south east (5% of the time) (Figure 4-2).

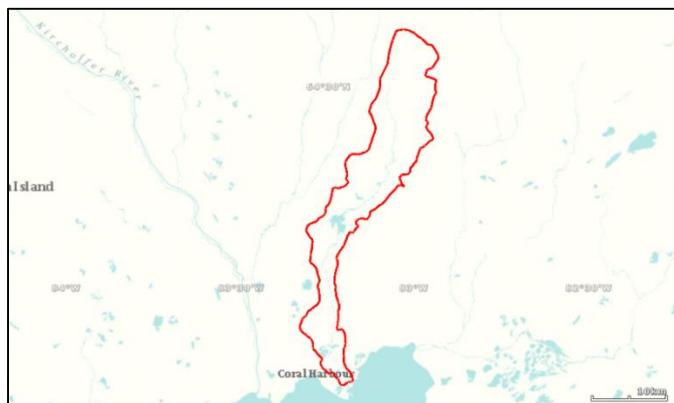
Figure 4-4: Post River Watershed

The Coral Harbour Airport Community Road Washout Rehabilitation Project is located within the Post River drainage area. The Post River is located on the eastern side of Southampton Island and has an approximate watershed area of 281 km² (Figure 4-4). The upper reach of the watershed originates approximately 48 km north of Coral Harbour and drains south into Hudson's Bay. The project site is defined as Airport Road, which provides access to Coral Harbour Airport.

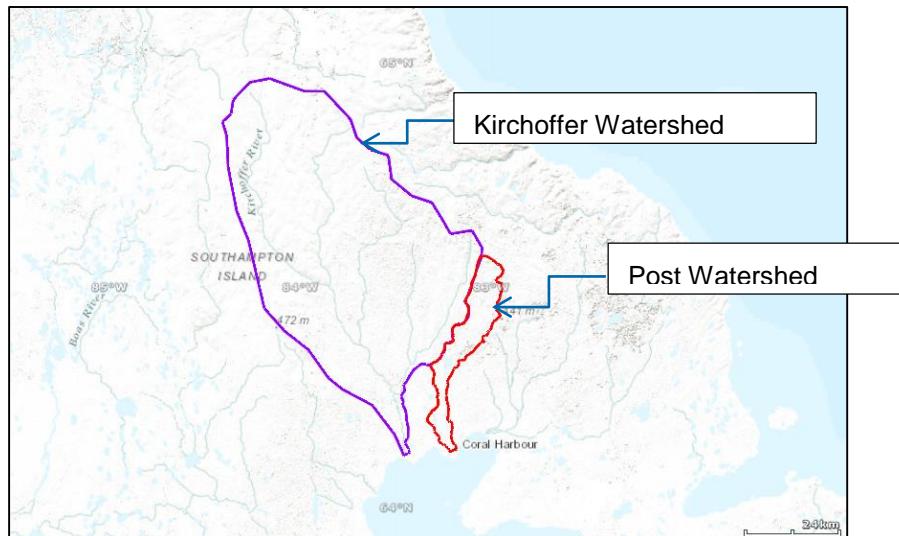
Figure 4-5: Post River and Kirchoffer River Watersheds

Due to the consistency of the freshet flow responses and the proximity of the Kirchoffer River station to the project site, the shape of the freshet hydrograph was used to scale the hydrograph for the Post River.

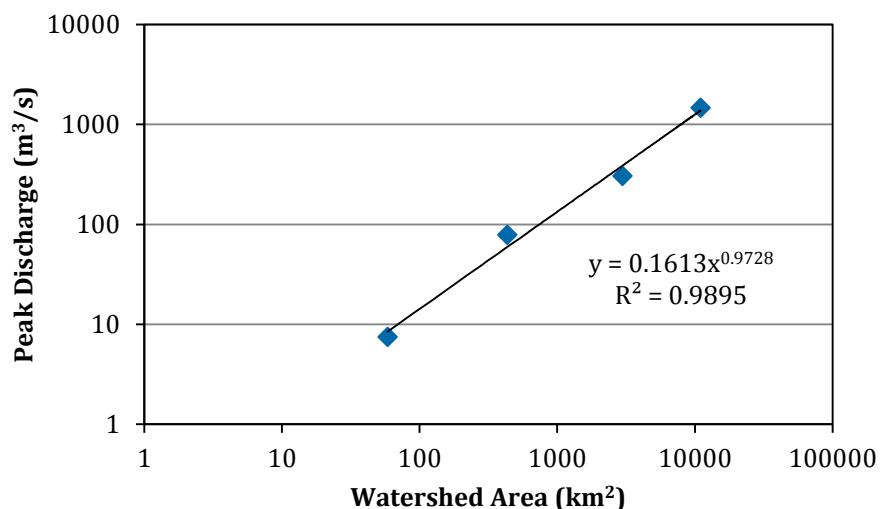
Figure 4-6: Comparison of Peak Flow to Watershed Area in 1991 for WSC Stations Used in Regional Analysis

The remaining four WSC stations outlined in Table 4-2 with nine or more years of available peak instantaneous flow data were used in a regional statistical flow evaluation to determine peak flows on the Post River for a range of return periods.

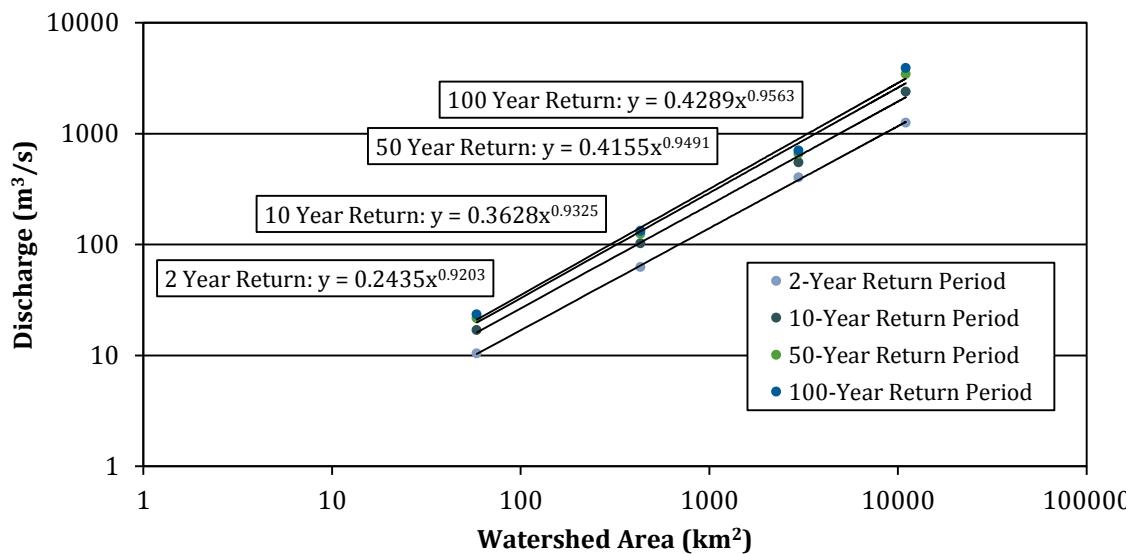
Figure 4-7: Post River at Airport Road: K Value Determination

Figure 4-7 depicts a log-log plot of flow compared to watershed area for each of the WSC stations for each return period. Each set of data was fitted with a power trend line which can be used to determine design floods for a given watershed area.

Using the above trend line equations, estimated flows for the Post River watershed (281 km²) were calculated for a range of return periods. Table 4-4 summarizes the results of the frequency analysis for the Post River watershed.

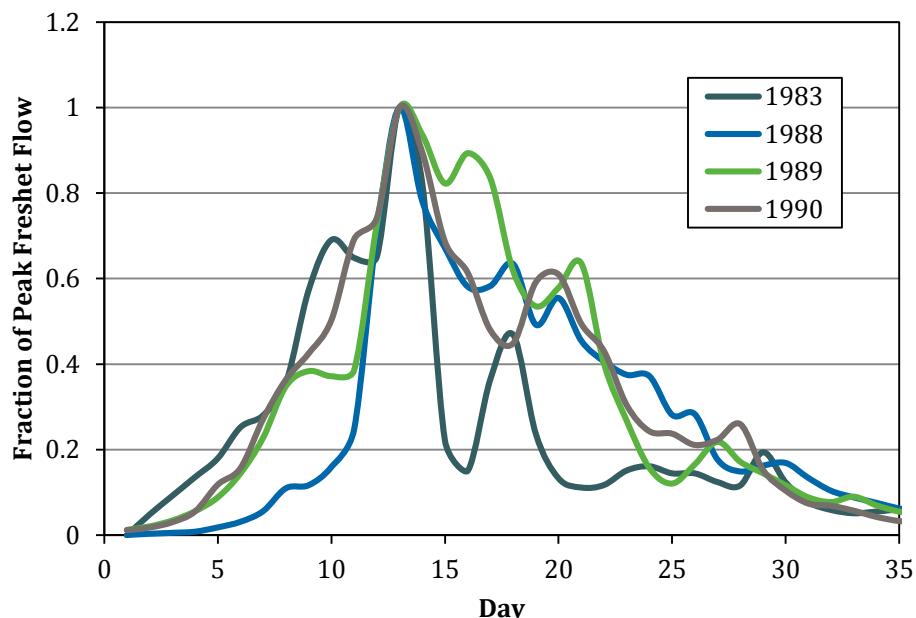
Figure 4-8: Typical Freshet Hydrograph

To give a hydrograph shape to estimated Post River peak flows, hydrographs from the nearby Kirchoffer River hydrometric stations were reviewed. Historical records demonstrate that the Kirchoffer River freshet period typically span over multiple days, often lasting more than three weeks (Figure 4-8). The four years of available Kirchoffer River freshet flow data were graphed and the most critical hydrograph was selected for the synthesis of the 100-year Post River freshet hydrograph (Figure 4-9). This synthetic Post River freshet hydrograph was later used in the hydraulic analysis of the Airport Road culvert system.

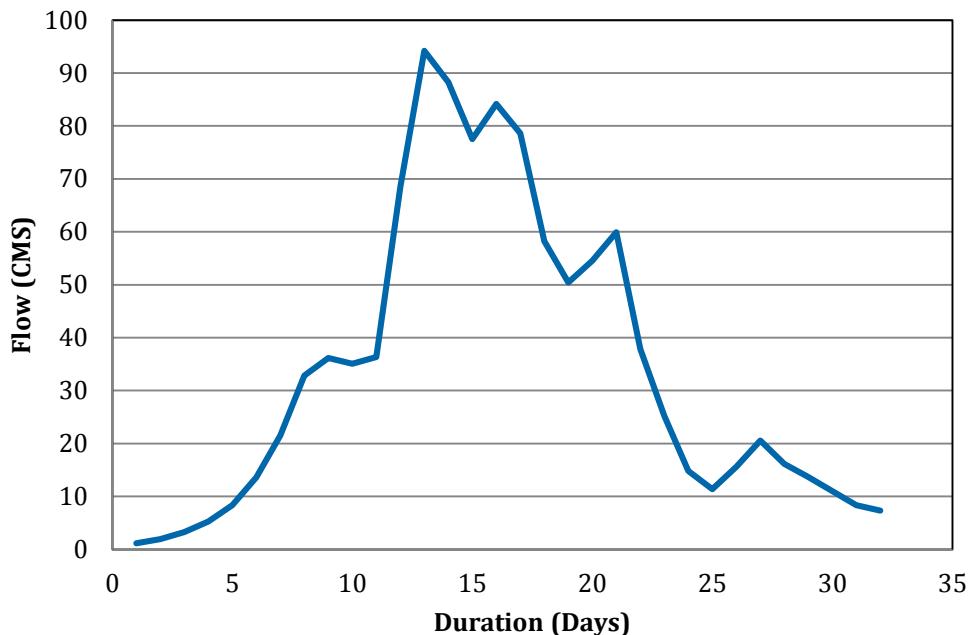
Figure 4-9: Synthesized Post River 100-Year Hydrograph
