# Water Licence Inspection Report

| <b>Queen's University</b> | <b>Melissa Lafreniere</b> |
| <b>8WLC-CBA2324/ July 12, 2024</b> | |

| <p><b>Section 1 Comments</b></p> <p><b>Inspector Statement</b></p> <p>On July 07, 2023, I, Isaiah James Bolt, Inspector with the Crown Indigenous Relations and Northern Affairs Canada (CIRNAC), along with fellow inspector Joseph Monteith of CIRNAC, conducted an on site visit of Cape Bounty Arctic Watershed Observatory project to verify compliance of the conditions found within their issued water licence.</p> <p>At the time of inspection the proponent did not have a copy of the issued water licence on site. It was verbally stated that one should be present on site at all times. The lead of the camp mentioned that they would get a copy sent in on their next fly in.</p> <p><b>Water Usage</b></p> <ol style="list-style-type: none"> <li>At the time of Inspection there were 5 people on site. The camp manager on site mentioned 3 more people would be arriving and there would be 8 people on site during the 2023 field season.</li> <li>Water is collected from the stream close by the air strip in front of the kitchen and lab tents. (Photo #8)</li> <li>Photo of

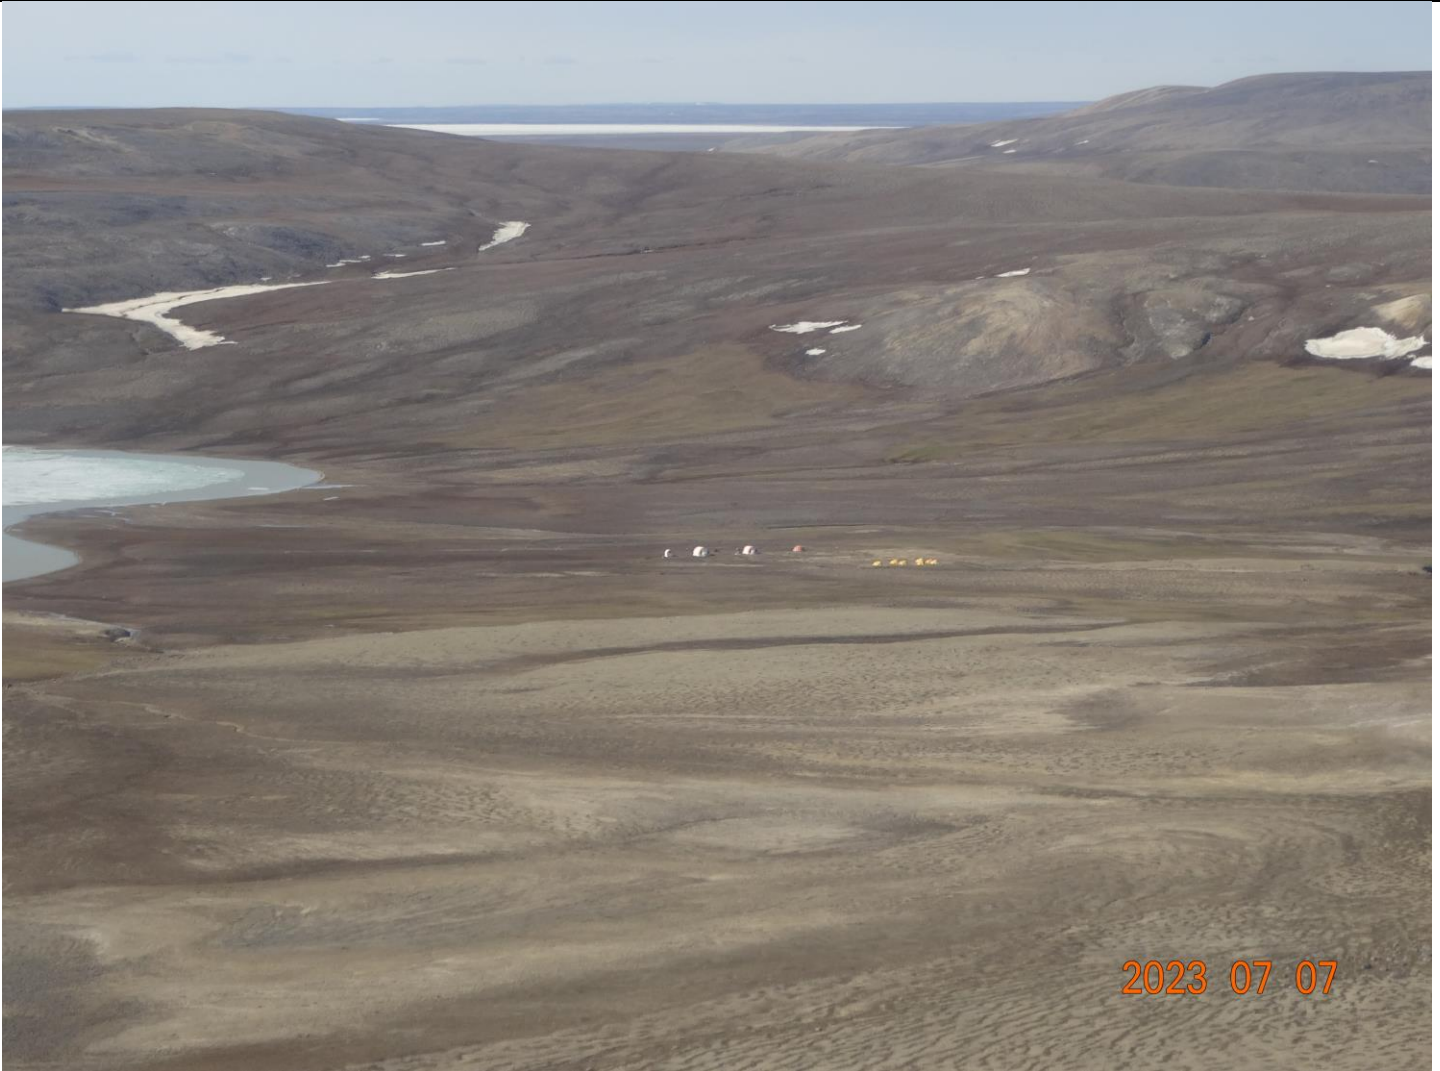
| Photo No. | Lat/Long (DD.MM.SS.SS, NAD83) |
|---|--|
| Photo #1 | <a href="#">Click or tap here to enter text.</a> |

**Description:**  
Aerial Photo of the main camp at Cape Bounty Watershed Observatory.

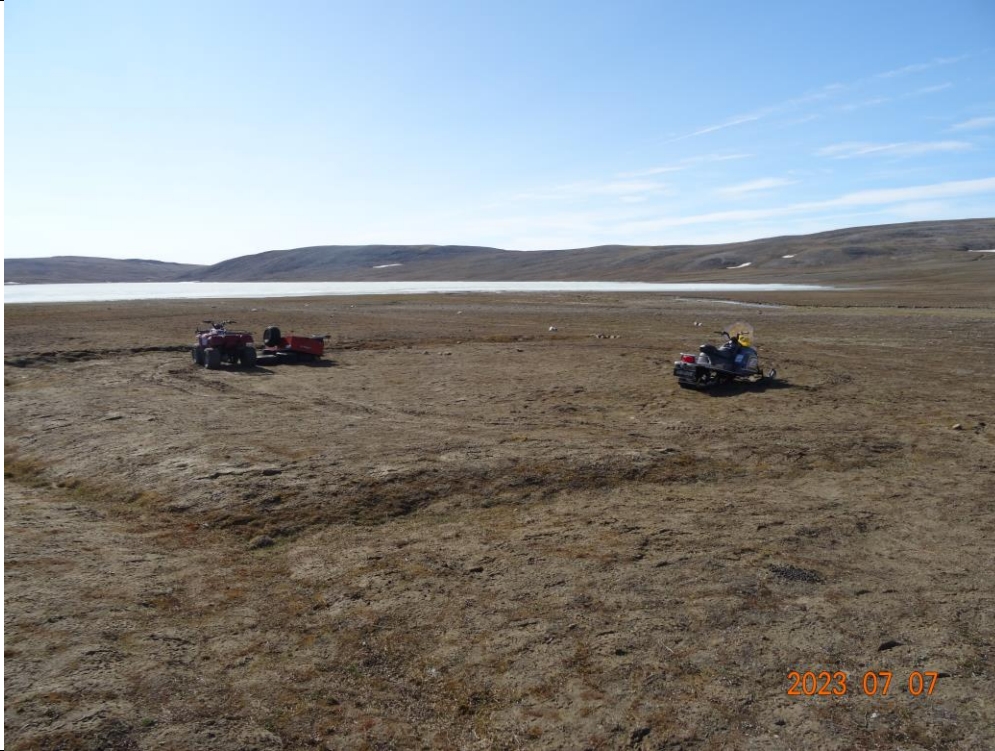
Photo #2

- 7. 1 drum and 3 jerry cans were observed in a secondary spill berm. (Photo #5)
- 8. 1 Drum-Fuel pump was stored in the secondary containment
- 9. 14 - 100lb propane tanks were stored behind the kitchen and Lab. (photo #4)
- 10. 5 - 20lbs propane bottles were observed onsite.
- 11. 1 snowmobile and 1 quad were observed onsite. No fuel was stored near the machines (Photo #2)

1 Kawasaki 250cc 4 wheeler, 1 wagon, and 1 300cc Skidoo on site.

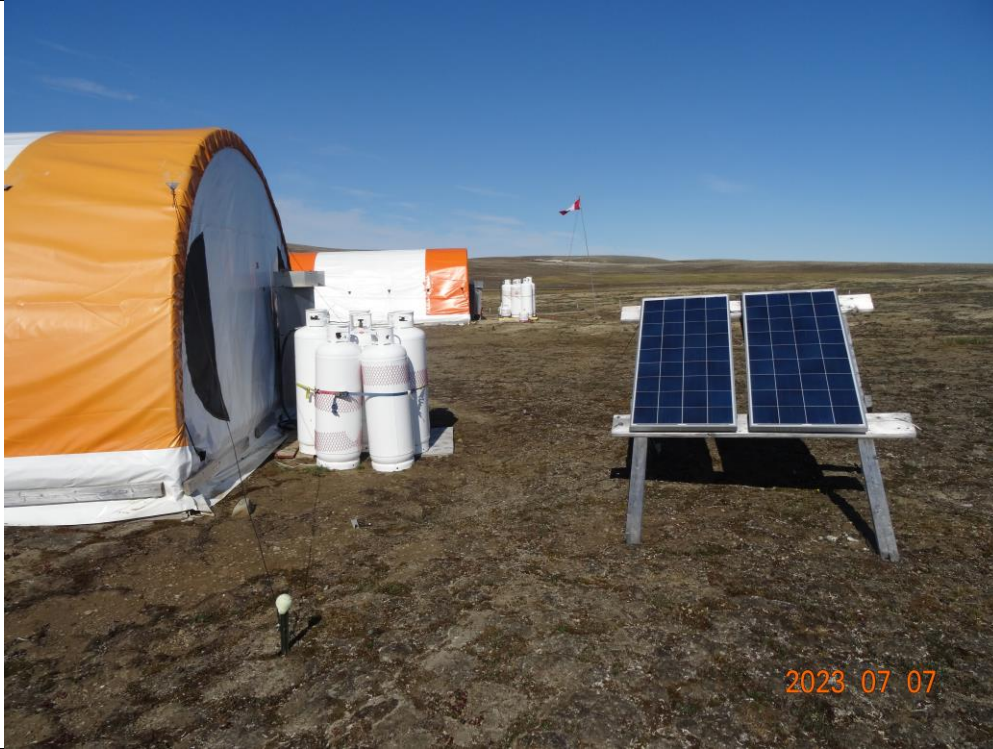
Photo #4

Propane tanks tied together and stored behind the tents. The tanks are placed on plywood.

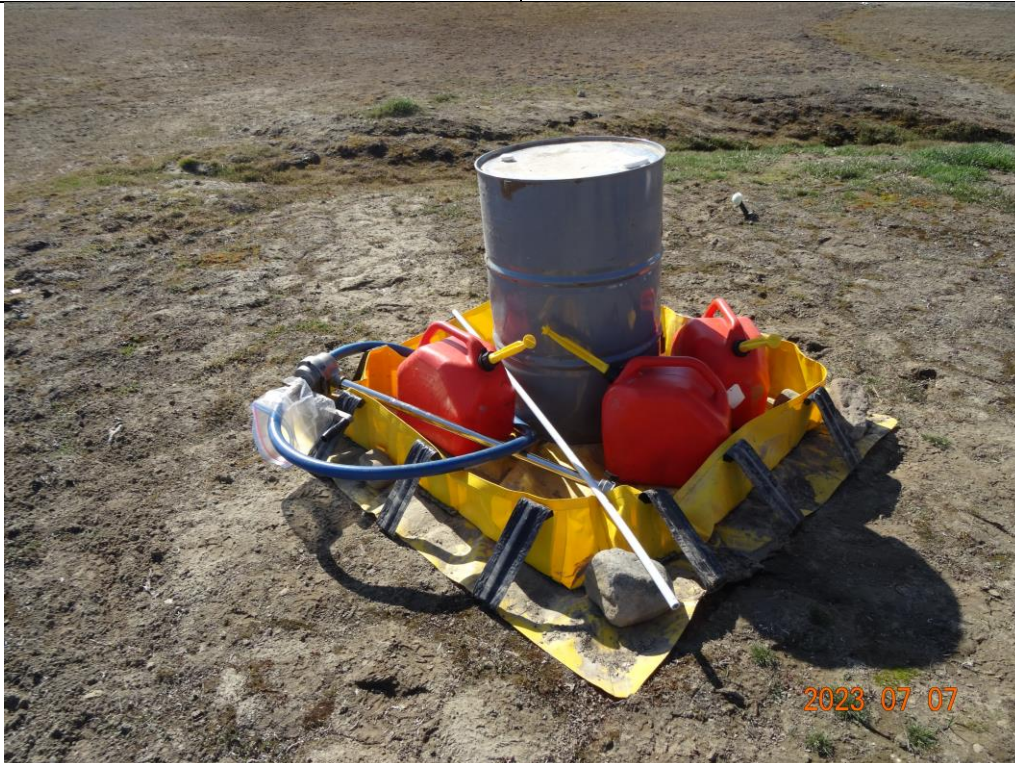
Photo #5

Secondary containment berm with 3 jerry cans and 1 drum of fuel. They also store their fuel pump in secondary containment.

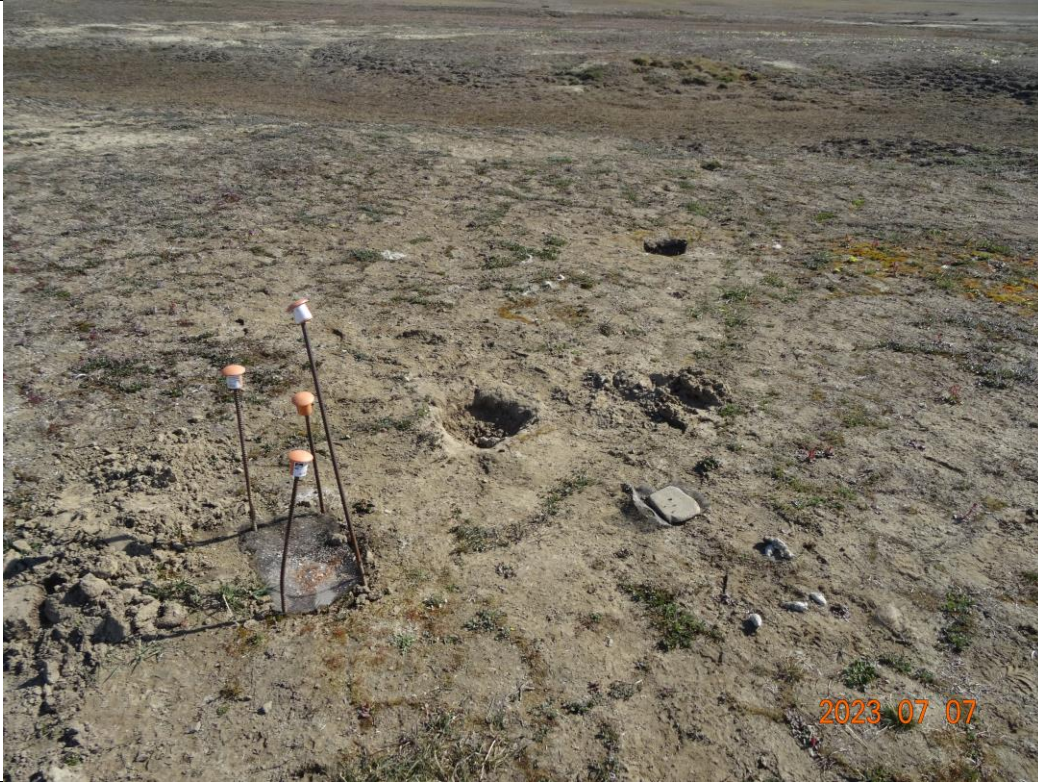
Photo #6

- 4. Grey water from the kitchen and Pee from the honey bucket is disposed of into a hole in the ground. New holes are dug when the current hole is filled. (Photo #6)
- 5. An Incinolet Toilet was observed on site. (Photo #7)
- 6. All Domestic waste is flown off site.

This image shows the grey water/pee sumps. The hole is covered with a mesh to catch food wastes. Those pot holes are old capped sumps.

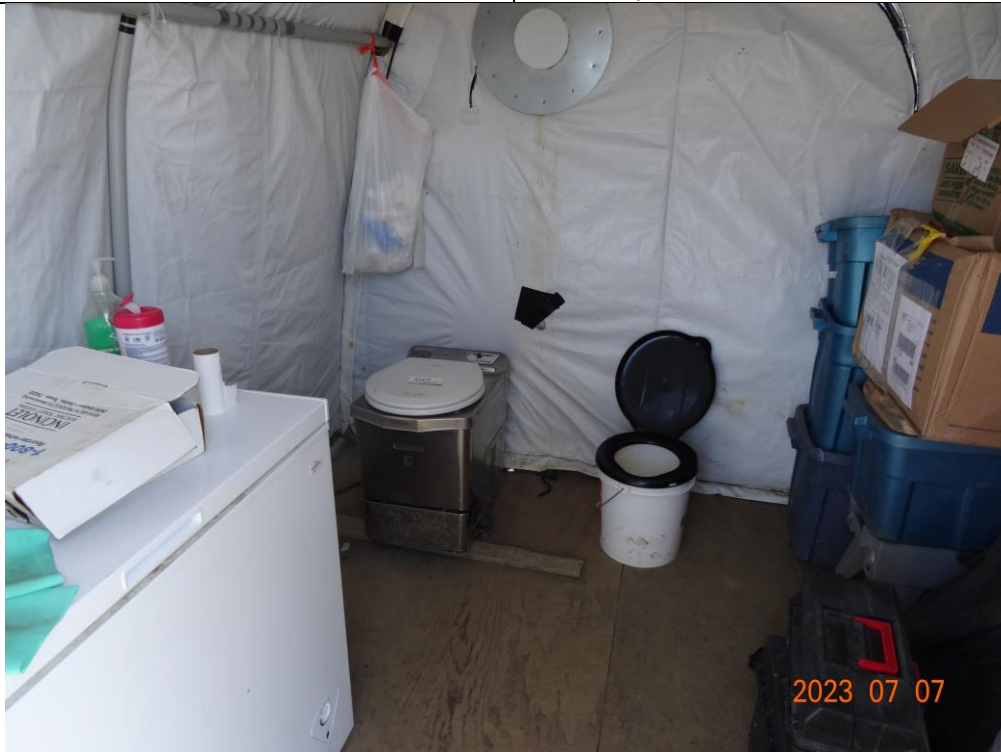
Photo #7

The incinolet and the honey bucket.

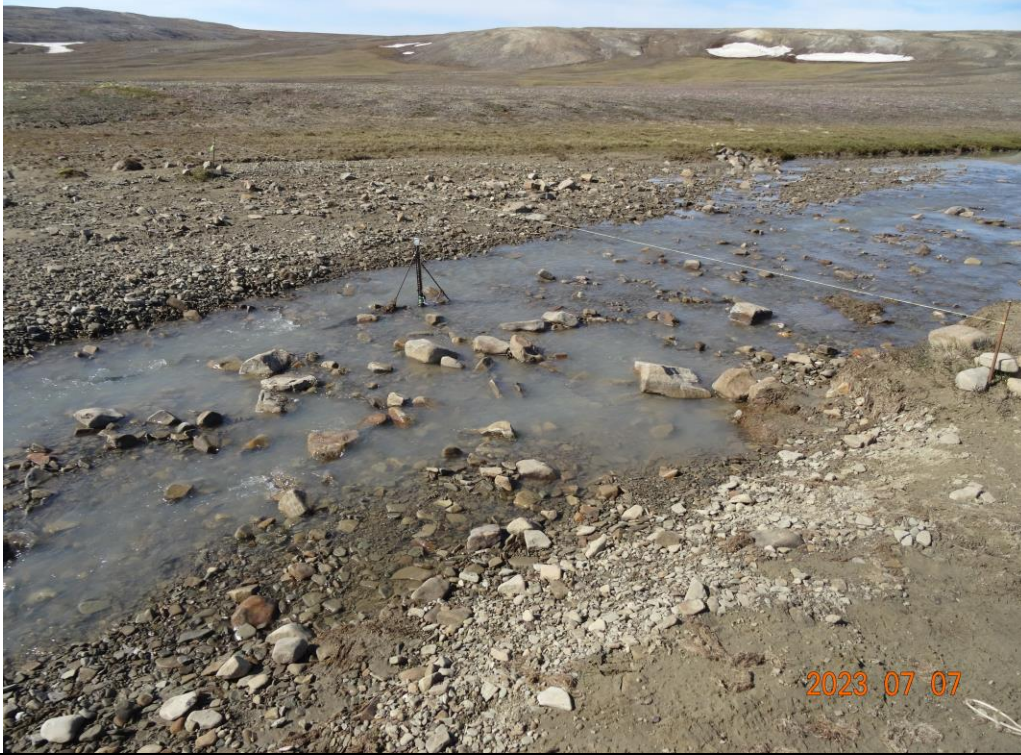
Photo #8

Water withdraw location

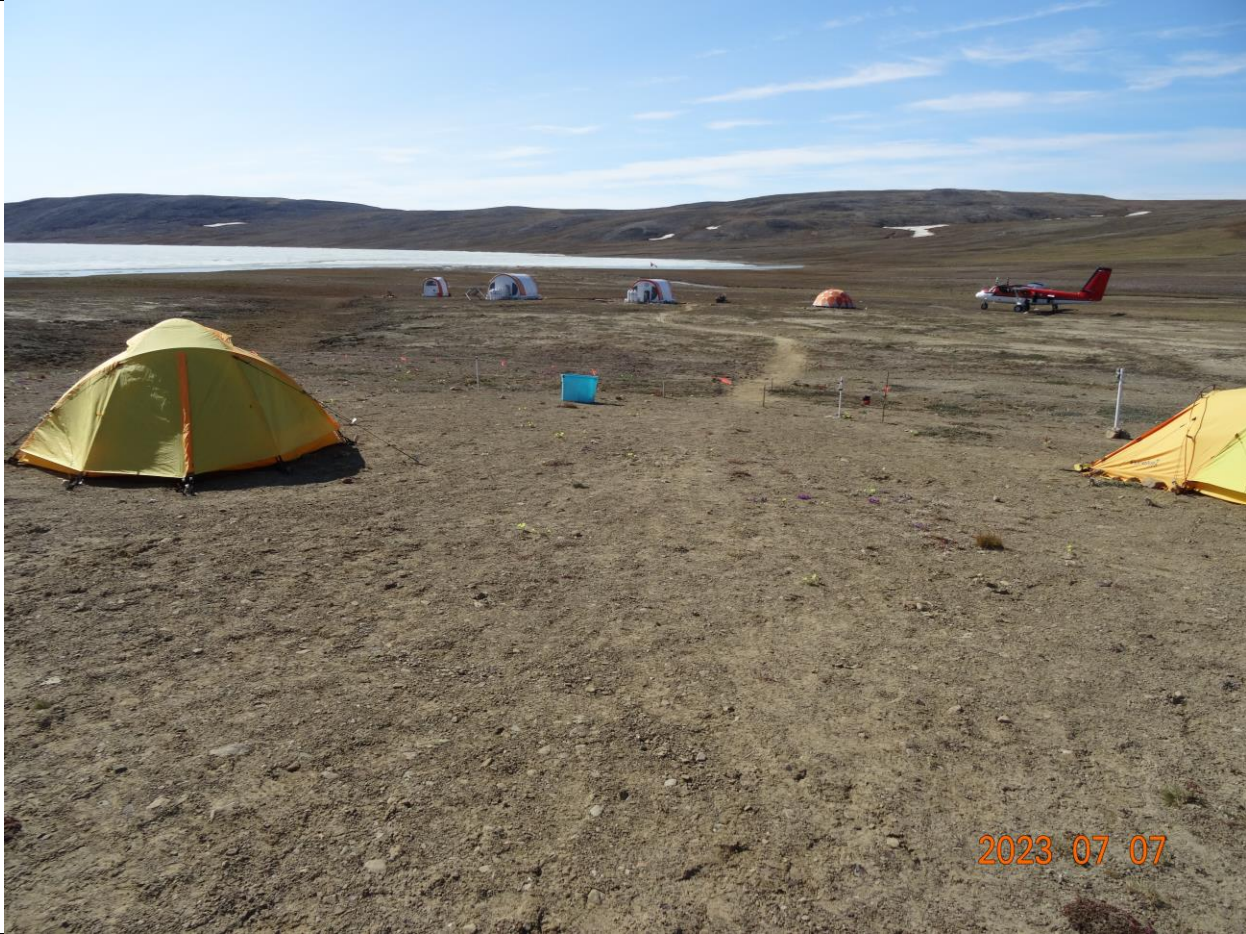
Photo #10

An image of the main camp, path and air strip from the sleeping tents area. The water withdraw river is visible above the path.
