WATER LICENCE INSPECTION FORM

| Mars Society | Shannon Rupert |
| 3BC-MAR1014 | Director |
| July 5, 2022 | Joseph Monteith |

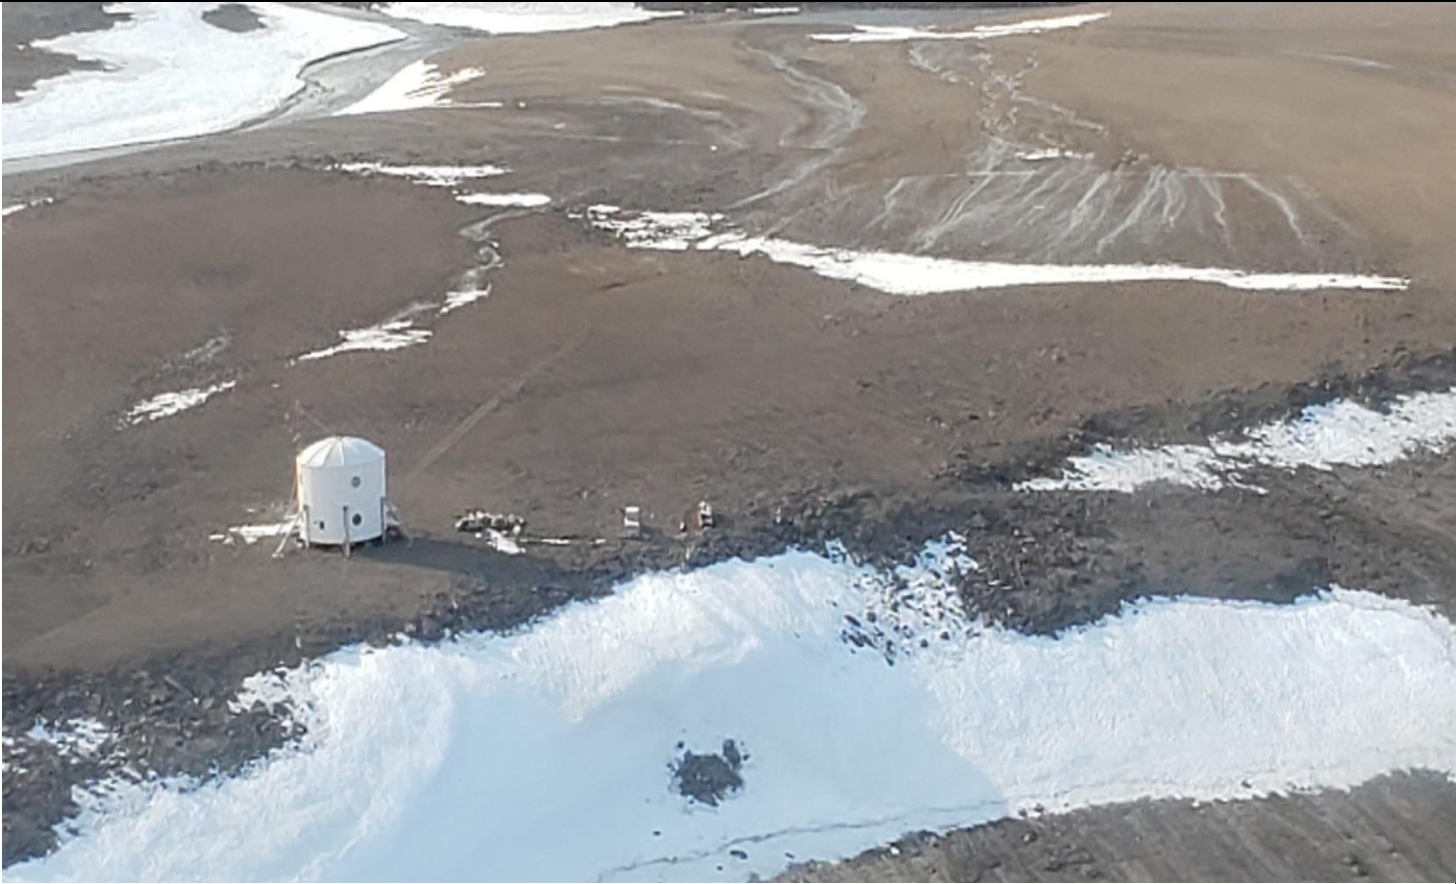
| Photo Log # | Location |
|---|---|
| Photo 2 | N75° 25' 52.9" W89° 49' 24.5" |

- 6. FMARS Structure still occupying site.
- 7. Fuel Cache observed on site. Spill Kit observed
- 8. Boxes of supplies observed on site
- 9. Waste Oil drums observed on site

**Description:** FMARS. Fuel Cache pile closest to FMARs, few wooden crates, and waste drum stockpile to furthest pile to FMARS.

Due to the expiry of the water license, remove all structures and equipment or re apply for a new water license.
