WATER AND LAND USE INSPECTION FORM

Permittee	Representative
Bathurst Inlet Developments	Boyd Warner
Permit No. / Expiry	Representative's Title
76F04002 (expired)	
Other Authorizations	Land / Other Authorizations
8WLC-PEL1718	
Date of Inspection	Inspector
08/08/2017	Eva Paul
Activities Inspected	
<input checked="" type="checkbox"/> Camp	<input type="checkbox"/> Drilling
<input type="checkbox"/> Roads/hauling	<input type="checkbox"/> Mining
<input type="checkbox"/> Other:	<input type="checkbox"/> Construction
	<input type="checkbox"/> Reclamation
	<input checked="" type="checkbox"/> Fuel Storage
	<input type="checkbox"/> Other:

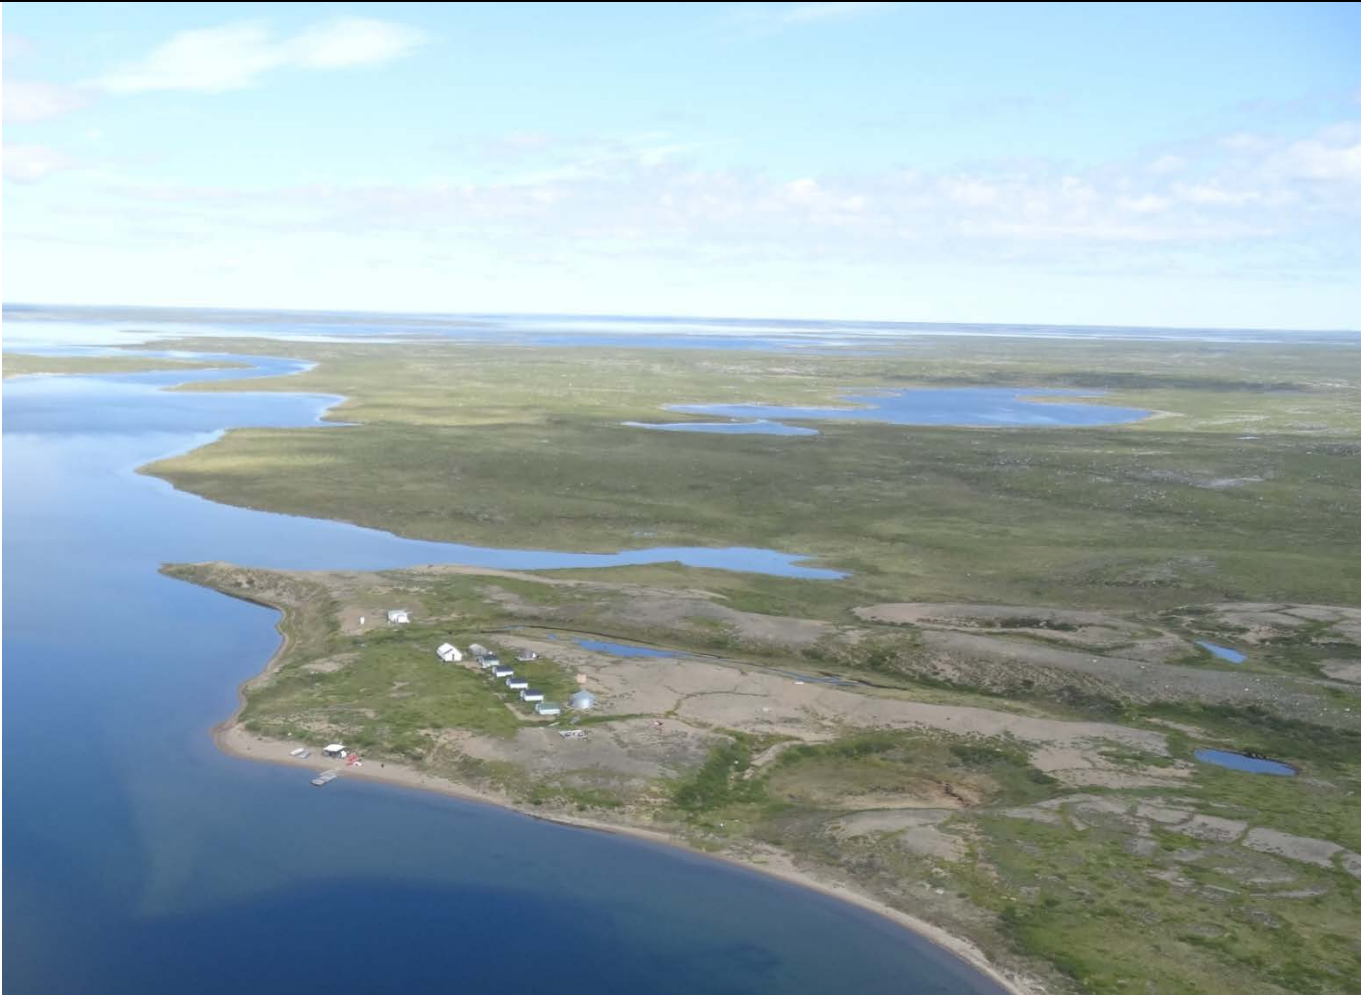
Date	Camera	Inspector	Authorization
July 8 2017	SONY DSC-HX50V	Eva Paul	8WLC-PEL1718 / 76F/4-2-2
Photo Log # 1		Location (NAD 83 DD MM SS.SS)	
Photo DSC06730 (cropped)		N	W

Description: Aerial view of Pellatt / Esker camp from South.

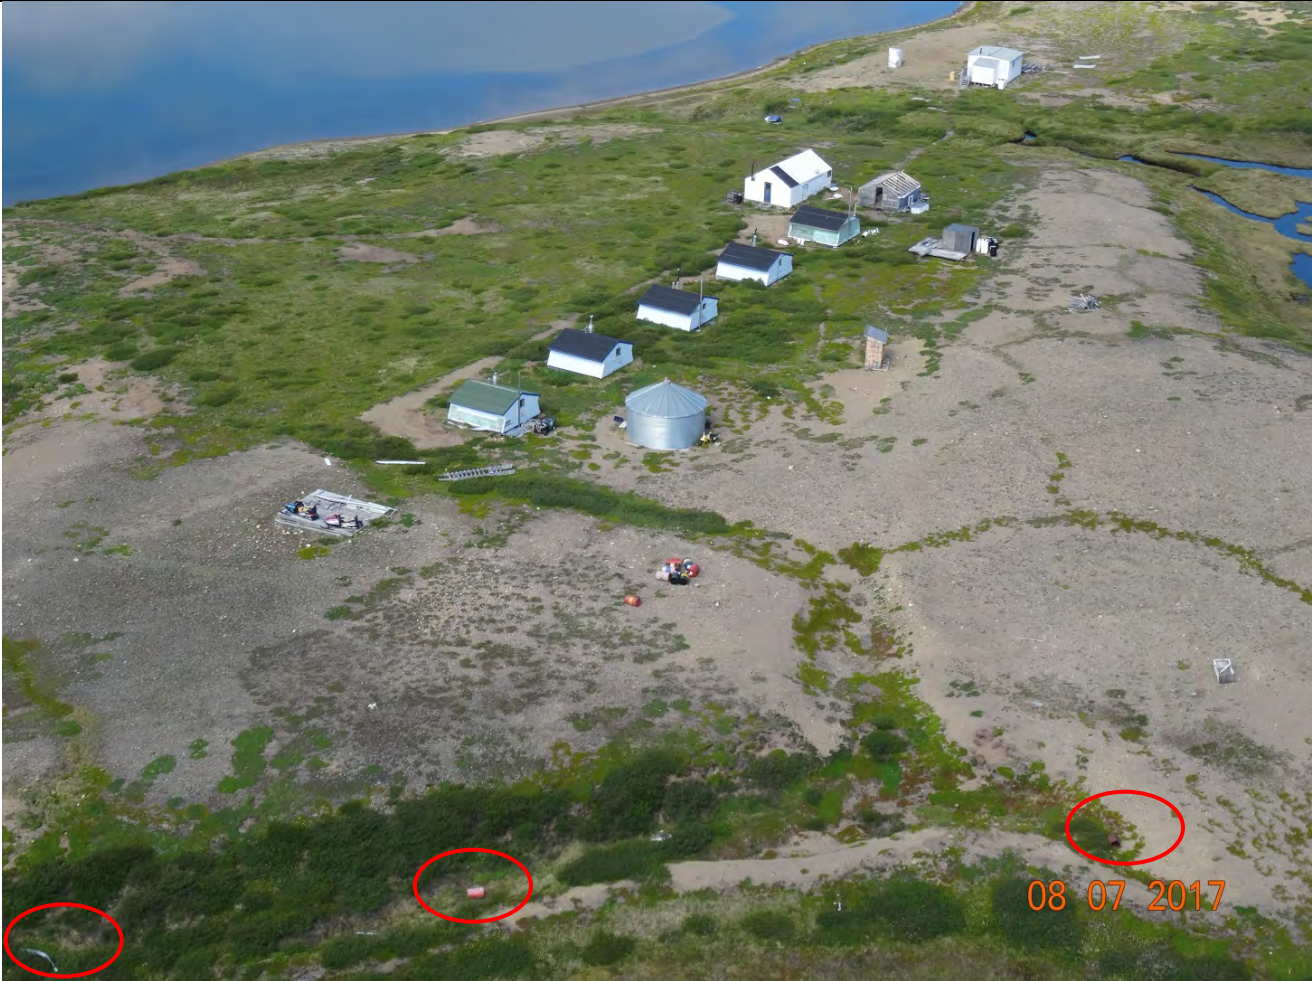
Photo Log # 2	Location (NAD 83 DD MM SS.SS)	
Photo DSC06732	N65 01 44.9	W109 38 01.1

Description: Camp from SE. Note barrel and debris in shallow ravine in foreground of photo.

- A. Pursue renewal of the leases with INAC Lands and ensure rent is paid and current to maintain overholding tenancy status until renewal.
- B. A thorough cleanup of this site is required. All garbage and debris, old barrels, and any other waste are to be addressed as soon as practically possible. A report with photos demonstrating the cleanup is to be submitted to the Inspector by July 31, 2018. Failure to do so will result in enforcement measures taken under the relevant legislation.
- C. Ensure latrines and all storage (including fuel) is located >31m from OHWM of any water body including wetlands.

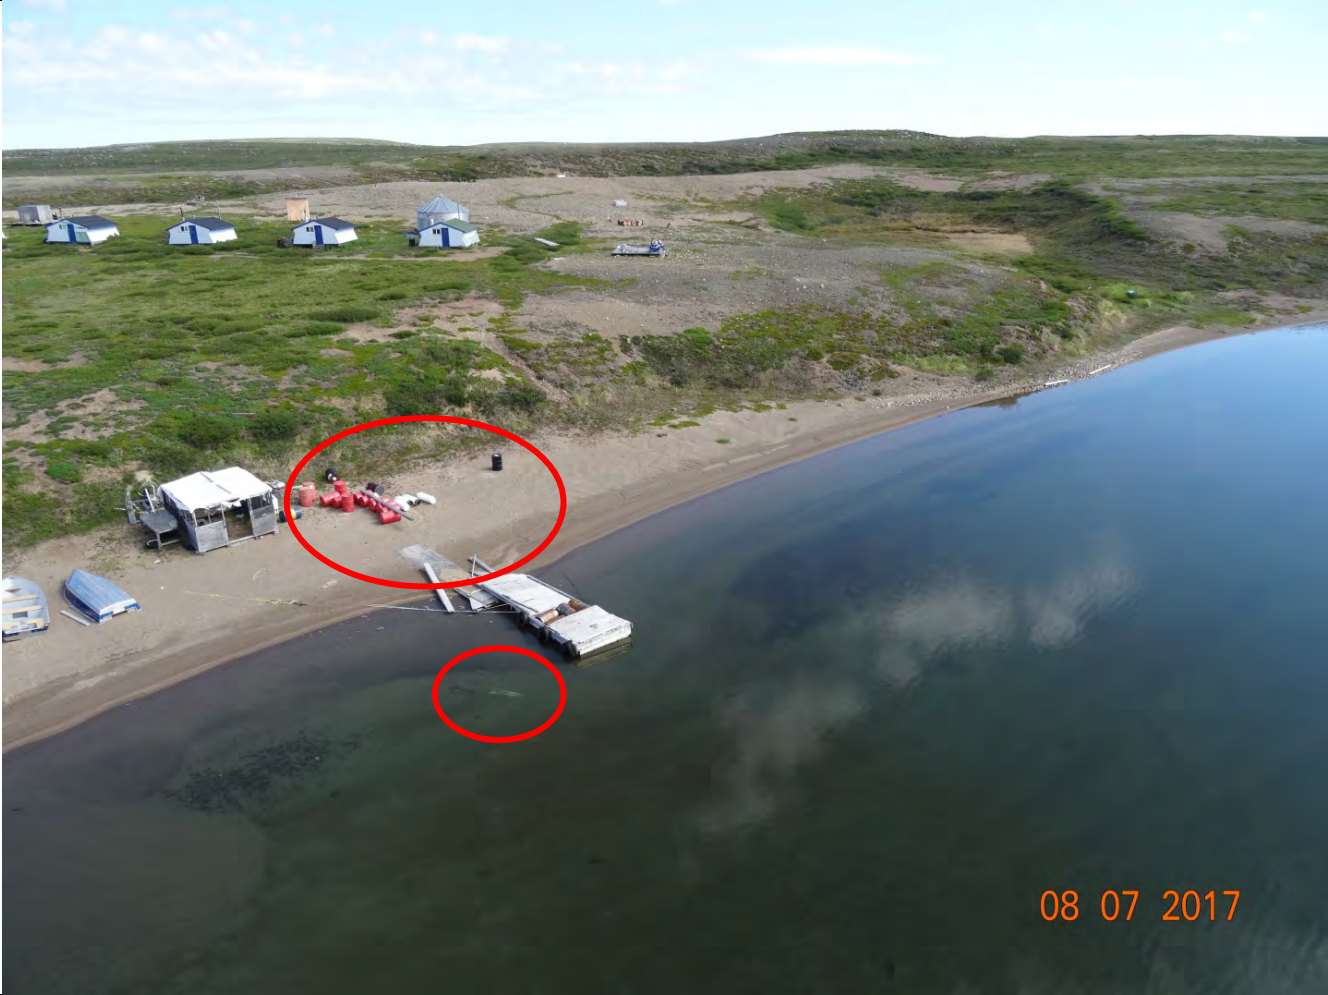
Photo Log # 3

**Description:** Dock structure partially embedded in sand. Debris visible in the water beside the dock, and up the shoreline that must be removed. Barrels, waste, and all structures must be >31m from OHWM. Barrels and waste should not be stored next to the water.

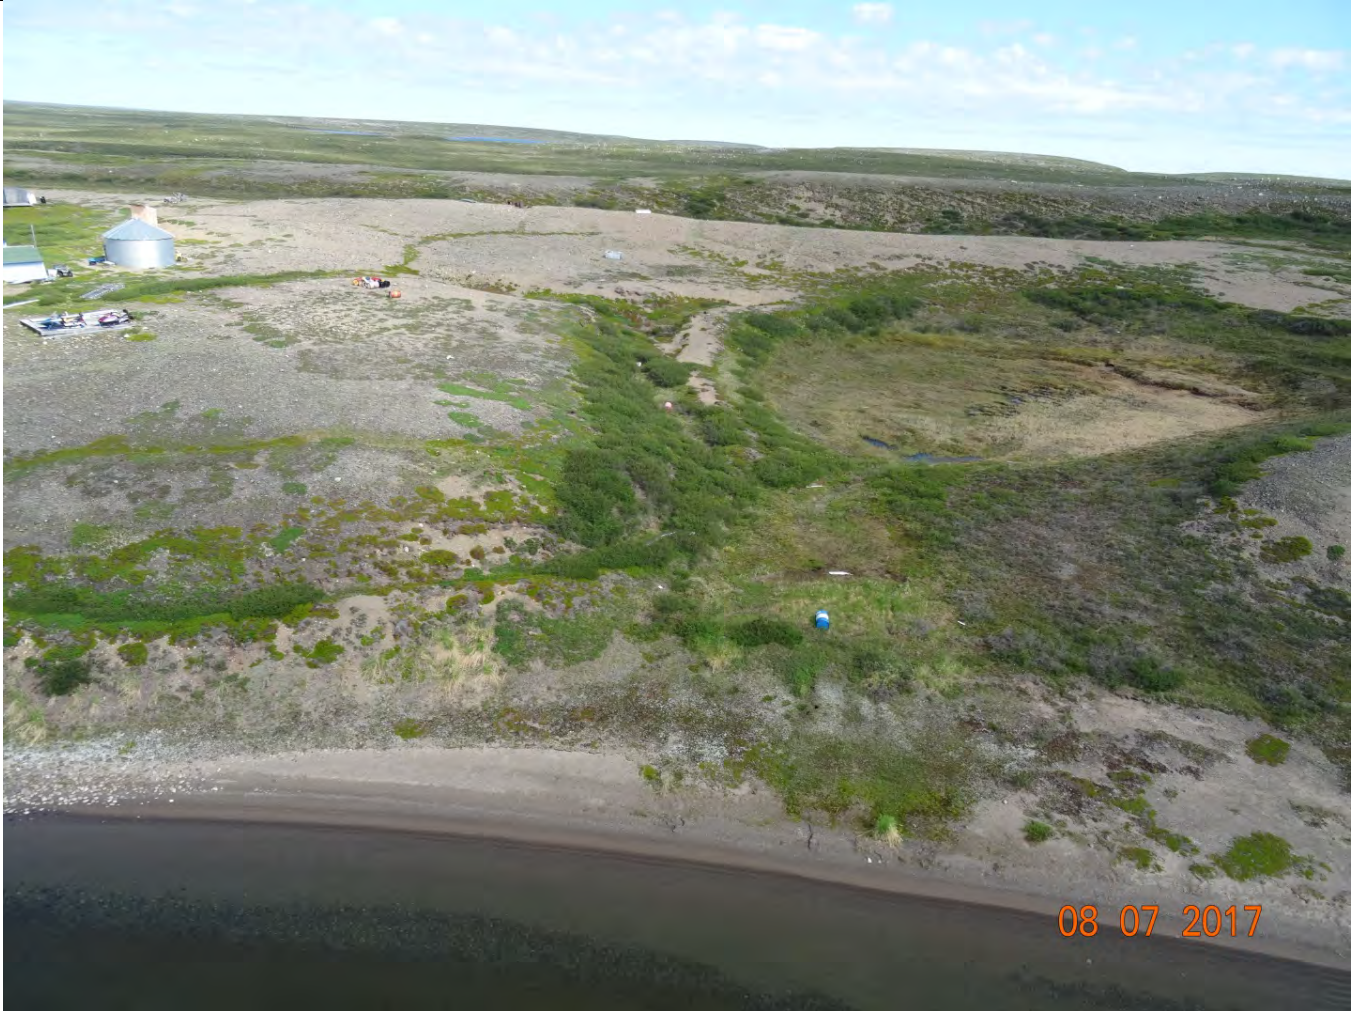
Photo Log # 4

**Description:** More barrels and debris that have blown from the camp.

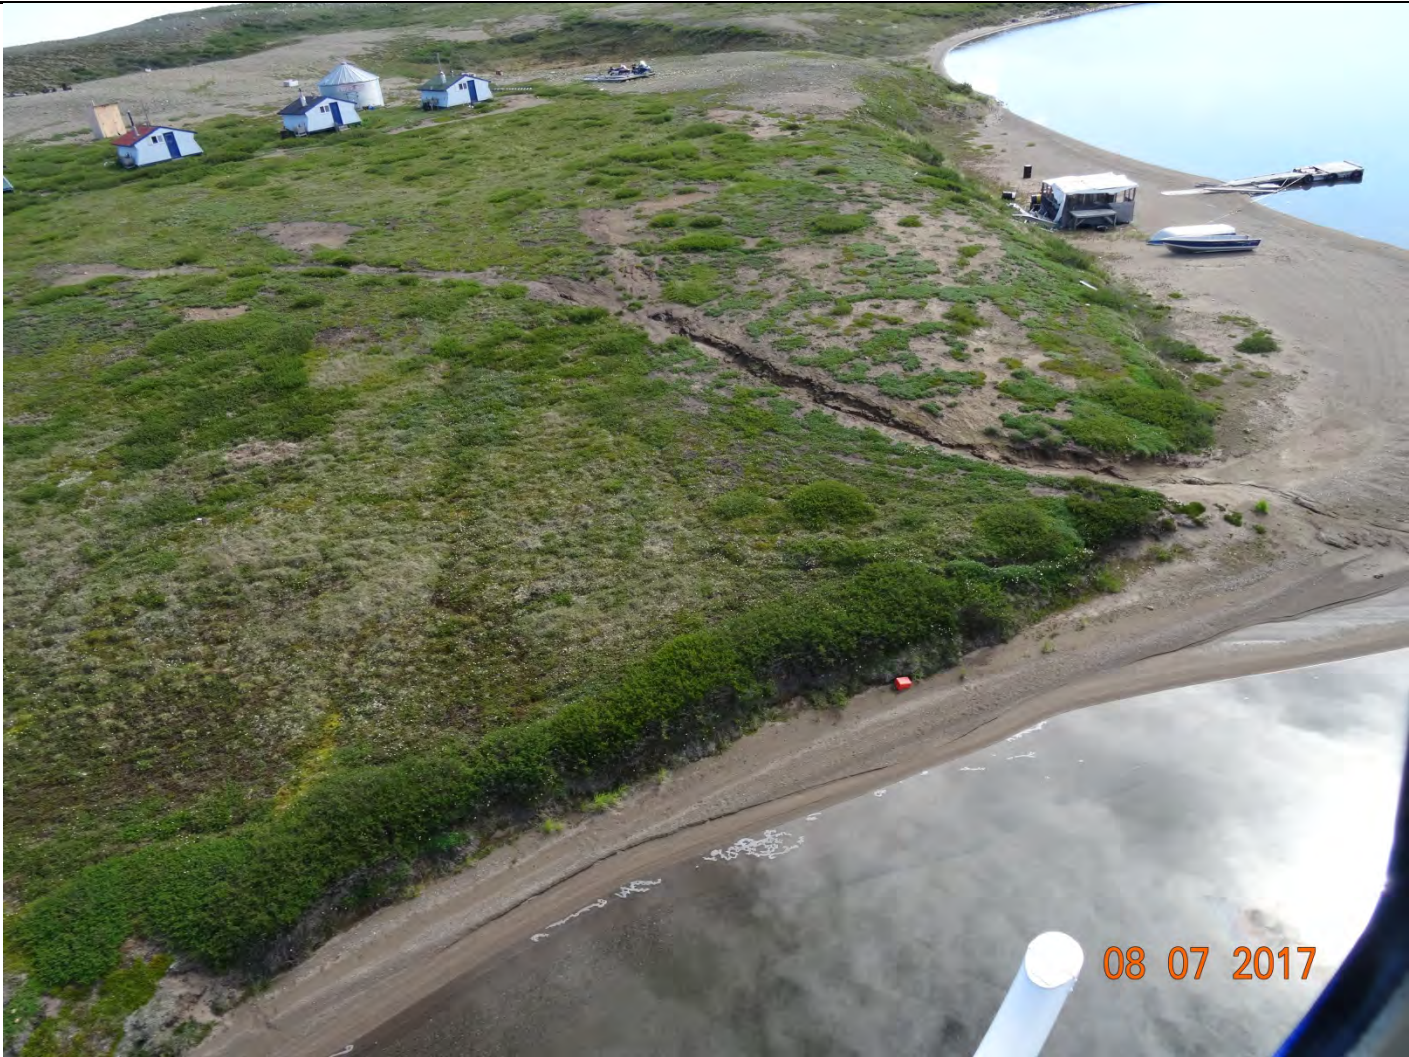
Photo Log # 7

Description: Jerry can noted on the beach.
