WATER LICENCE INSPECTION FORM

Licensee	Licensee Representative
Combustion Performance	Gabriel Choquette
Licence No. / Expiry	Representative's Title
8wIw-WAG1920	Business owner
Land / Other Authorizations	Land / Other Authorizations
3AM-IQA1626	--
Date of Inspection	Inspector
October 13, 2020	Jonathan MESHER
Activities Inspected	
<input type="checkbox"/> Camp	<input type="checkbox"/> Drilling
<input type="checkbox"/> Roads/Hauling	<input type="checkbox"/> Other:
<input type="checkbox"/> Mining	<input checked="" type="checkbox"/> Construction
	<input type="checkbox"/> Other:
	<input type="checkbox"/> Reclamation
	<input type="checkbox"/> Fuel Storage

The licensee is currently operating Wash and Go project in the City of Iqaluit, this licensee uses two types of pumps/ water storage tanks to operate this business. On June 30<sup>th</sup>, 2020 the inspector noted the licensee withdrawing water from a location adjacent to the north forty landfill( see photo 1 for pumping location), at that time the inspector questioned the licensee about the approved withdrawal location. The licensee informed me that they are approved to withdrawal from that waterbody but down stream of that location,

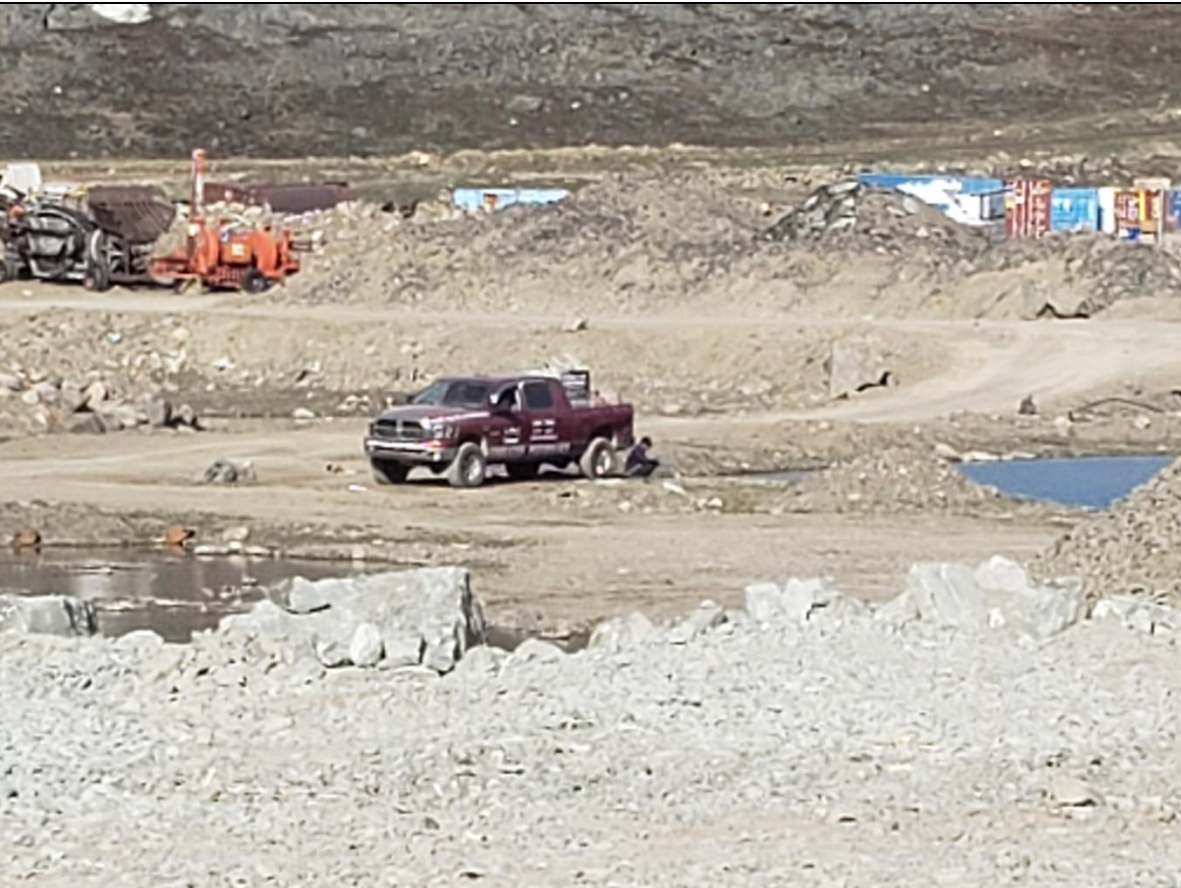
Date	Camera	Inspector	Authorization
	Sony Cyber-shot	J.Mesher	8WLW-WAG
Photo Log			
Photo 1

Description: Water withdrawal form unapproved area

SECTION 2		<input type="checkbox"/> Comments	<input checked="" type="checkbox"/> Non-Compliance with Act or Licence	<input checked="" type="checkbox"/> Action Required
1.The licensee is to only withdrawal from locations approved by the NWB.				
2.Due to the over usages of water, the inspector is requesting that the licensee amend their license to allow for such usage or limit daily usage to the approved quantity.				
Inspector's Name				
Jonathan MESHER				
Signature

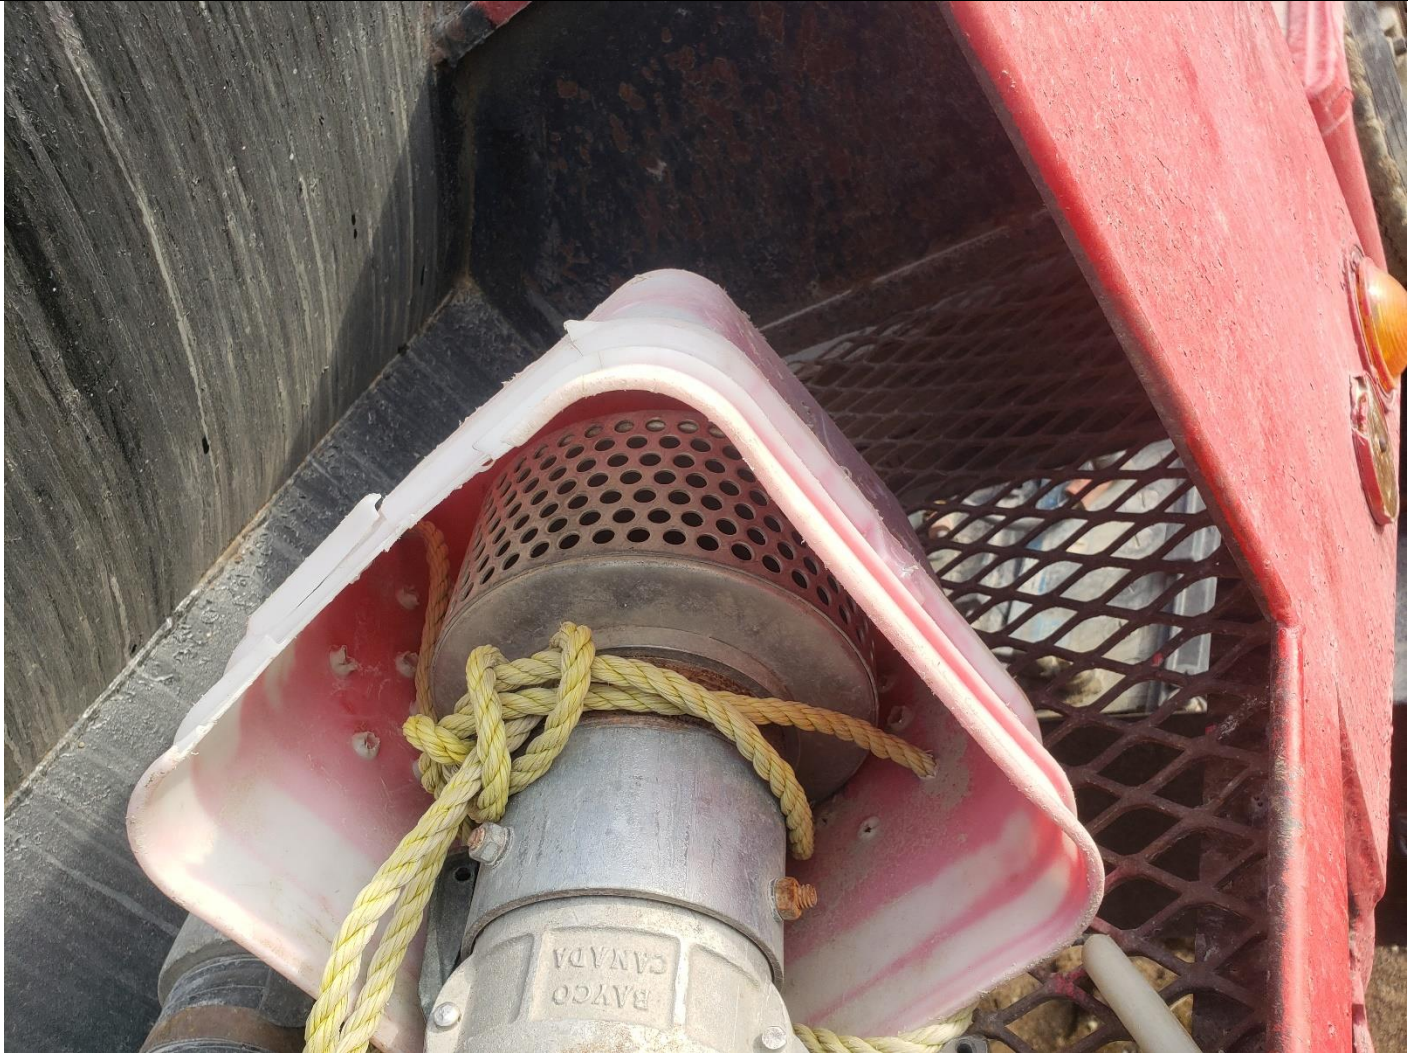
Photo 3

Description: Fish Screen
