Re: Spill Update; Nanisivik Mines Ltd.

Reference: Spill Number 95-160

N.W.T. SPILL REPORT

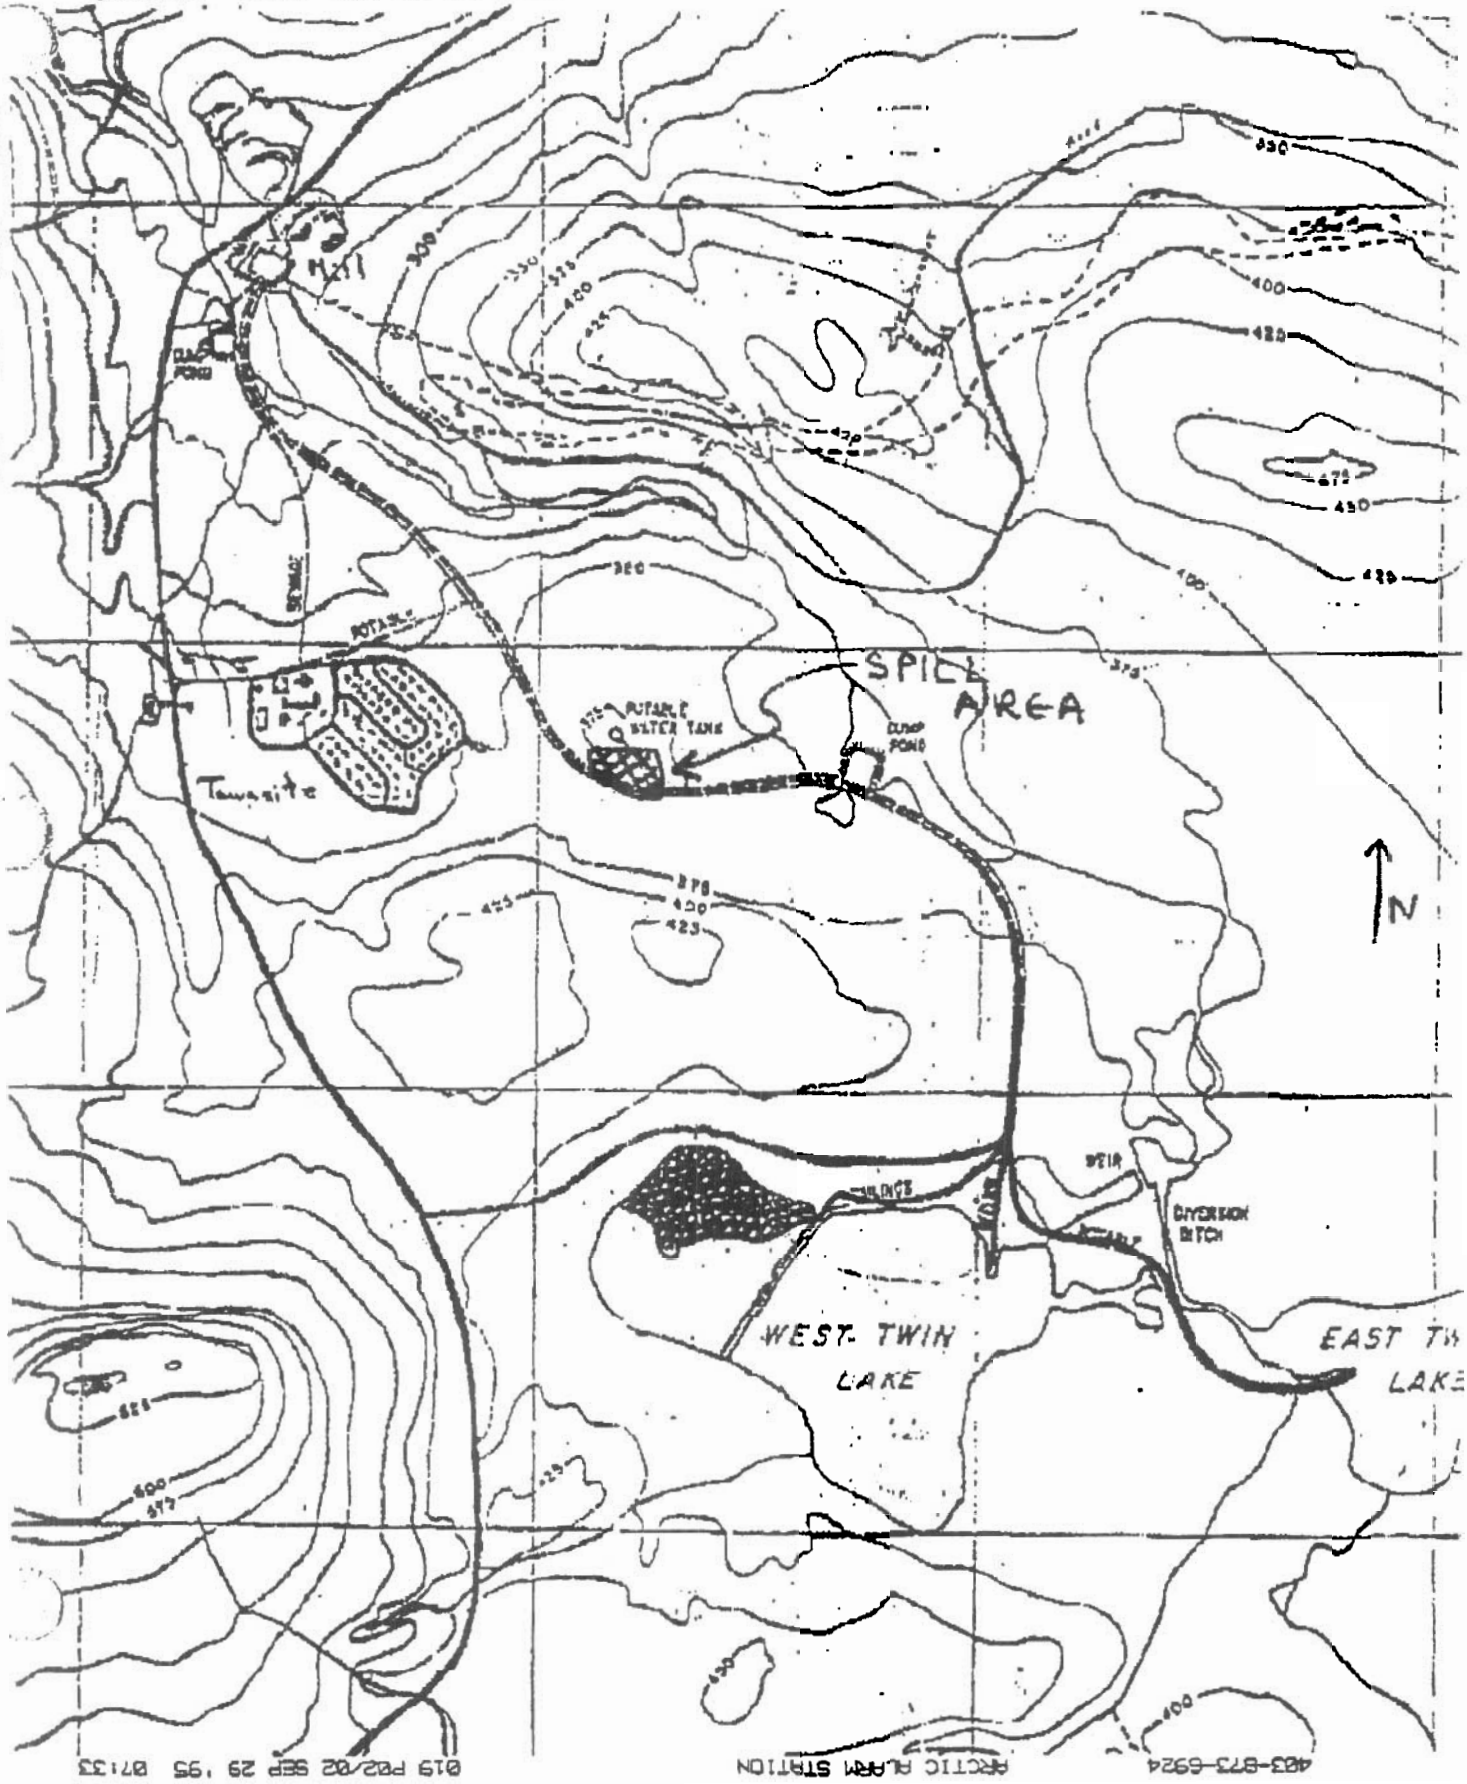
D Location and map coordinates (if known) and direction (if moving):
Nanisivik (attached plan)

F Product(s) spilled and estimated quantities (provide metric volume/weight if possible):
Mill tailings - 10 cubic meters

G Cause of spill:
Gasket failed at joint in tailings pipe

H Is spill terminated? ✓ yes / ☐ no	I If spill is continuing, give estimated rate:	J Is further spillage possible? ☐ yes / ✓ no	K Extent of contaminated area (in square metres if possible): 500 sq. metres

L Terrain affected (soil or surrounding [illegible]): Snow, rough terrain	M [illegible]: Natural depression

N Action, if any, taken or proposed to contain, recover, clean up or dispose of product(s) and contaminated materials:
Area will be scraped down with heavy equipment and contaminated material will be hauled to West Twin disposal area.

Q Comments and/or recommendations:
Area will be reinspected in the summer of 1996 after the snow cover leaves to determine if further remediation is required.
