Application for Water Licence Cancellation

APPLICATION FOR WATER LICENCE CANCELLATION

1. LICENCE NO: 1BR-BEA1015	2. EXPIRY DATE: May 1, 2015
3. NAME AND MAILING ADDRESS OF LICENSEE Natalie Plato Director, Lands and Contaminated Sites Aboriginal Affairs and Northern Development Canada PO Box 2200 Iqaluit NU X0A 0H0 Phone: 867-975-4730 Fax: 867-975-4736 e-mail: natalie.plato@aandc-aadnc.gc.ca	**4. ADDRESS OF CORPORATE OFFICE IN CANADA** (if applicable) N/A Phone: _____ Fax: _____ e-mail: _____

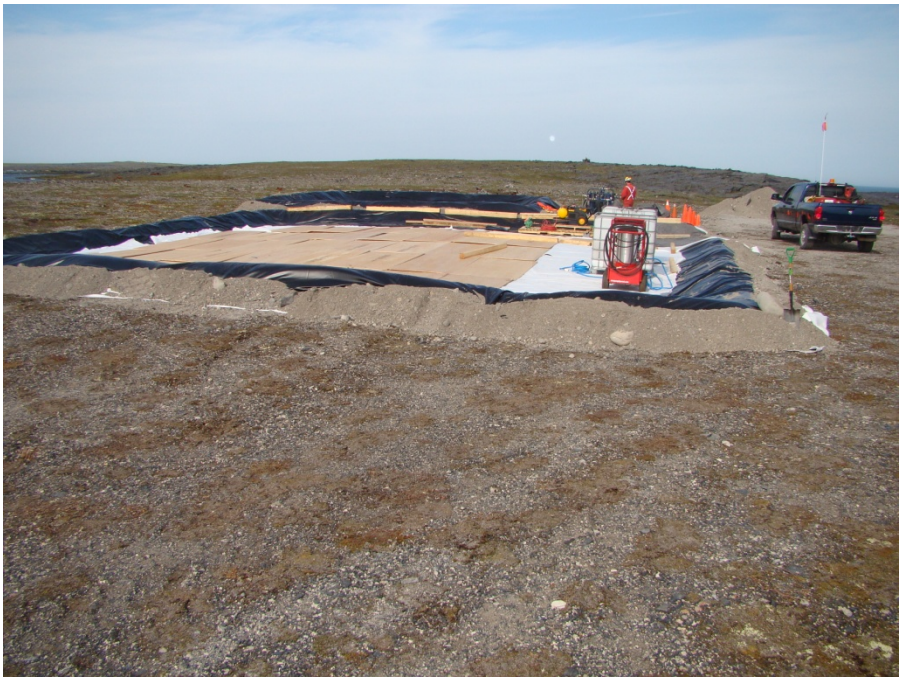
Photograph 25. Demolition of Crawler Dozer at the Beach Area ↑

Photograph 26. Material Processing Area (MPA) ↑

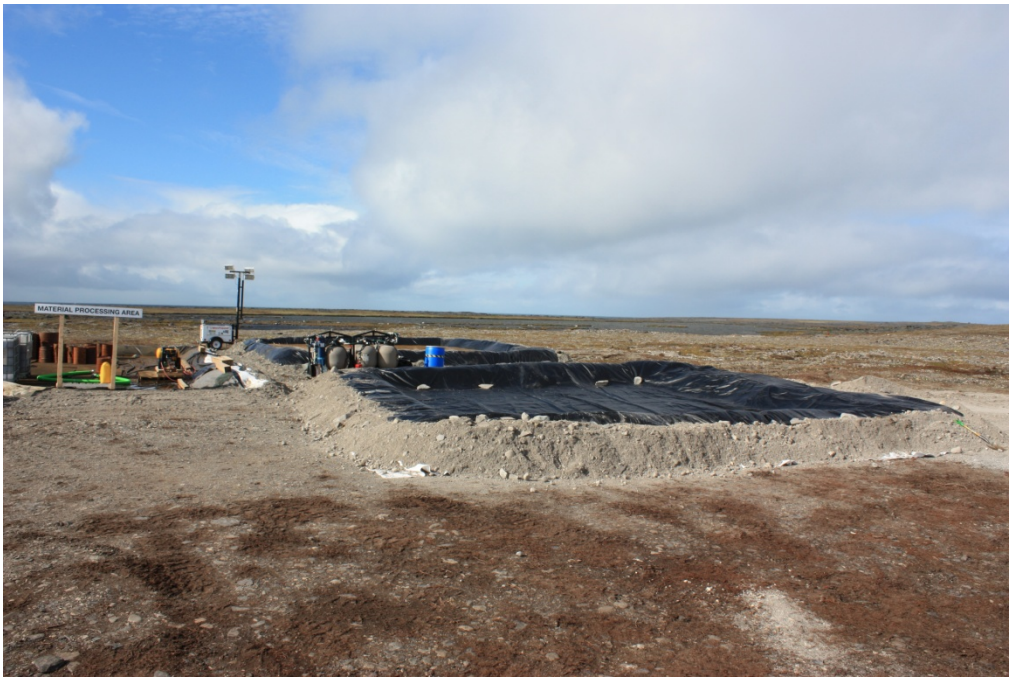
Photograph 27. Lagoon #1 at the MPA (held rinsate prior to treatment) ↑

Photograph 28. Lagoon #2 at the MPA (held rinsate after treatment) ↑

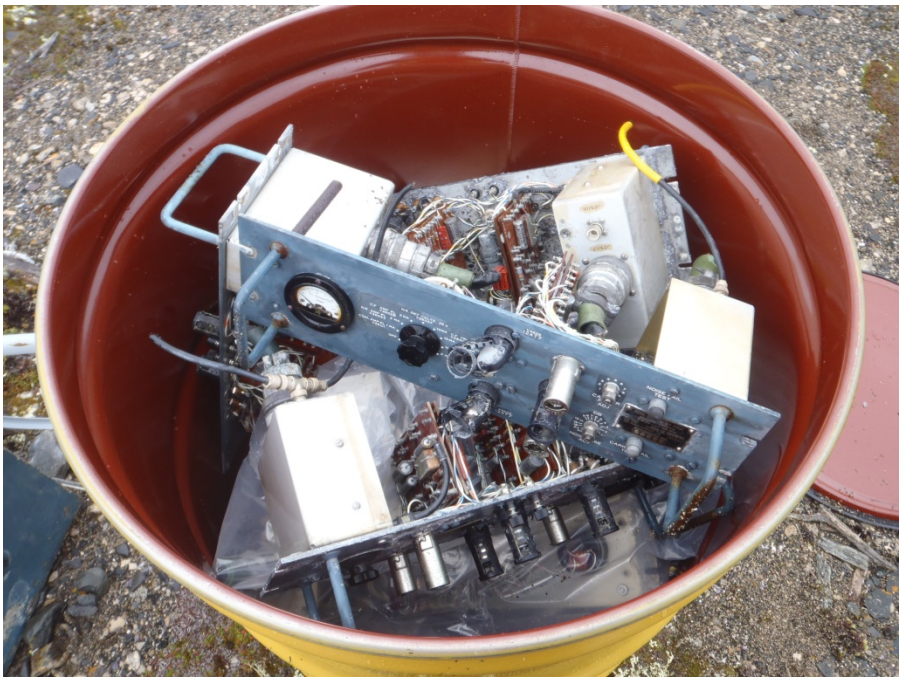
Photograph 37. Electrical Components from the Beach Area ↑

Photograph 38. Containerization of Electrical Components ↑

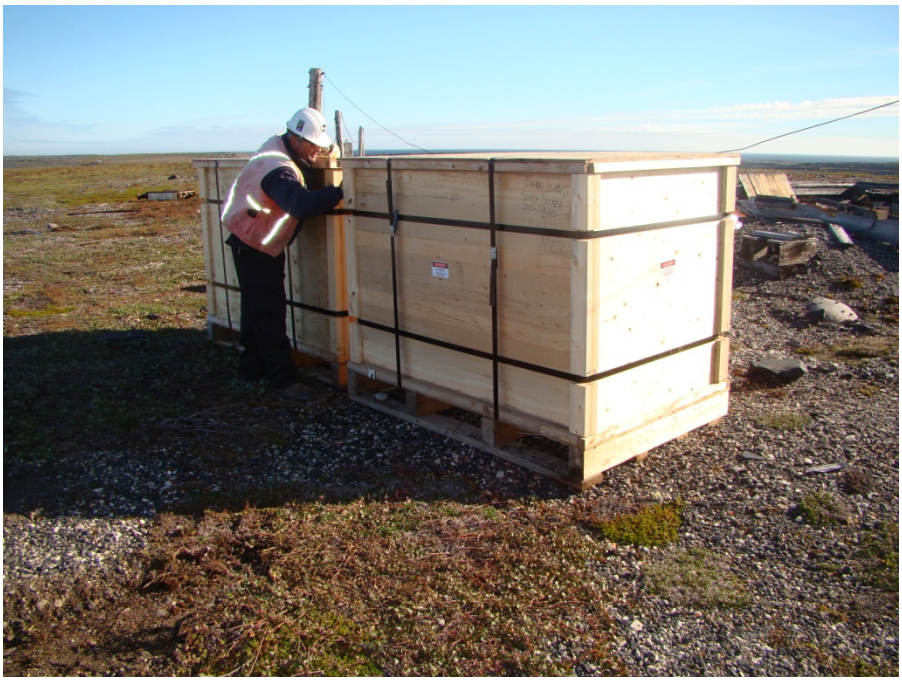
Photograph 41. Containerization of Zinc Piping ↑

Photograph 42. Sea-Can Prepared for Off-Site Shipment ↑

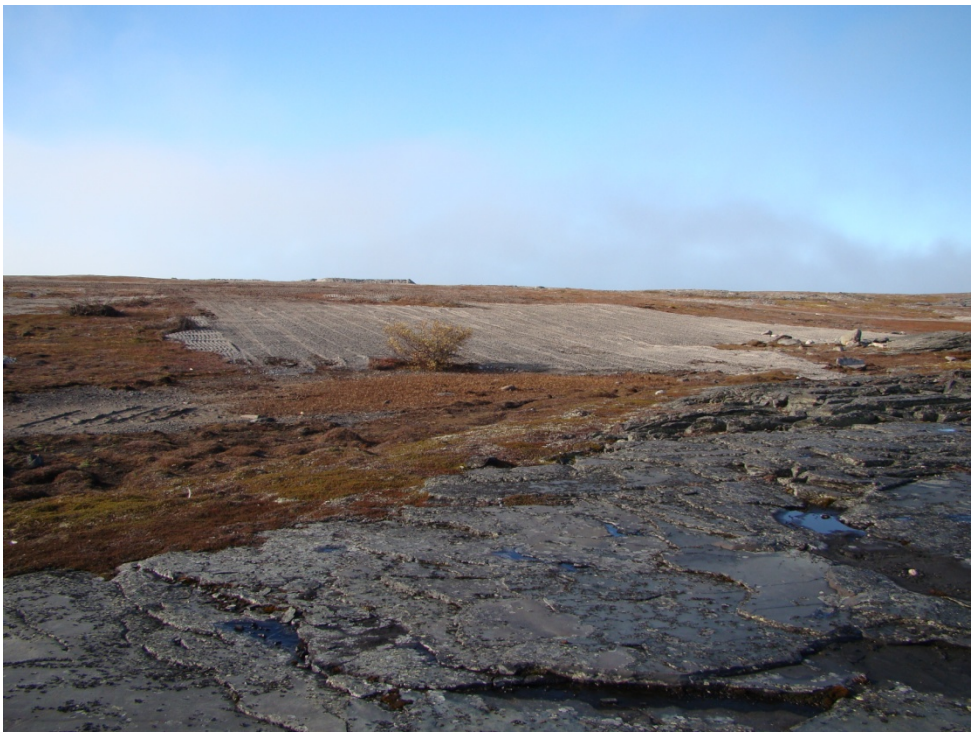
Photograph 23. Area 3 – Barrel Cache and North Landfill Area (During) ↑

Photograph 24. Area 3 – Barrel Cache and North Landfill Area (After) ↑

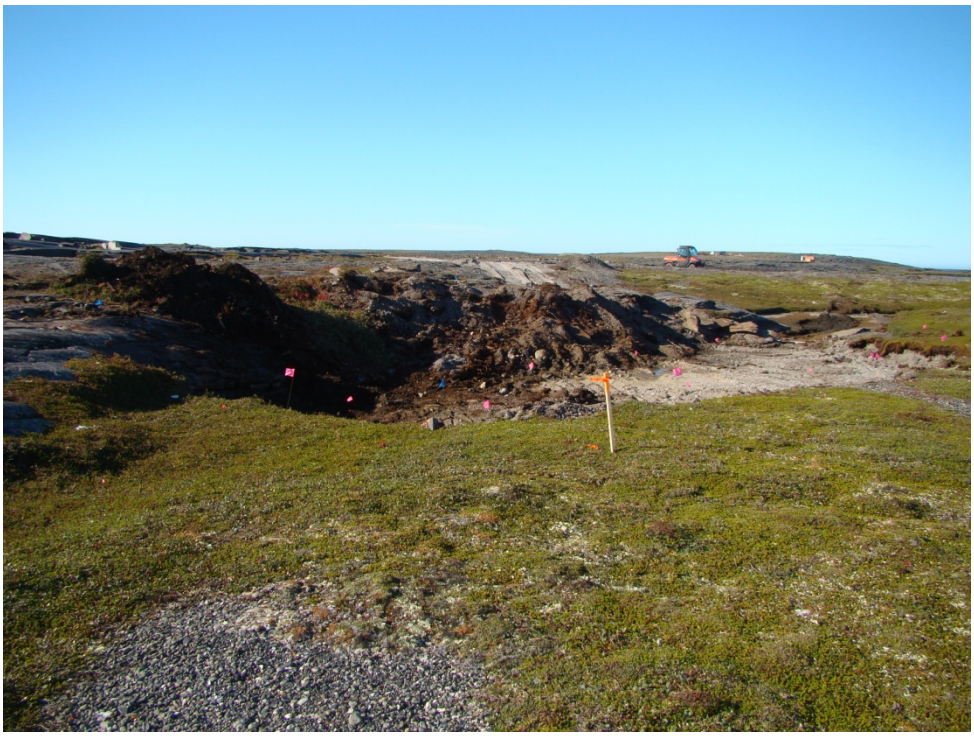
Photograph 37. Area 4 – Existing Landfill Area (Before) ↑

Photograph 38. Area 4 – Existing Landfill Area (During) ↑

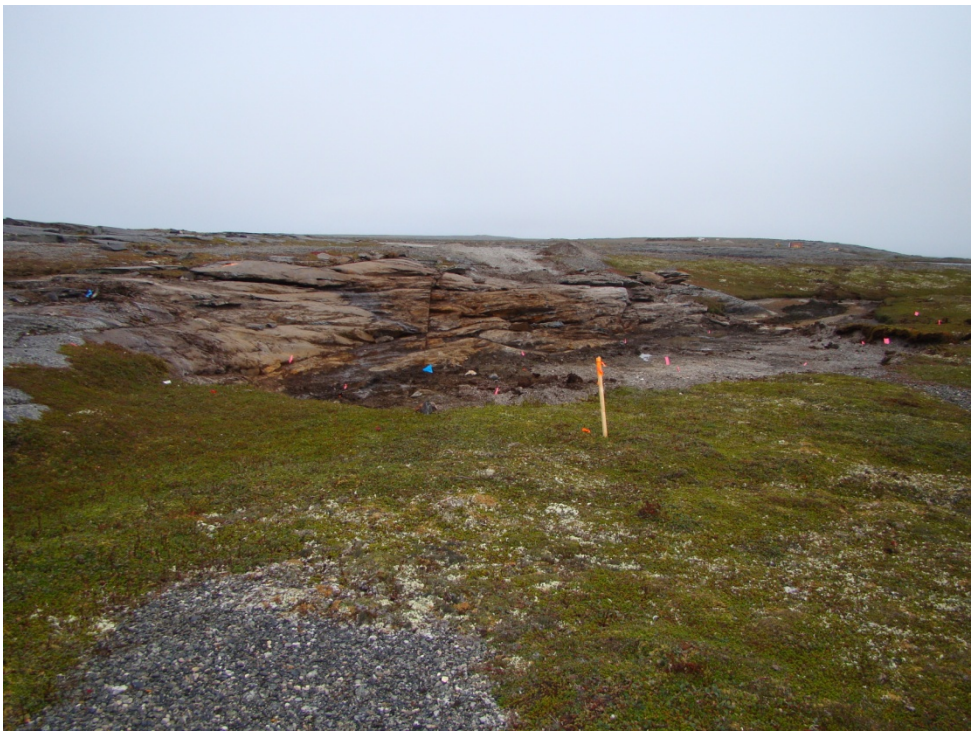
Photograph 39. Area 4 – Existing Landfill Area (During) ↑

Photograph 40. Area 4 – Existing Landfill Area (After) ↑

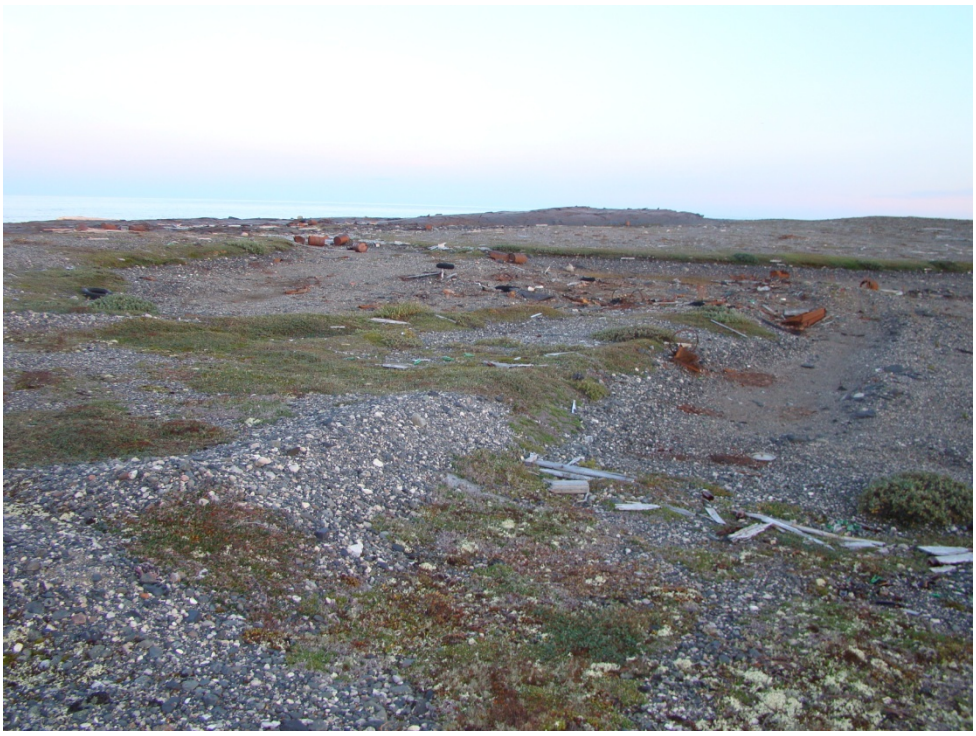
Photograph 46. Area 5 – Airstrip Area – View 2 (After) ↑

Photograph 47. Unknown Debris Area (Before) ↑
