Water Licence Inspection Report

Authorization	Representative
Contaminated Sites Nunavut	**Dele Morakinyo**
Authorization No. / Expiry	**Representative's Title**
1BR-BER2527/August 05, 2027	**Project Manager**
Inspection Date	**Inspector**
August 02, 2026	**Isaiah James Bolt**

N2025U0012

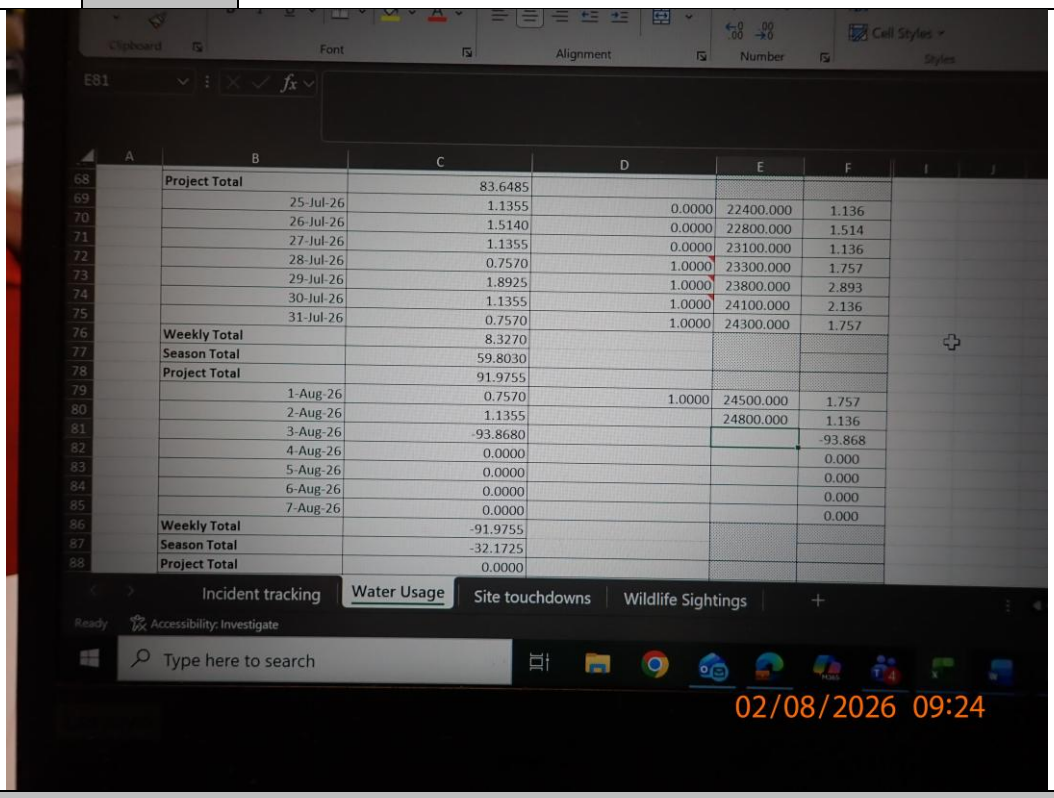
Photo #	6	Coordinates:

5. Camp water log was observed (Photo #6). Water is logged in m^3. Camp is well within their $6m^3$ per day threshold.
6. No grease trap was installed on the kitchen sink. (Photo#7). Grease trap was installed after inspection.

Water Log, Column C shows the water volume in m^3 Camp is well within $6m^3$ Per day.
