Defence Construction Canada

The Collection of Landfill Monitoring Data at the CAM-4 Kugaaruk Site – 2008 DRAFT Report

October, 2008

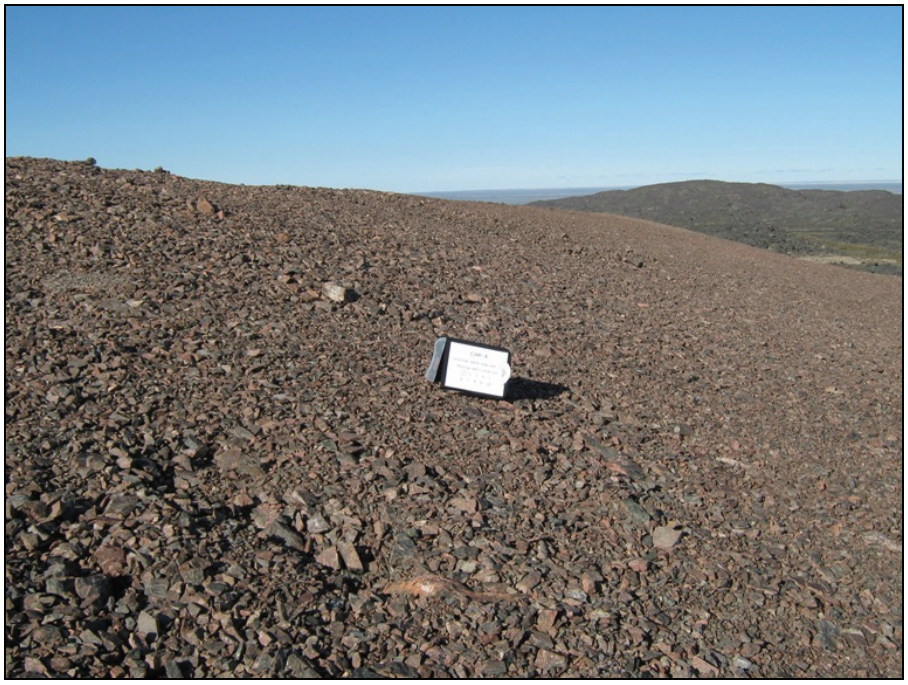
Photograph SNH-1A. Southwest corner at the toe, facing northeast.___ ↑

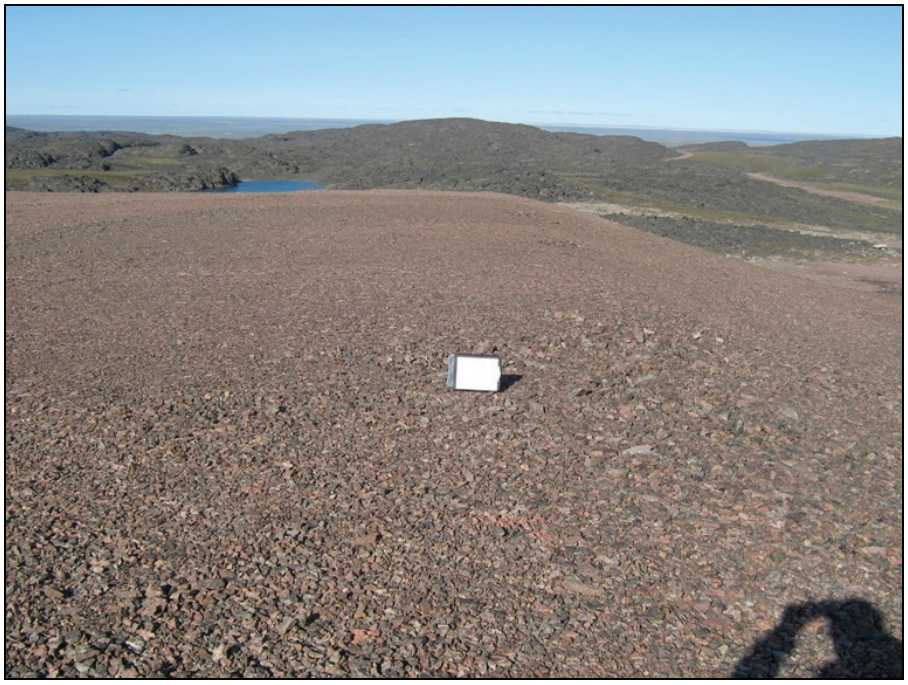
Photograph SNH-2A. Southwest corner at the crest facing northeast. Some tire tracks from a vehicle that tried to drive up onto the landfill near clipboard.___ ↑

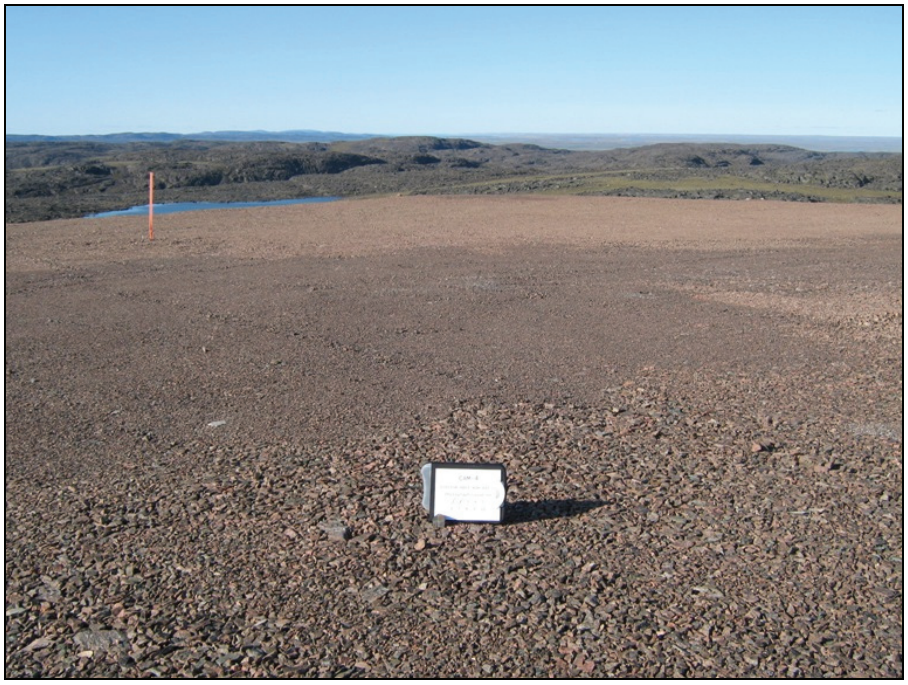
Photograph SNH-3A. Facing northeast over landfill surface.___ ↑

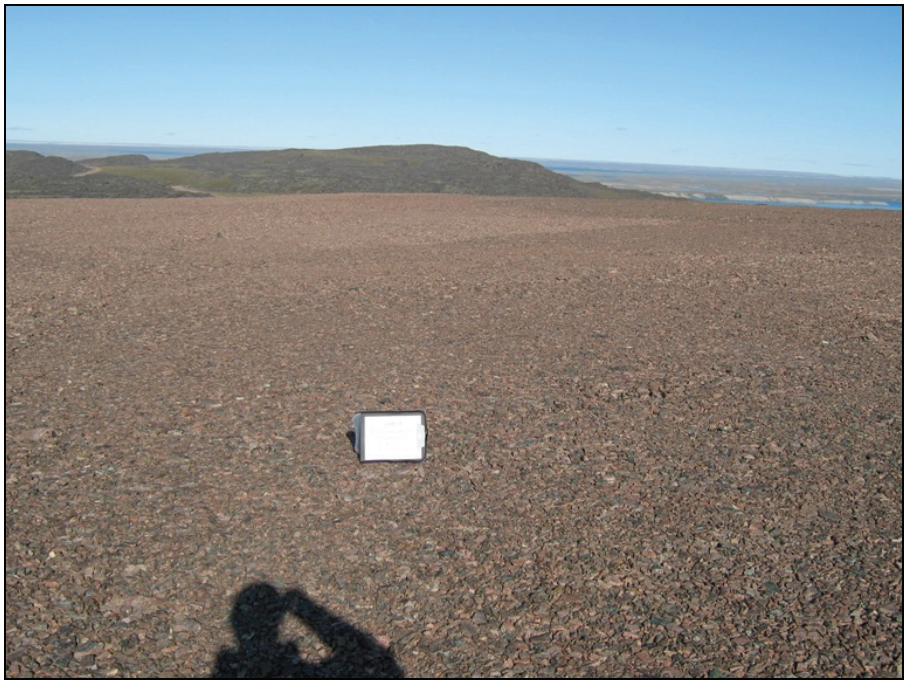
Photograph SNH-3B. Facing southeast over landfill top.___ ↑

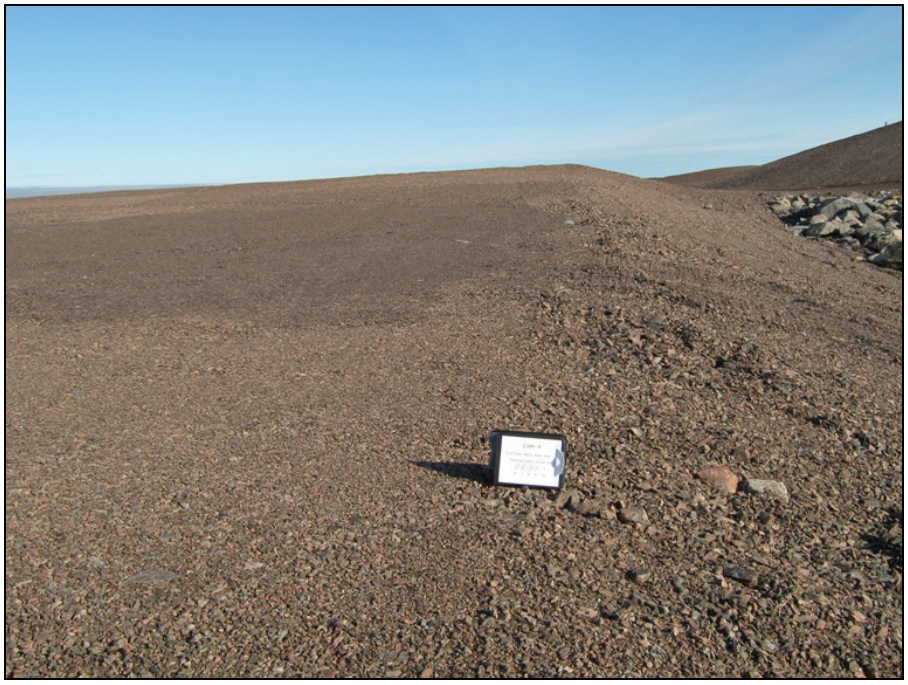
Photograph SNH-4A. Northwest corner crest, facing south.___ ↑

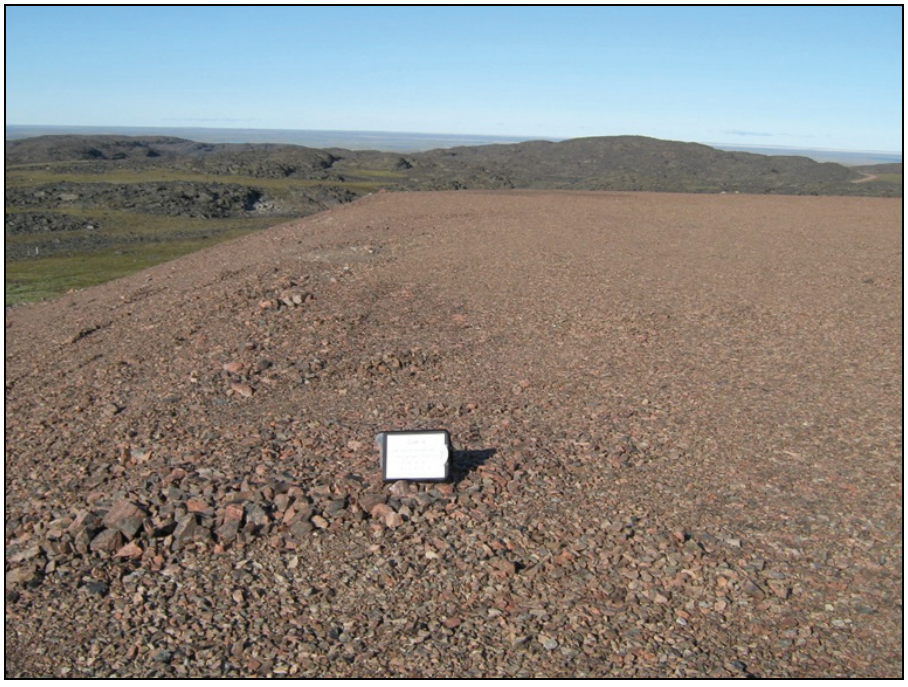
Photograph SNH-4B. Northwest corner crest, facing east___ ↑

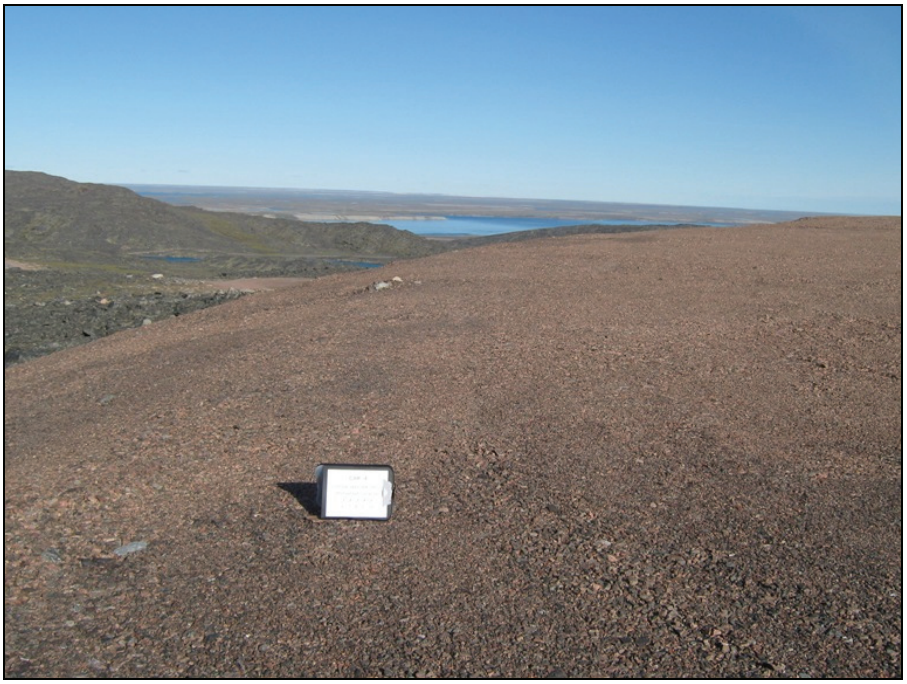
Photograph SNH-6A. Northeast corner facing south.___ ↑

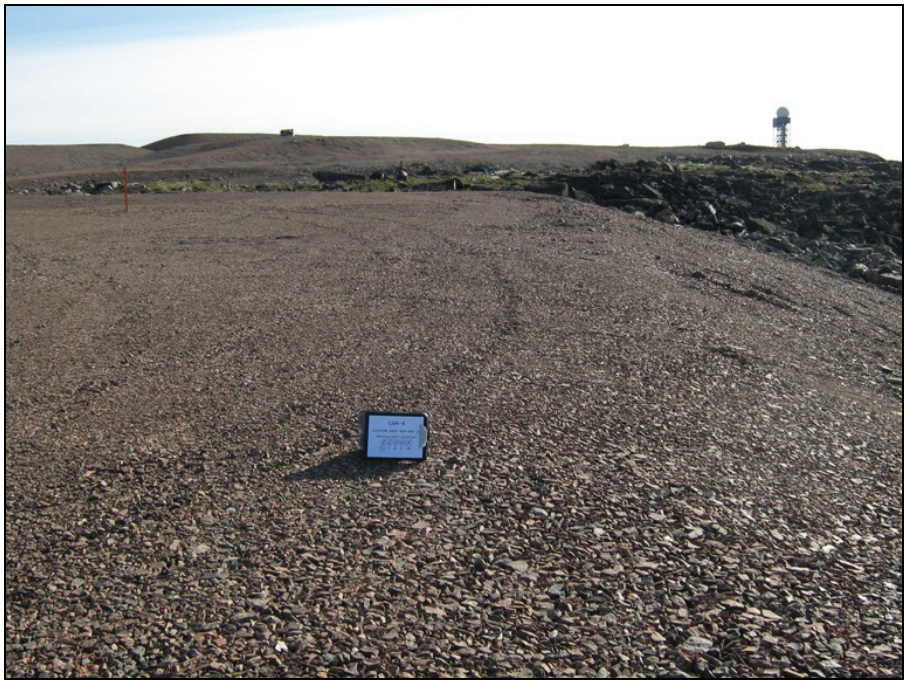
Photograph SNH-6B. Northeast corner facing west.___ ↑

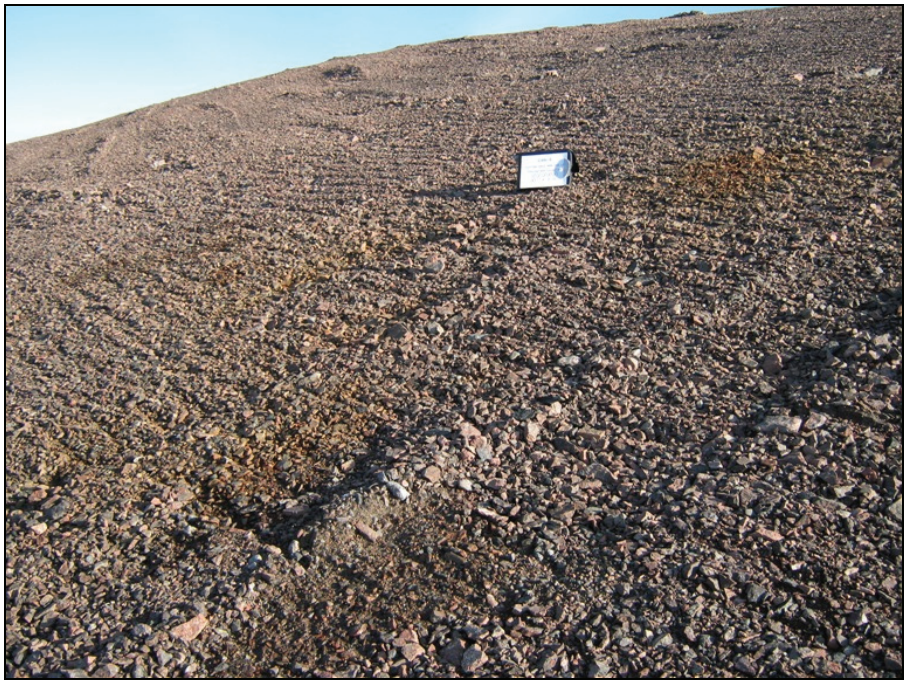
Minor erosion gullies were observed on the east slope that appear to be self-armouring (Photo SNH-8 in Appendix A2). An area of minor seepage and orange staining was observed on the lower half of the northeast slope (Photos SNH-7A and 7B in Appendix A2). Some minor drainage was observed along the road at the south toe (Photo SNH-10 in Appendix A2). No issues of concern that require immediate attention were identified.

Photograph SNH-7A. Facing slope. Some seepage and orange staining over 10m x 10m area on lower half of east slope, towards the northeast corner toe.___ ↑

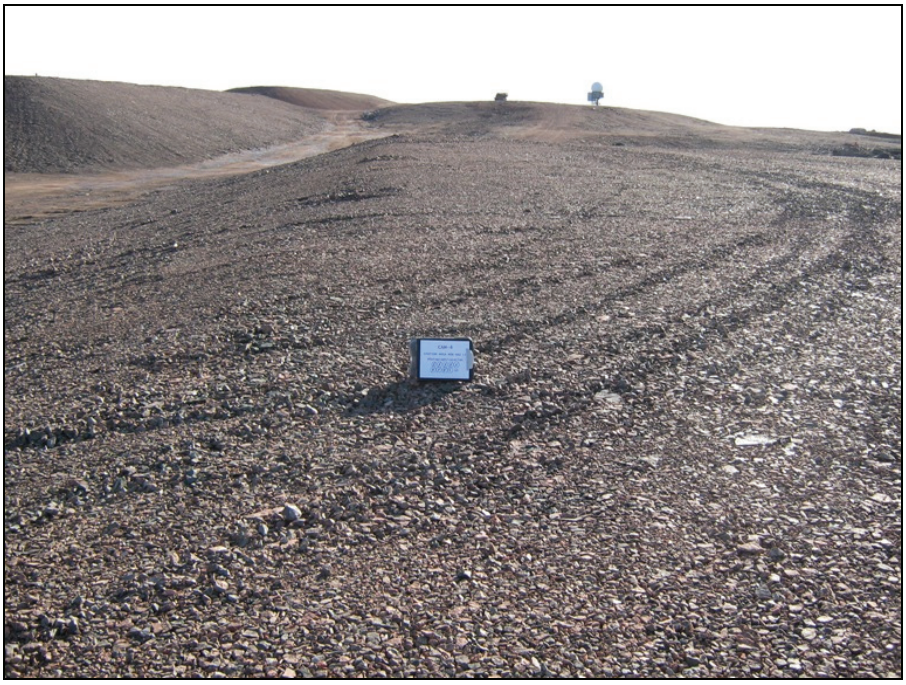
Photograph SNH-9A. Facing west along south crest.___ ↑

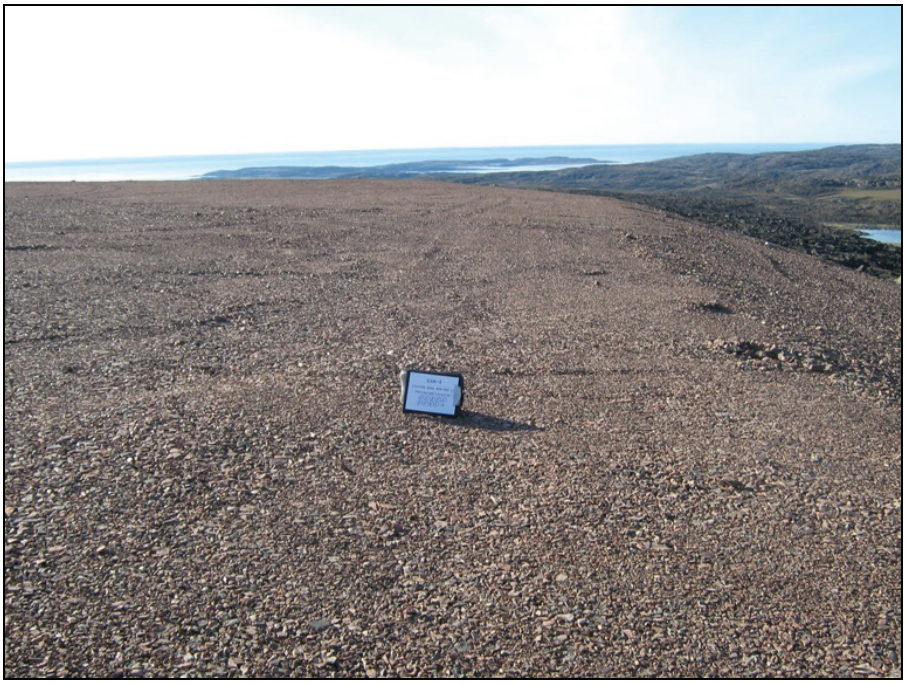
Photograph SNH-9B. Facing north along east crest. Some tire tracks but no damage.___ ↑

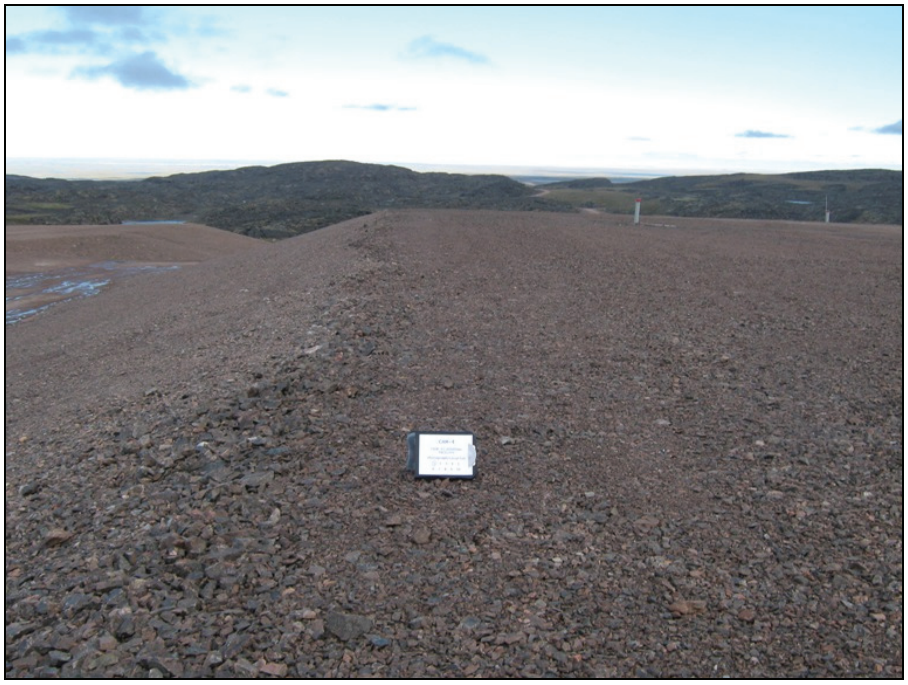
Photograph TII-1A. Northwest corner of landfill facing east along crest.___ ↑

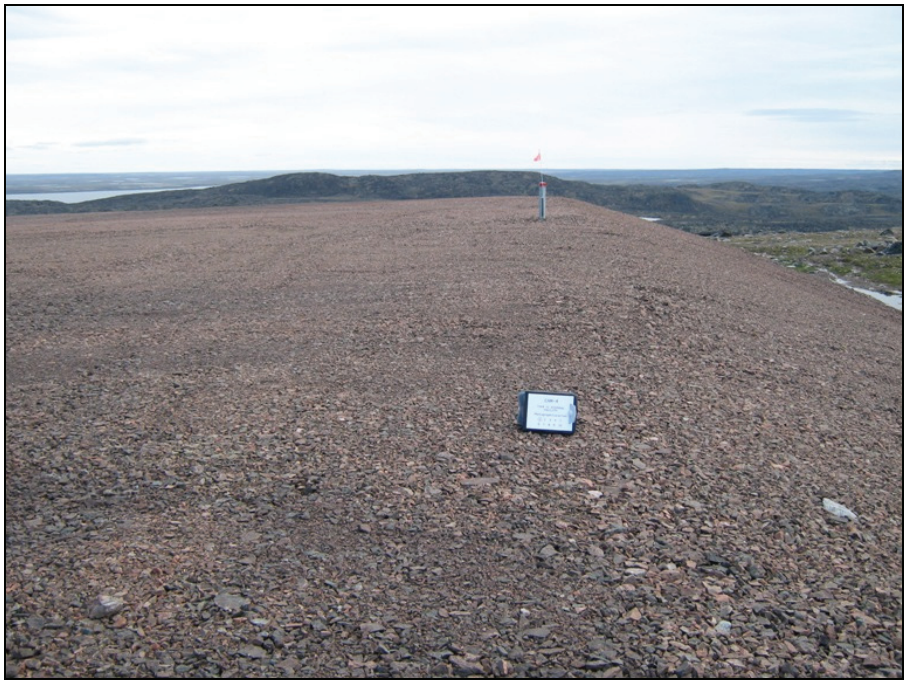
Photograph TII-1B. Northwest corner of landfill facing south along crest.___ ↑

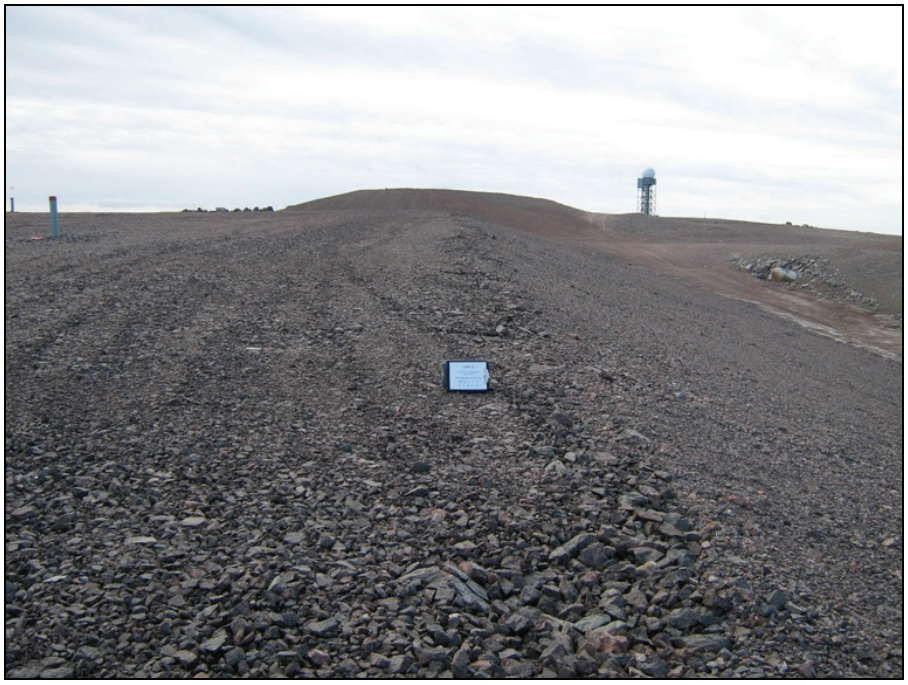
Photograph TII-2A. Northeast corner of landfill facing west.___ ↑

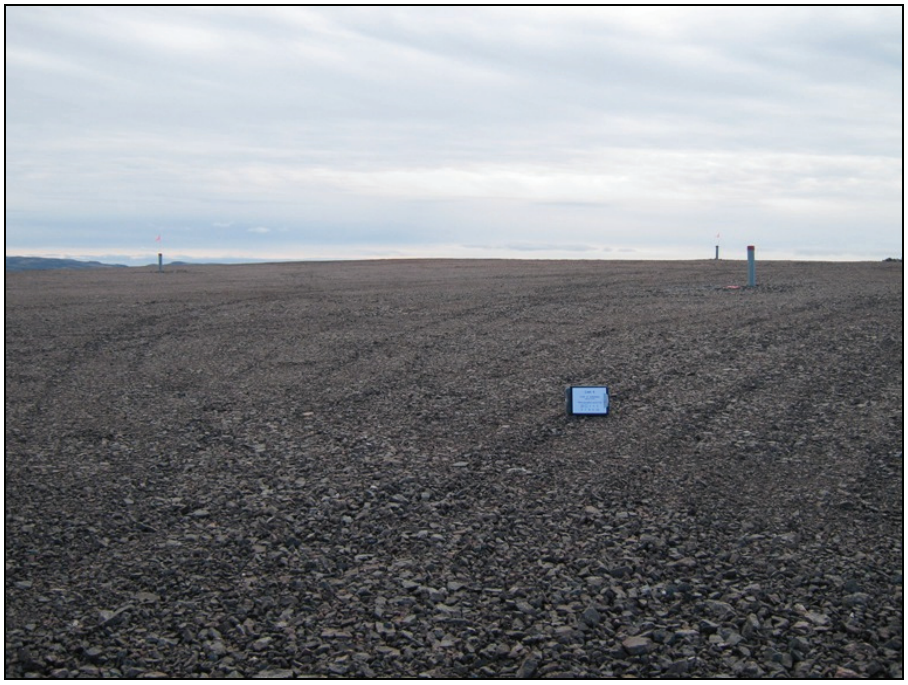
Photograph TII-2B. Northeast corner of landfill facing southwest.___ ↑

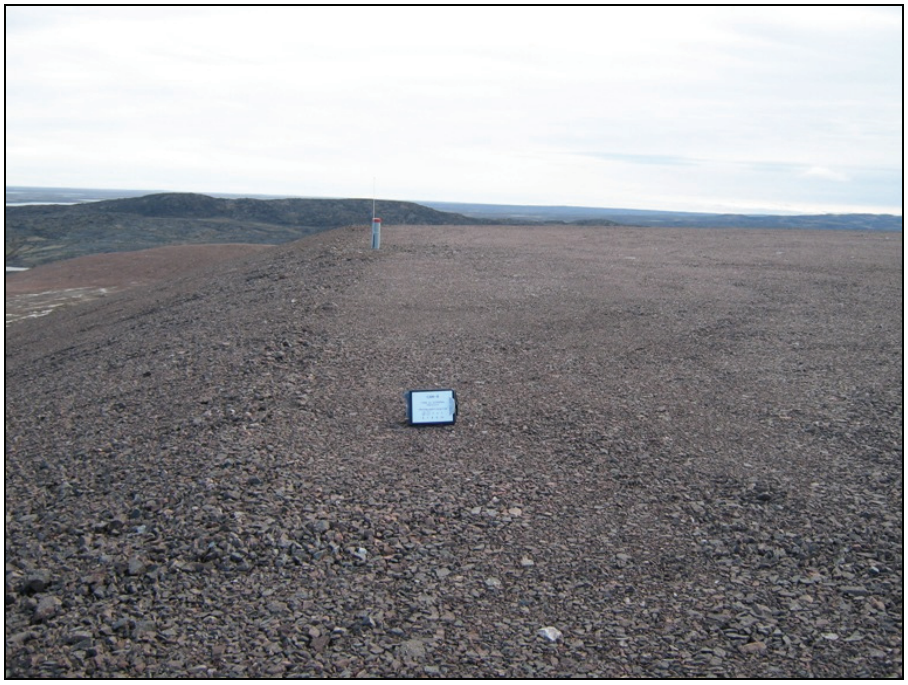
Photograph TII-2C. Northeast corner of landfill facing south.___ ↑

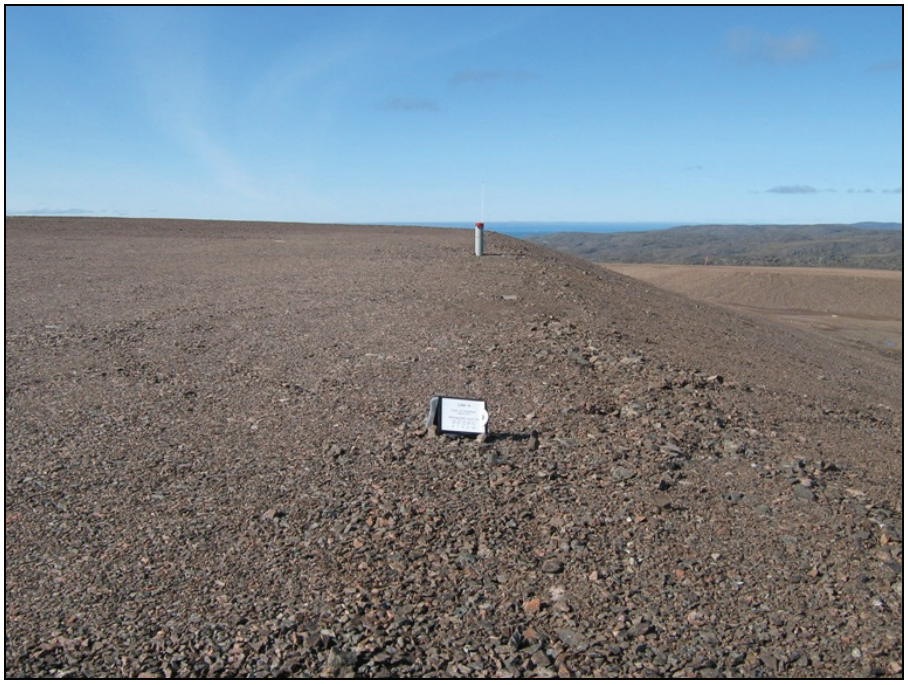
Photograph TII-5A. Southeast crest facing north.___ ↑

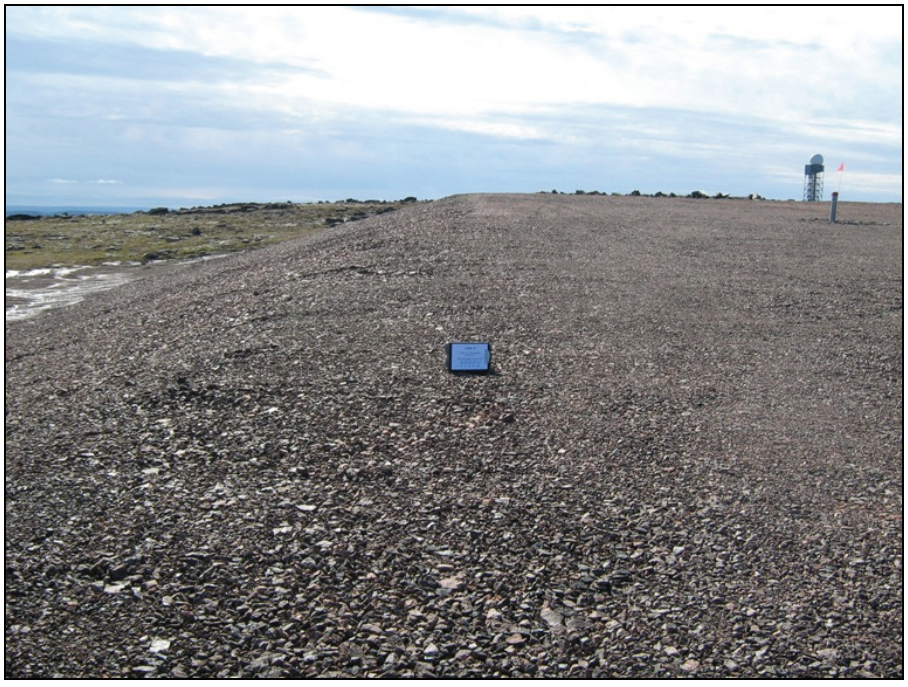
Photograph TII-5B. Southeast crest facing west. Some coarse rockfill along crest edge but there does not appear to be tension cracks.___ ↑

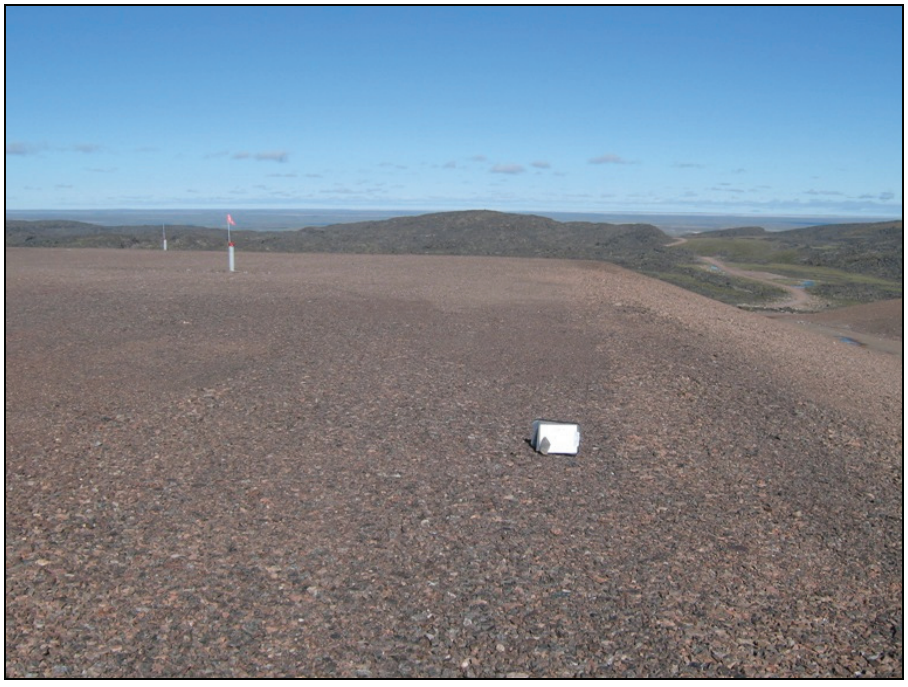
Photograph TII-9A. Facing east along crest from the southwest corner of the landfill.___ ↑

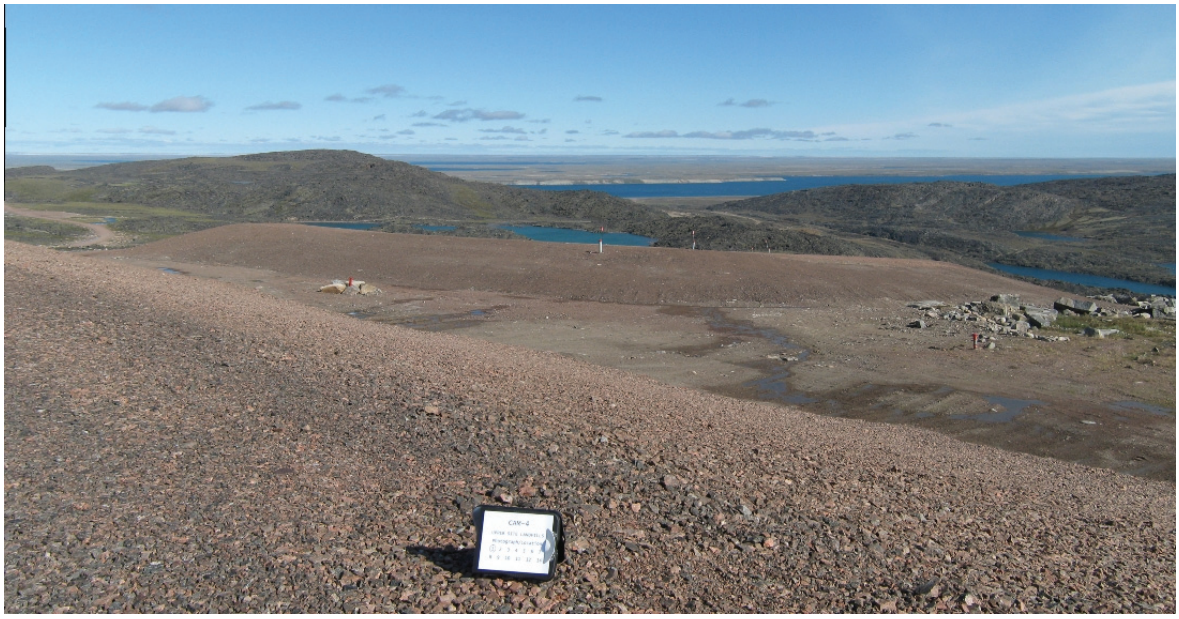
Photograph USL-1. Panoramic photo facing southeast towards west slope of Upper Site Landfill.___ ↑

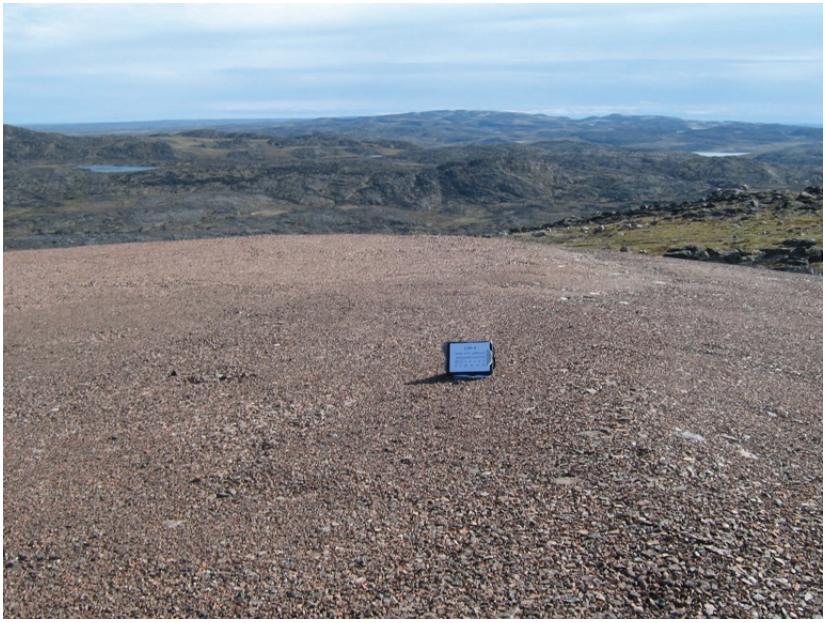
Photograph USL-2A. Facing southeast along crest.___ ↑

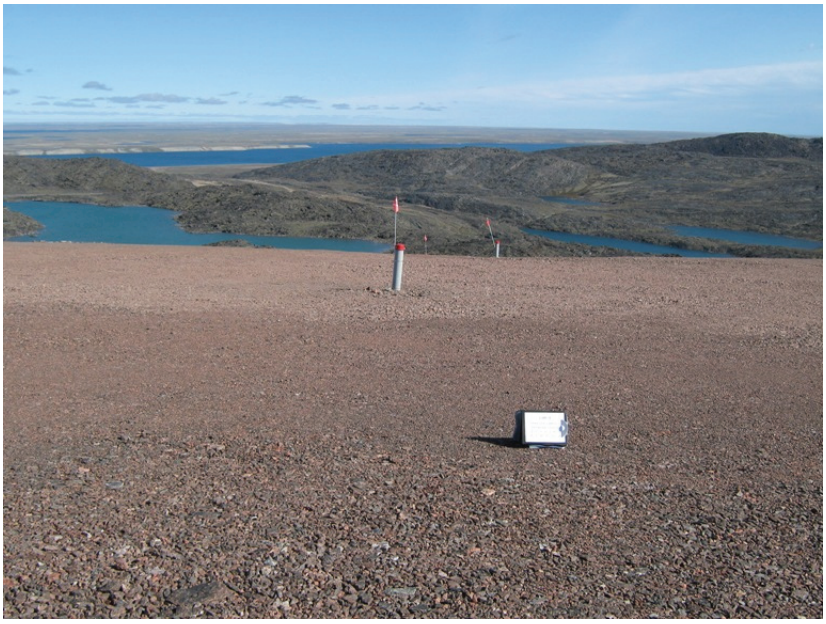
Photograph USL-2B. Facing east along line of thermistors.___ ↑

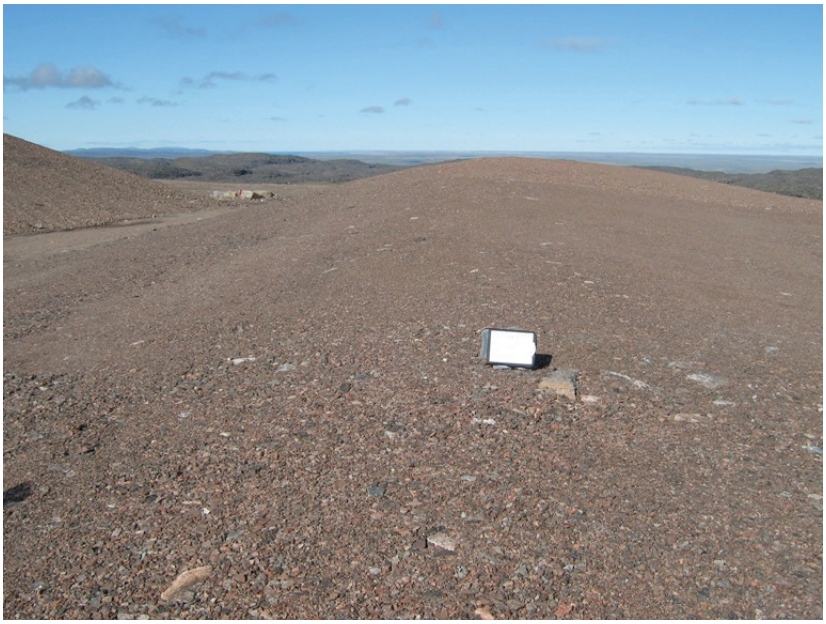
Photograph USL-2C. Facing north along west crest.___ ↑

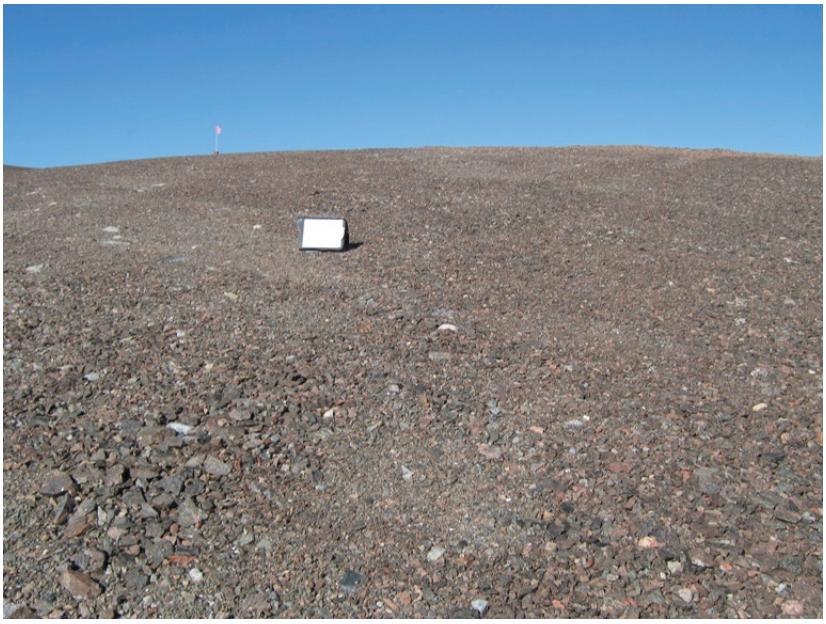
Photograph USL-3. Facing south slope.___ ↑

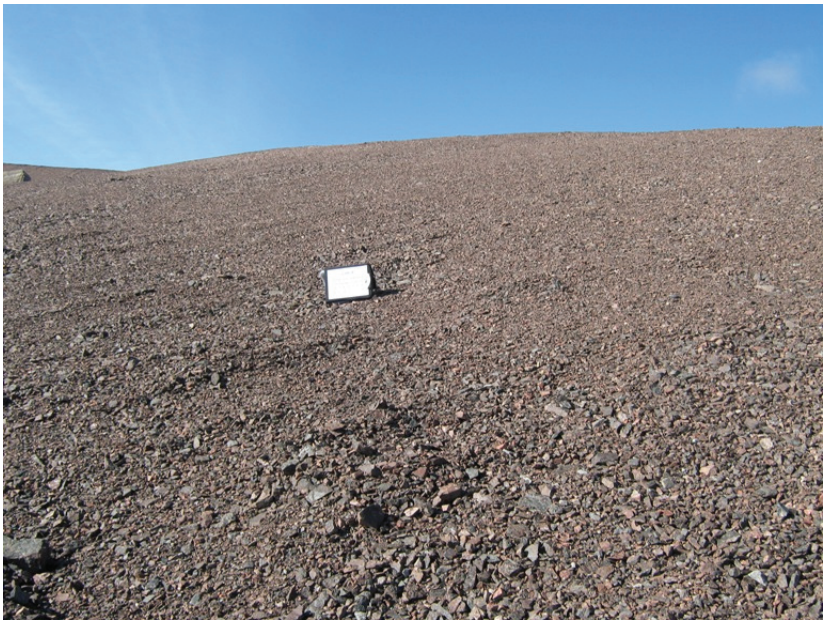
Photograph USL-4. Facing west along south slope.___ ↑

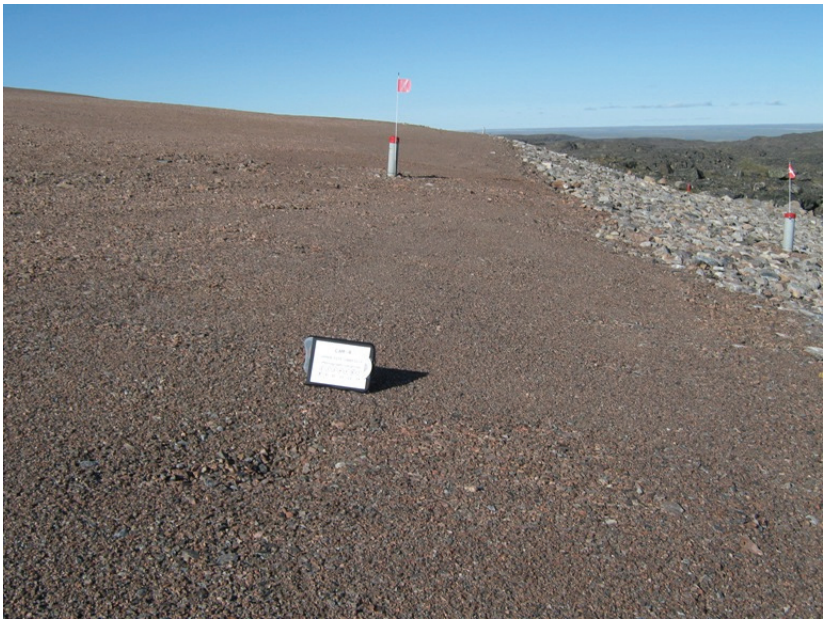
Photograph USL-9A. Facing north along crest from southeast corner.___ ↑

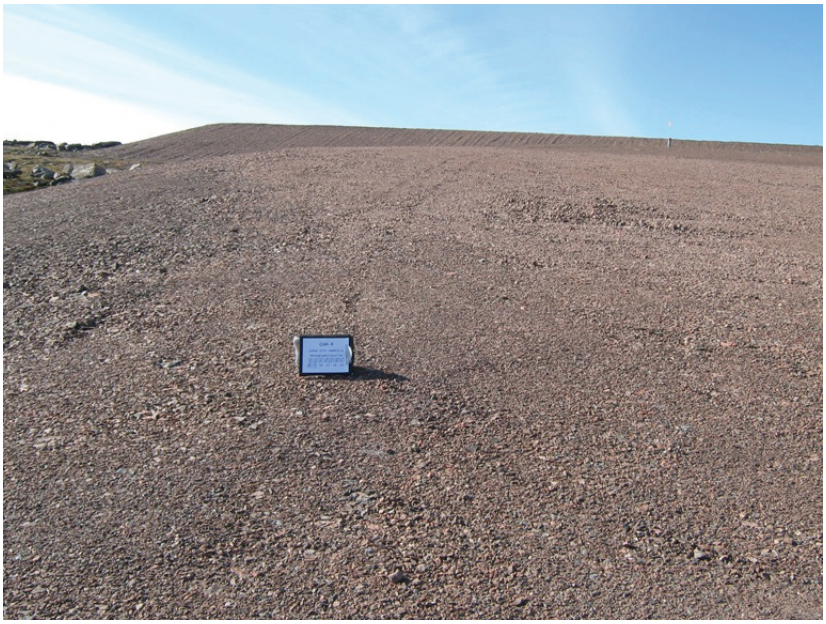
Photograph USL-9B. Facing west along south crest from the southeast corner.___ ↑

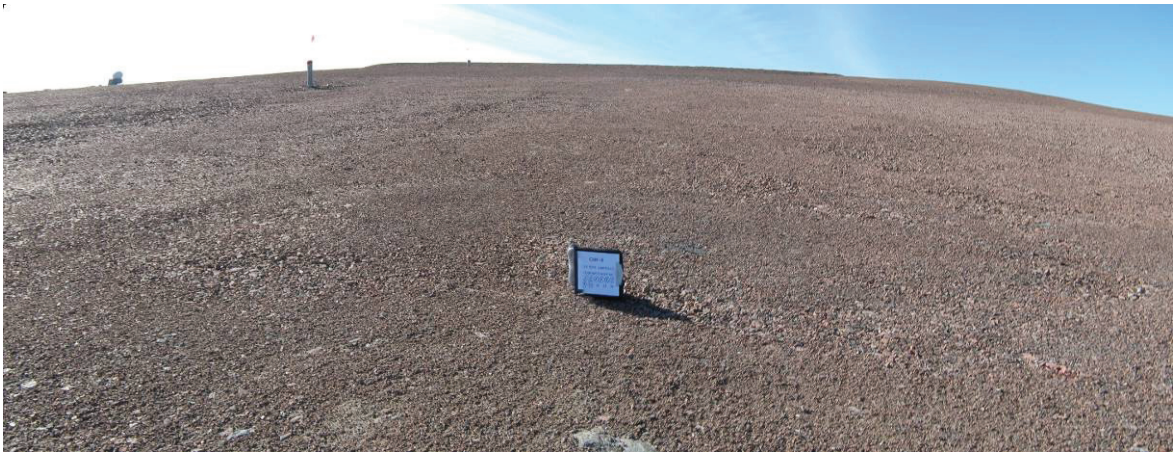
Photograph USL-10A. Panoramic photo of the top of the landfill facing west.___ ↑

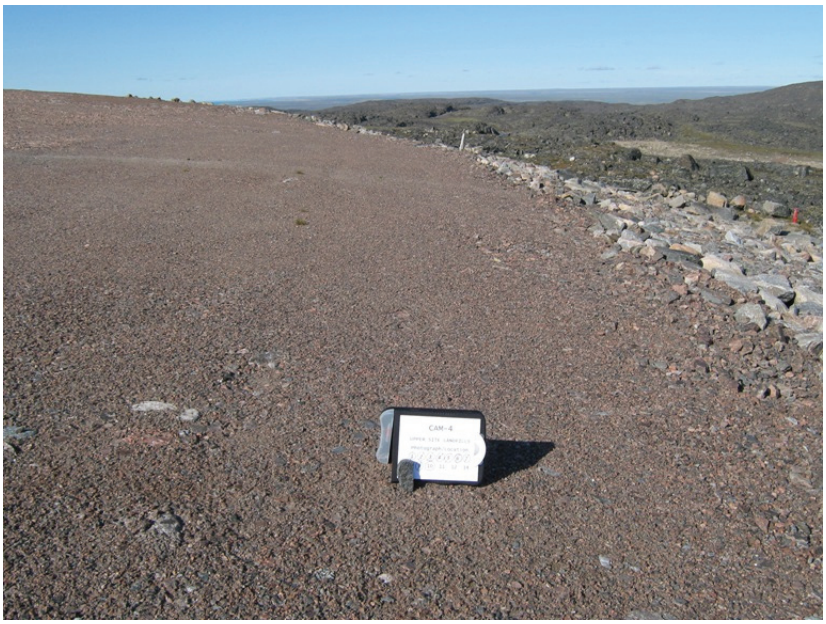
Photograph USL-10B. Facing north along crest.___ ↑

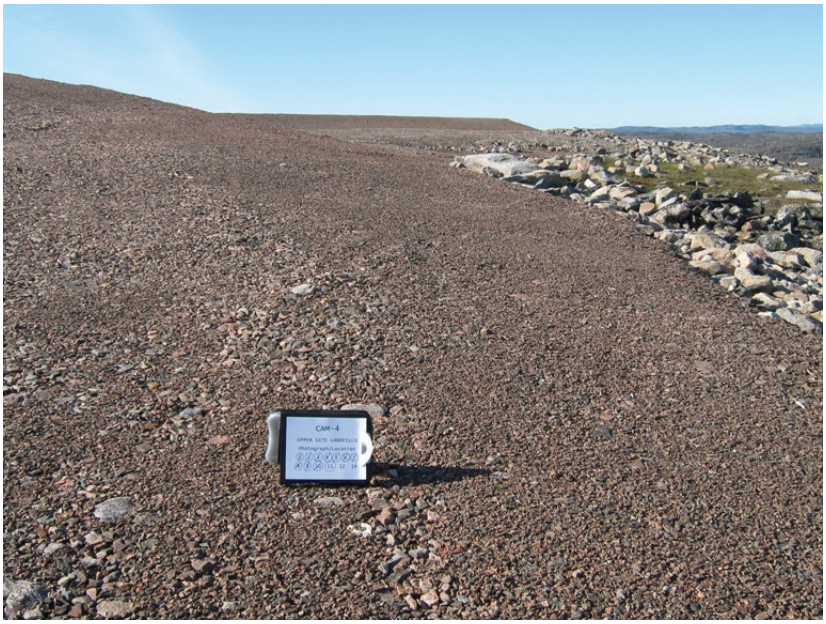
Photograph USL-11B. Facing northwest.___ ↑

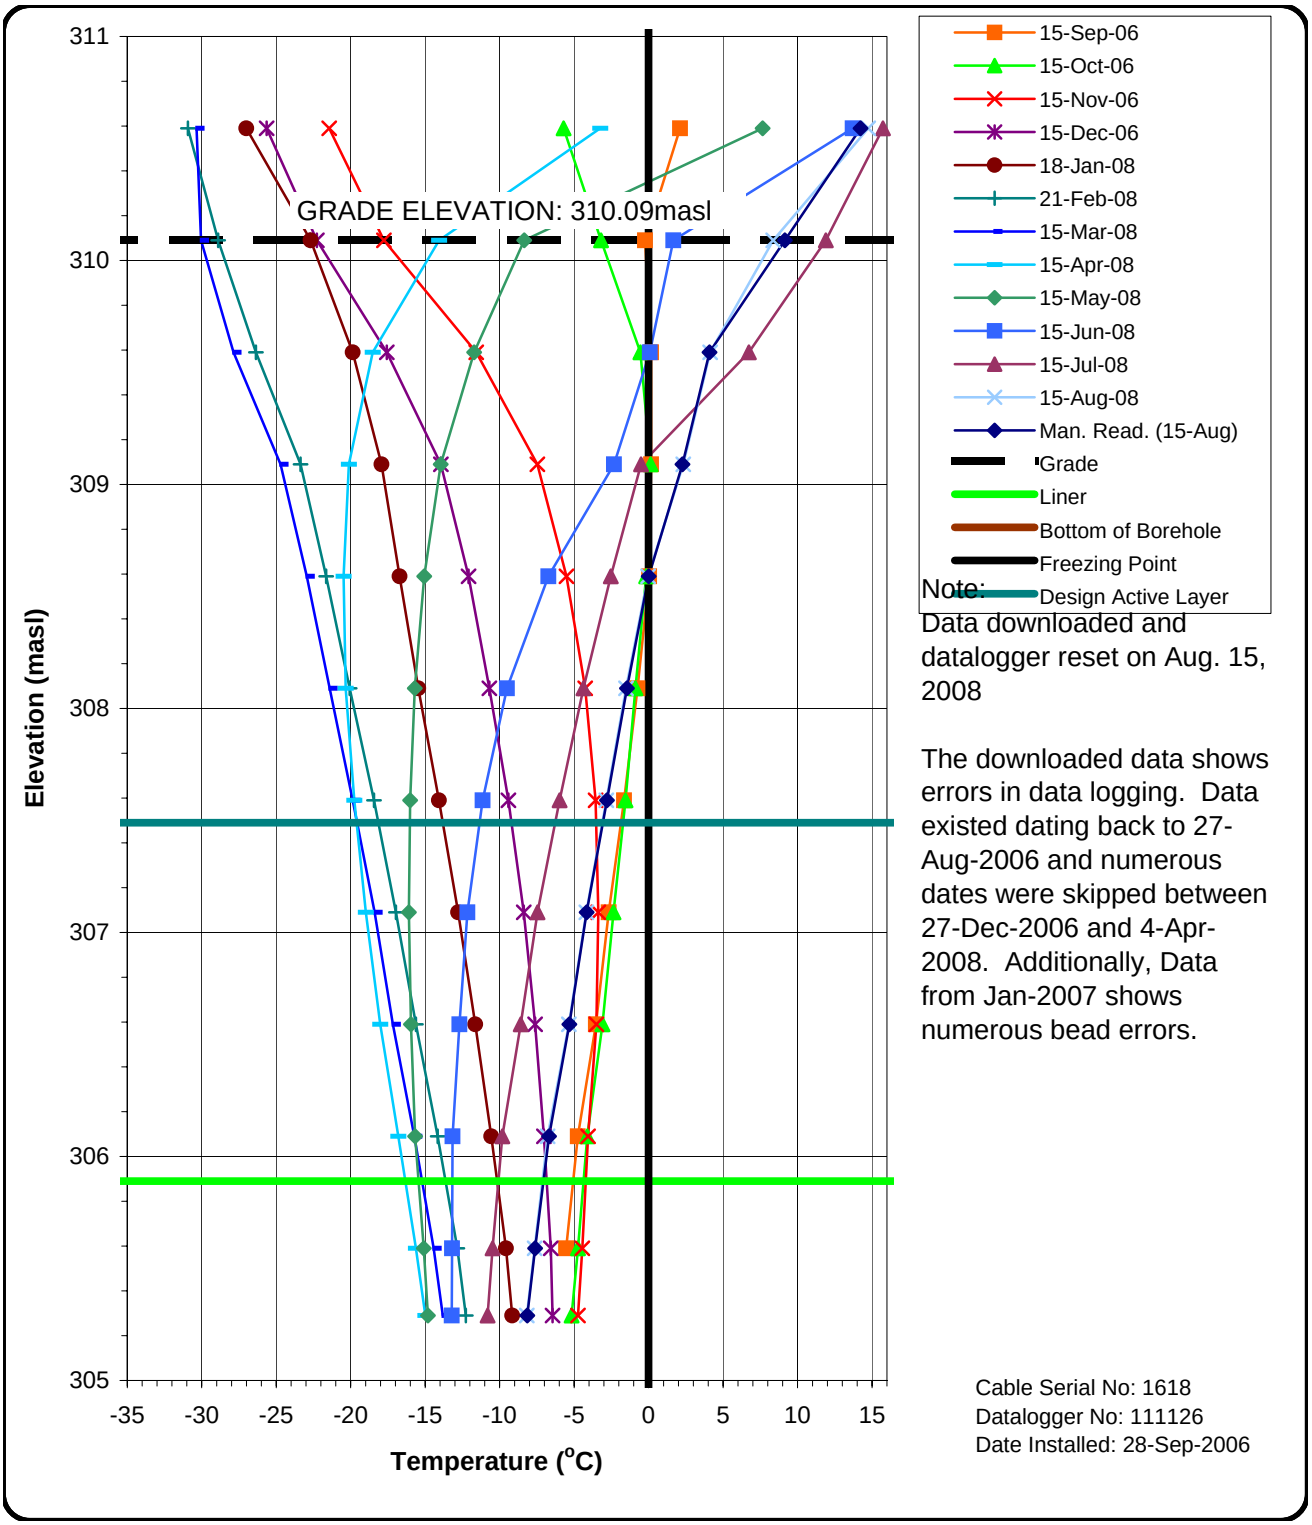
Graph C-3
Ground Temperature Profile
Upper Site Landfill
Vertical GTC VT-3

The downloaded data shows errors in data logging. Data existed dating back to 27-Aug-2006 and numerous dates were skipped between 27-Dec-2006 and 4-Apr-2008. Additionally, Data from Jan-2007 shows numerous bead errors.

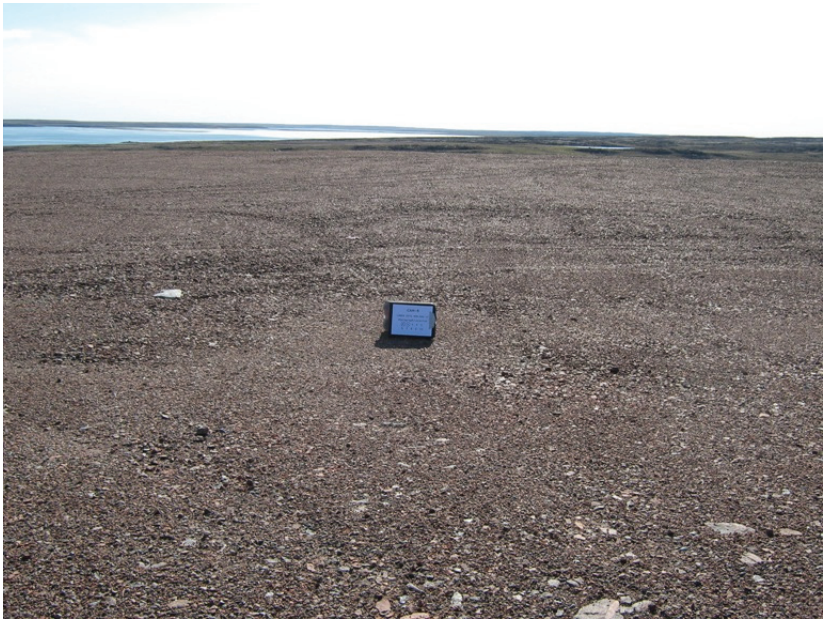
Photograph LNH-2C. Top of the landfill facing south from the centre of the north crest.___ ↑

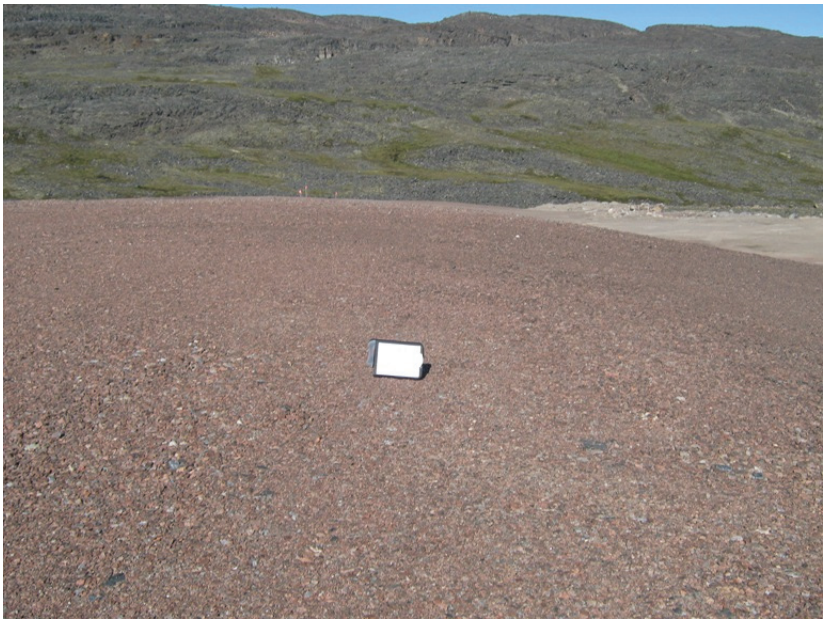
Photograph LNH-3A. Facing north from the centre of the east crest.___ ↑

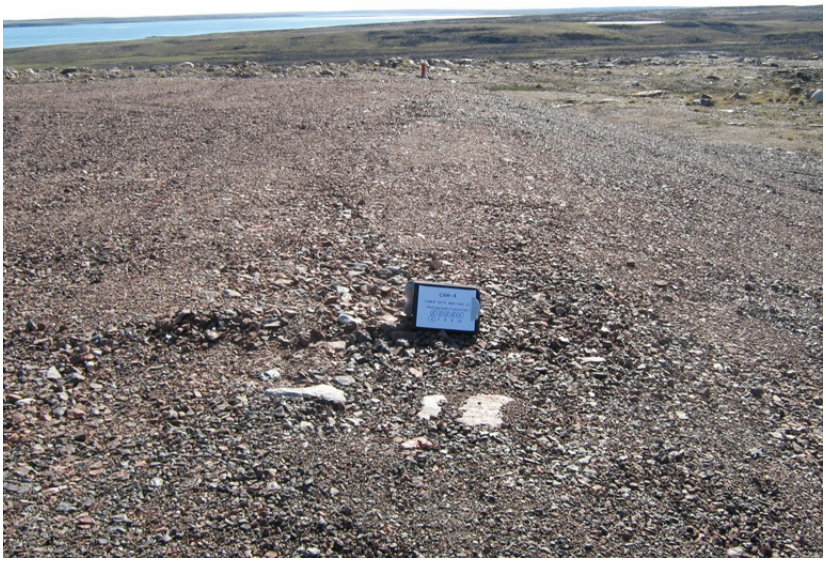
Photograph LNH-6B. Facing south along the crest from the centre of the west crest.___ ↑

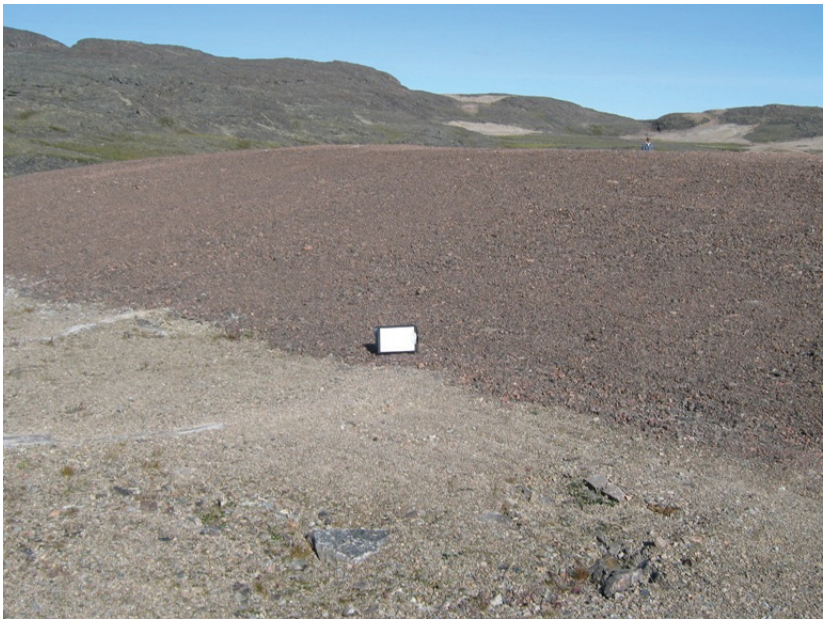
Photograph LNH-7A. Facing northeast towards the west slope.___ ↑

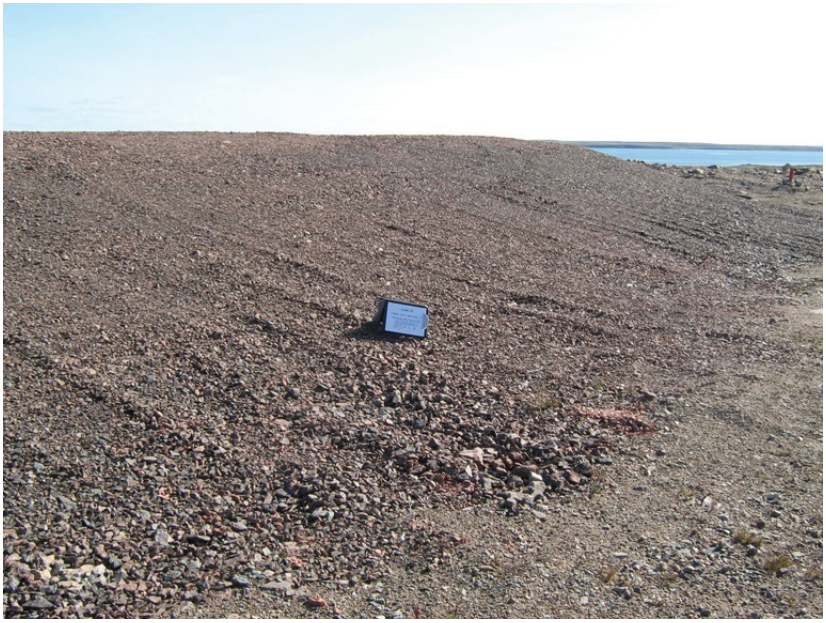
Photograph LNH-7B. Facing southeast towards the west slope.___ ↑
