Defence Construction Canada

The Collection of Landfill Monitoring Data at the CAM-4 Kugaaruk Site – 2008 DRAFT Report

October, 2008

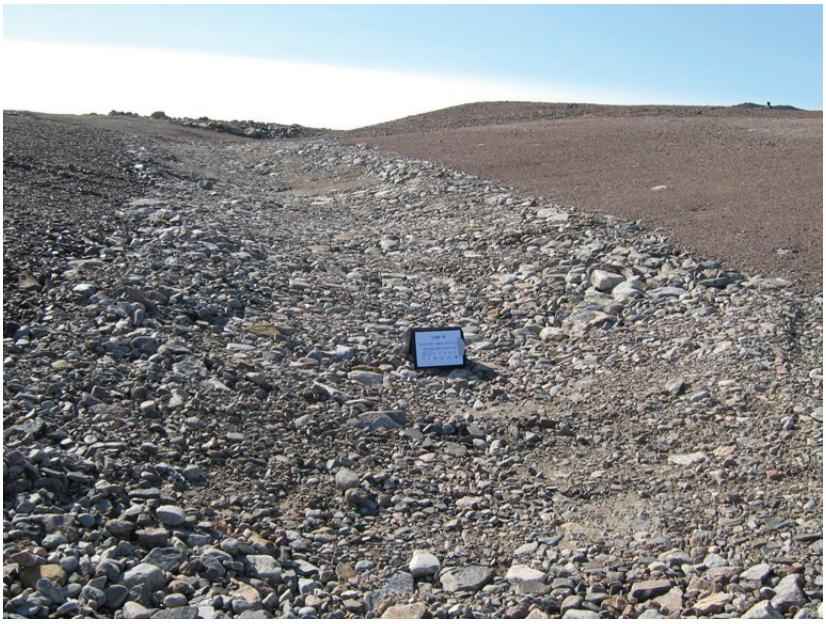
Photograph LSL-2A. Looking west, upstream, along the rip-rap lined drainage channel. ↑

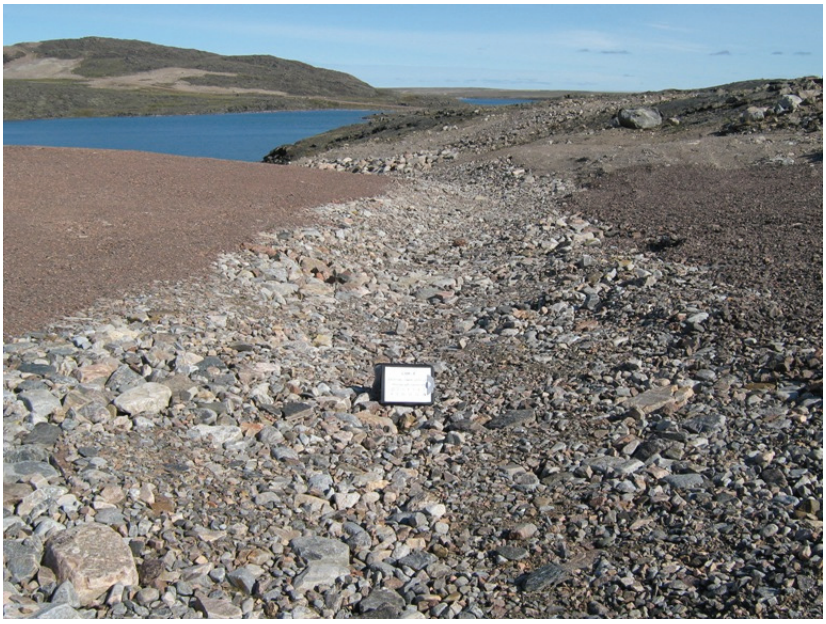
Photograph LSL-2B. Facing east, downstream, along the rip-rap lined drainage channel. ↑

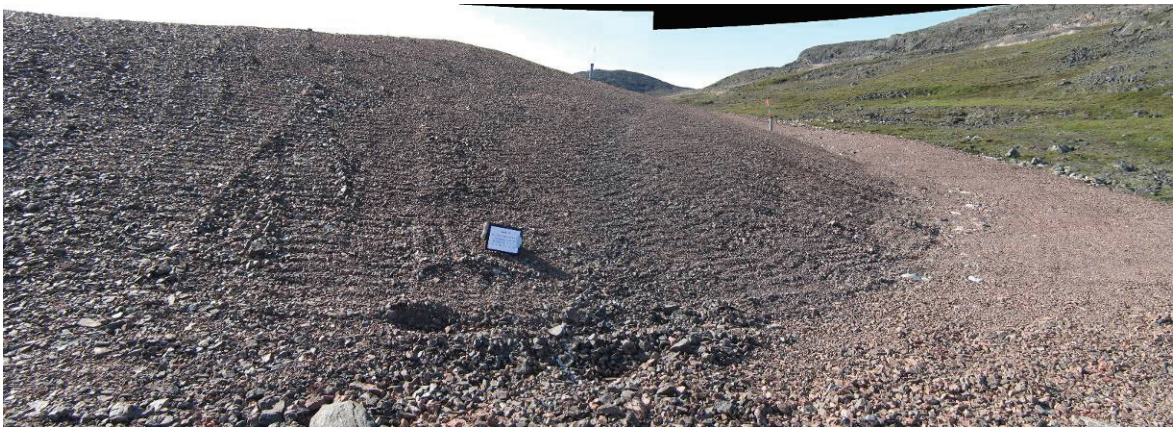
Photograph LSL-4. Panoramic photo facing west to the northeast corner of the landfill. ↑

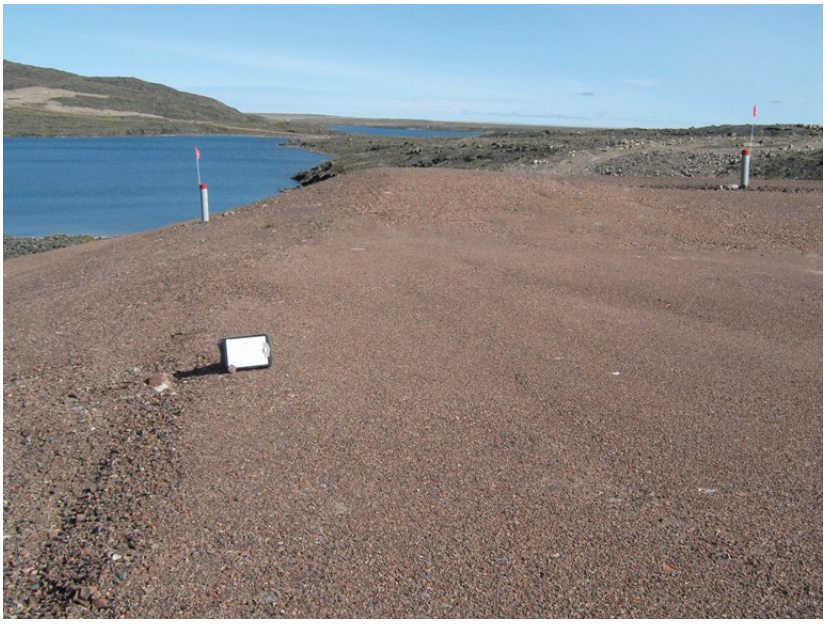
Photograph LSL-7. Facing southwest to the north slope near thermistors. Seepage from lower half of slope, with no staining observed. Very small tuffs of grass/vegetation observed. ↑

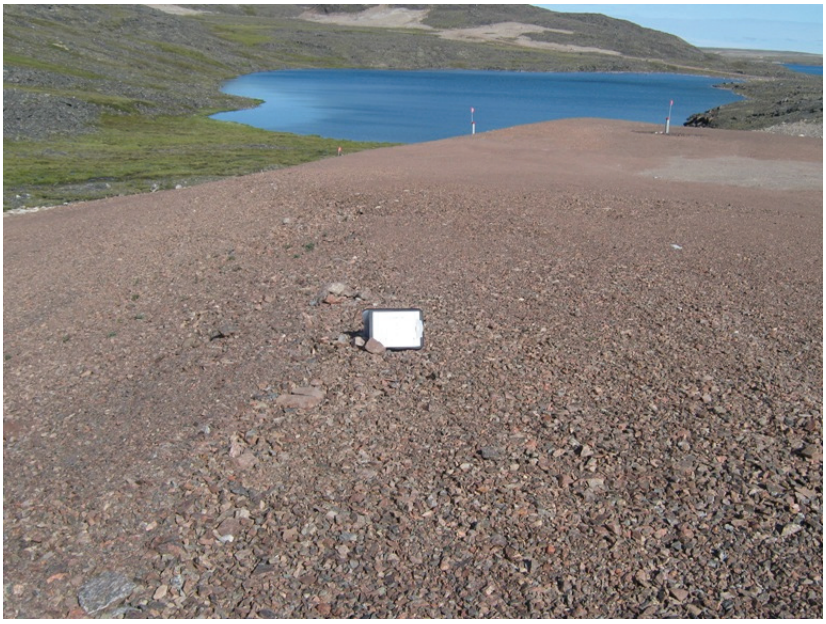
Photograph LSL-10. Panoramic photo facing southeast to the north slope at northwest end. Minor erosion of fines but self armouring. ↑

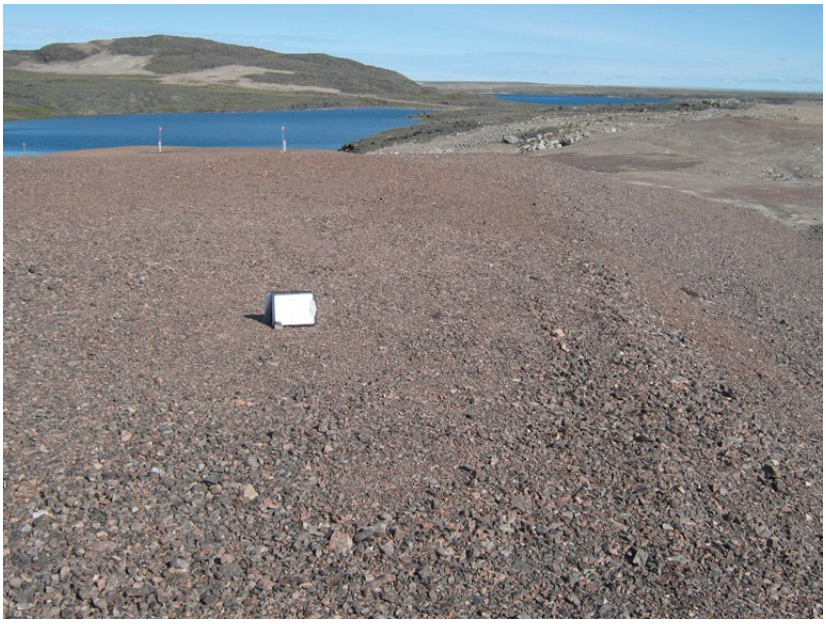
Photograph LSL-12. Facing east along crest at the southwest corner. ↑

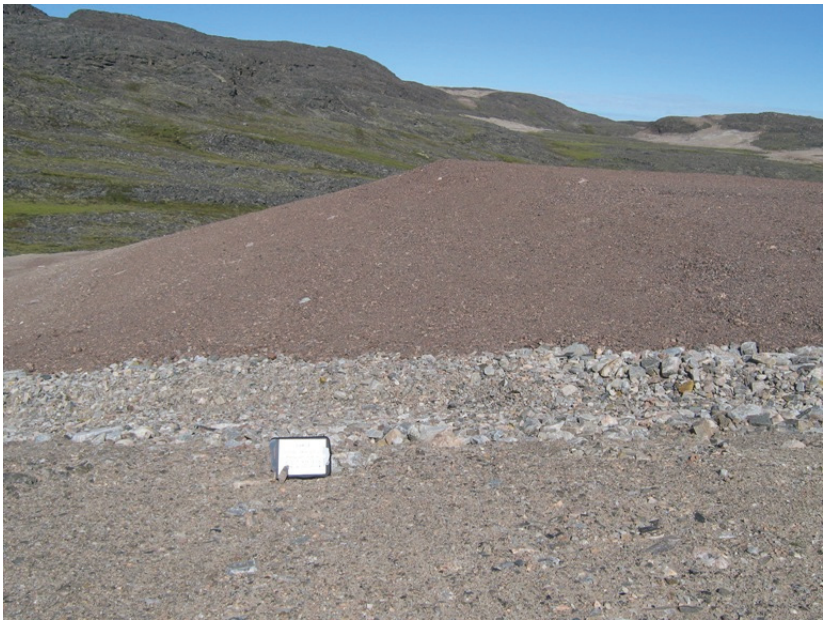
Photograph LSL-13. Facing northeast to the west slope and rip-rap lined drainage ditch at the toe of the landfill. ↑
