September 30, 2019

Re: August 2019 – Monthly Monitoring Report for Water Licence 2AM-DOH1335

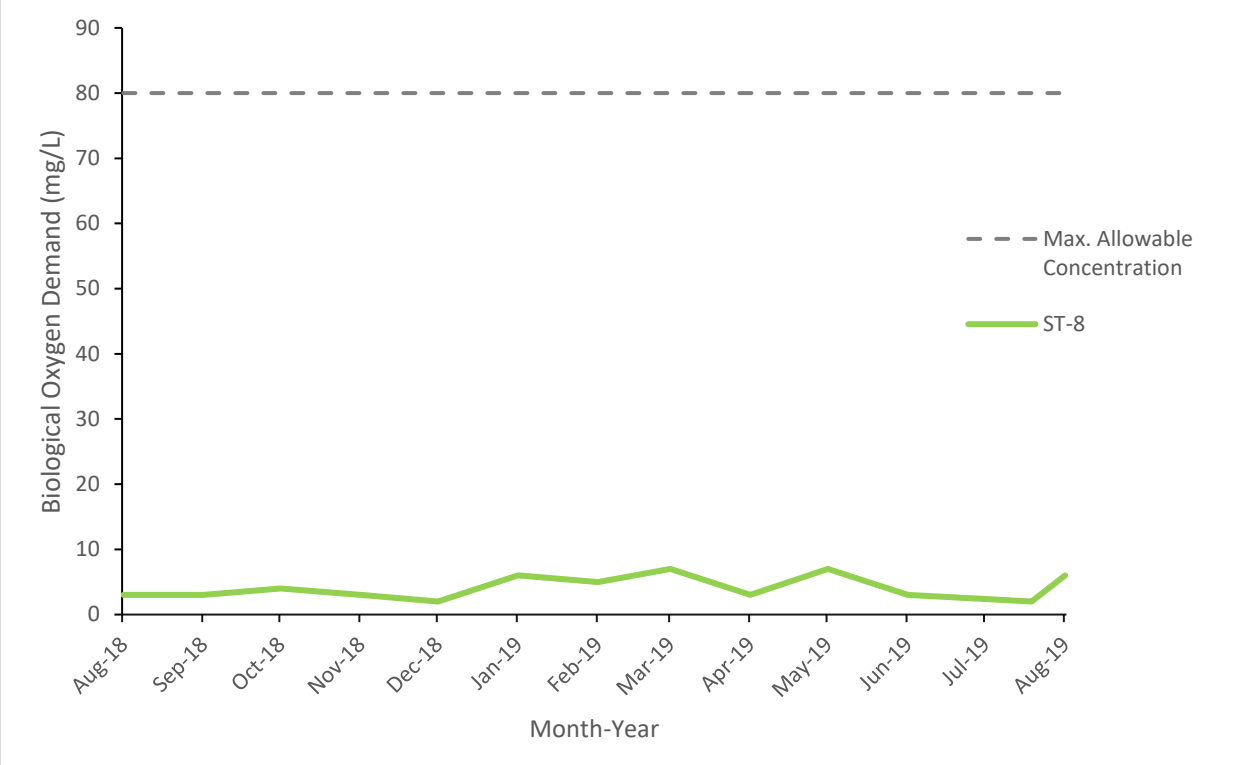
Figure 3. Biological Oxygen Demand Results Consistently Below Discharge Criteria for Wastewater Treatment Plant (ST8)

Note: Maximum Average Concentration as per Part F Item 4(b).

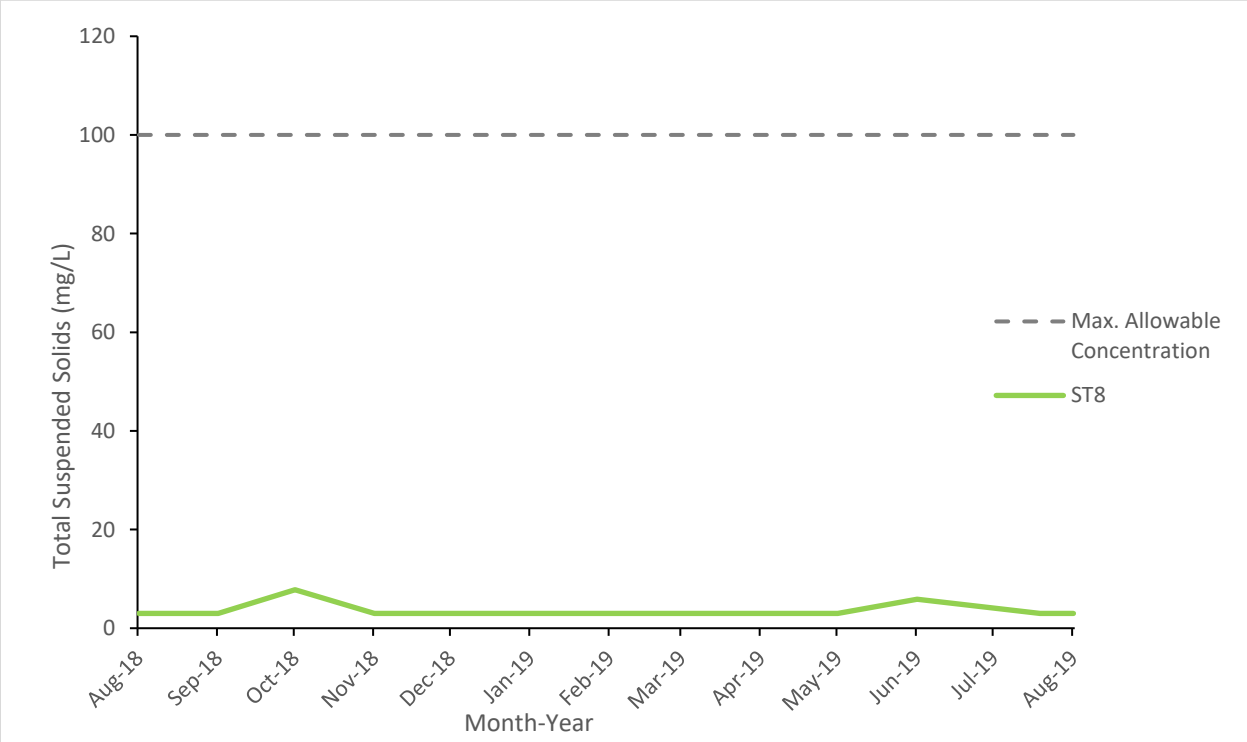
Figure 4. Total Suspended Solids Results Consistently Below Discharge Criteria for Wastewater Treatment Plant (ST8)

Note: Maximum Average Concentration as per Part F Item 4(b).
