PROJECT: ANNUAL INSPECTION OF PERIMETER TAILINGS DAMS

TITLE: DAM 4 INSPECTION PHOTOS

BGC Engineering Inc.
AN APPLIED EARTH SCIENCES COMPANY
Calgary Alberta Phone: (403) 250-5185

TITLE: DAM 5 INSPECTION PHOTOS

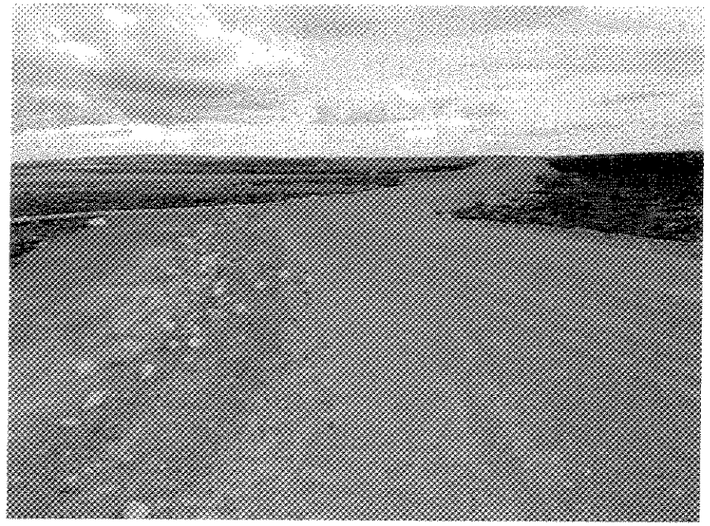
Shows a view of the crest looking towards the east.

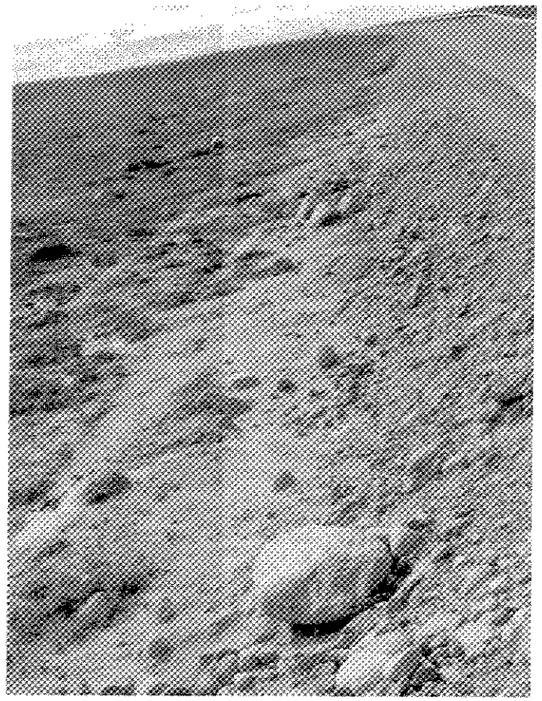
Shows the toe area of the dam.

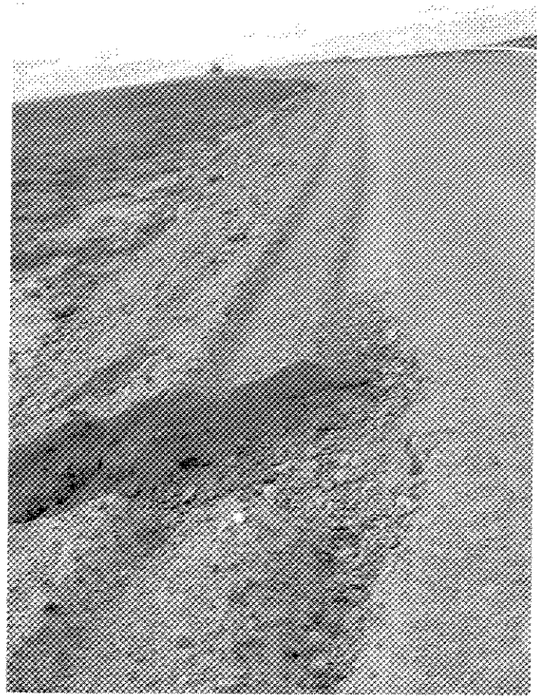
Shows the upper portion of a large washout at the toe.

No other signs of erosion or deformation were noted at the toe other than that one gully that should be repaired.
