2016 - 2017 Annual Monitoring Report

for Agnico Eagle Mines Ltd.'s Meadowbank Gold Project

Nunavut Impact Review Board
File No. 03MN107
November 2017

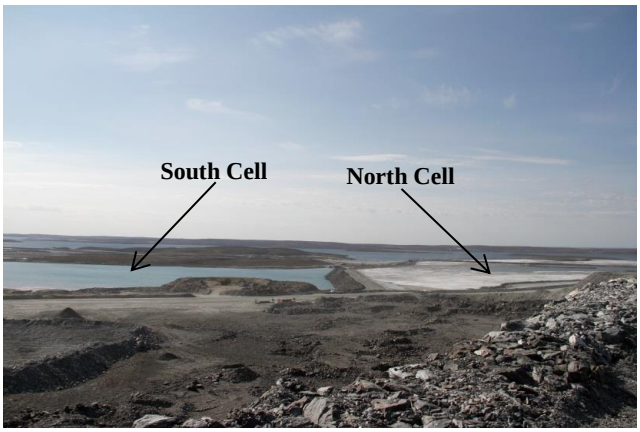
Photo 39: Tailings Storage Facility

Progressing reclamation has commenced at the North Cell of the tailings storage facility starting in the winter of 2015 by capping the tailings following the completion of tailings deposition in this cell (see Photo 39)

When viewing the North Cell of the tailings storage facility, the Monitoring Officer observed the thermistors, installed in 2012 to measure freezeback, and did not observe any apparent rips in the exposed lining of Saddle Dams 1 and 2 or at the Stormwater Dike (see Photo 40).

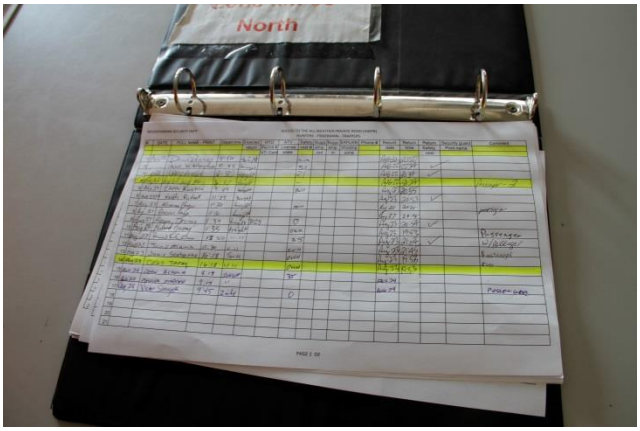
Photo 53: Gatehouse sign-in sheet

Agnico Eagle maintains one (1) gatehouse at kilometre 5 of the access road, and second gatehouse at an appropriate distance from the entrance to the mine site and camp at Meadowbank. Only the gatehouse at kilometre 5 is manned by Agnico Eagle staff who monitors the safety and security of all personnel using the road. All traffic is required to check-in (via radio or in person) with the employee at the gatehouse prior to proceeding along the road (see Photo 52) from either the mine site or from Baker Lake. The Agnico Eagle employee manning the kilometre 5 gatehouse maintains a daily logbook of all persons travelling the access road for non-mine use, and members of the public travelling along the road are required to sign-off an indication of having read Agnico Eagle's *All Weather Private Access Road Safety Rules & Procedures for Road Access* policy prior to being granted access to the road (see Photo 53).

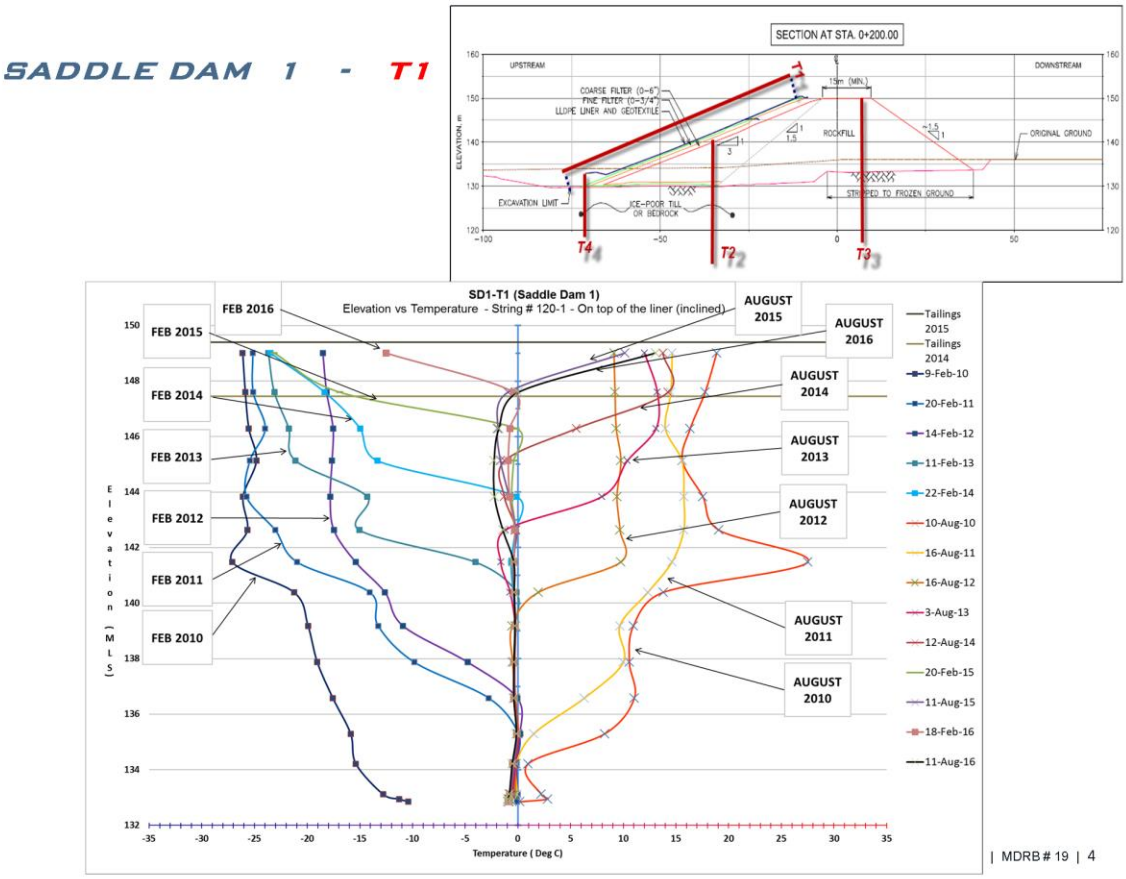
Figure 6. Thermistor Results SD1-T1

Agnico started to determine capping thickness in 2009 by installing thermistor SD1-T2, SD1-T3 and SD1-T4 on Saddle Dam 1 to monitor the thermal condition within the structure and its foundation. The results are illustrated on Figure 6 to 9. Thermistor data from within the structure indicates that the dike foundation remained frozen since the installation of the instrumentation. The foundation remained in a frozen state with temperatures ranging from about -2°C to -10°C. No seepage has been observed since the beginning of service of the structure. The structure is performing as expected.

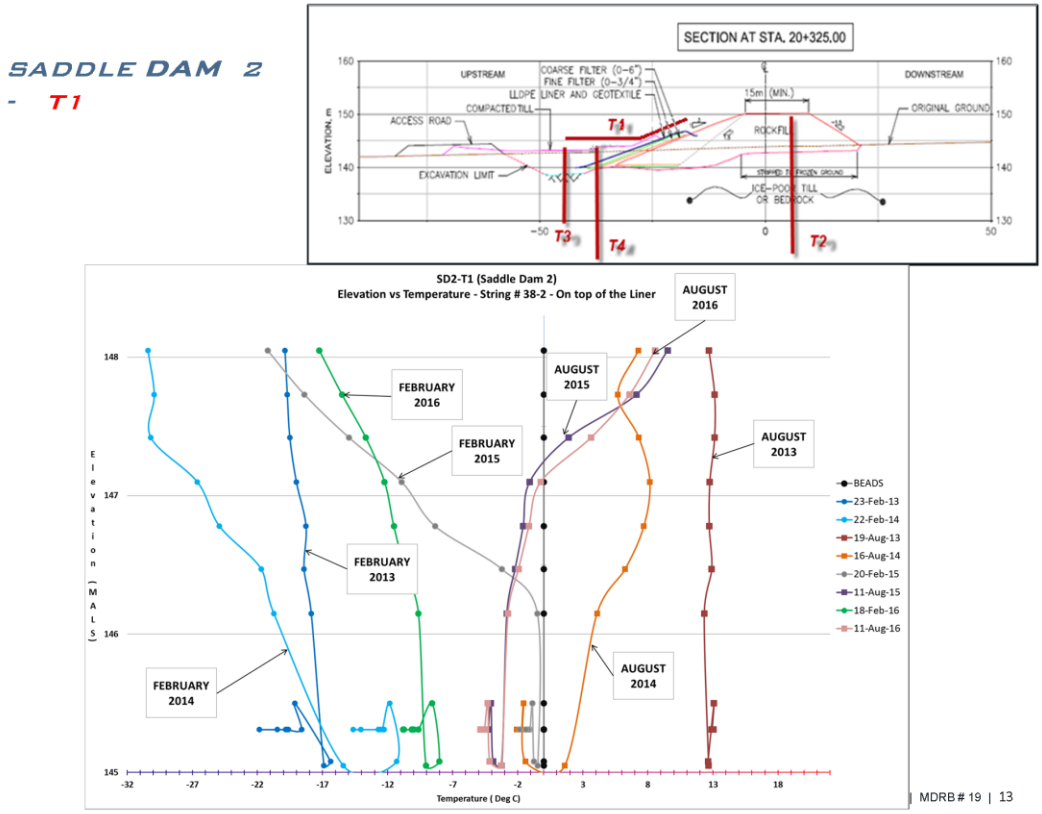
Figure 10. Thermistor Results SD2-T1

Agnico also installed thermistors SD2-T1, SD2-T2, SD2-T3 and SD2-T4 on Saddle Dam 2. The results are illustrated on Figure 10 to 13. Thermistor data from within the structure indicates that the dike foundation remained frozen all year long in 2016 with temperatures ranging from about -5°C to -8°C. The SD2 dike shows temperature already similar to permafrost condition and even colder and so both for the foundation and the embankment. No signs of seepage or thawing of the foundation soil were observed. The structure is performing as expected. The SD2-T1 thermistor string was installed in 2012 in the centre of the upstream face of the dike immediately on top of the geomembrane liner to monitor the thermal regime of the tailings in contact with the structure. Value between 0°C and -5°C were recorded during the year (in the winter and in the summer) below El. 147m. It is anticipated that data collected from this location will be useful in monitoring the freezing of the tailings in the coming years. The SD2-T2 thermistor string was installed vertically through the upstream crest in the centre of the dike at El. 140 m. It shows that the dike foundation and rockfill shell remained frozen during the past year (temperature varying from -1.5°C to -7.5°C). The SD2-T3 thermistor string was installed vertically through the upstream liner tie-in trench near the centre of the dike at about El. 144 m. It shows that the dike foundation and the semi-pervious backfill placed on top of the compacted till remained frozen during the past year

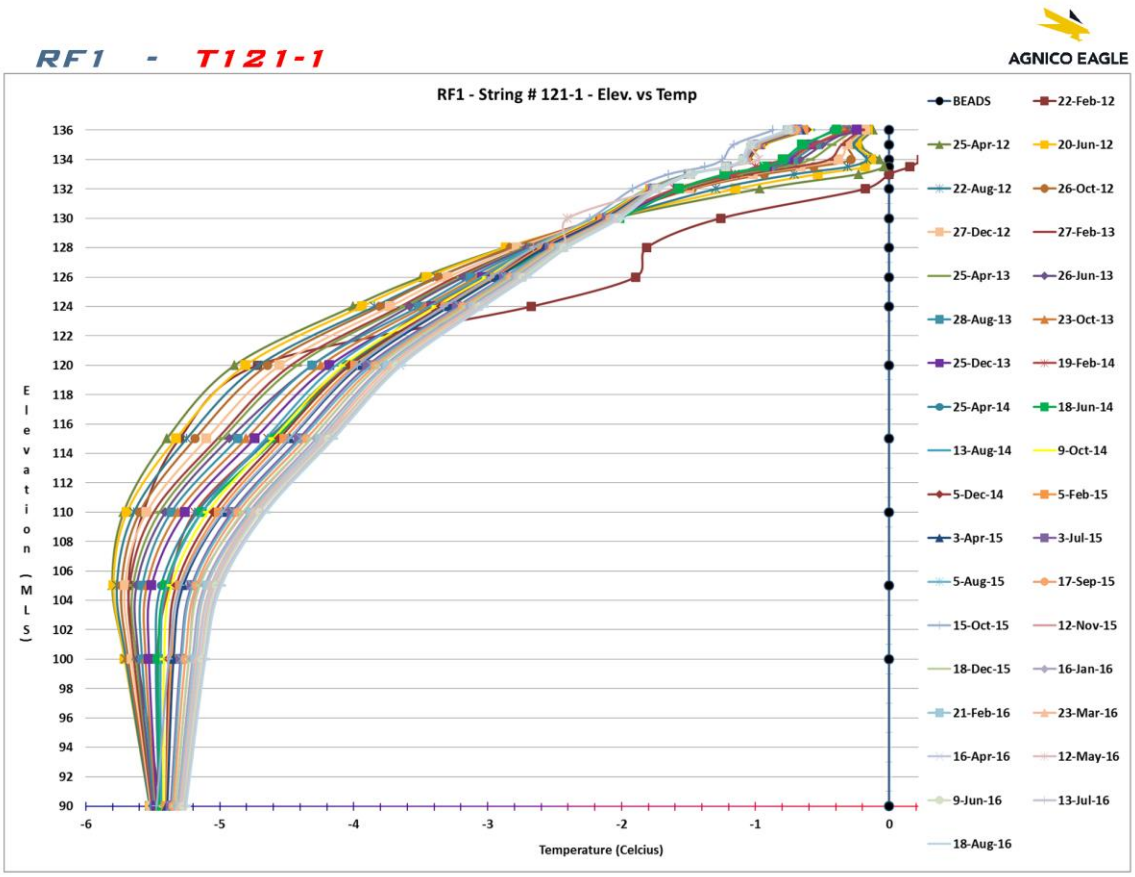
Figure 14. Thermistor Results RF1-T121-1

Other thermistors were installed in 2012 in the TSF to monitor the temperature of the tailings as well as the temperature of RF1 and RF2 (which delineates the eastern side of the North Cell TSF). Plots of these thermistors data are presented in Figure 14 to 17. Three thermistors are installed on RF1 (T121-1, T73-6, and RF1-3). Thermistor T121-1 shows temperatures which vary from -0.8°C to -5.4°C. Thermistor T73-6 shows a wide range of temperatures above El. 145 m, but below that elevation the temperature fluctuates between 0.2°C and -0.5°C. A similar trend was observed last year. This trend indicates the presence of an active zone within the upper elevation of the deposited tailings. RF1-3 shows frozen conditions all year long below El. 147 m with temperatures varying between 0°C and -4°C. Above that elevation, the temperature seems to fluctuate seasonally between 11°C and -11°C. This trend indicates the presence of an active zone within the upper elevation of the deposited tailings. One thermistor is installed on RF2 (T122-1) and shows temperatures which vary from -2°C to -6.5°C, indicating that the RF2 foundation is in a frozen state. It is important to state that tailings deposition was completed in the North Cell in summer 2015 and that no deposition occurred in 2016.

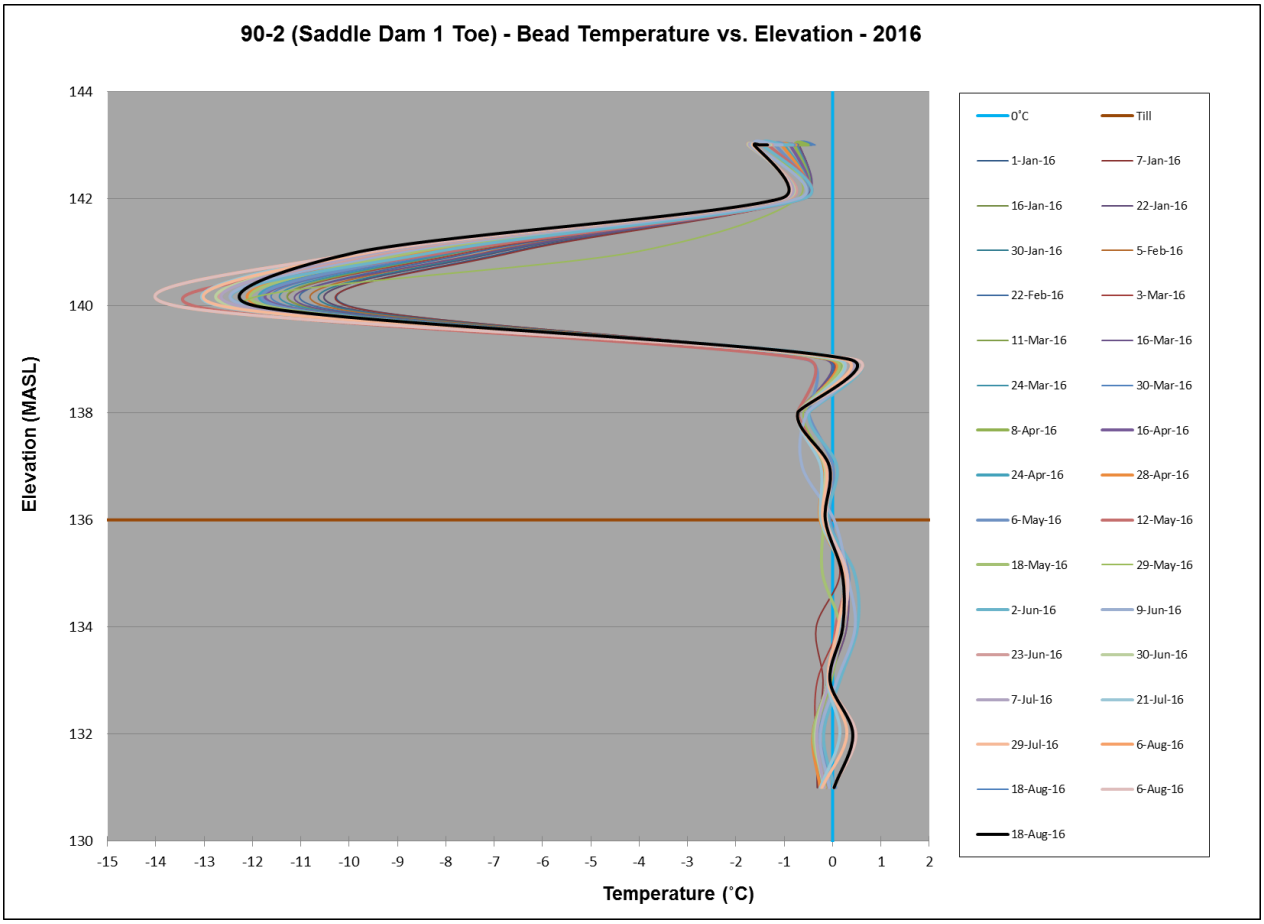
Figure 18. Thermistor Results SD1-90-2

Thermistor SD1-1 was installed in 2012 in the tailings upstream of SD1. All the nodes from SD-1 are covered by more than 6.0 m of tailings. The thermal results from this thermistor show that the tailings are frozen until elevation 139m. The foundation (till from the tundra) showed temperature close or below 0 Celsius. Plot of this thermistor data for 2016 are presented in Figure 18.

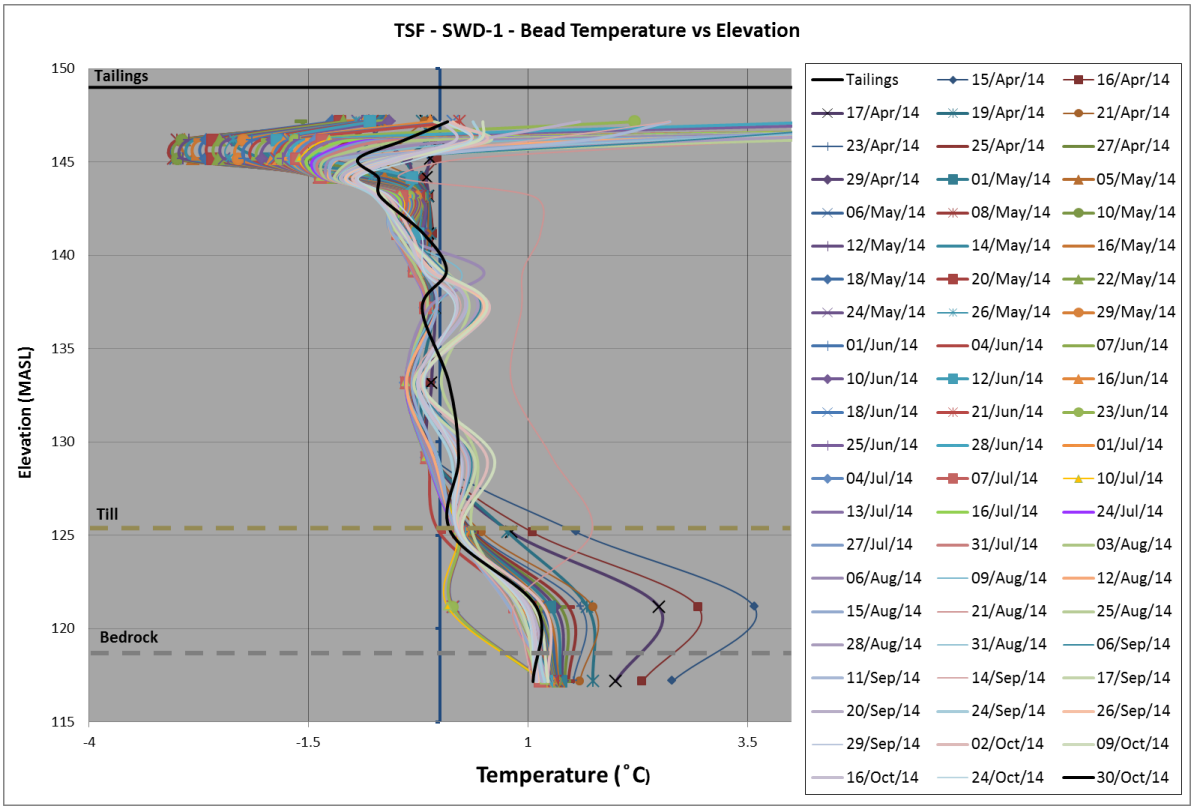
Figure 19. Thermistor Results TSF-SWD-1

foundation (till and bedrock) show temperatures above 0 Celsius, as expected since this thermistor is located in the talik portion of Second Portage Arm. Due to technical difficulties to protect the thermistor cables from excessive tension, thermistors SD2-1 and SWD-1 were operational respectively until July 2014 and October 2014. Figures 19 and 20 are presenting data recorded during that time Agnico installed in winter 2016 two new thermistors in the North Cell TSF to monitor the tailings freezeback, the permafrost aggradation and talik beneath Second Portage Lake. These instruments are located more in the area of the reclaim pond where water is still ponding at elevation 148m and act as a thermal barrier. These thermistors are showing that the center area of North Cell TSF is warmer than the perimeter area. The thermistor NC-T1 shows a frozen layer from the surface to elevation 144 to 147m. Under this elevation, tailings temperatures vary from 0°C (elavation 144m) to 5° elevation 110m). Bedrock is also unfrozen from elevation 87 to 110m. This area of the tailings pond was always covered by the reclaim water pond in operation and the freezing process is affected by the water compared to exposed tailings beaches. However a trend for April 2016 to December 2016 shows temperatures are slowly decreasing.. For NC-T2, tailings temperature is varying around the frozen boundary from elevation 123m to 138m. Under this elevation tailing temperatures reach around 2°C. The difference between both locations is due to the reclaim pond surface which does not extent over the NC-T2 as much than the NC-T1 at the end of the operation of then North Cell TSF. Figures 21 and 22 are presenting data recorded during the last year. This information was used by Agnico to review the water management strategy of the North Cell to promote freezeback of this area until capping is completed which consist of minimizing the water ponding inside the North Cell TSF. As previously mentioned, tailings deposition was completed in the North Cell in summer 2015 and that no deposition occurred in 2016.

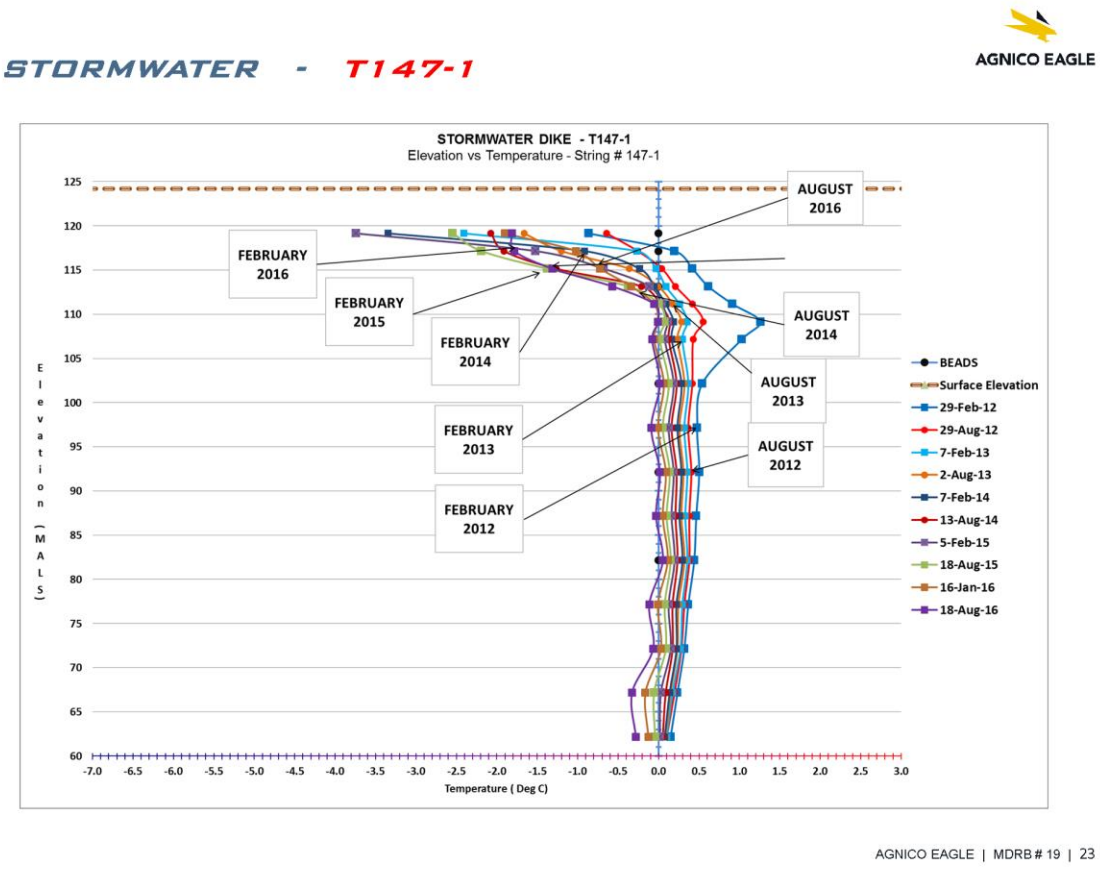
Figure 23. Thermistor Results SWD-147-1

In 2012, Agnico installed a thermistor (T147-1) at the downstream toe of Stormwater Dike. Results for this thermistor can be found in Figure 23. This thermistor is being used to monitor the freezeback of the talik, and in the future will be used to monitor the thermal regime beneath the tailings in the South Cell. Thermistor T147-1 shows the existence of a frozen crust of material from El. 120 m to El. 110 m that stayed frozen during the summer of 2016. Below El. 110 m, the temperature varied between -0.3°C and 0.1°C. This thermistor is located under the active reclaim pond of the South Cell and was not exposed to freezeback conditions since the beginning of the operation of the South Cell. Freezeback will occur once the operation of the South Cell deposition will be completed.

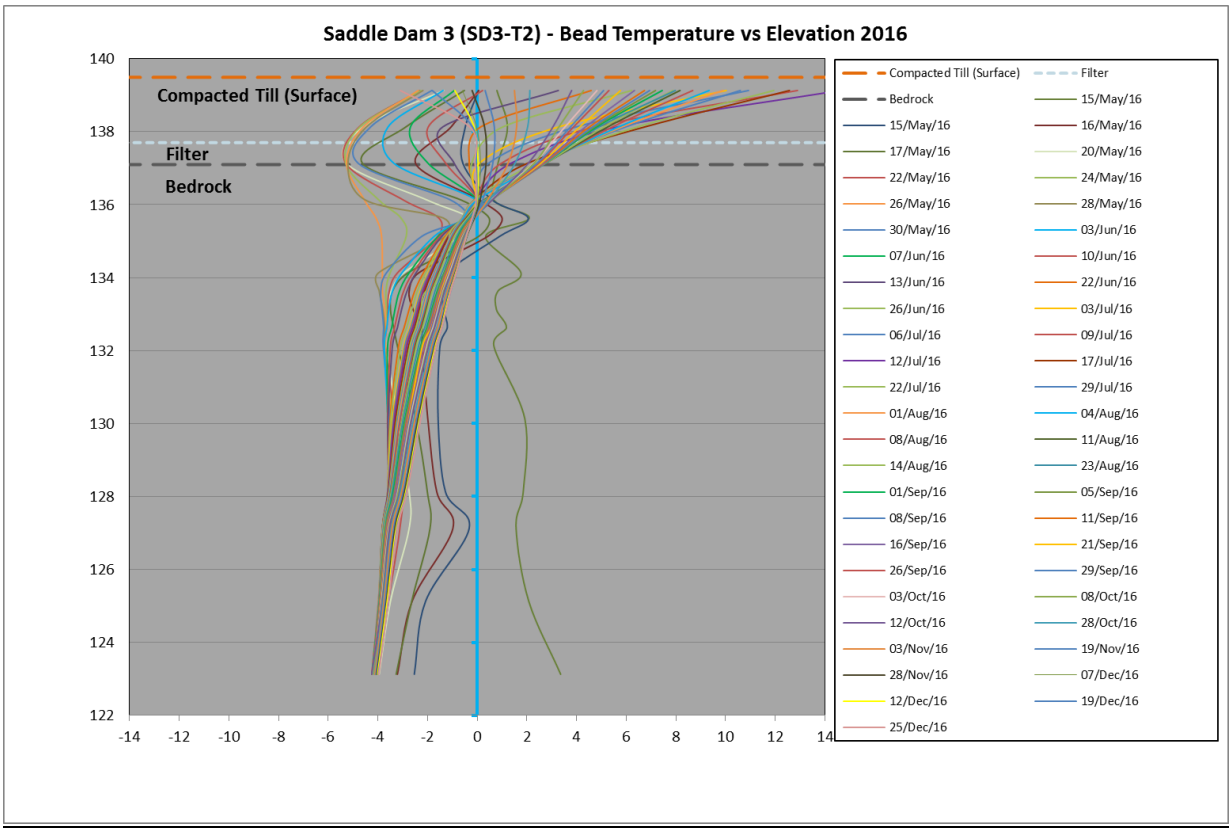
Figure 24. Thermistor Results SD3-T2

During the construction season 2015 of SD-3, Agnico identify a fault zone under the foundation and the 2016 instrumentation campaign was done in order to evaluate performance of the foundation. It is important to mention that no tailings or reclaim water is ponding so far against the upstream face of SD3. All thermistor are showing that the foundation is frozen from around elevation 123m to 134m. Over this elevation, SD3 is exposed to freeze and taw cycle as showed on Figures 24 to 27. SD3-T4 is showing warmer temperature from elevation 130 to 132m. Investigation will be done by Agnico to understand the thermal behavior. .

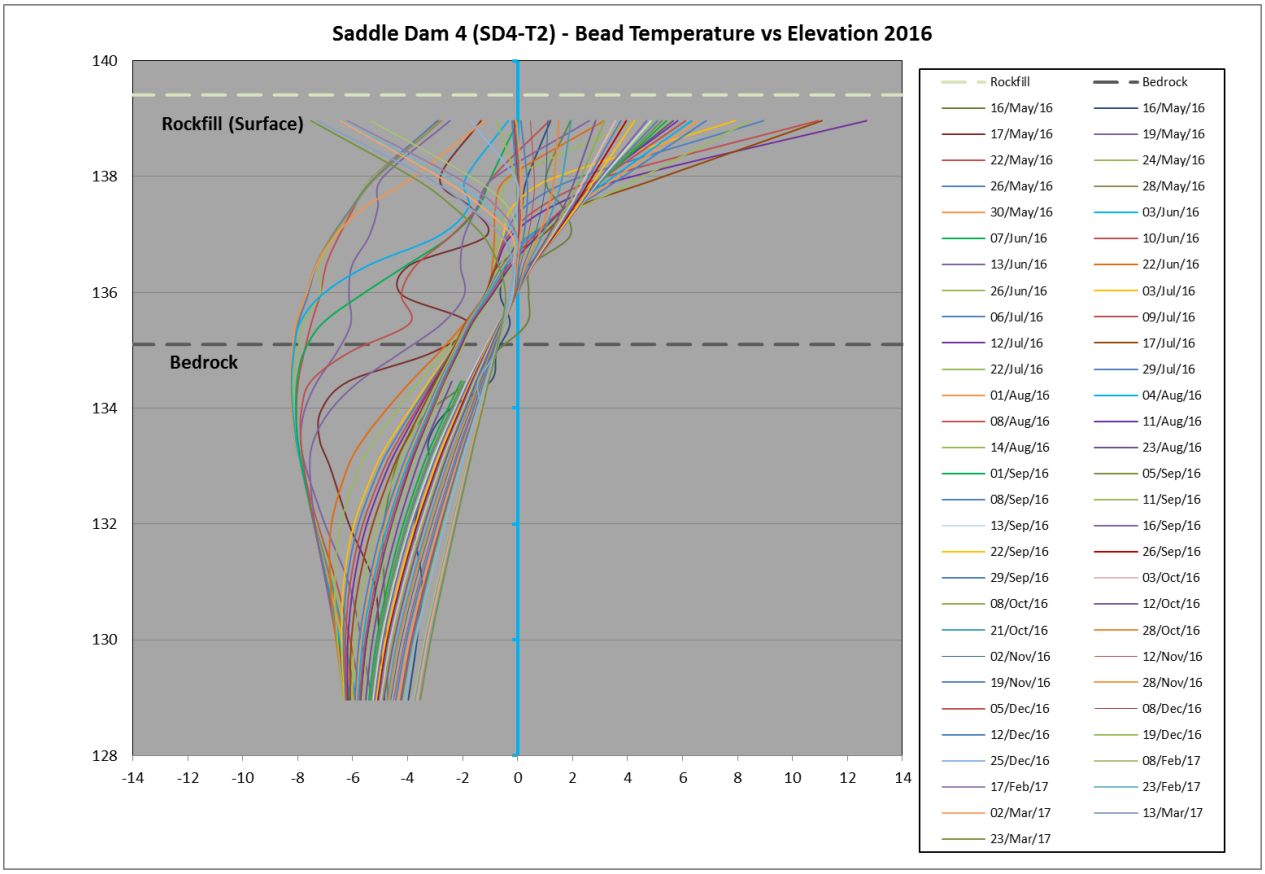
Figure 28. Thermistor Results SD4-T2

SD4 presents the same behavior than SD3 as no tailings or reclaim water is ponding so far against this structure. All thermistor are showing that the foundation is frozen from around elevation 127m to 135m. Over this elevation, SD4 is exposed to freeze and thaw cycle as showed on Figures 28 and 29.

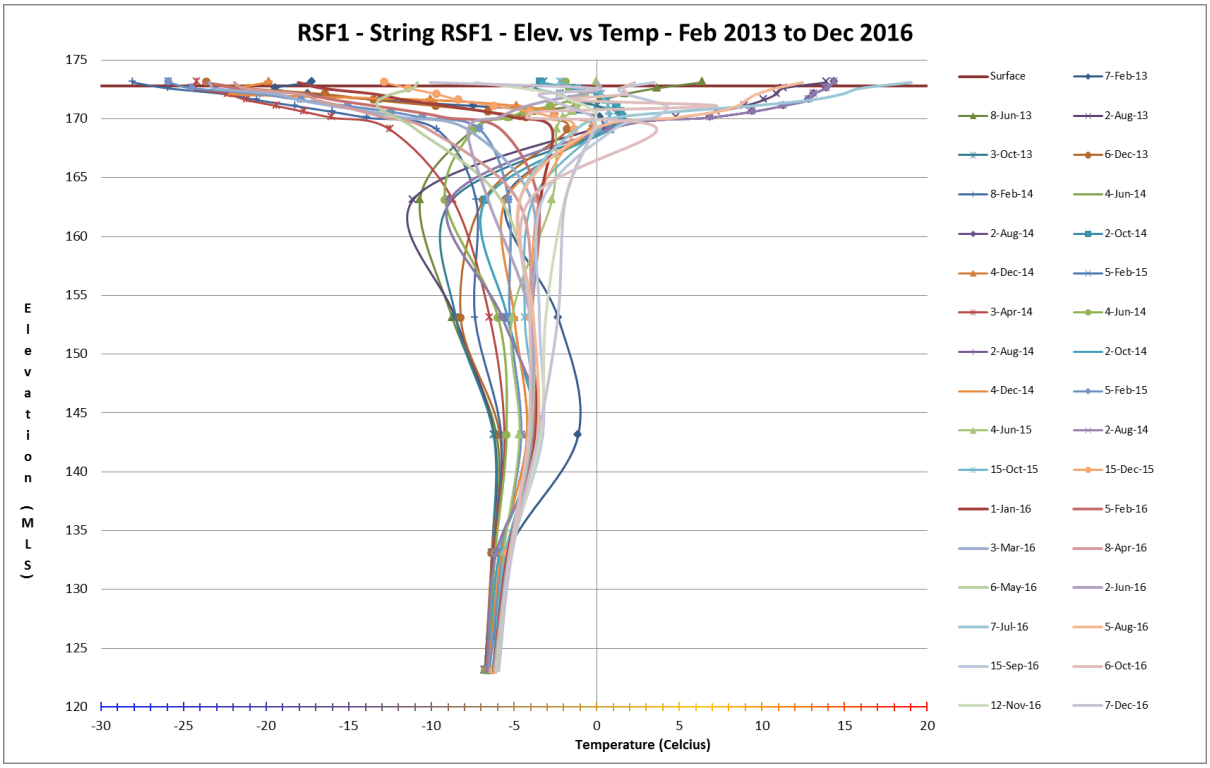
Figure 30. Thermistor Results RSF1

Thermistors are also installed in the Waste Rock Storage Facility, to measure the freezeback of the waste rock pile and also to verify the performance of the NAG cover placed over the PAG material in the RSF. Thermistor RSF-1 was installed in February 2013 and RSF-3, RSF-4, RSF-5 and RSF-6 were installed on the RSF in November 2013. Plots of these thermistor data are presented in Figure 30 to Figure 34. No major differences were observed since last year. The results of the thermistor RSF-1 for 2016 indicate that below approximately 5.5 m from the surface, the temperature remains below 0 Celsius all year long. The results of the thermistor RSF-3 for 2015 indicate that below approximately 3.0 m from the surface, the temperature remains below 0 Celsius all year long. Between approximately 28.0 m to 39.0 m from the surface, the temperatures can get close to 0 Celsius and then decrease with depth. The results for the thermistor RSF-3 indicates that below approximately 5.5 m from the surface, the temperature remains below 0 Celsius all year long. The results of the thermistor RSF-4 for 2014-2015 indicate that below approximately 3.0 m from the surface, the temperature remains below 0 Celsius all year long. Between approximately 35.0 m to 65.0 m from the surface, the temperatures are between -1 and 0 Celsius and then decrease with depth. This instrument was damaged in spring 2015. The results of the thermistor RSF-5 for 2015 indicates that below approximately 2.0 m from the surface the temperature remains below 0 Celsius all year long, and at further depth, the temperature remains between 0 and -9 Celsius all year long. The results of the thermistor RSF-6 for 2015 indicates that below approximately 4.5 m from the surface the temperature remains below 0 Celsius all year long, and at further depth, the temperature remains between -1 and -18 Celsius all year long. Agnico will refer you the 2016 Annual Geotechnical Inspection found in Appendix B1.

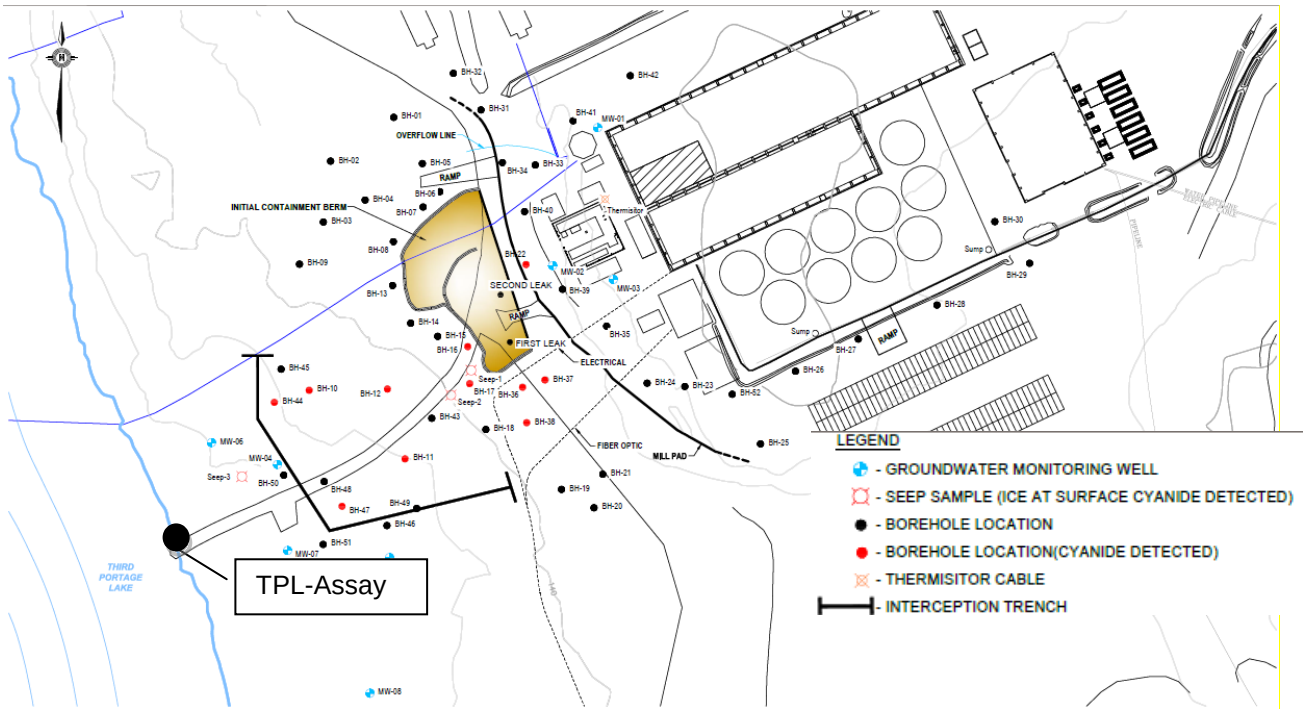
Figure 38. General Layout of the Assay Road Seepage

In summary, monitoring in TPL indicates that there has been no impact to the near shore receiving waters. The seepage appears to be effectively contained and the source area has been repaired. Follow up monitoring will continue in 2017 in accordance with the 2017 Freshet Action Plan which includes requests made by KIA in 2014 at the Water Licence renewal hearing.

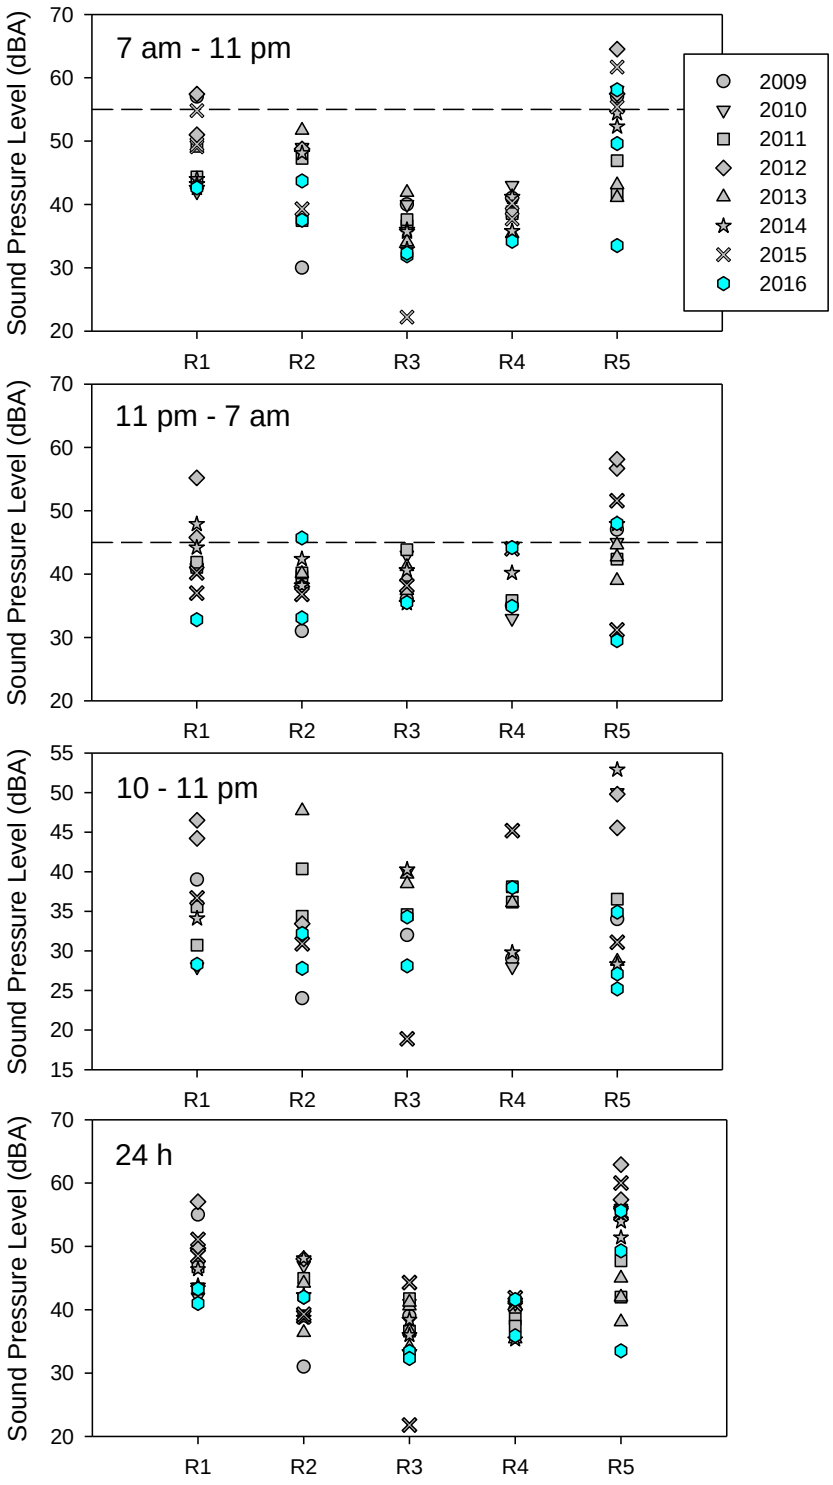
Figure 43. L_{eq} values calculated from filtered data for various time periods at locations R1 – R5 on the Meadowbank site in surveys from 2009 - 2016. Dashed lines indicate target sound levels (day-time and night-time only).

Since the FEIS prediction for R5 was exceeded in 4 out of 36 monitoring hours, an analysis of trends over time for this station was performed. As demonstrated in Figure 43, there is no clear trend towards increasing sound levels at R5, with the highest sound levels generally occurring in 2012.

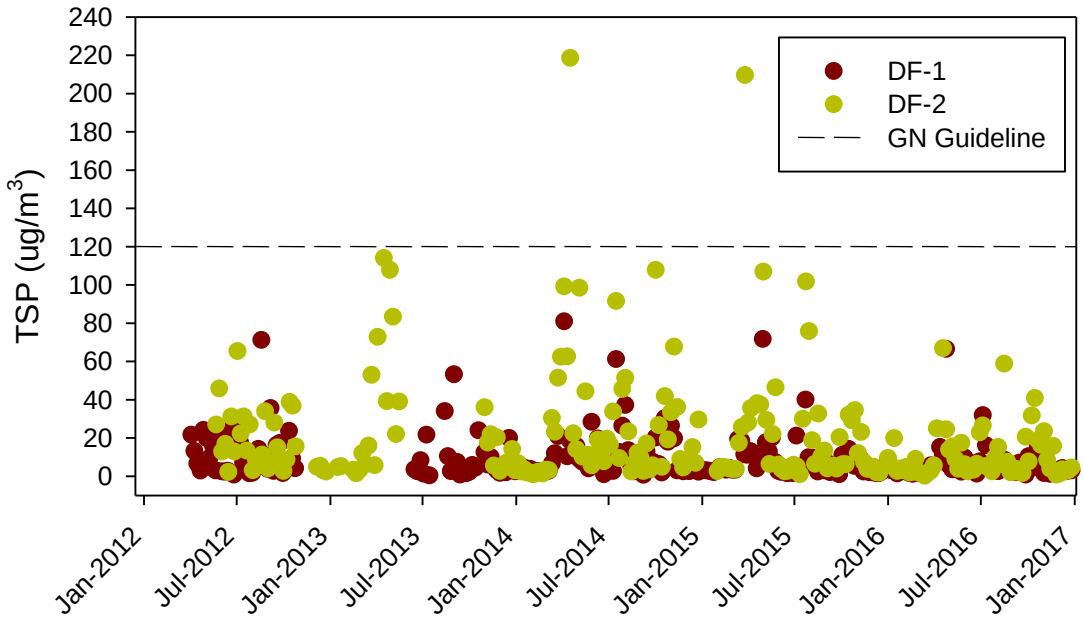
Figure 44. Measured concentrations of total suspended particulates at two monitoring stations on the Meadowbank site since monitoring began in 2012.

Since some measurements of TSP (24 h) and one dustfall sample exceeded FEIS model predictions for project inputs, it cannot be assumed that FEIS predictions are not being exceeded for these parameters. Therefore, an examination of historical trends was performed to determine any tendency towards increasing Project-related effects. As demonstrated in Figure 44 and 45, no trends towards increasing dust generation or deposition are apparent. A slight trend towards decreasing dust deposition at DF-1 may be occurring.
