Water Licence Inspection Report

On May 29, 2026 Resource Management Officer Kyle Amsel (Inspector) for Crown-Indigenous Relations and Northern Affairs Canada conducted an Inspection of Water Licence 2AM-MEA1530 (Licence) issued to Agnico Eagle Mines Ltd. (Proponent) for use of water and deposit of waste in support of a Mining Undertaking (Undertaking).

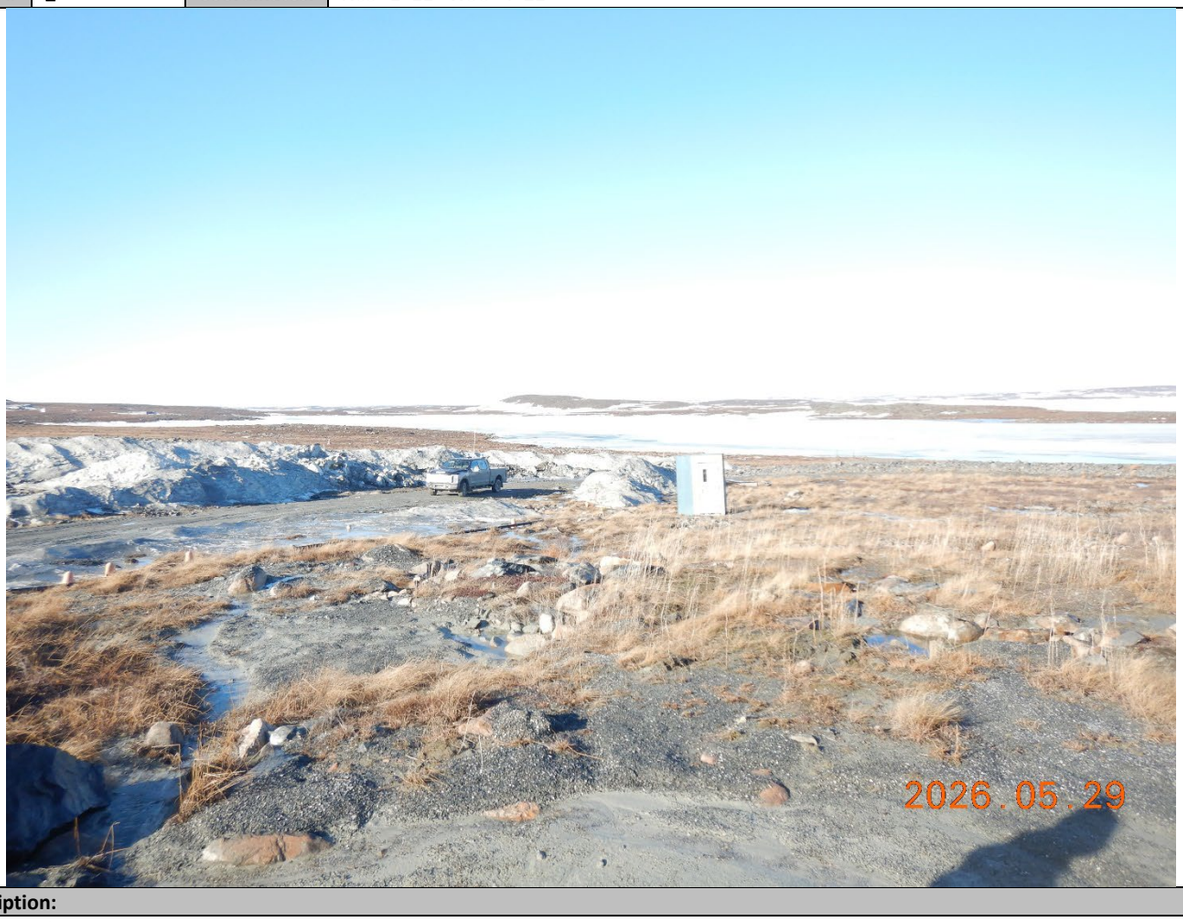
Photo #	2	**Coordinates:**	N65^0 1’ 11” W96^0 4’ 21”

1) At the time of Inspection water usage at ST-1 Third Portage Lake water barge was 227,509m^3 (Photo 1)
2) Mill Seep (Photo 2)
   a) The Mill Seep is actively flowing and Year-To-Date (YTD) recovery has totalled 5,156m^3

b) Leach pad repairs have been completed.
   c) There have been no hits for weak acid dissociable cyanide.
3) Goose Pit (Photo 3)
   a) There is a bubbler operational on the pit to help meet water quality targets in the pit for ammonia and Thiocyanide.

Mill Seep Area.
