Report: *2010 Annual Geotechnical Inspection*

December 3, 2010

2010 Annual Geotechnical Inspection Meadowbank Gold Project, Nunavut

Project Number: 10-1428-0033/2000
Document Number: 1216 Ver. 0

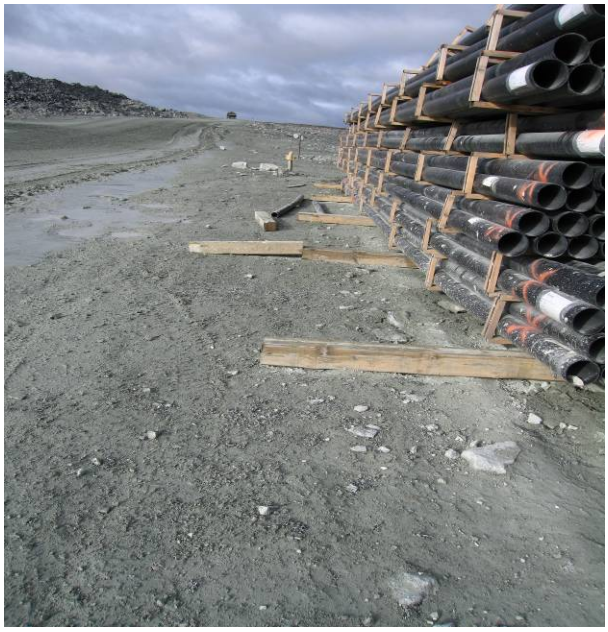
PHOTOGRAPH A1-19 – East Dike

Description: Looking south along upstream side from north abutment.

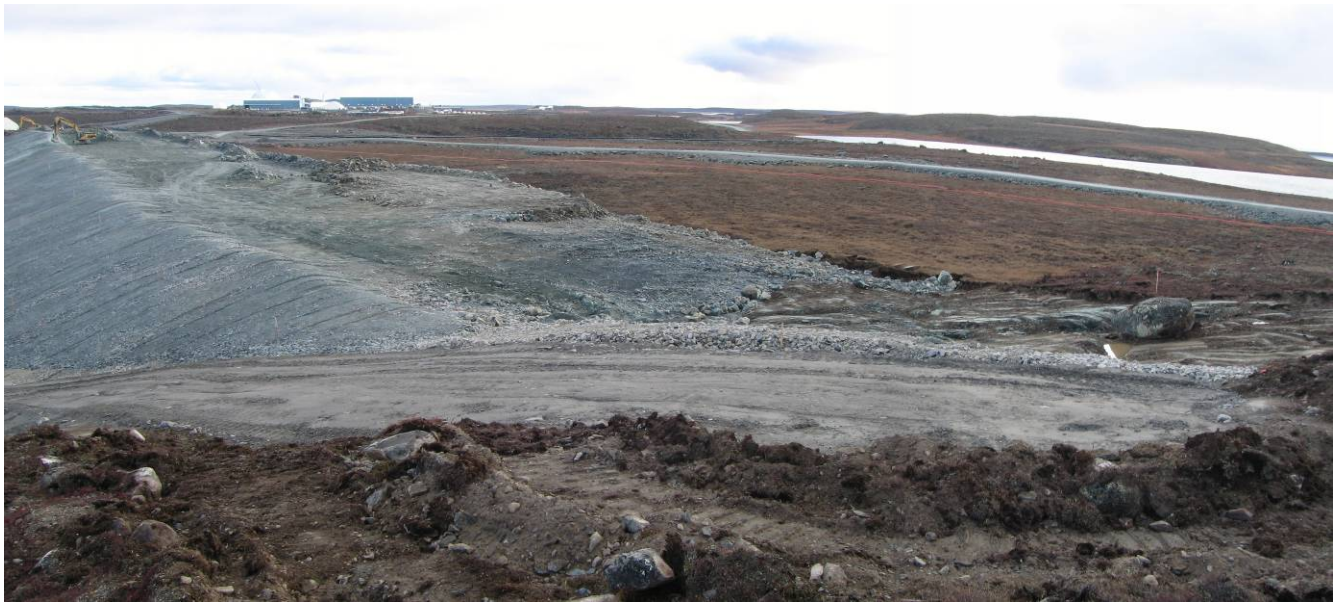
PHOTOGRAPH B3-5 – Saddle Dam 2

Description: Foundation preparation work of bedrock at toe of dike for liner connection.

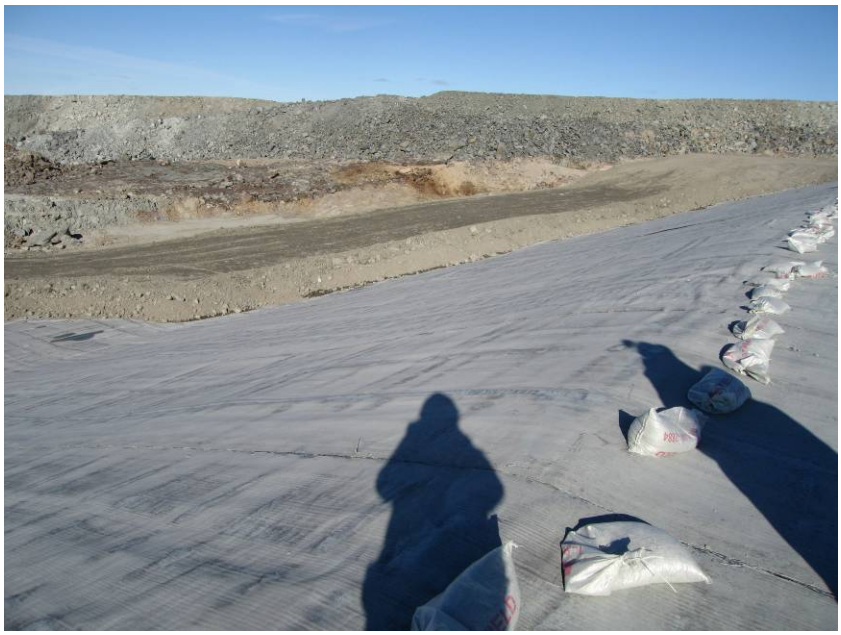
PHOTOGRAPH B4-2 – Stormwater Dike

Description: Stage 2 bituminous liner and connection at bench (El. 140 m) with Stage 1 liner. Dike crest at 148 m.

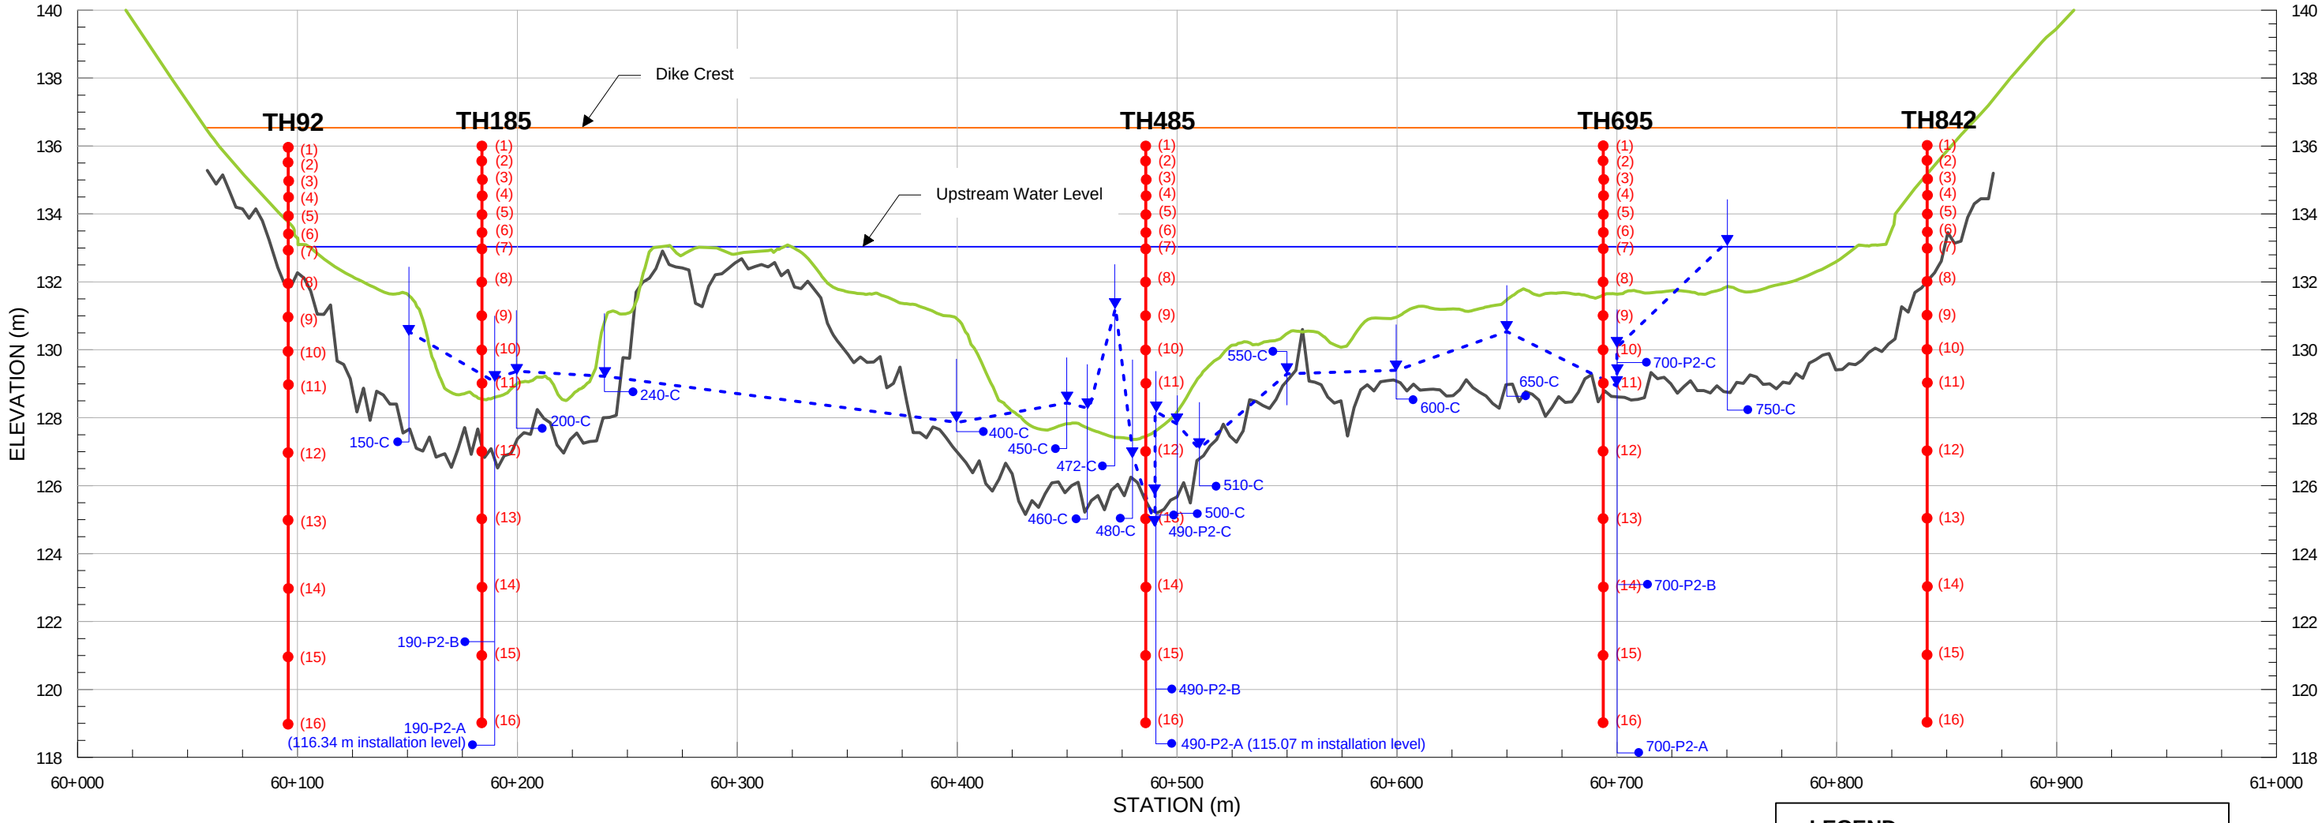
East Dike - Longitudinal Section

NOTE: TH92 node(9) at elevation 131, data not reported since May 1, 2010 as it appears not to be functioning.

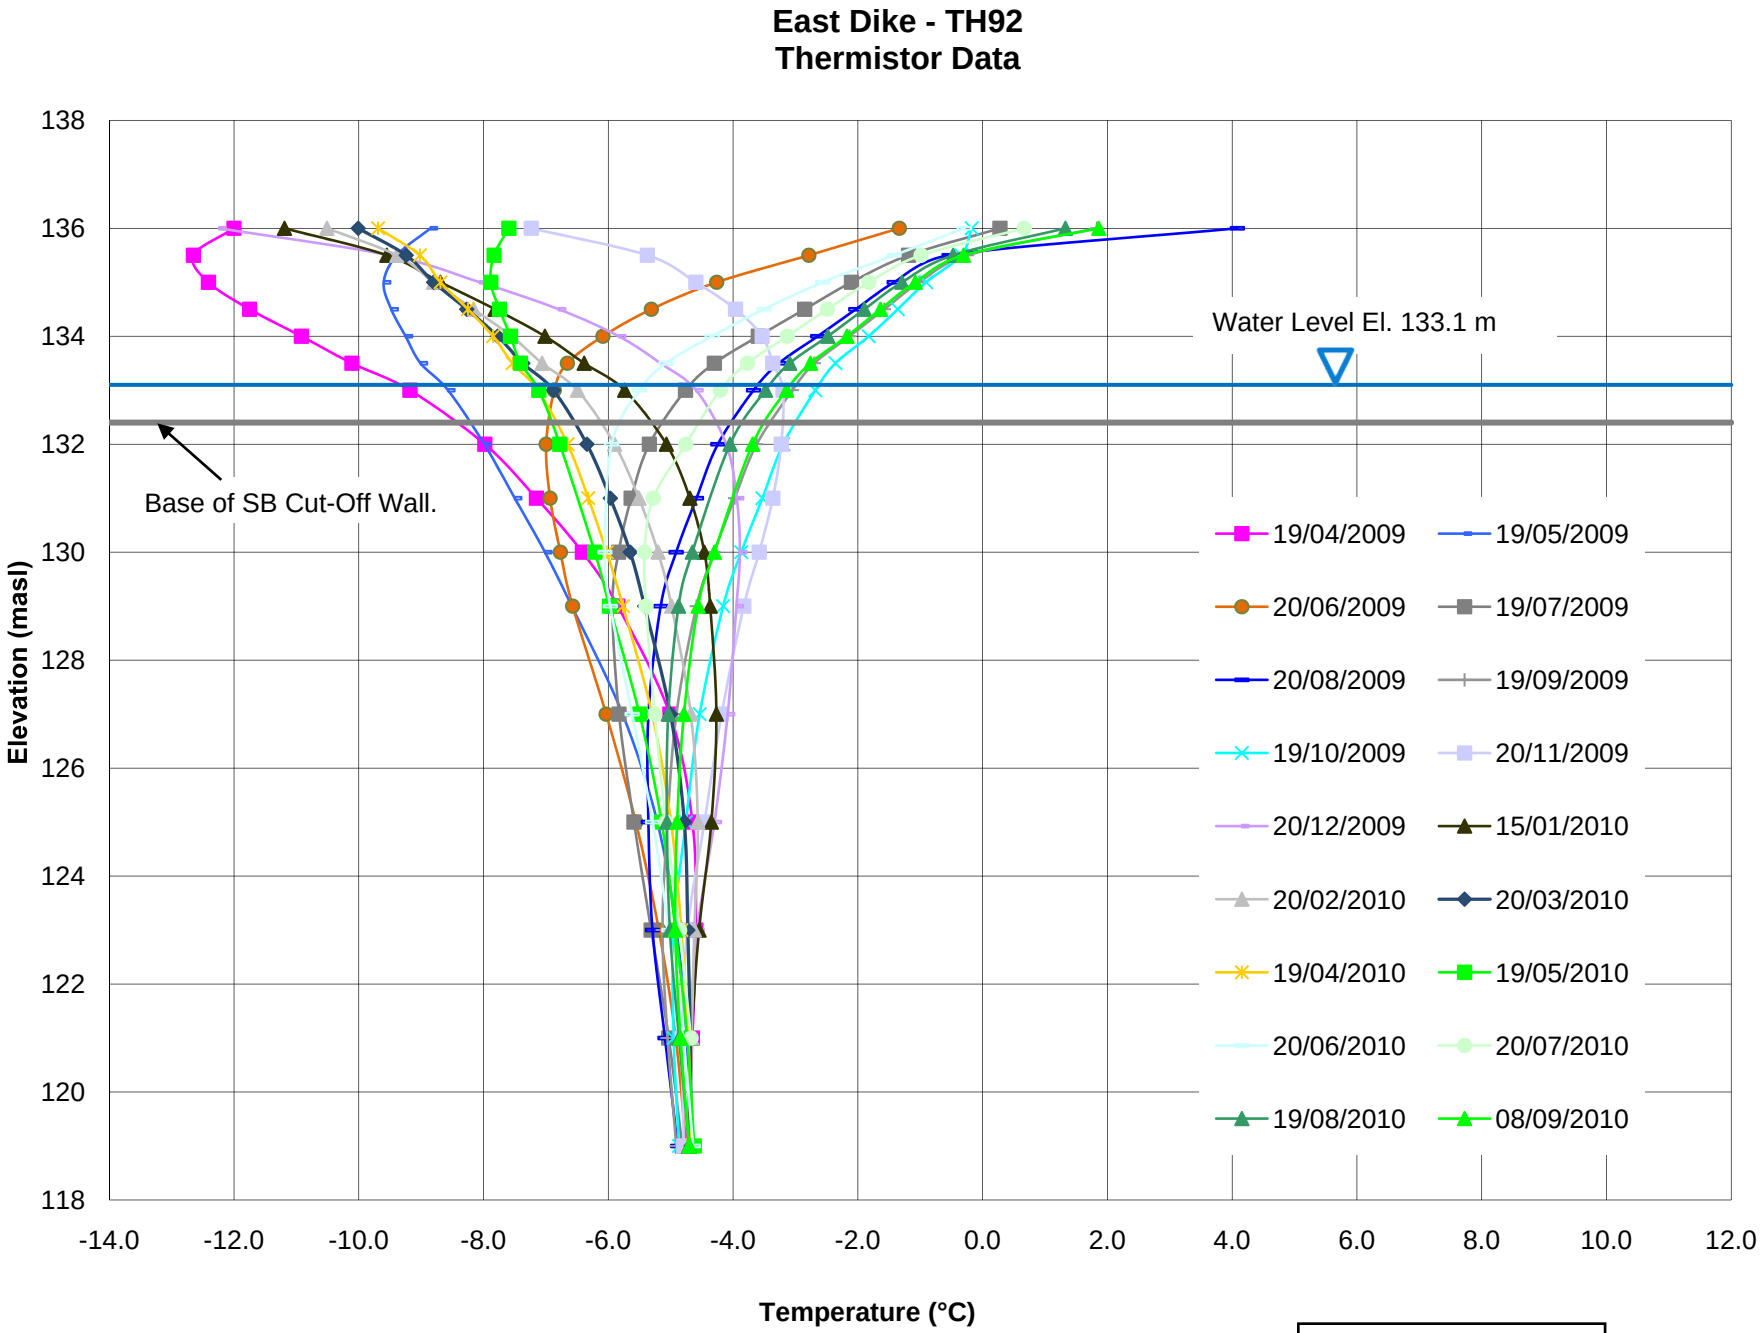
FIGURE C1-12

Note: Node 9 (El. 131 m) values since May 2010 are unstable and therefore not shown.

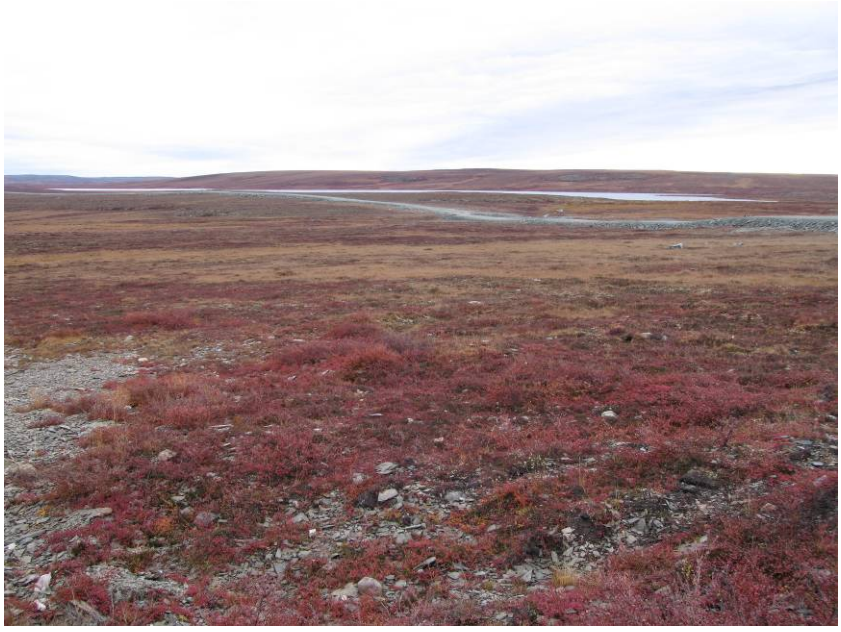
PHOTOGRAPH D1-2 – AWPR

Description: From Quarry 8 looking (km 43) north towards Meadowbank.

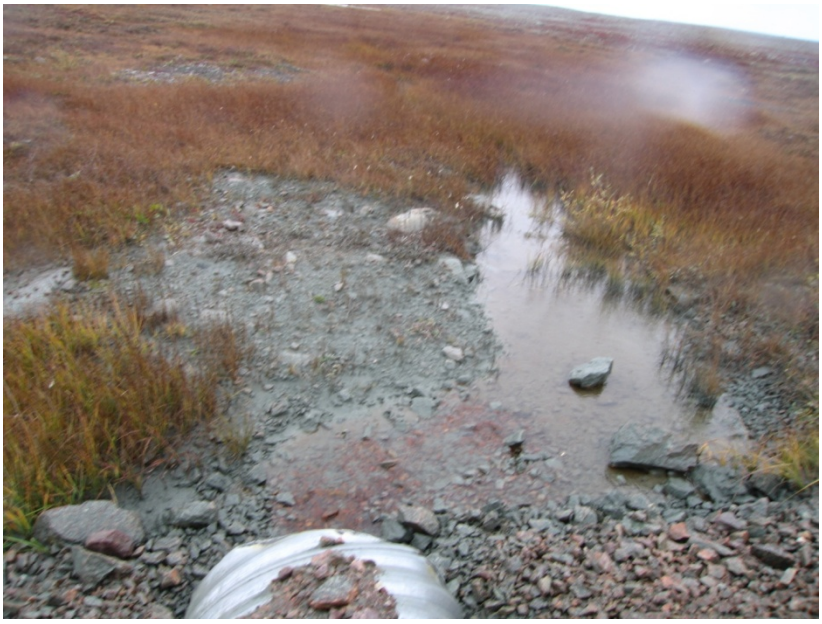
PHOTOGRAPH D2-3 – PRC-2, Km 0+470

Description: From upstream looking at culverts. Note both culverts have inflow.

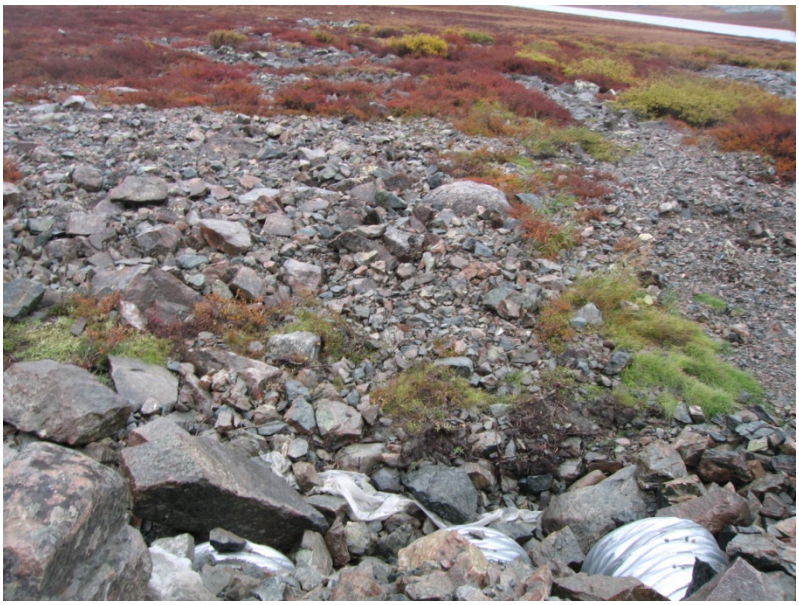
PHOTOGRAPH D2-18: 4 new culverts, approximately km 8+850

Description: Upstream view of culverts.

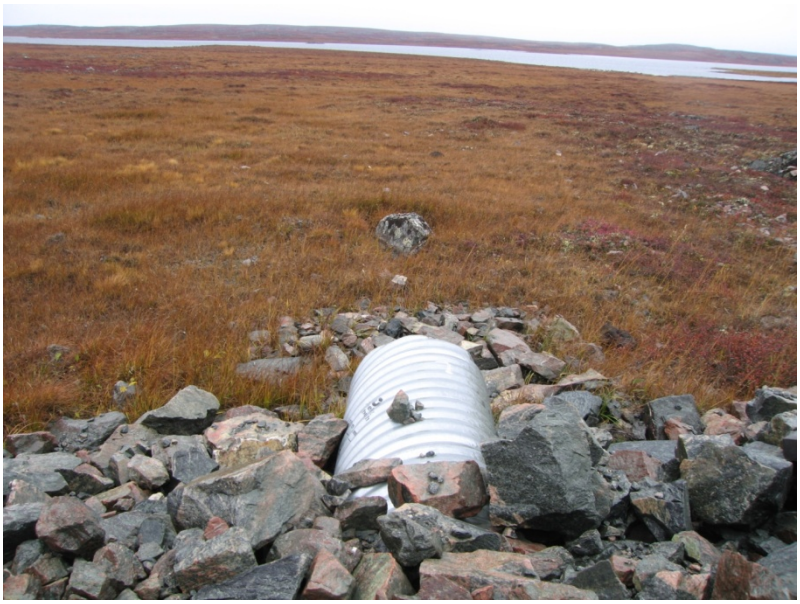
PHOTOGRAPH D2-28: PC-13, km 12+745

Description: From upstream looking at culvert. Culvert partially crushed at inlet.

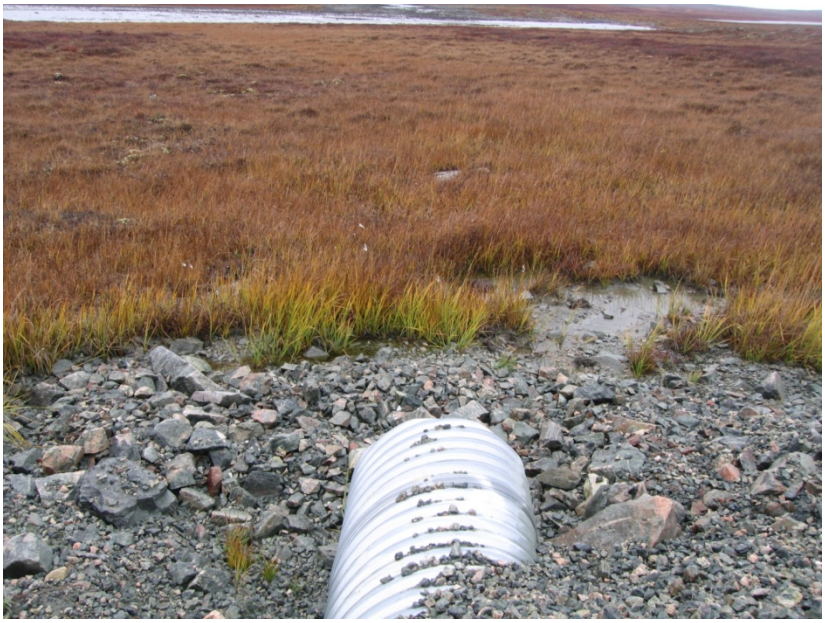
PHOTOGRAPH D2-42: PC-6, km 19+075

Description: Upstream view of culvert and valley. Good condition, uniform grade, no sign of erosion.

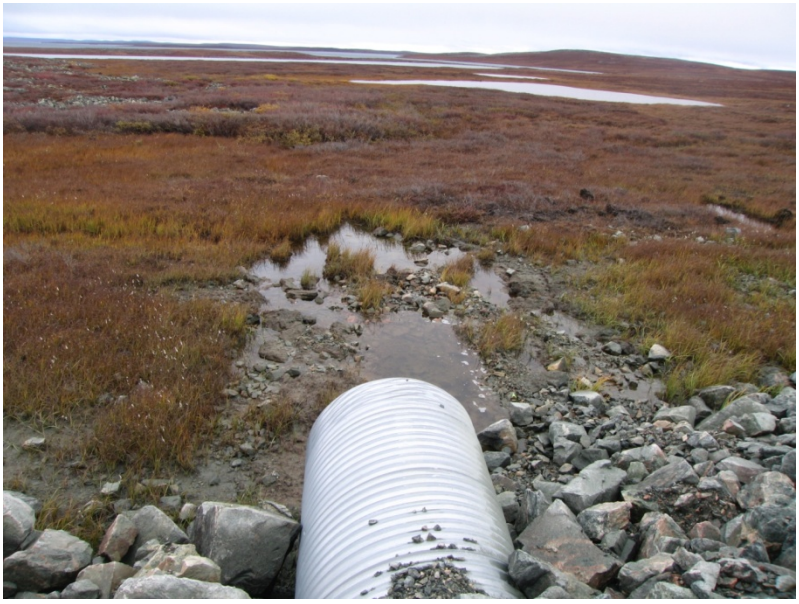
PHOTOGRAPH D2-45: PC-7, km 20+505

Description: Downstream view of culvert and valley.

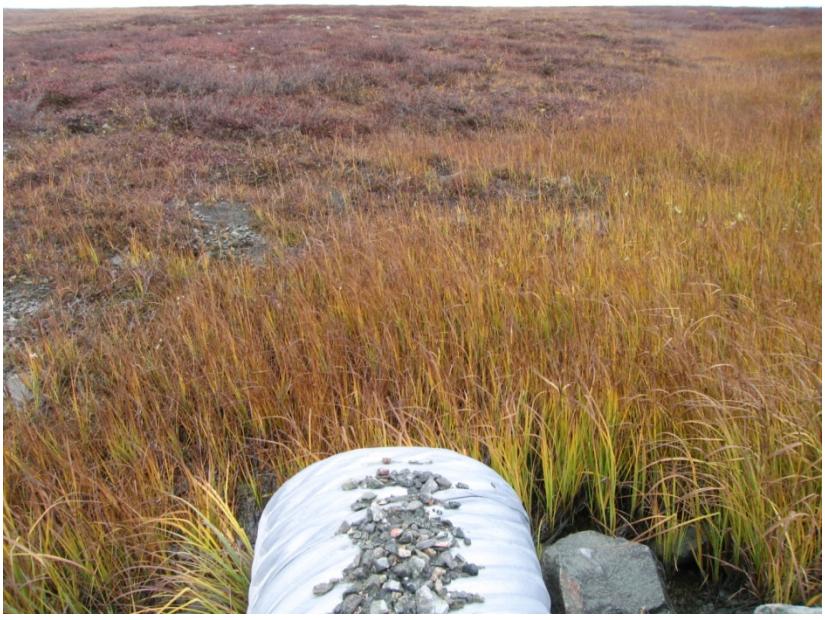
PHOTOGRAPH D2-47: R-07, km 25+900

Description: Downstream view of culvert and valley.

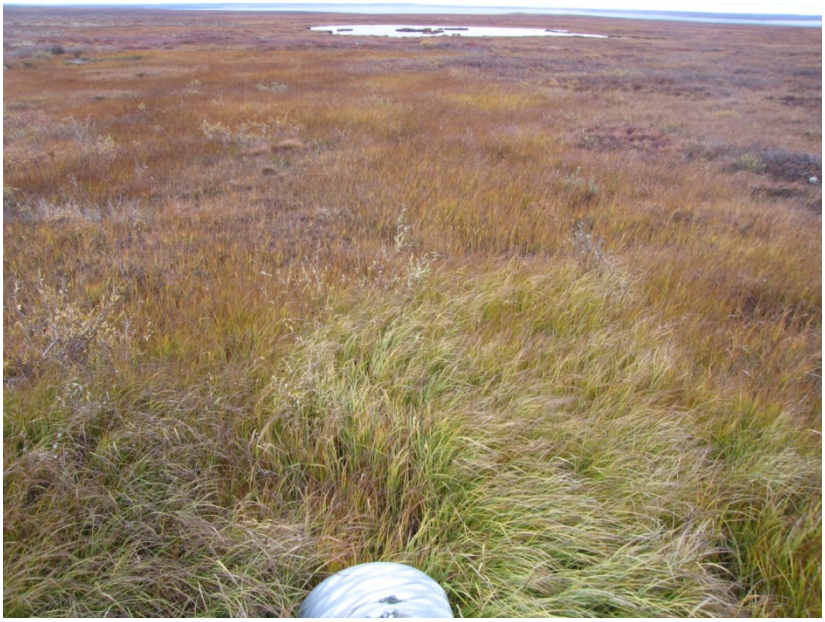
PHOTOGRAPHS D2-49: PC-8, km 29+785

Description: Upstream view of culvert and valley. Good condition, uniform grade, no obstruction, no sign of erosion.

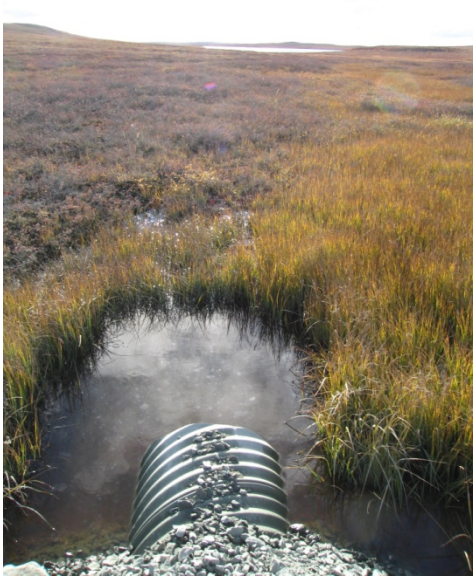
PHOTOGRAPH D2-55: PC-11, km 39+552

Description: From upstream to downstream view through culvert. Some gravel from road within culvert.

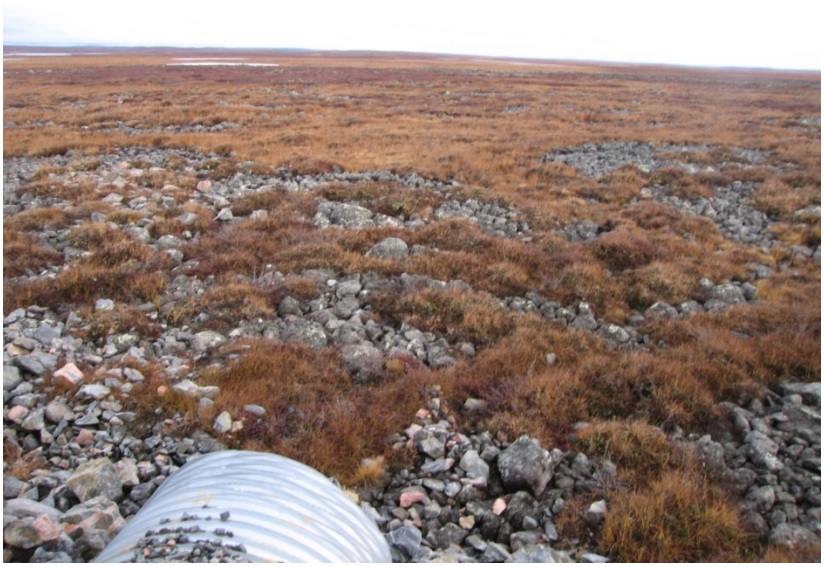
PHOTOGRAPH D2-63: R-14, km 67+840

Description: Downstream view of middle and left culverts.

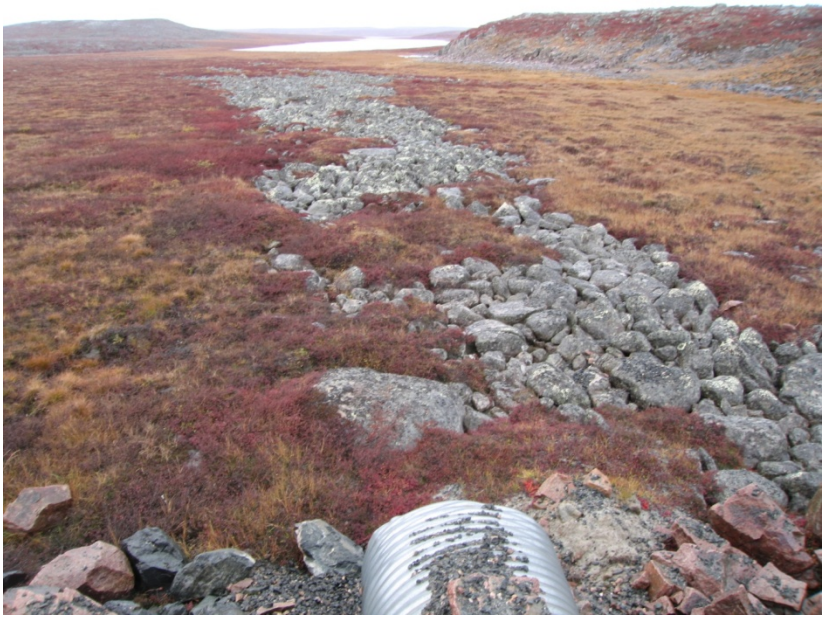
PHOTOGRAPH D2-68: R-18A, km 81+045

Description: Downstream view of culverts and valley.

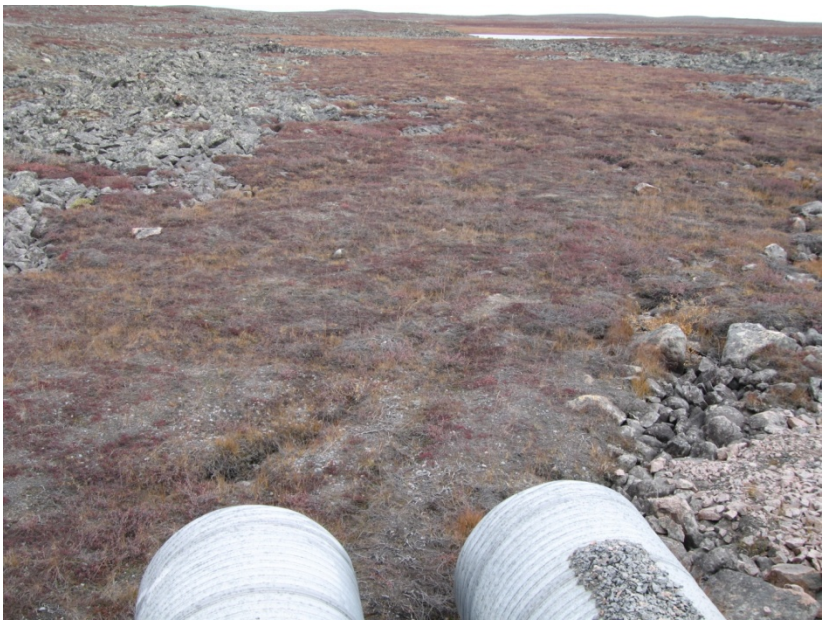
PHOTOGRAPH D2-70: R-20, km 85+490

Description: Downstream view of culvert and valley.

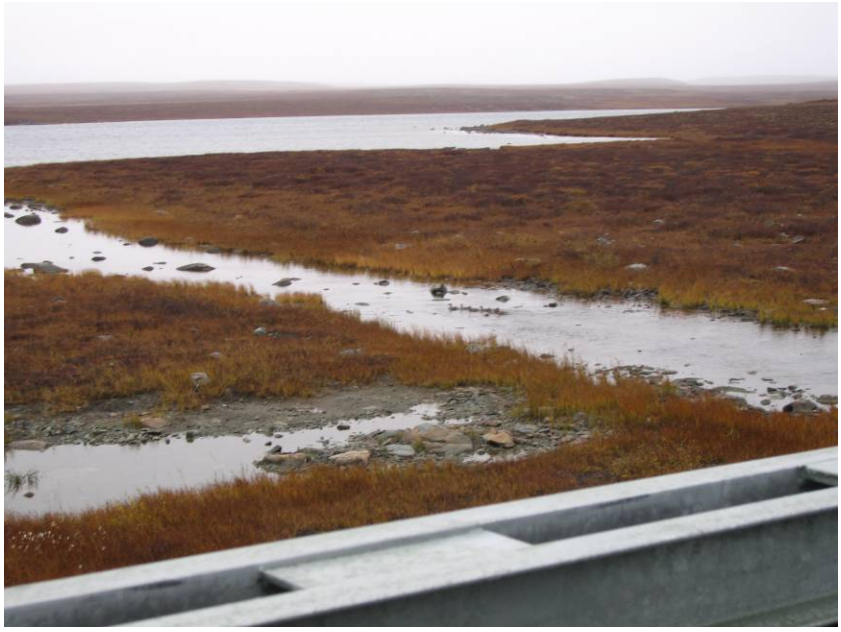
PHOTOGRAPH D3-9 – Bridge 1 - R02, km 8+750

Description: Downstream to upstream view, left abutment containment. Bent assumed during construction.

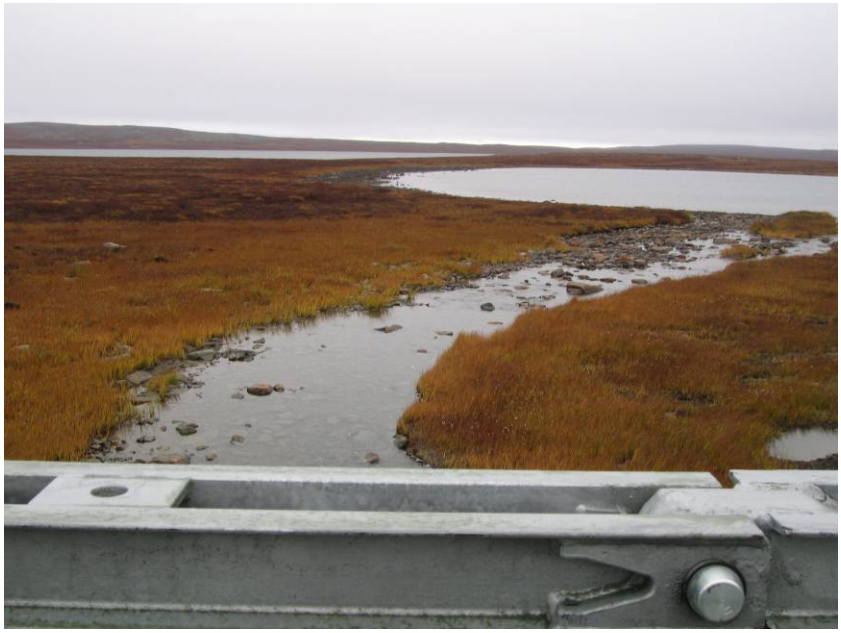
PHOTOGRAPH D3-11 – Bridge 2 - R05, km 17+600

Description: Upstream view from bridge deck, 30 m Acrow Panel Bridge. View of valley.

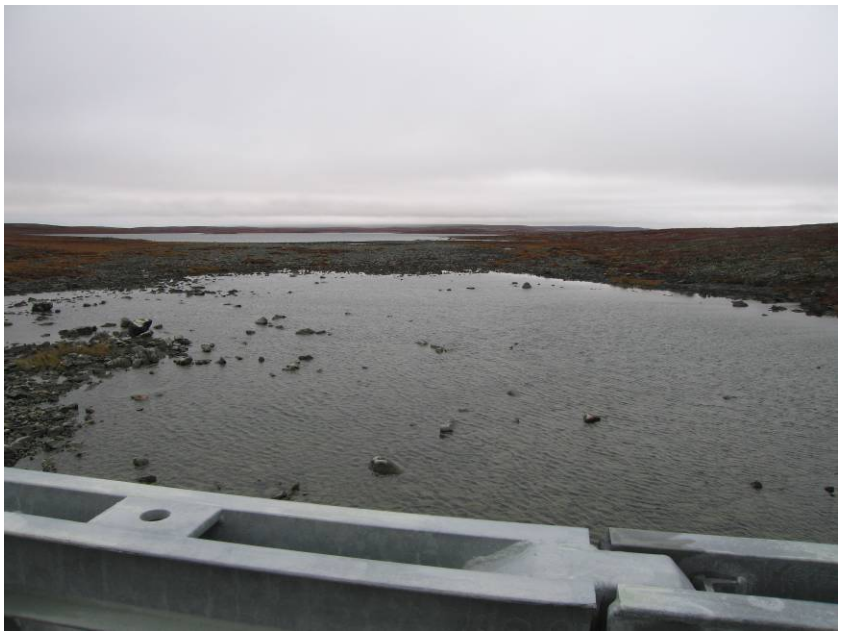
PHOTOGRAPH D3-15 – Bridge 2 - R05, km 17+600

Description: View from upstream to downstream of left abutment, note damage to containment but not a significant concern.

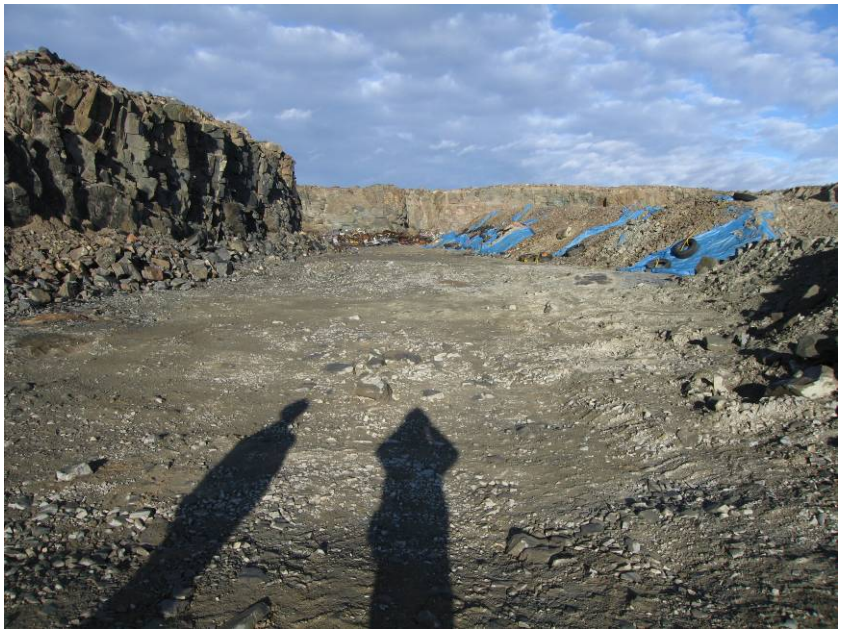
PHOTOGRAPH E-77 – Quarry 21

Description: Looking southwest.

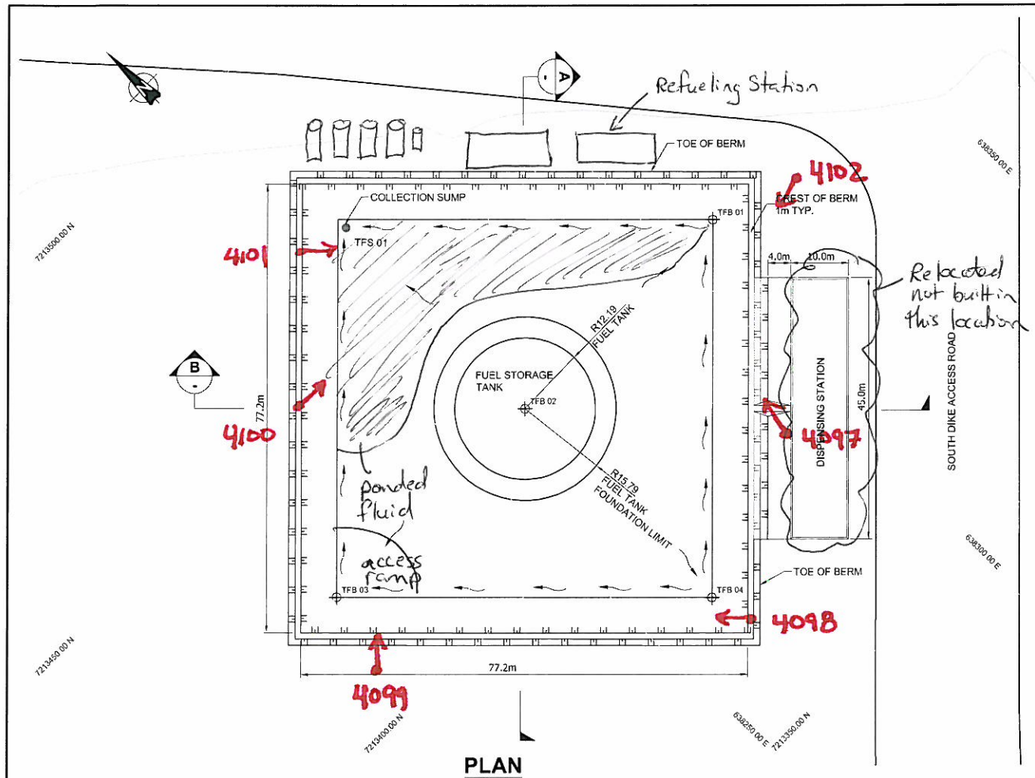
PHOTOGRAPH F2-5 – Meadowbank Tank Farm

Description: View of ponded fluid within the secondary containment area, looking southeast.
