REPORT

2012 Annual Geotechnical Inspection Meadowbank Gold Mine, Nunavut

Submitted to:
Agnico-Eagle Mines Limited
Meadowbank Division
PO Box 540
Baker Lake, Nunavut
X0C 0A0

Report Number: Doc 1394 1212210073 0115_13
Document Number: Geotechnical Inspection Ver 0 Rev1
Distribution:

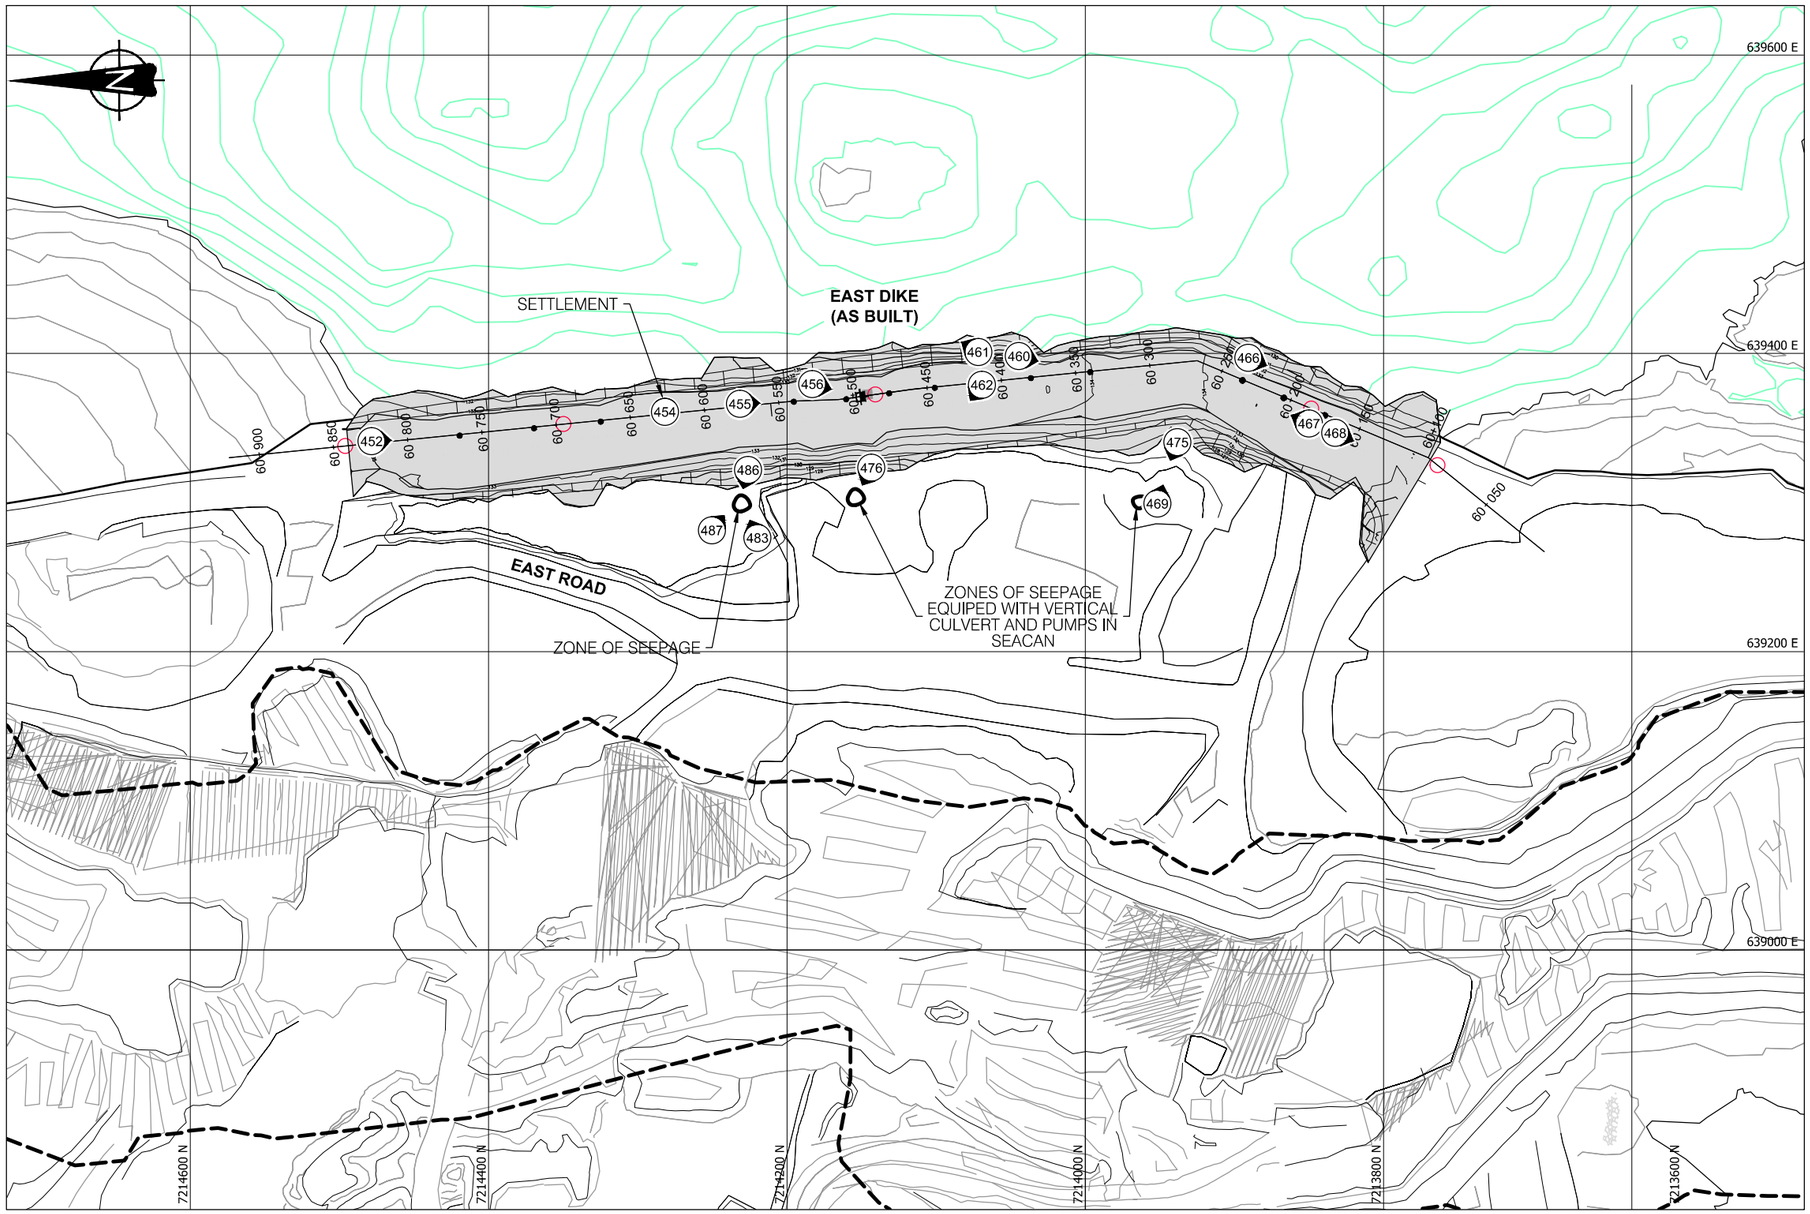
FIGURE A1

At the time of the 2012 inspection, no sign of cracking was observed in the vicinity of the 2009 sinkhole. A small circular depression was found 5 m downstream of the cut-off wall at the base of the berm near Sta. 60+554. The small circular depression is 450 mm long, 300 mm wide, 300 mm deep and is located in loose material probably pushed there by a grader and is not considered a concern. Due to the proximity of the depression to the 2009 sinkhole, periodic visual monitoring is recommended.

In 2011, the downstream seepage at Sta. 60+498 had been stable at a rate of about 864 m^3/day (10 L/s) with no visual signs of turbidity, which was consistent with rates recorded during previous years. In 2011, the seepage downstream at Sta.60+247 appeared stable at around 345.6 m^3/day (4L/s) with no visual signs of turbidity noted, which was consistent with previous rates. At the time of the inspection, all seepage was being captured within the sumps and no sign of additional seepage on the ground surface or downstream in the Portage Pit was observed. No active monitoring of the seepage rate at these locations occurred in 2012 but AEM has been visually inspecting the flow in the sumps and no turbidity was noted. It is understood that AEM performed a pump test after the installation of the sumps, it was noted that the measured flow were consistent with 2010 and 2011 data. It is recommended to measure the flow and assess the turbidity. It is understood that flow meters are going to be installed at the exit of each pump.

A third zone of seepage at Sta. 60+575 was observed during the inspection. During previous inspections a small seepage in this area was also observed. In 2011, the flow rate measured about 86.4 m^3/day (1 L/s). At the time of the inspection the seepage was being monitored every 3 days and the flow was between 1.2 to 2.5 m^3/day (0.014 to 0.029 L/s). It is recommended to continue monitoring the flow.

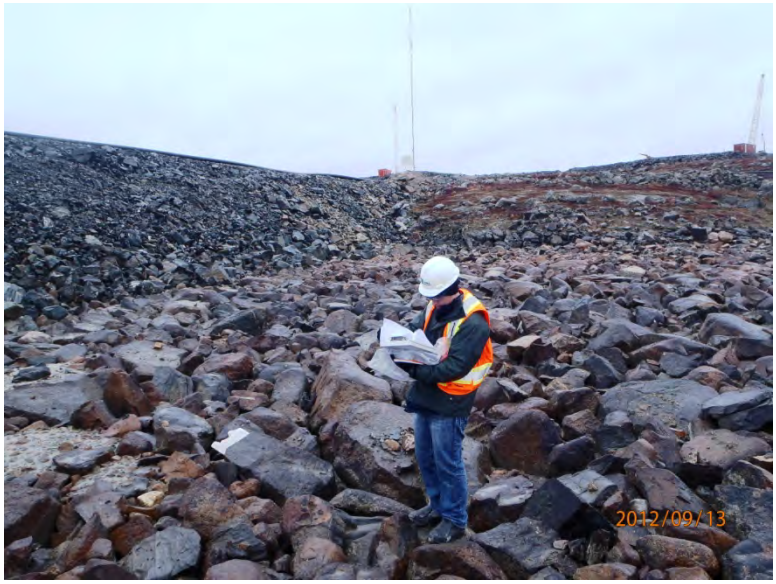
Description: Observation of water between boulders at the downstream toe.

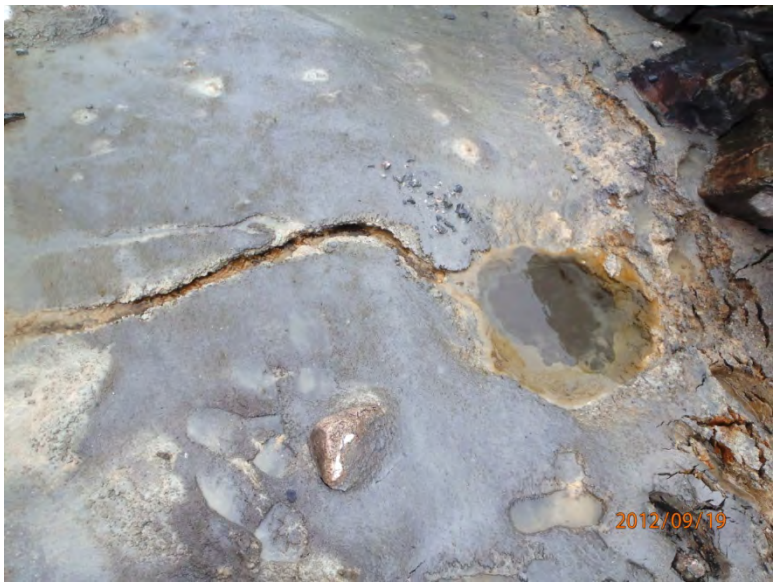
Description: Close-up on the north channel seepage at Sta. 30+378. Notice the pipe used to monitor the flow.

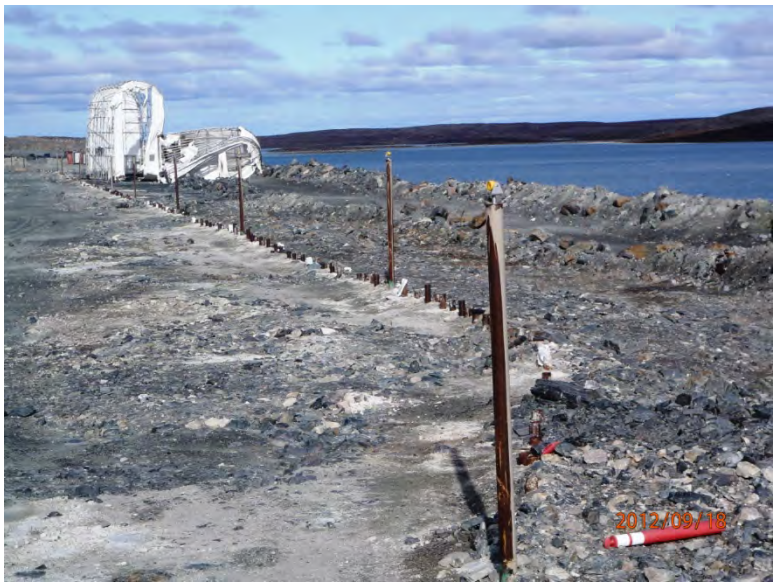
Description: Depression on the crest 4 m from centreline at Sta. 31+130.

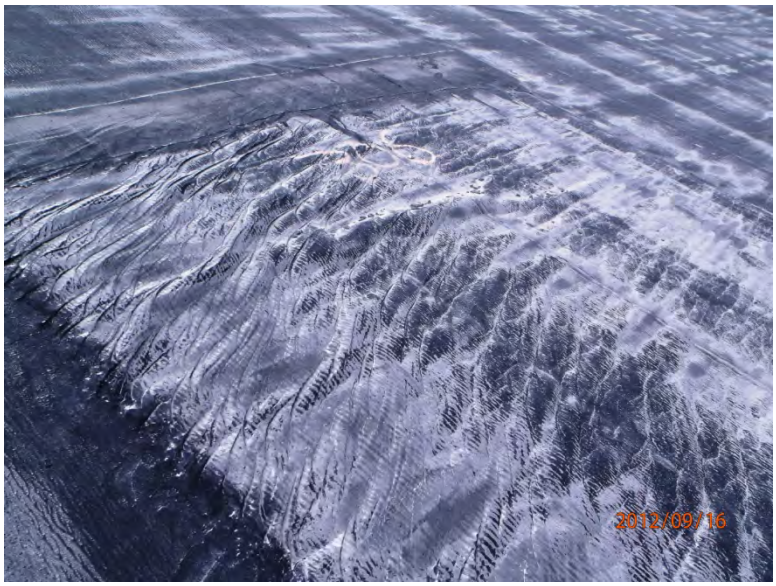
Description: Looking at three holes identified in the liner at Sta.10+242 at El. 147m.

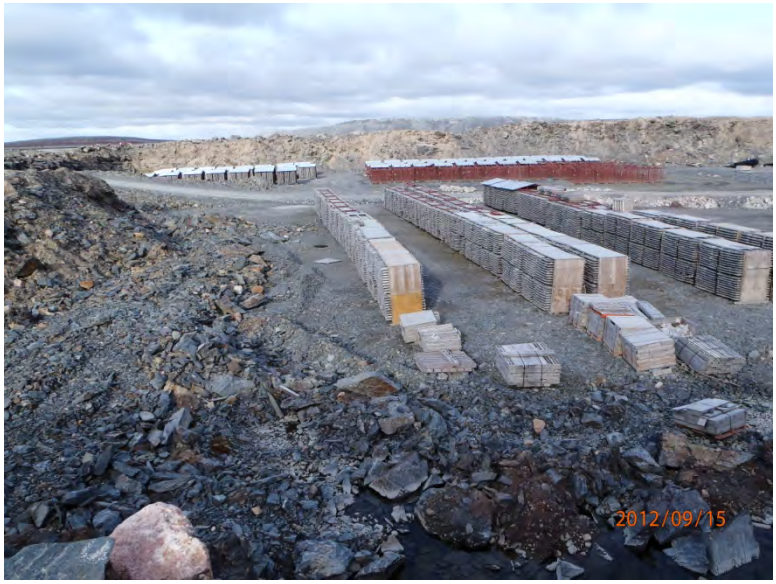
Description: Looking at the northeast wall. Note the presence of contaminated soil temporary stored inside the quarry.
