Attachment 8.1 – Site Assessment of North Railway Alignment, October 4, 2017

Site Assessment of North Railway Alignment

H352034-1000-220-068-0001

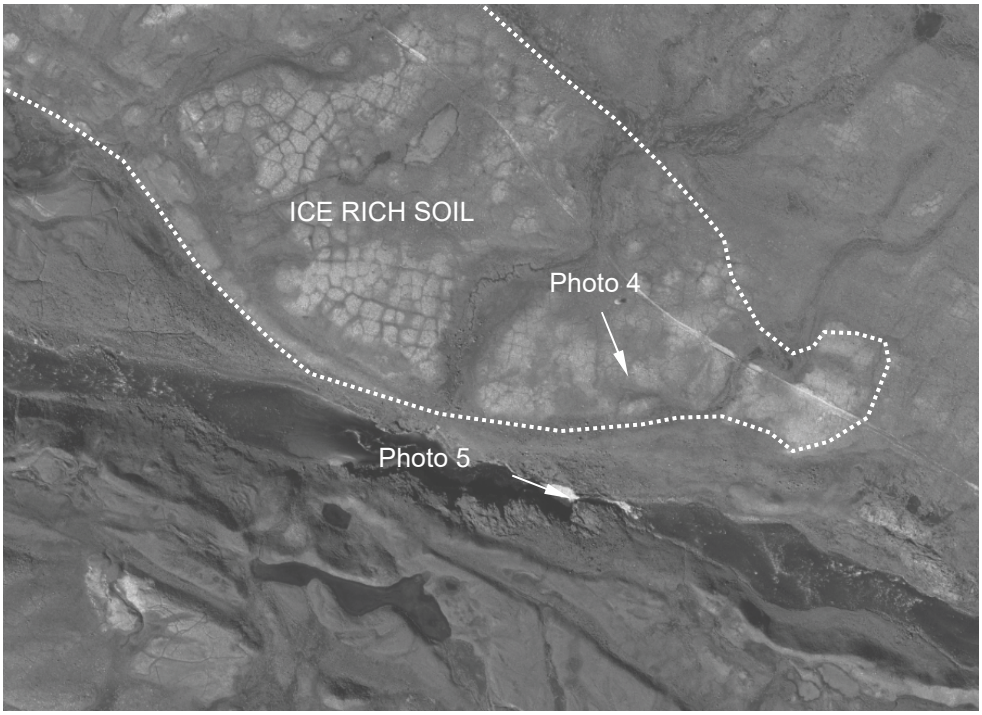
Figure 3-1: Ice Rich Soil Near CH 10+500

Photographs 4 and 5 show the upstream and downstream reaches of Phillips Creek near the waterfall located at CH 10+800. See also Figure 3-1. These photographs (i.e., 4 and 5) show outcropping granitic bedrock in Phillips Creek and ice rich soils situated immediately east of the creek. Between CH 0+000 and 12+000, similar granitic outcrops occur periodically between Philips Creek and the granitic ridge. Referring to Drawing H352035-GEOSKT-229-292-000, Sheet 1 of 4, there are several pre-existing permitted granitic quarries within this segment of the railway as denoted by the diamond (♦) symbols.
