Hope Bay Mining Ltd.
Suite 300
889 Harbourside Drive
North Vancouver, BC
V7P 3S1
T 604.985.2572
F 604.980.0731
www.newmont.com

July 22, 2011

RE: 2BB-BOS0712 Orbit 25 Drill Rig Brine and Cuttings Spill Clean-Up Activities and Preliminary Restoration Plan

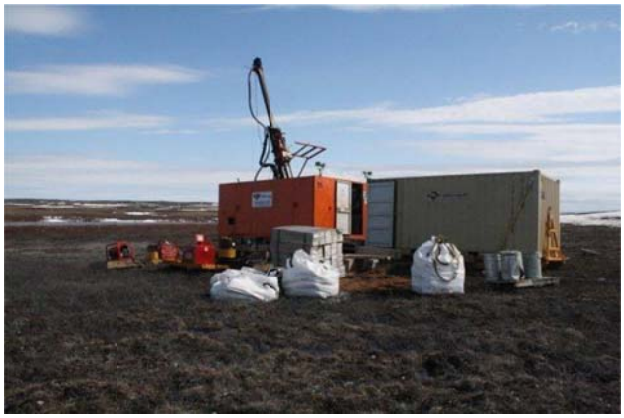
Photos for the Orbit 25 drill rig taken in early June 2011, prior to vegetation greening, were provided to the Hope Bay site management team upon request for information on the drill. Cuttings are evident on the eastern downhill slope of the drill, but salt burns are not evident.

Early June 2011. View west toward Orbit 25 Drill Rig prior to greening of vegetation.	Early June 2011. Aerial view north toward toward Orbit 25 Drill Rig. Cuttings spill evident.
