# 2BE-PEL0813 Inspection August 11, 2012
# Photos

## Amaruk Airstrip

## Amaruk Camp

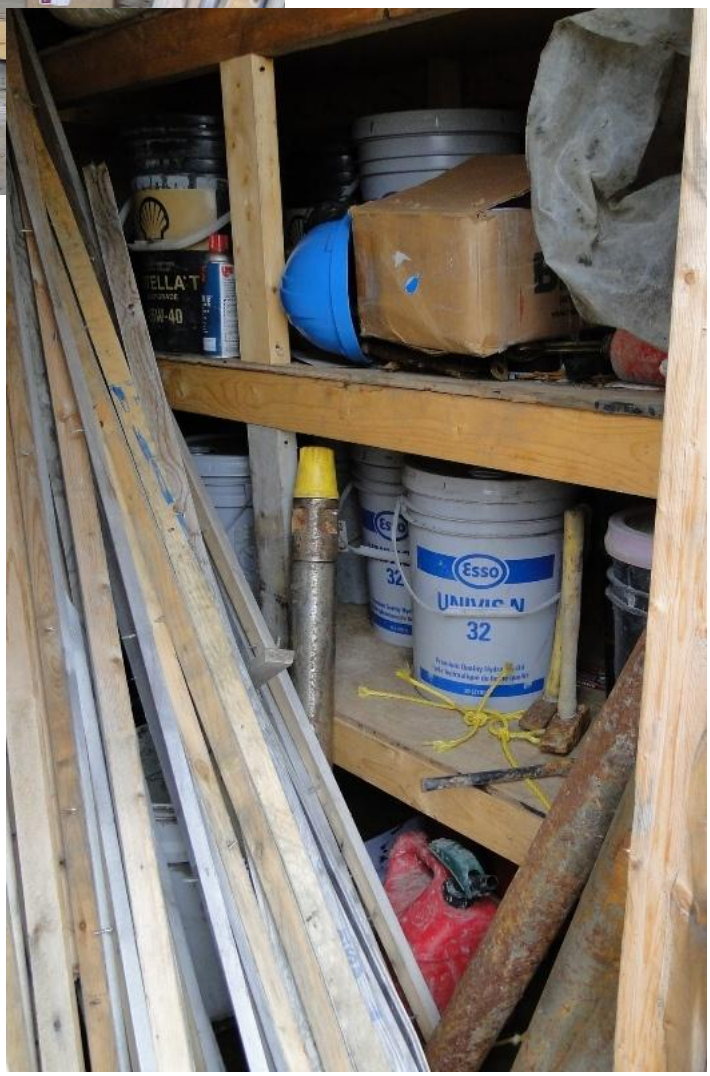
Figure 14. Right side of shed with oil pails and jerry can visible.

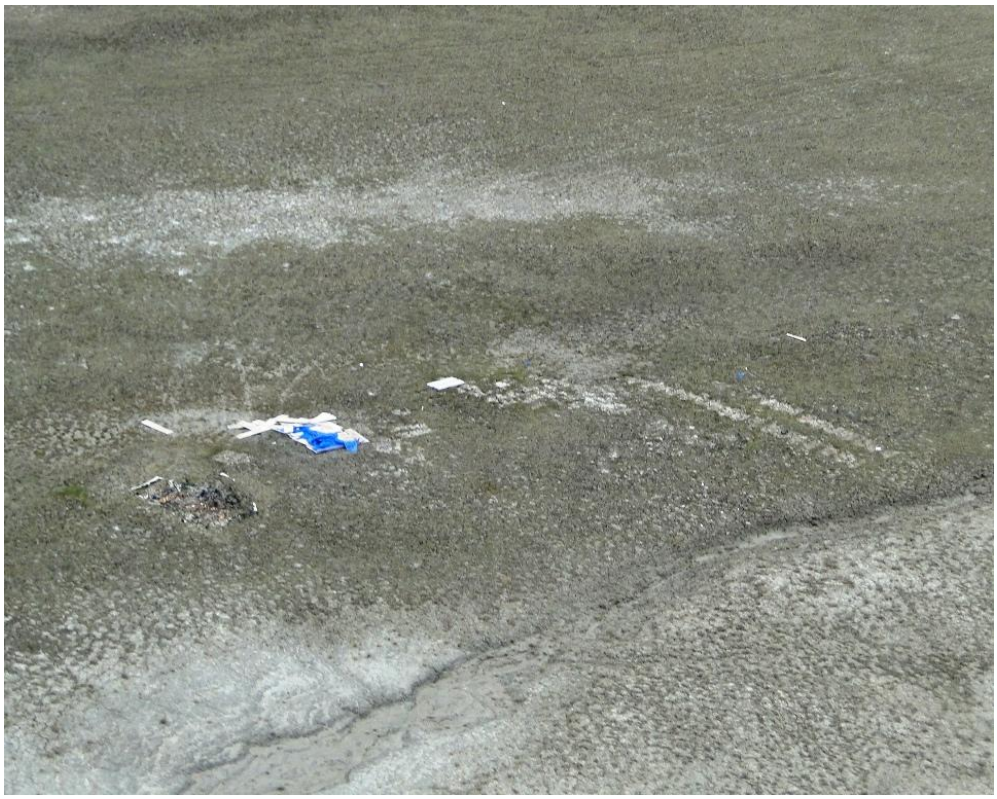
Figure 20. Qavvik cache.  Ashes, waste, and barrel imprints visible.
