Water Licence Inspection Report

Authorization	Representative
WhiteCliff Minerals	**Eric Sondergaard**
Authorization No. / Expiry	**Representative's Title**
2BE-RCE2532	
Inspection Date	**Inspector**
July 02, 2026	**Isaiah James Bolt**
Other Authorization/s	
N2024C0029	
Activities Inspected	
☐**Municipal** ☒ **Camp, Commercial** ☐ **Drilling** ☐ **Mining** ☐ **Construction** ☐ **Reclamation** ☒ **Fuel Storage** ☐ **Roads/Hauling** ☐ **Winter Hauling** ☐ **Camp, Private** ☐ **Other** Click or tap here to enter text.

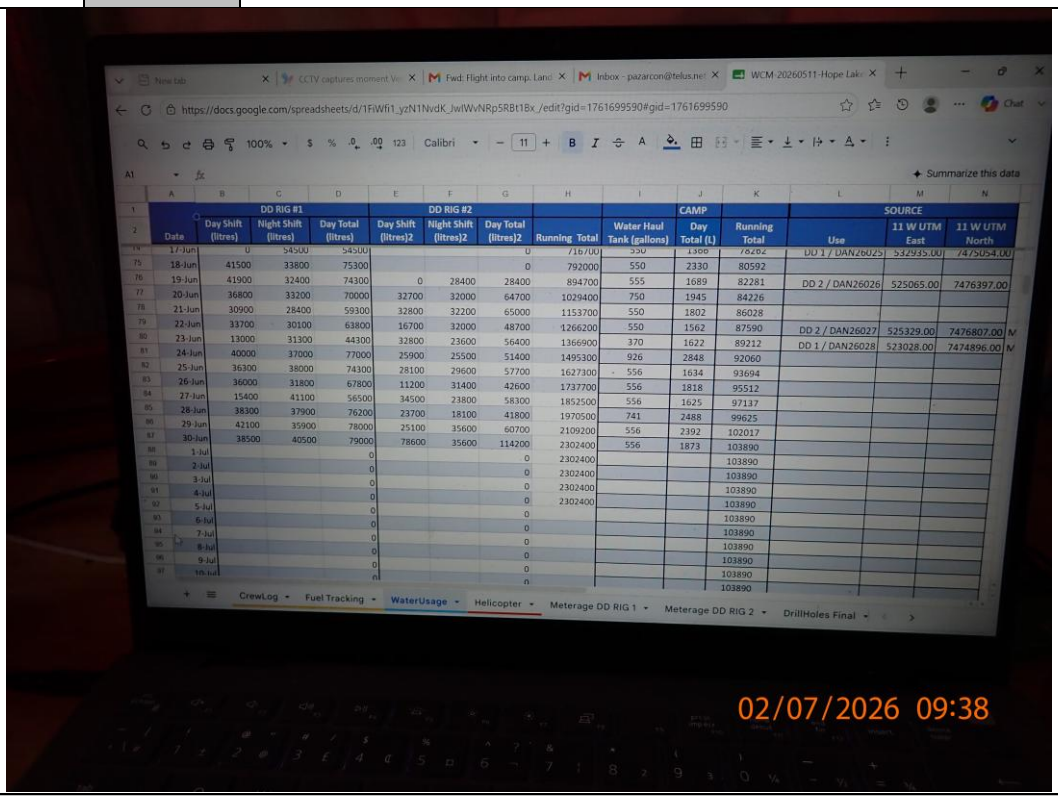
Photo #	9	Coordinates:

8. Grey water discharge location was observed. No concerns noted (Photo #8).
9. A photo of the water usage log was taken (Photo #9). Based on the water logs and the total allowable withdrawal limits found in the license the proponent is well within their daily limits.

Water Usage Log, including drills and camp.
