# Water Licence Inspection Report

| Authorization | Representative |
|---|---|
| **Municipality of Cambridge Bay** | **Beni Gatsoundou** |
| **3BM-CAM2030** | **Assistant SAO** |
| **August 26, 2026** | **Jonathan Mesher** |

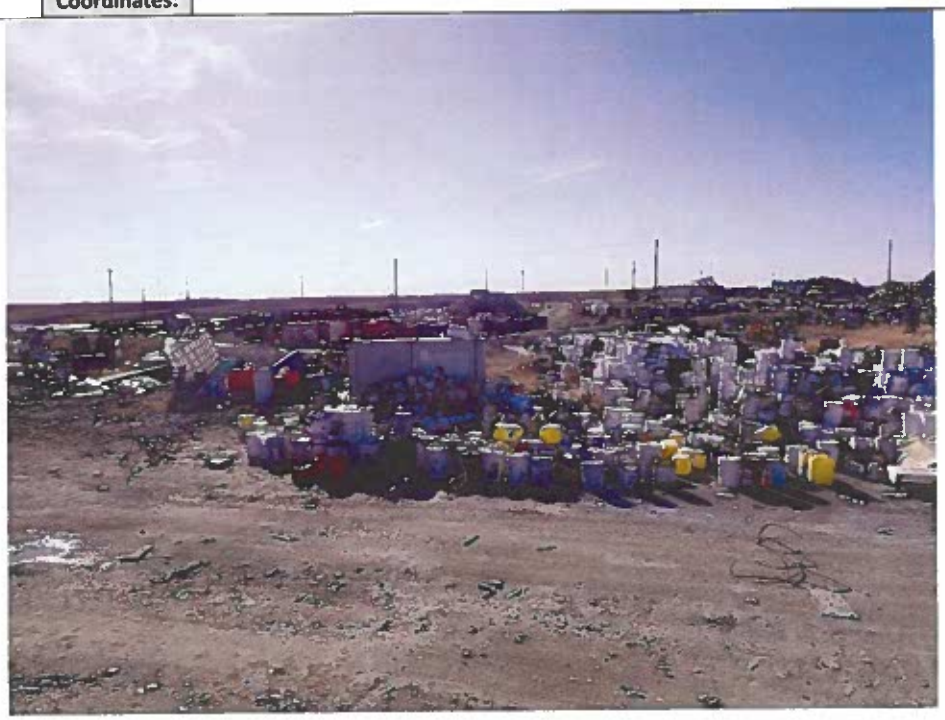
| Photo # | 2 | Coordinates: | 3BM-CAM2030 municipal Landfill |

b) The licensee has not been separating burnable waste from non-burnable waste and is indiscriminately burning wa Section 5.2 of the operation and maintenance manual states "Materials such as cardboard, untreated wood prod natural fiber textiles should be diverted to the burn pit." see photos 1 and 2 for the lack of separation between no burnable waste.

d) Section, 6.4 Litter Control, states the following "Limit the size of operating areas so that waste can be compacted and covered at regular intervals;" and "The Landfill Operator shall regularly collect litter from the site, surrounding areas and along access roads." The licensee is not cover the waste and it does not appear they are collecting litter around the surrounding areas. See photos 1 and 2 for the lack of cover material causing windblow litter.

The licensee has not notified the inspector or provided the required information described in Part D, item 10 of the licence 3BM-CAM2030. See photos 2 and 3 for photos of open burning at the landfill.

Landfill not managed as approved and burning of materials not approved in the licence.

b. The licensee to ensure open burns only occur as approved and the required information regarding the open burn is provided in the annual report and the notice to the inspector.

c. The licensee is to start piling, compacting and covering the waste as described in the Hamlet of Cambridge Bay Municipal Solid Waste Disposal Facility Operation and Maintenance Manual. If the licensee believes they are unable to comply with this requirement of the license they will need to contact the Nunavut Water Board to get approval to manage the landfill in a different manner.

d. The licensee is to pick up the windblown litter surrounding the landfill as described in section 6.4 of the Hamlet of Cambridge Bay Municipal Solid Waste Disposal Facility Operation and Maintenance Manual.
