2017 Annual Geotechnical Inspection

2017 Annual Geotechnical Inspection Meadowbank Gold Mine, Nunavut

Report Number: 1784282-1574-RPT-Rev0

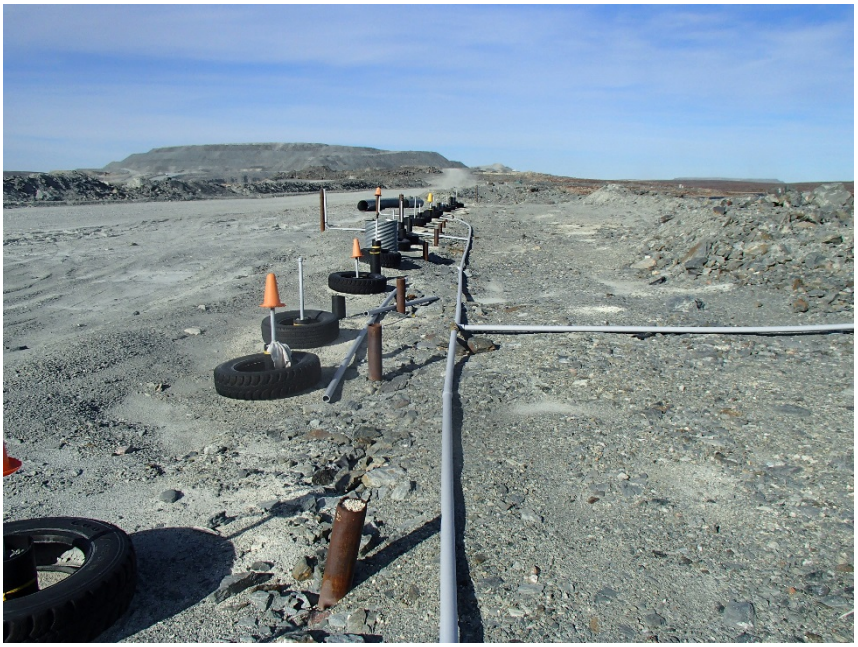
Photograph A1-1 East Dike

Description: From approximately Sta. 60+375, looking south at the crest.

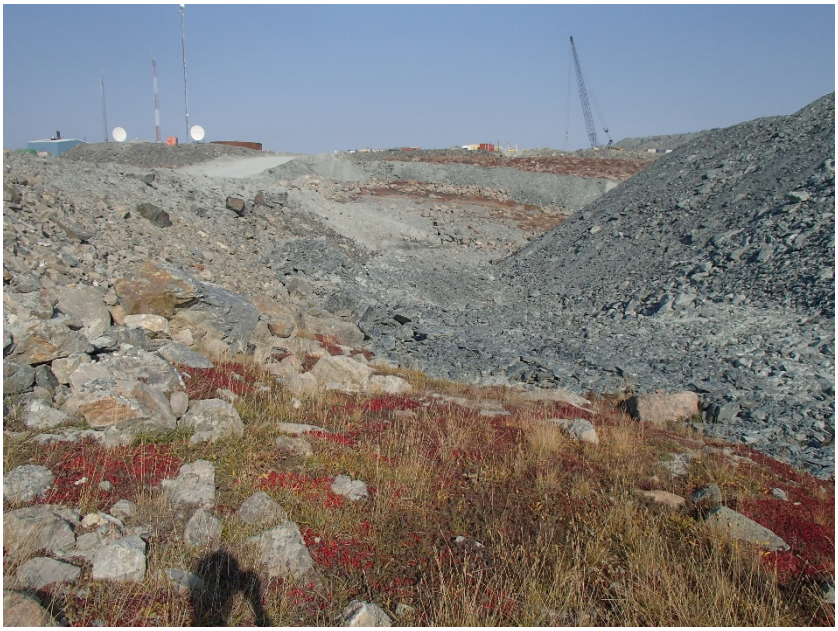
Photograph A2-4 South Camp Dike

Description: From the north abutment, looking south at the crest.

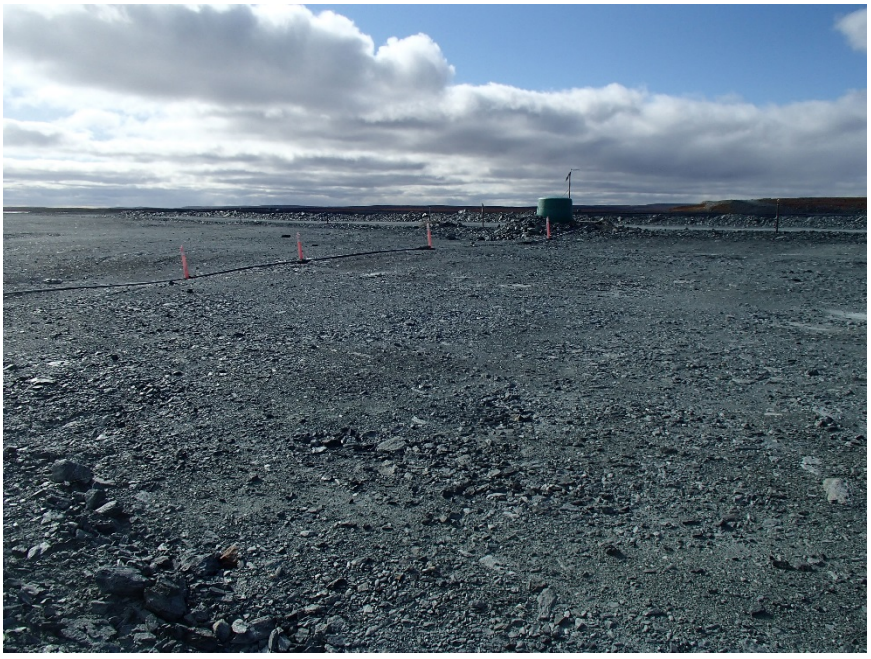
Photograph A3-16 Bay Goose Dike

Description: From approximately Sta. 31+080 on the crest, looking north at the downstream slope and toe.

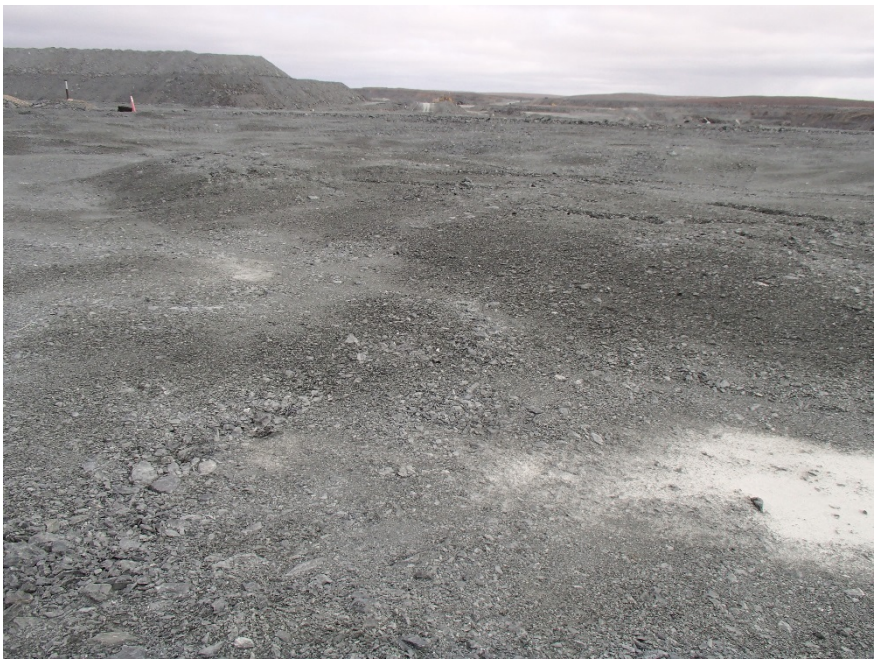
Photograph A3-41 Bay Goose Dike

Description: From approximately Sta. 32+030 looking southwest at the crest.

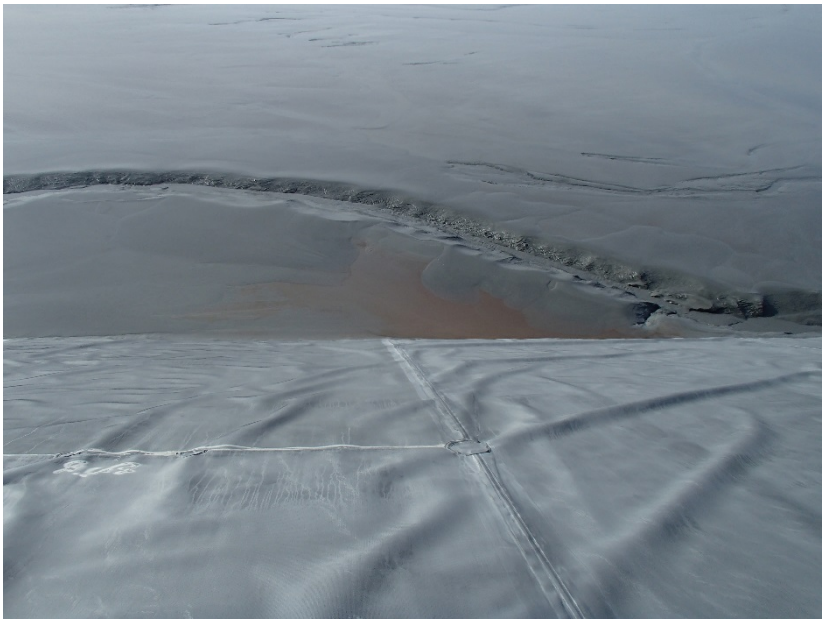
Photograph B1-15 Tailings Storage Facility

Description: From the northern abutment of Central Dike, looking west at the South Cell.

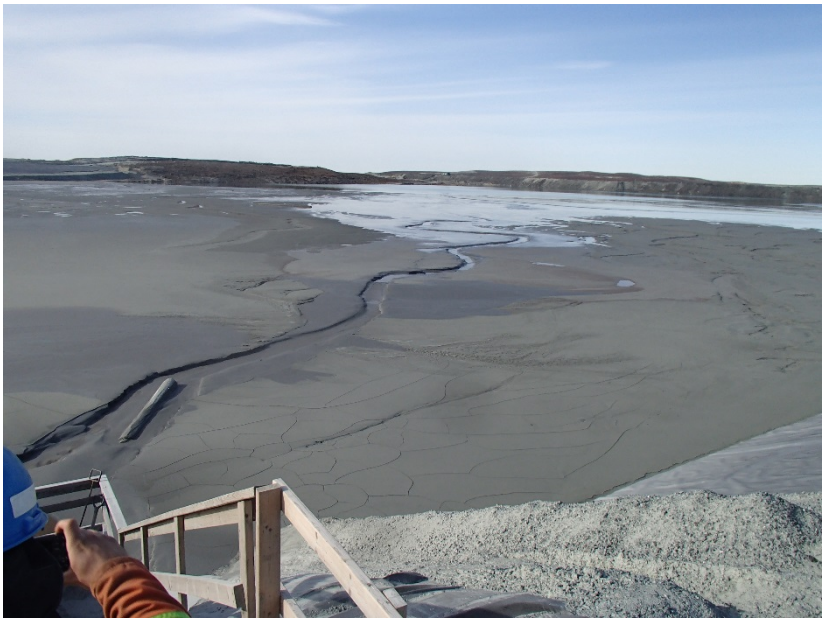
Photograph B1-17 Tailings Storage Facility

Description: From Central Dike looking west at the South Cell. A small pond with an orange colour is present in the tailings.

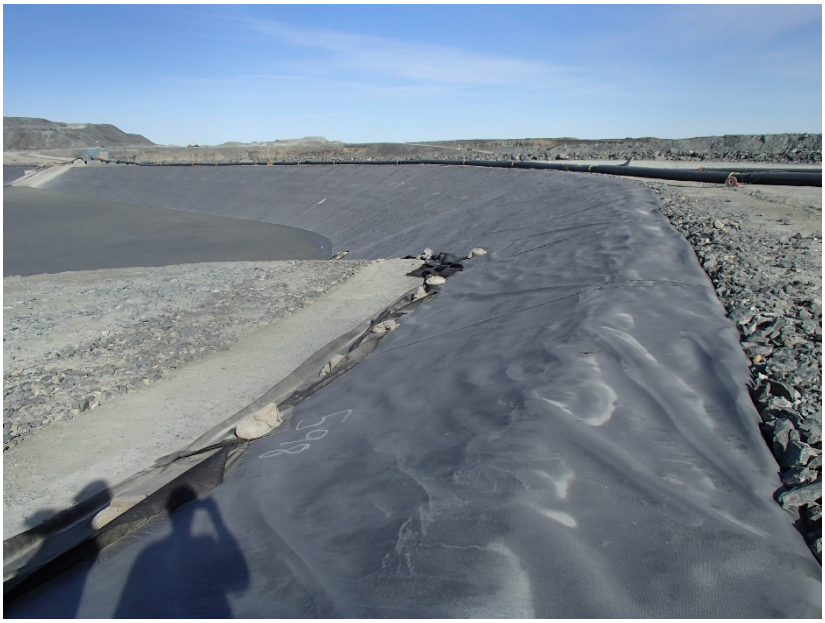
Photograph B1-18 Tailings Storage Facility

Description: From Central Dike looking west at the South Cell towards Saddle Dam 5.

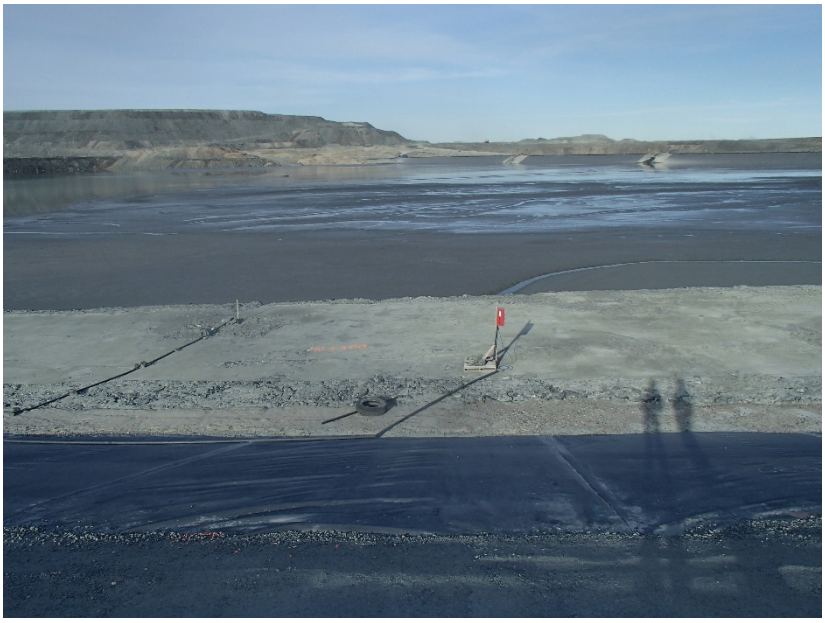
Photograph B1-19 Tailings Storage Facility

Description: From Central Dike looking north at Central Dike and the South Cell.

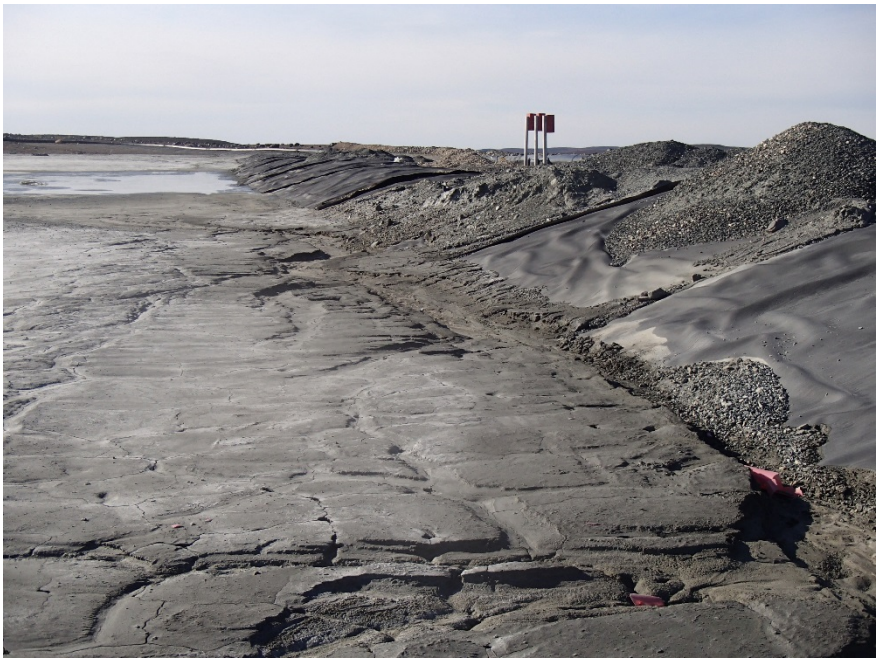
Photograph B2-4 Saddle Dam 1

Description: From approximately Sta. 0+225, looking south at the crest.

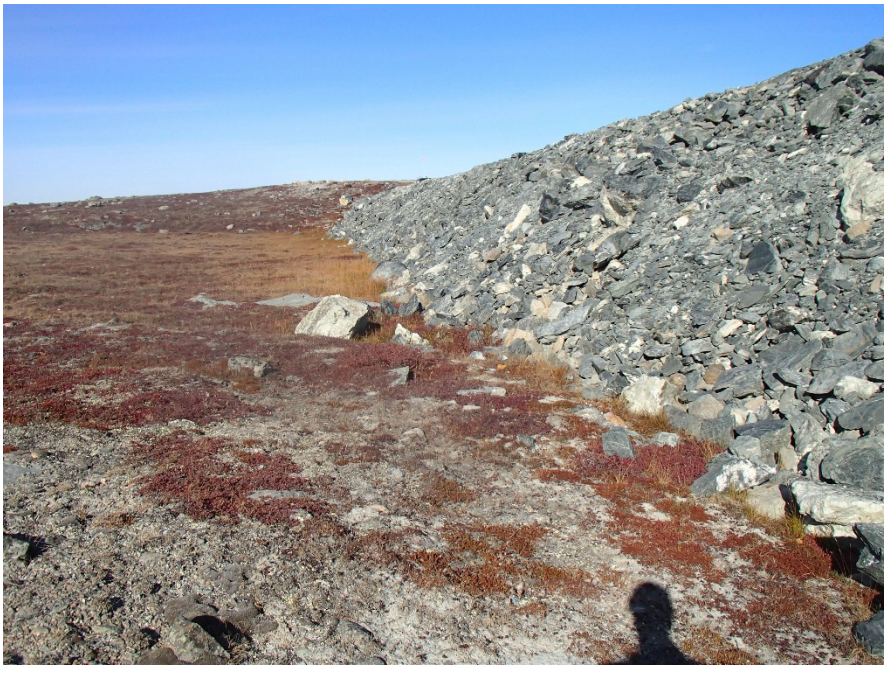
Photograph B3-2 Saddle Dam 2

Description: From approximately Sta. 20+370 looking southeast at the crest and upstream slope.

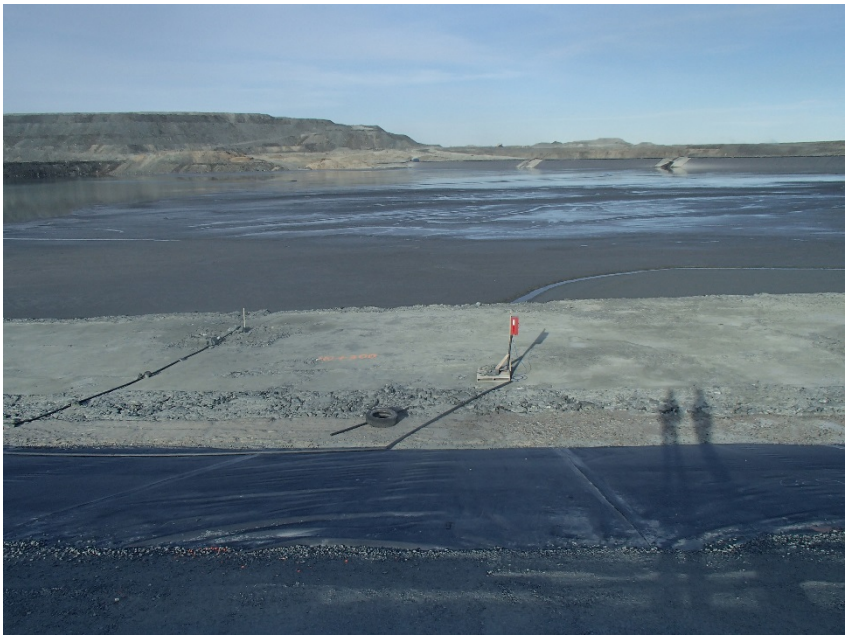
Photograph B6-2 Saddle Dam 4

Description: From 40+150 approximately, looking southeast at the crest and the downstream slope.

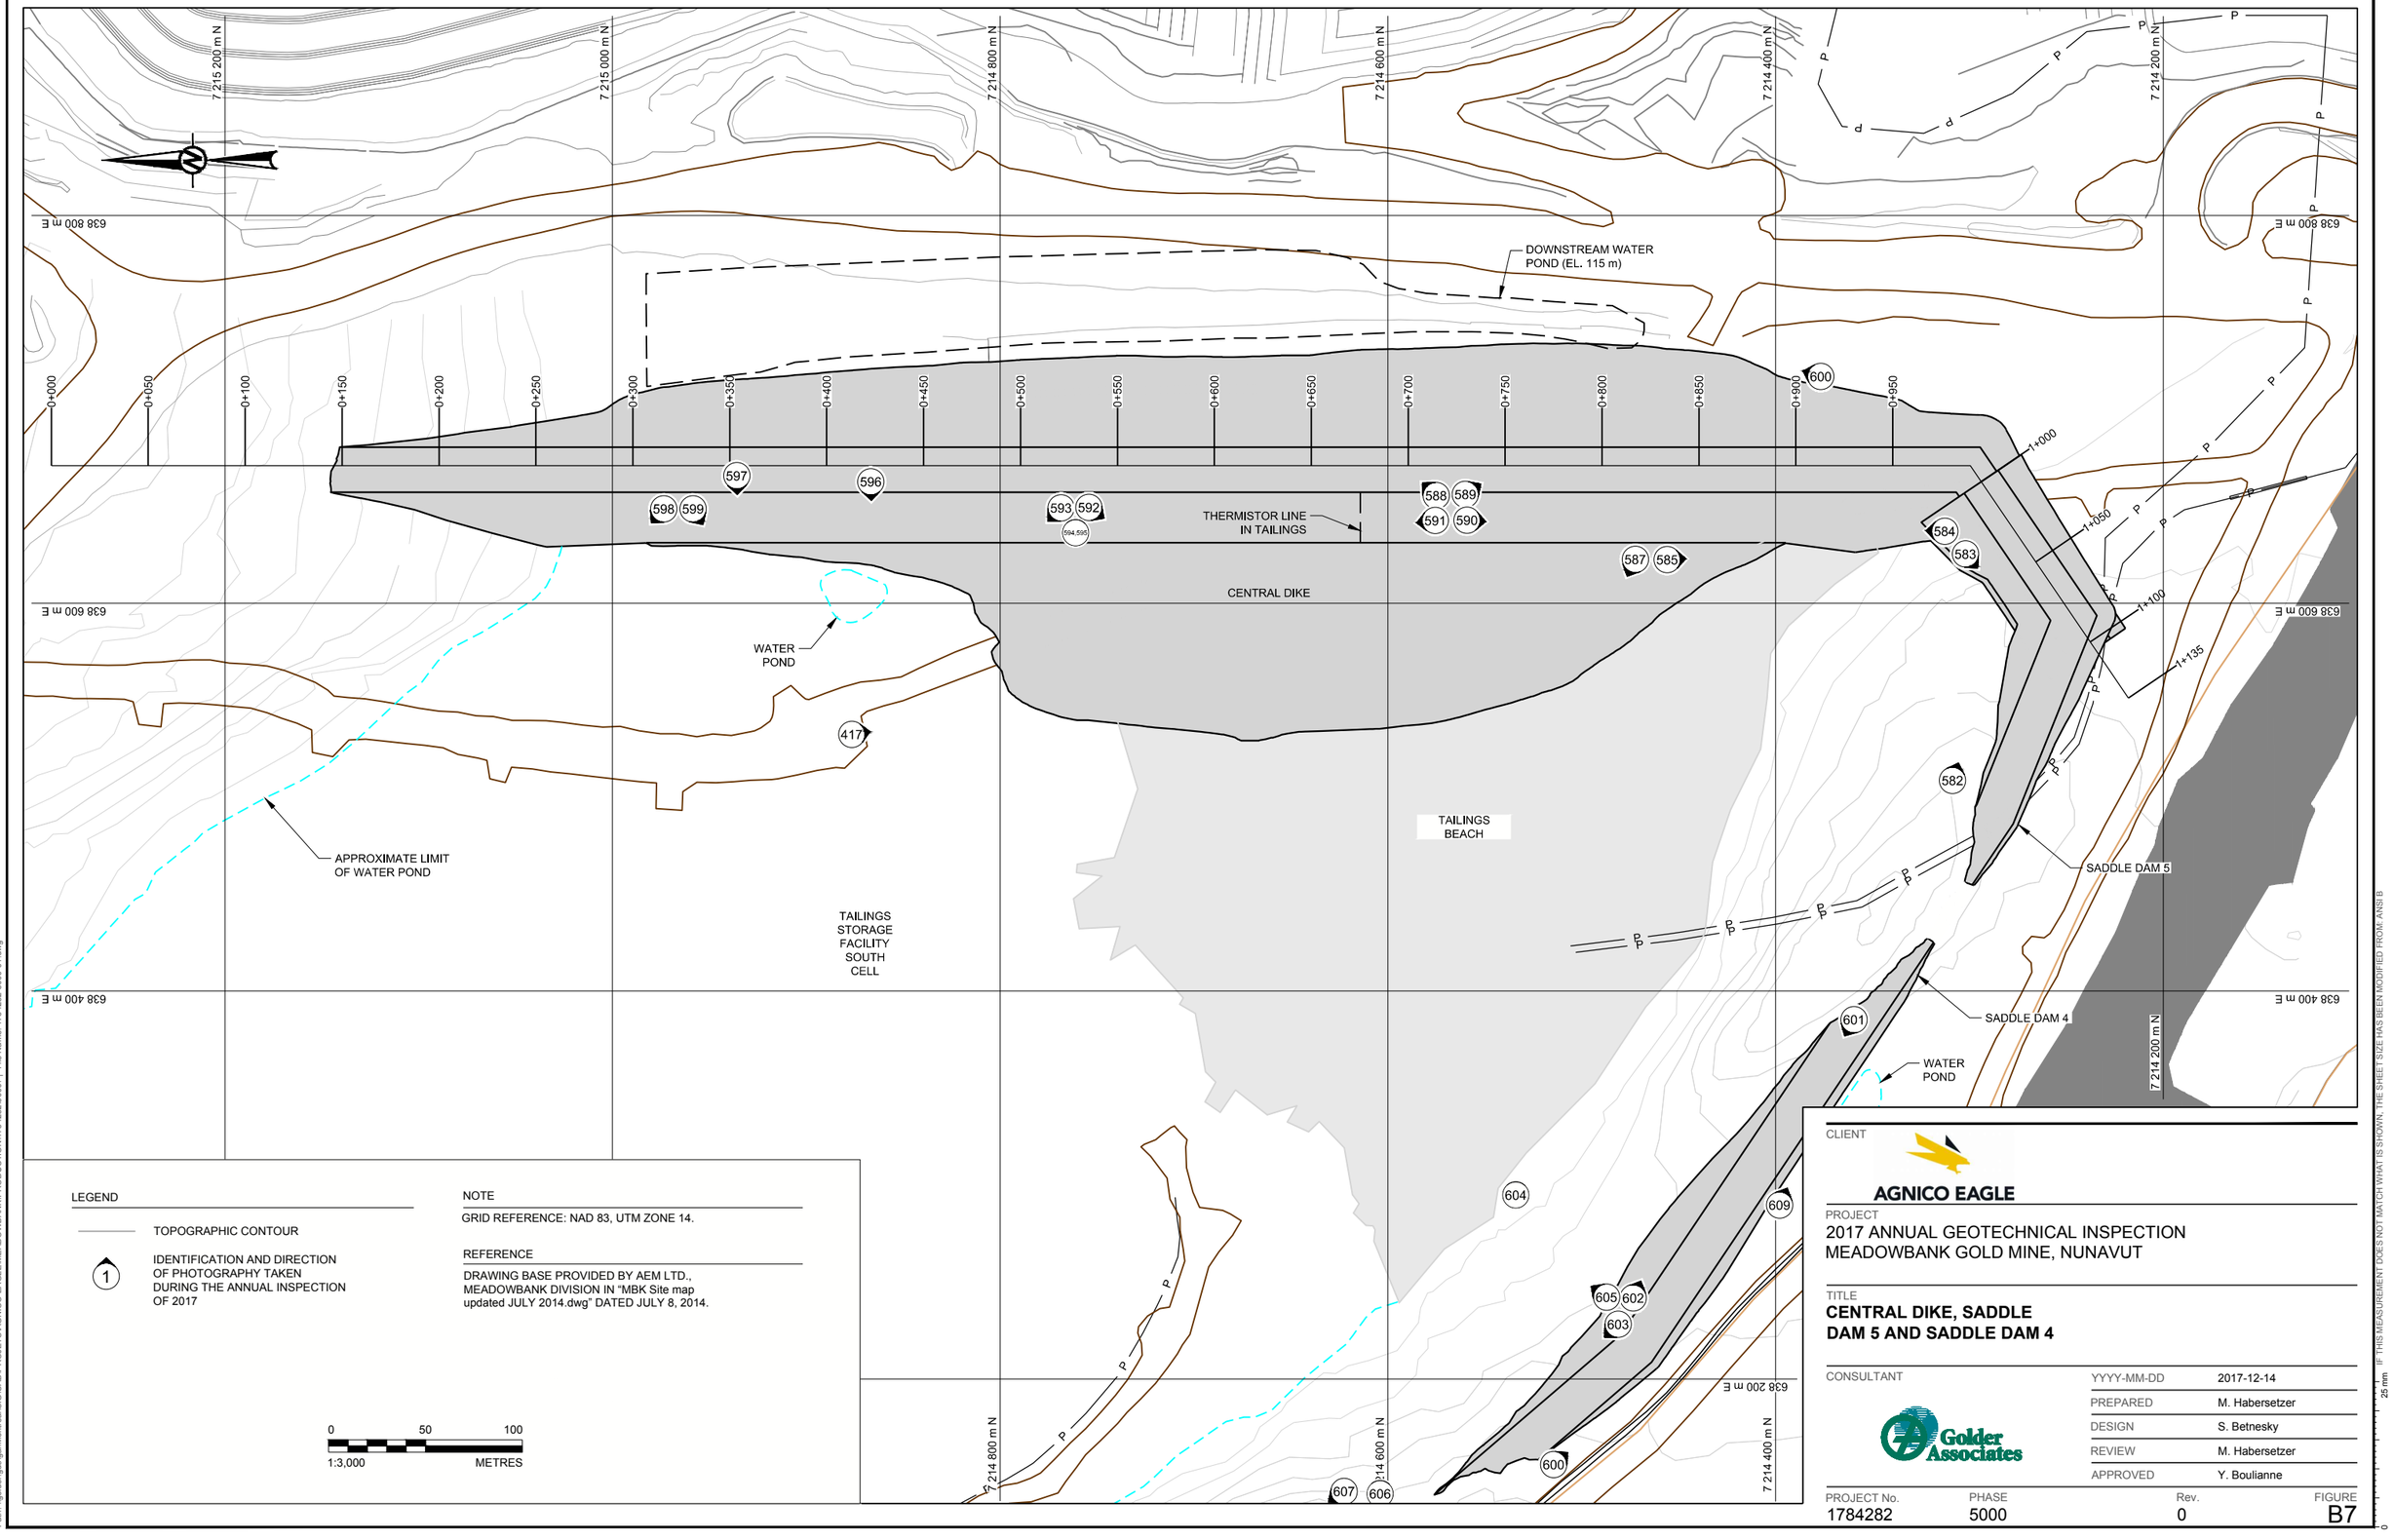
Photograph B6-9 Saddle Dam 4

Description: View of the bedrock on the northwestern extremity Saddle Dam 4. Important surface cracks are visible.

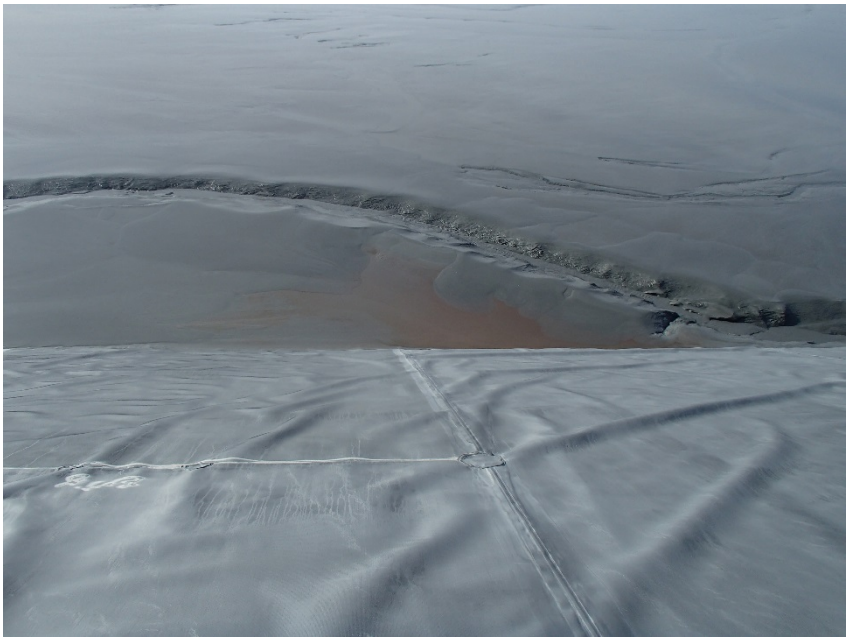
Photograph B7-2 Central Dike and Saddle Dam 5

Description: From approximately Sta. 0+325 looking west at the South Cell.

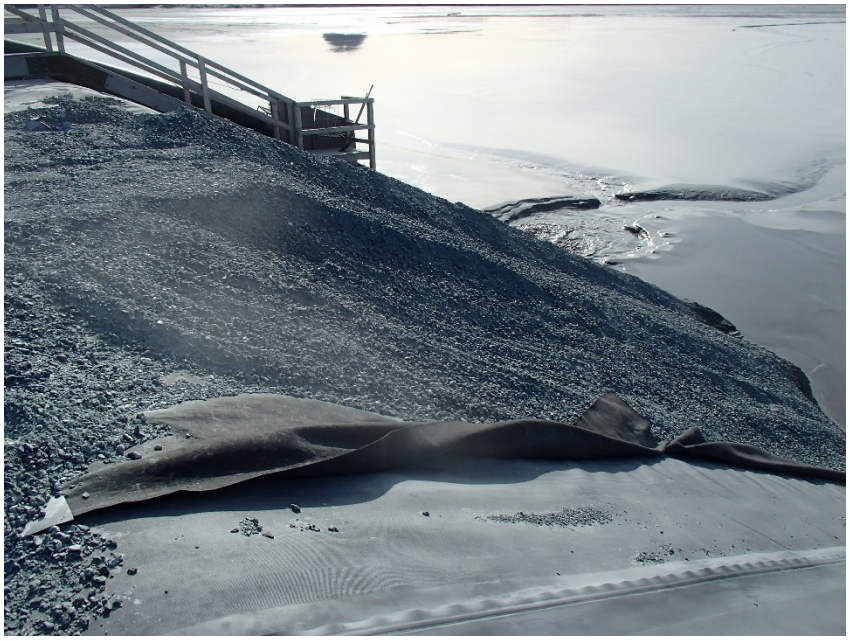
Photograph B7-6 Central Dike and Saddle Dam 5

Description: From approximately Sta. 0+525 looking southwest at the upstream slope. Adequate tailings beach against the south section of the structure.

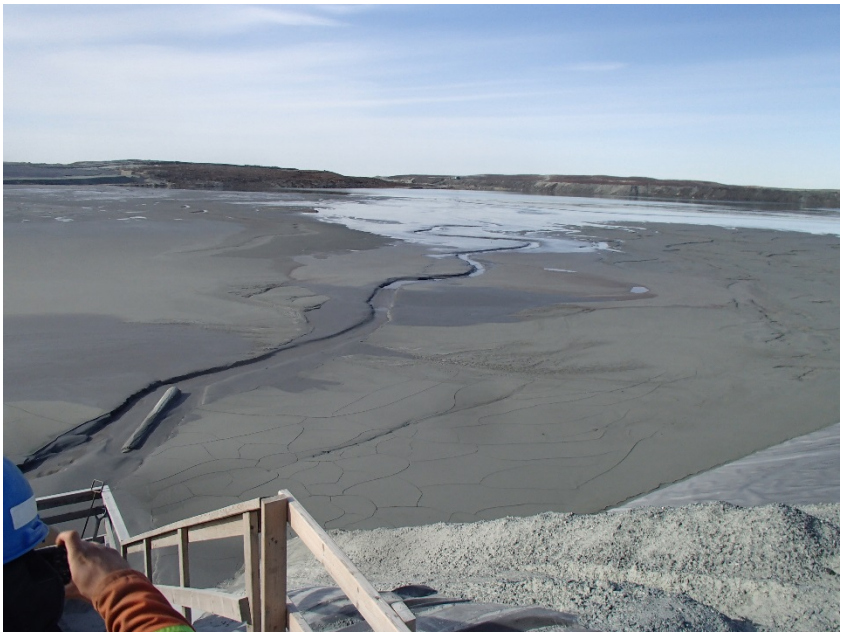
Photograph B7-12 Central Dike and Saddle Dam 5

Description: From approximately Sta. 0+720 looking north at the crest.

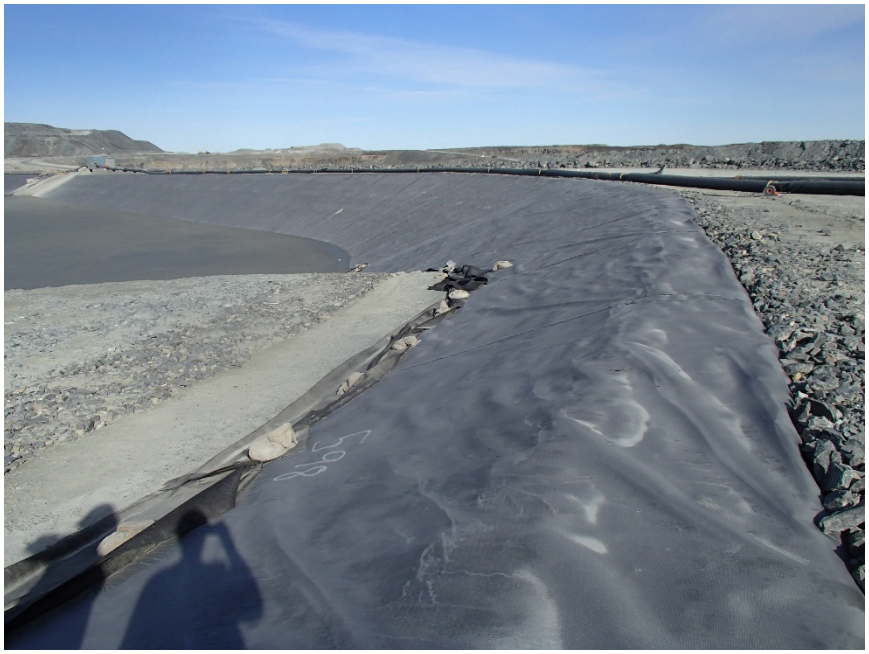
Photograph B7-14 Central Dike and Saddle Dam 5

Description: From approximately Sta. 0+800 on the crest, looking west at the upstream slope and a tailings deposition finger

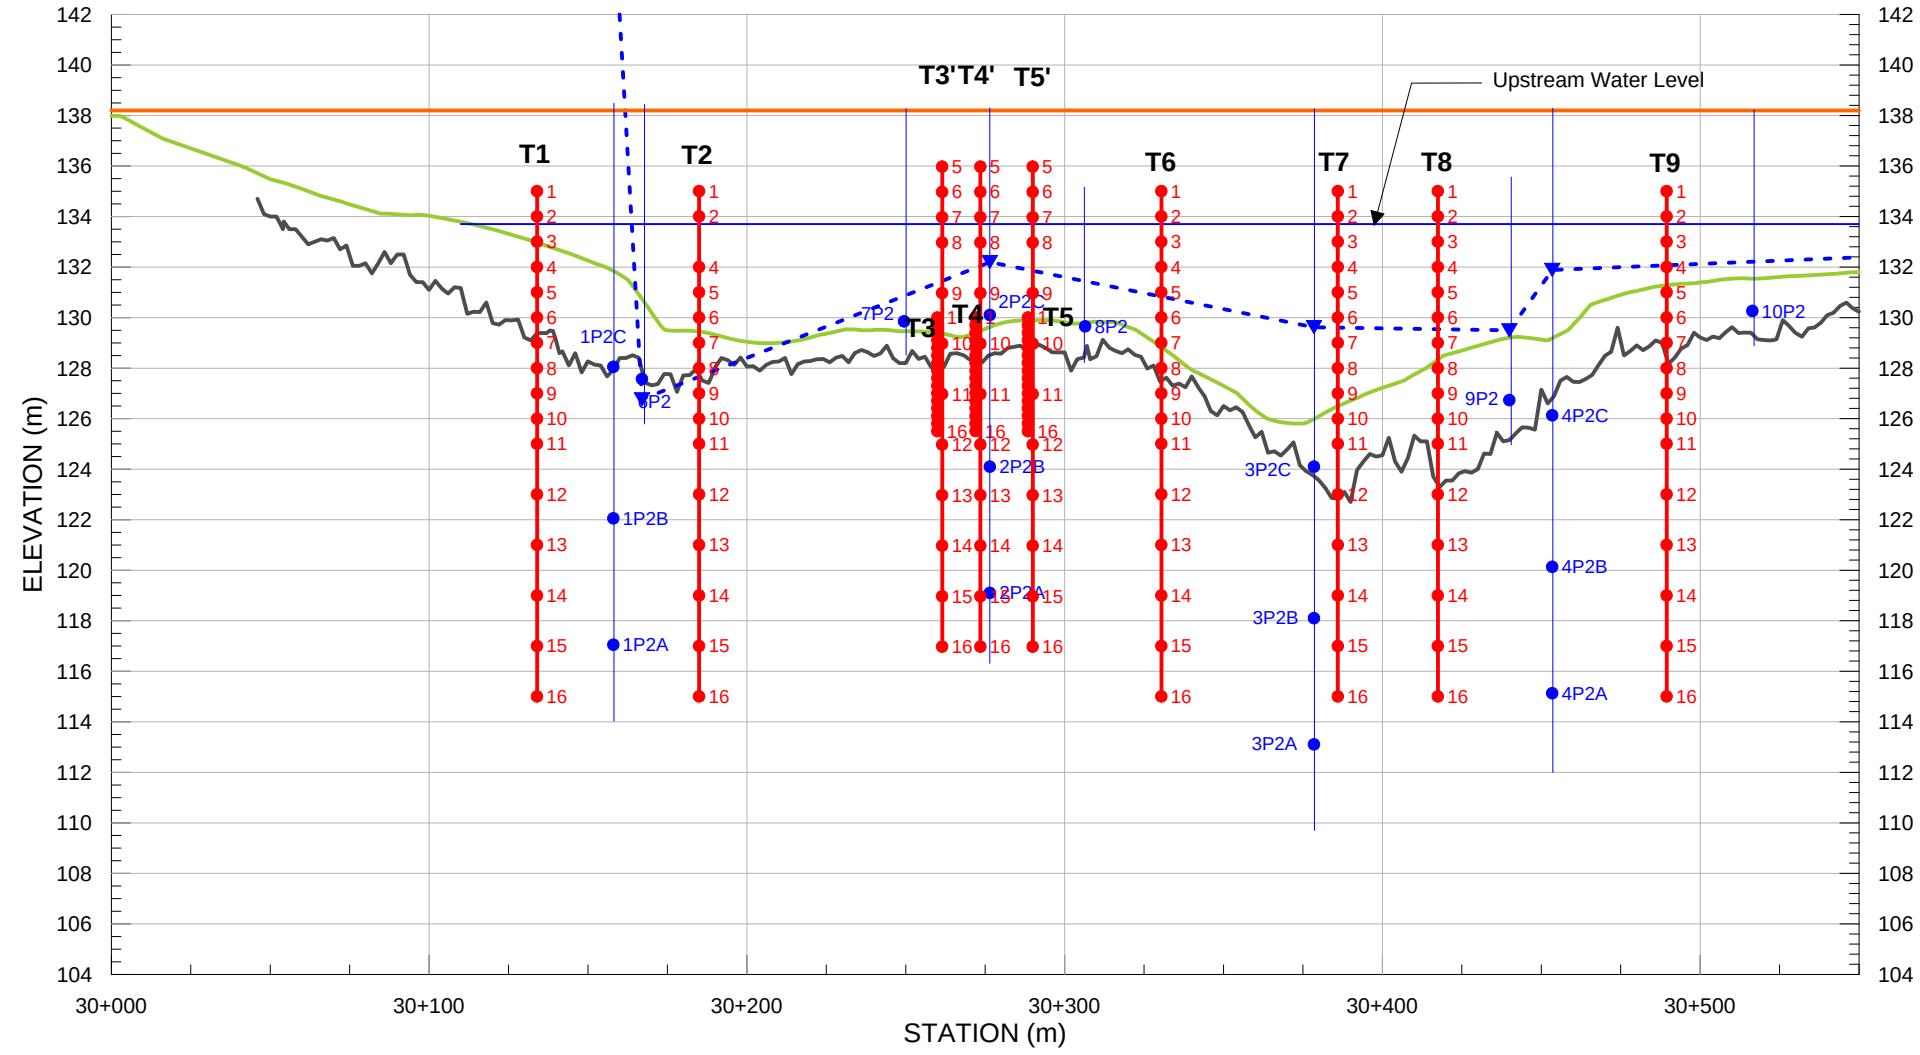
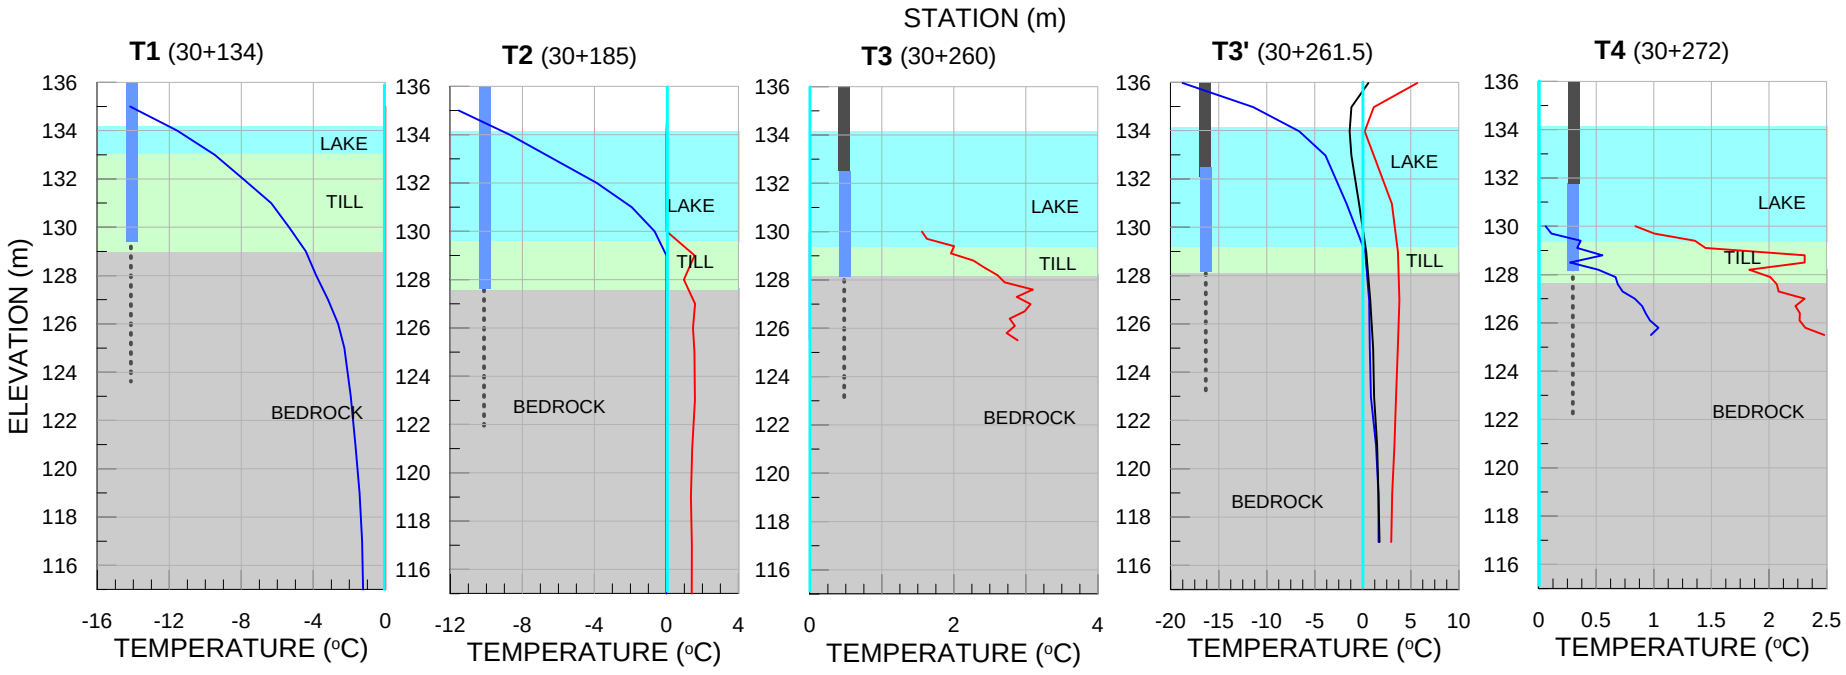
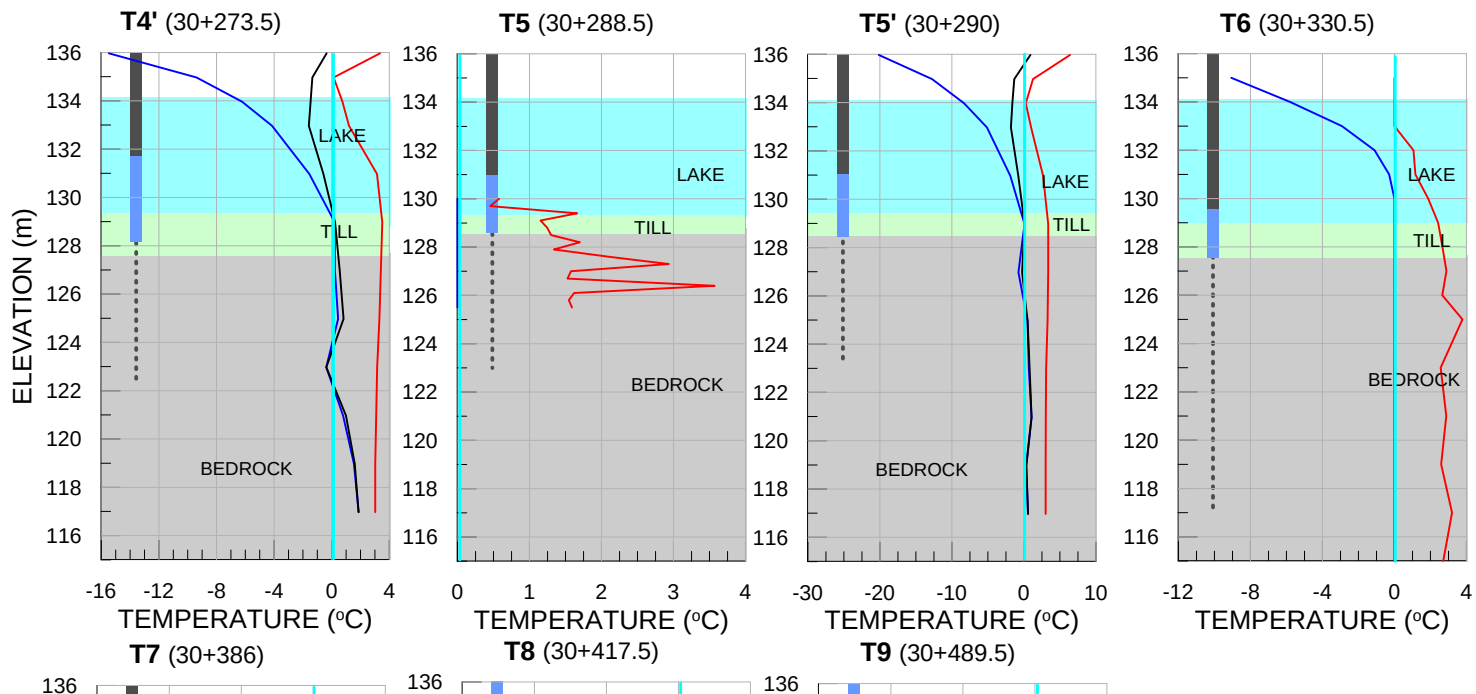
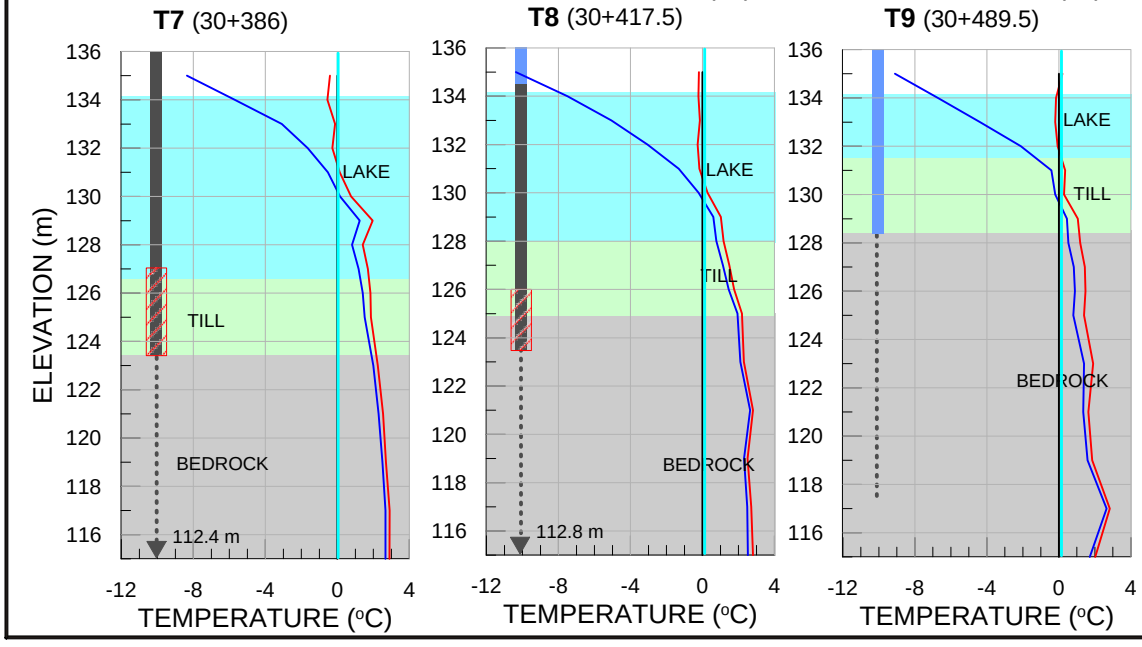
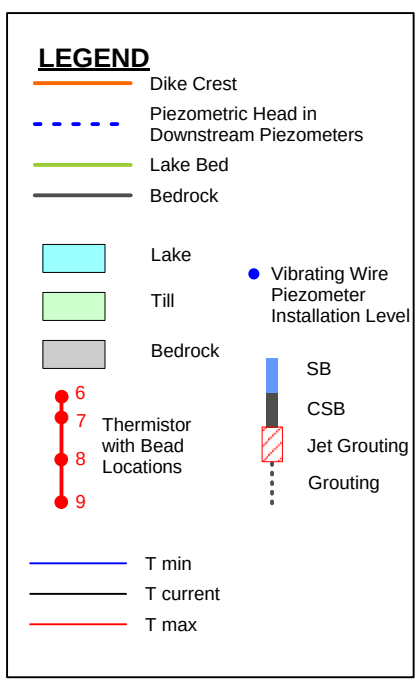
"North Channel" Bay-Goose Dike - Longitudinal Section

NOTES:
1. Third node of thermistor T2 (elevation 135 m) is not functional.

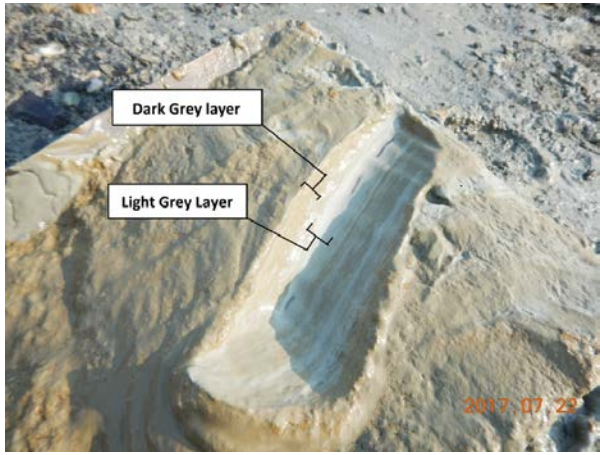
CHANGE IN COLORATION OF D/S POND

Orange Sludge Observed in the Pond Following Change In Coloration

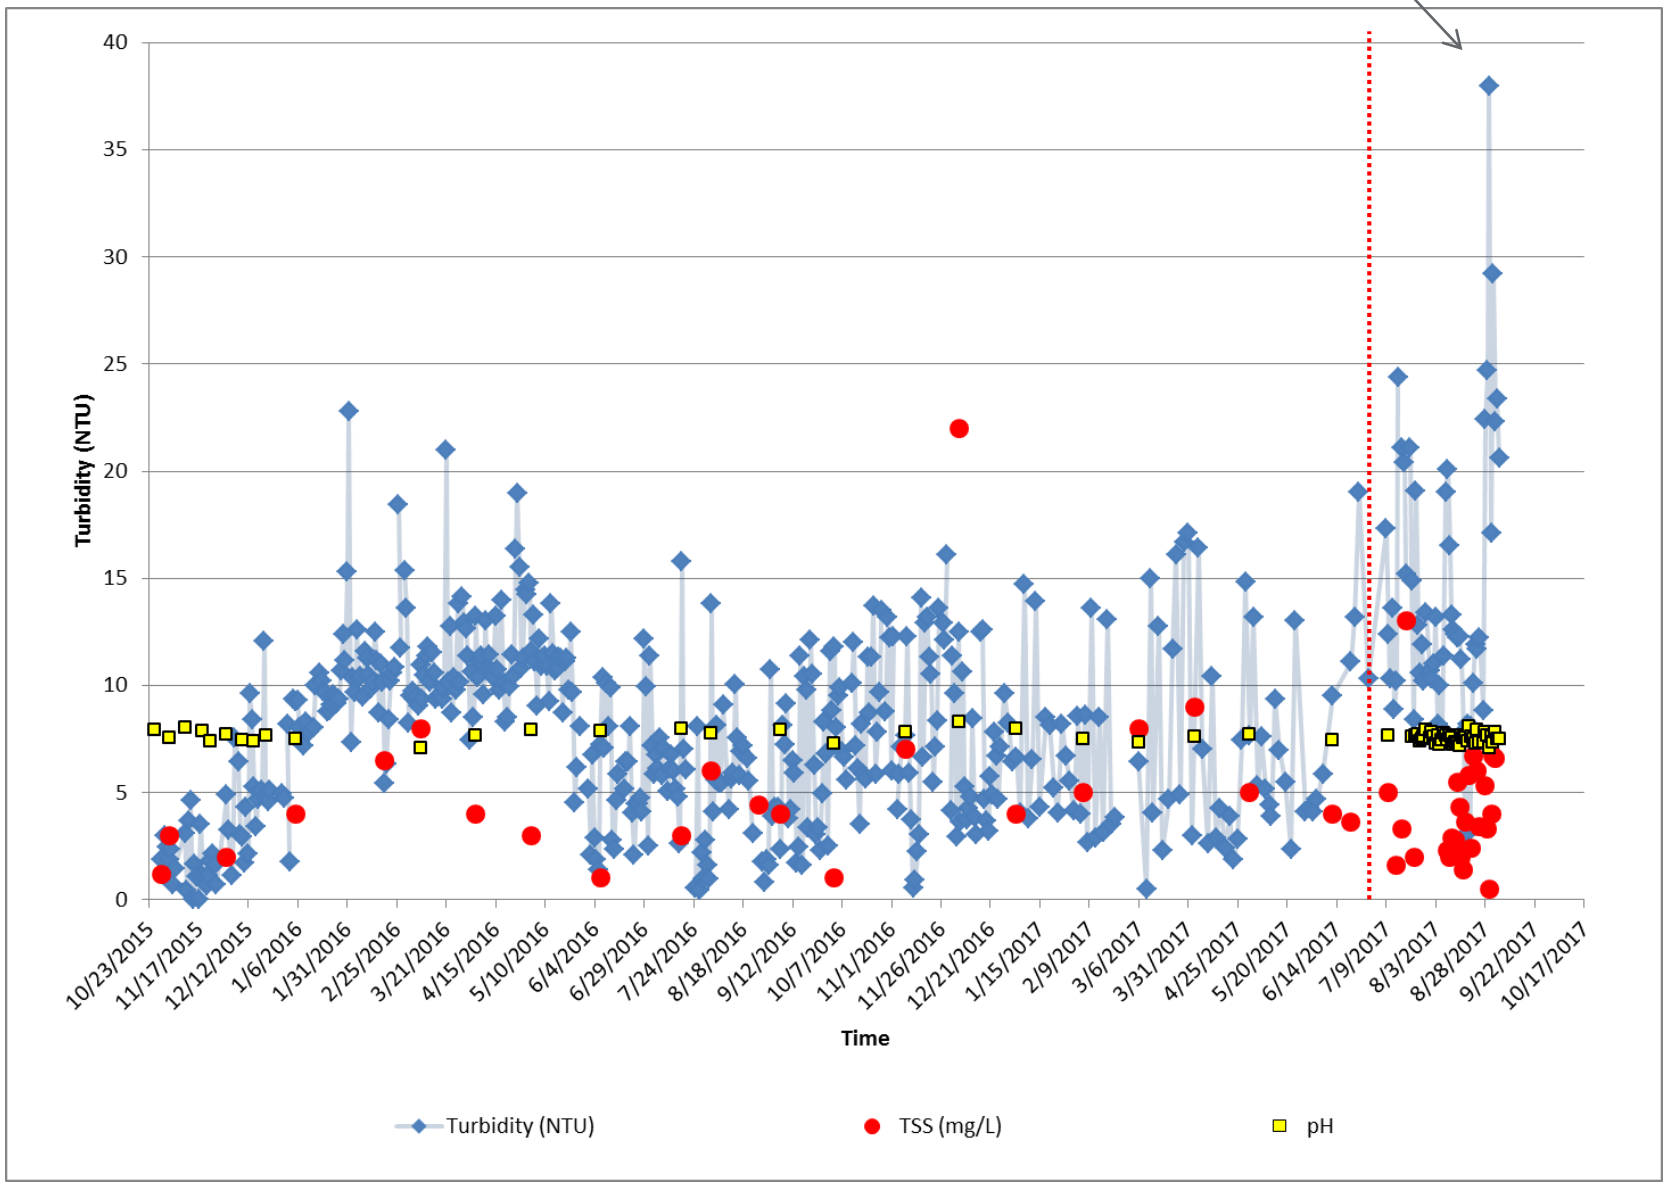
D/S POND TSS, PH, TURBIDITY

Turbidity at 38NTU
TSS at 0.5 mg/L

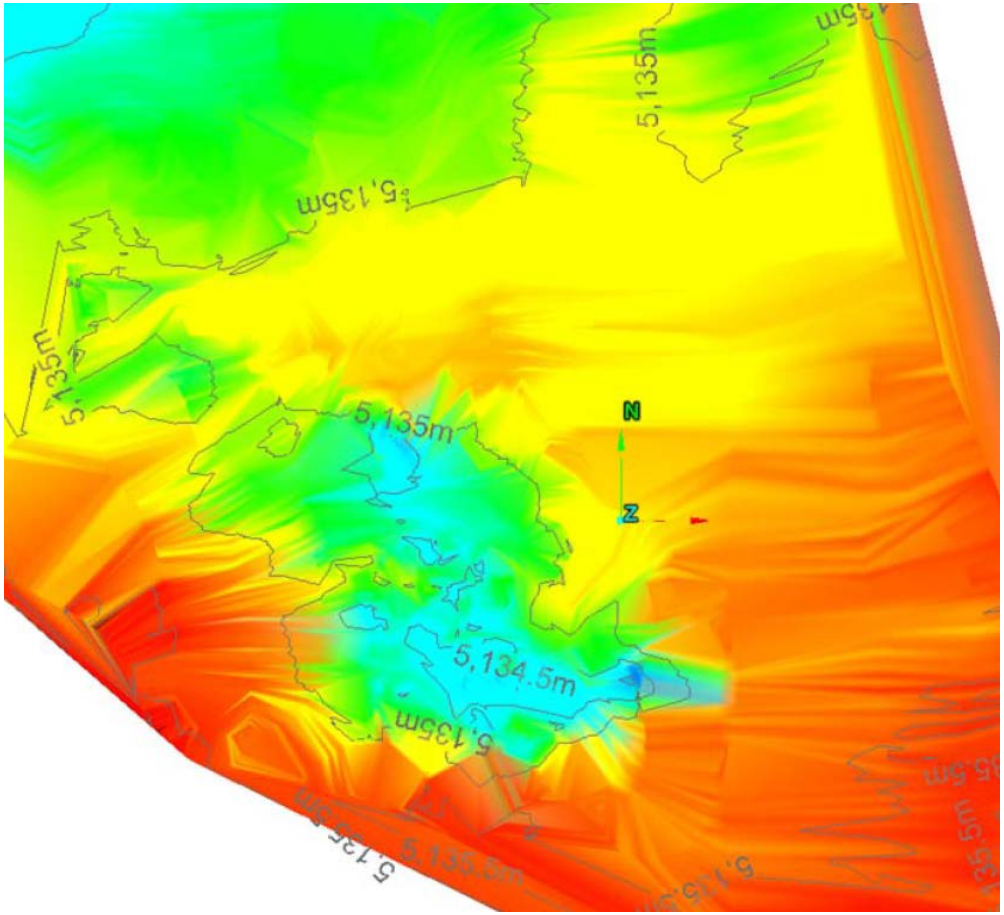
DEPRESSIONS IN TAILINGS POND

First Observed On July 23 2017 During an Helicopter Inspection

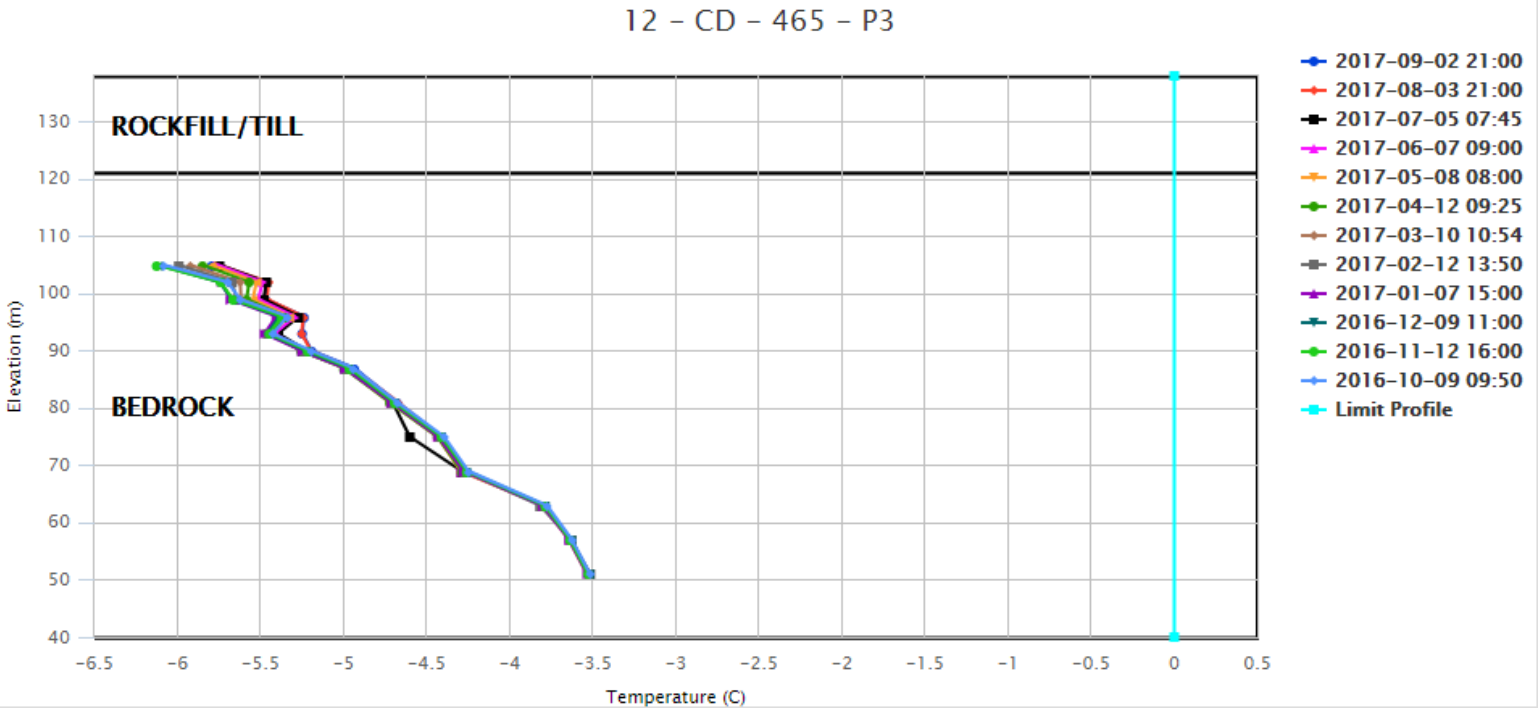
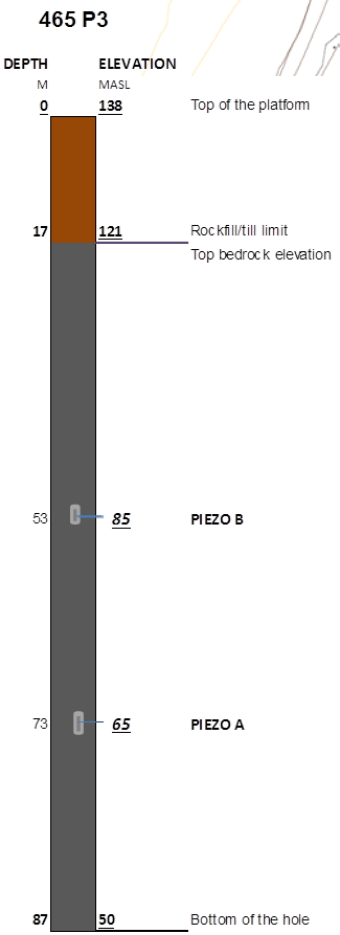
THERMISTOR 465 P3

Bedrock Below 0º C at 465-P3 [-6 to -3.5º C]

Bead below El. 69 m stopped working in June 2017
