2017 Annual Geotechnical Inspection

2017 Annual Geotechnical Inspection Meadowbank Gold Mine, Nunavut

Report Number: 1784282-1574-RPT-Rev0

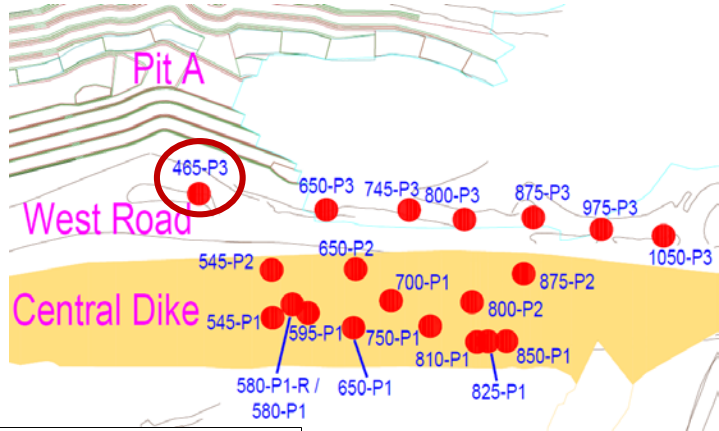
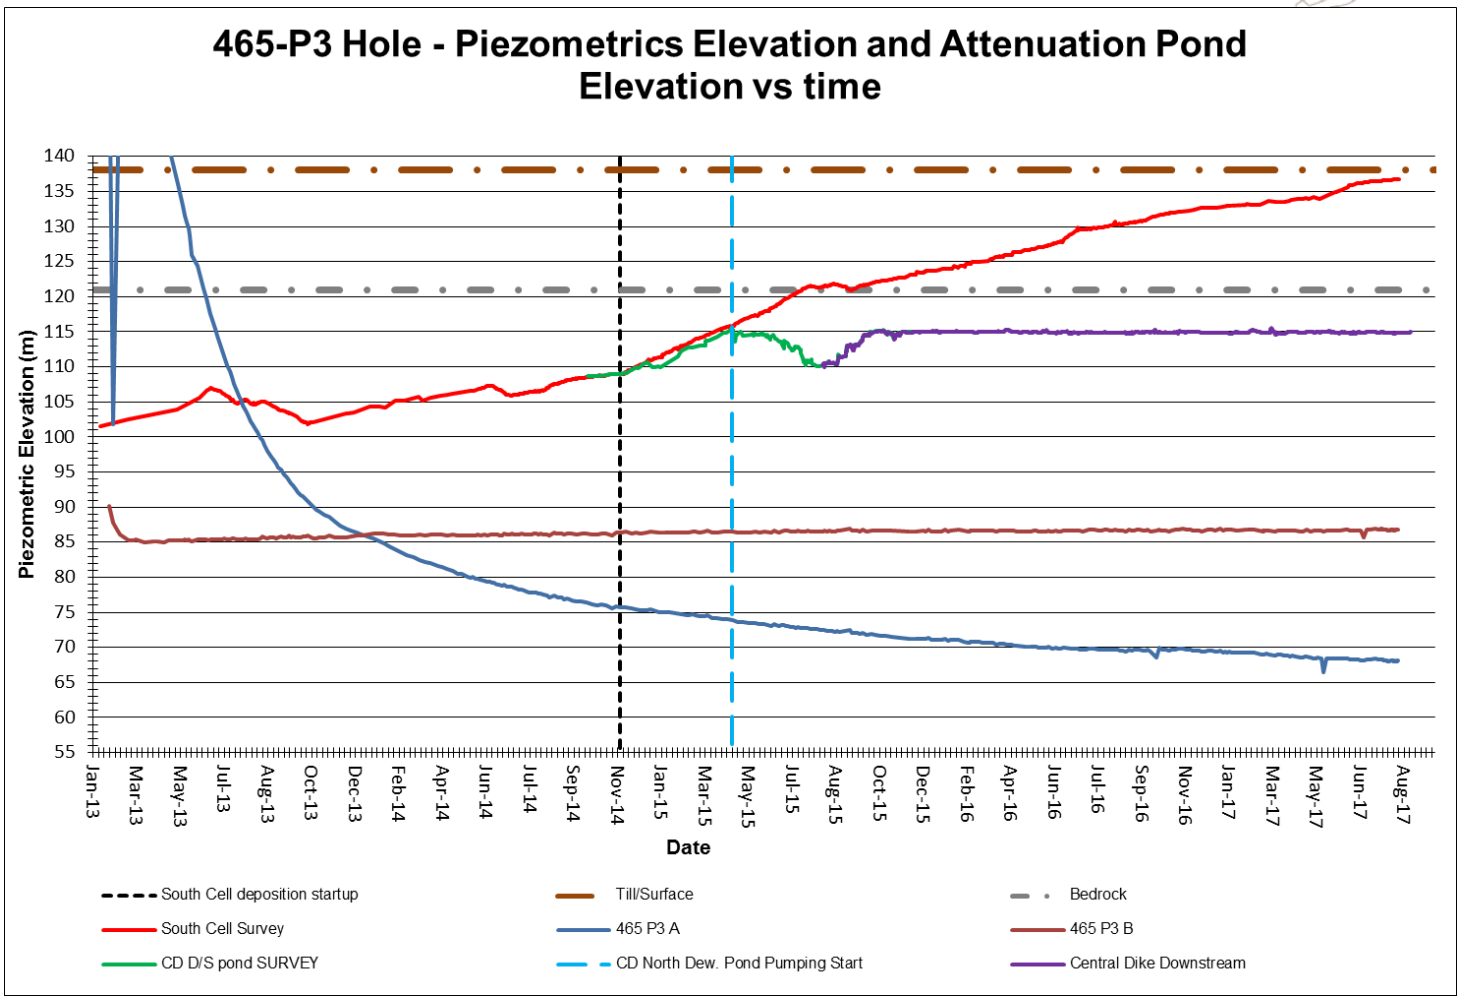
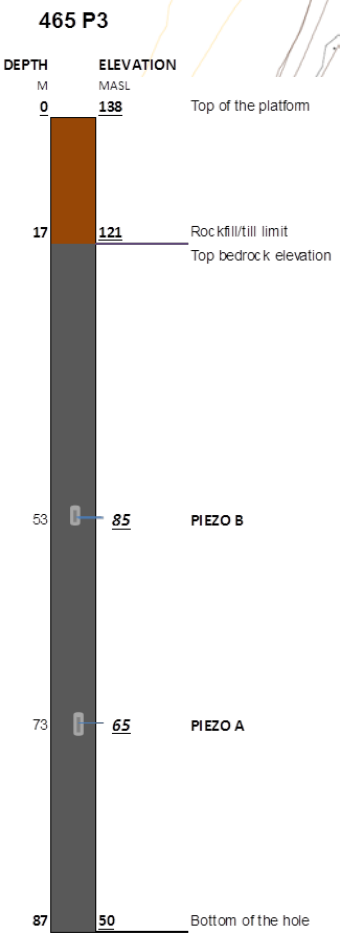
PIEZOMETERS 465-P3

Frozen Piezometers

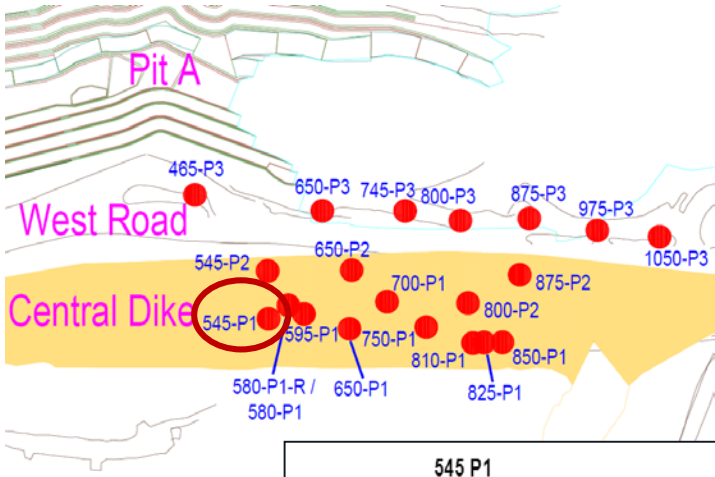
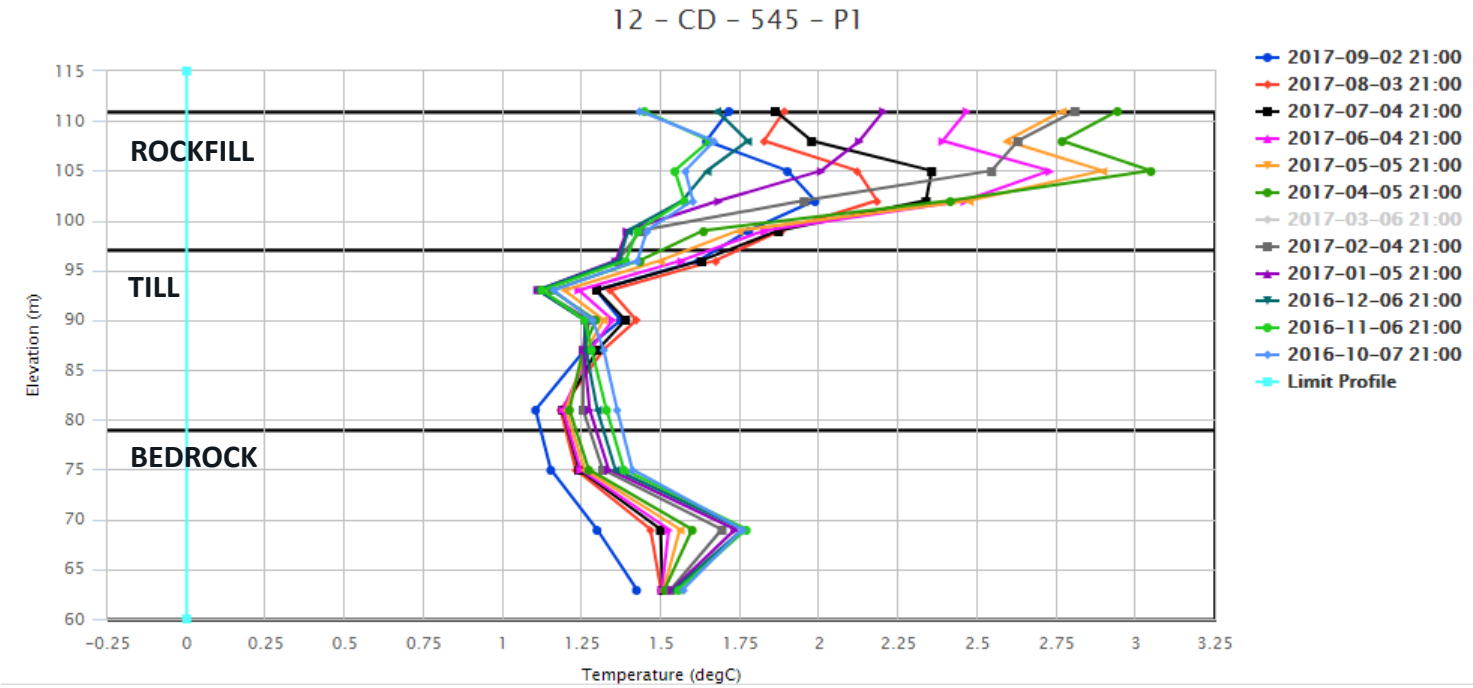
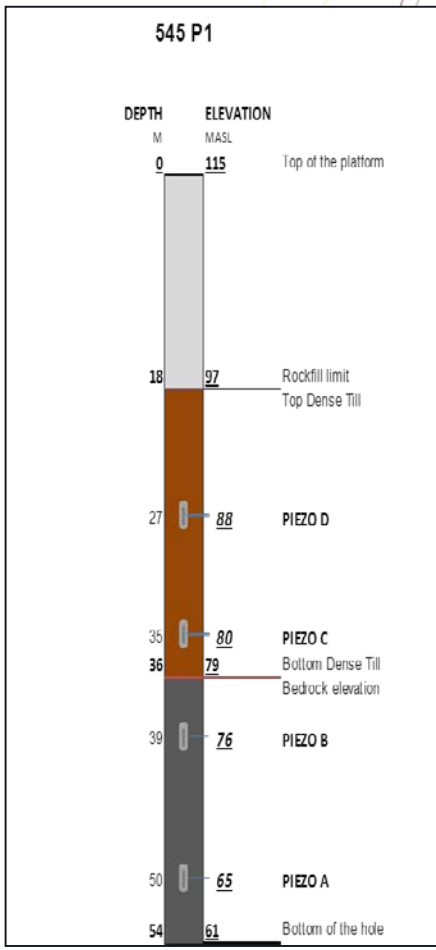
THERMISTOR 545-P1

- 545-P1 thermistor is showing the same temperature profile than last year. Warmer peak observed at elevation 70m since the installation.
- Temperature in the bedrock/till unit is in between 1.1 and 1.75º C.

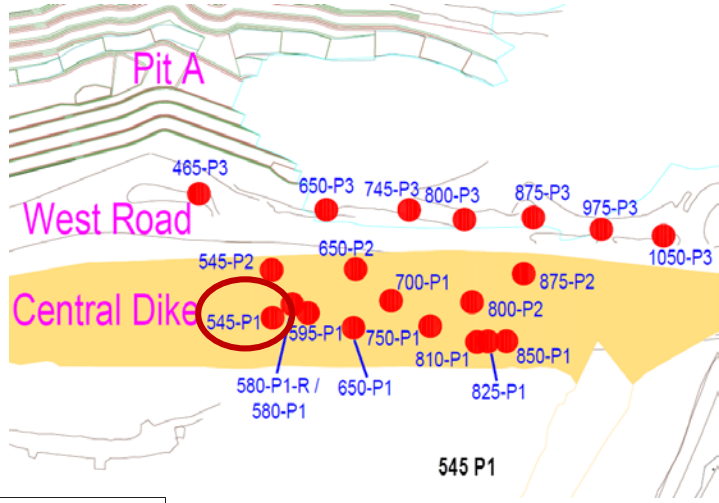
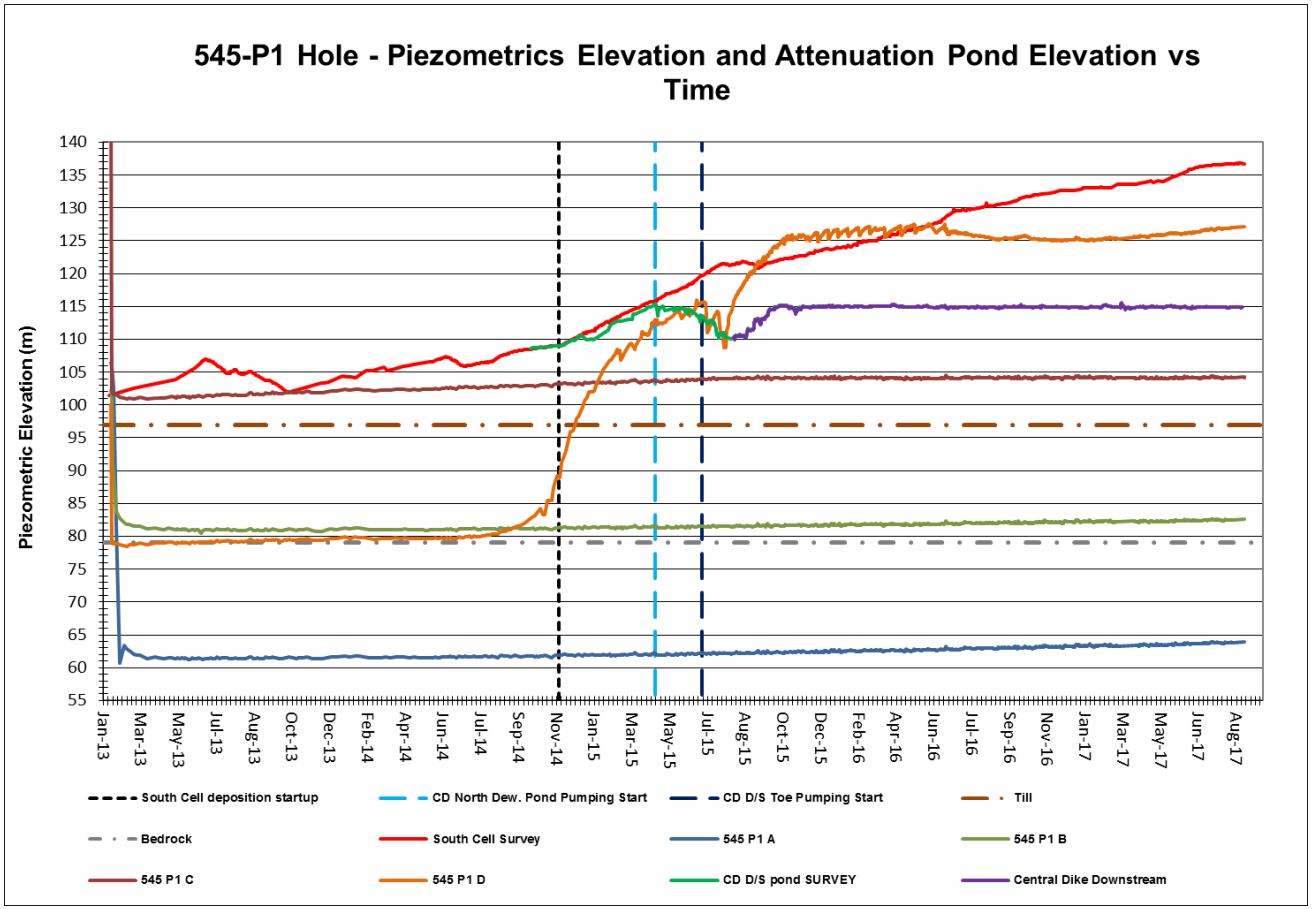
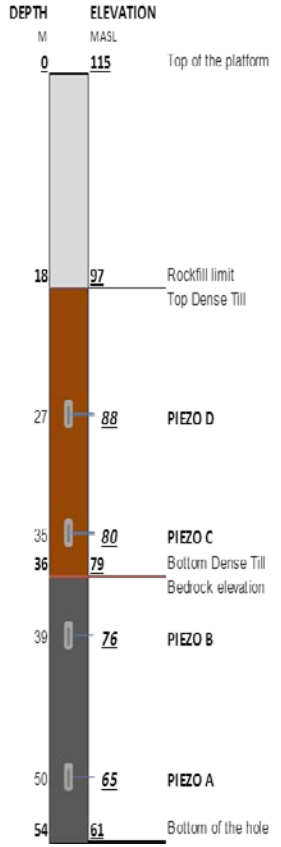
PIEZOMETER 545-P1

- Piezometer D still constant, no change since August 2015
- Piezometer A is recording suction since its installation
- Identification of the piezo on the field is confusing. Interpretation of the readings must be done with precaution.

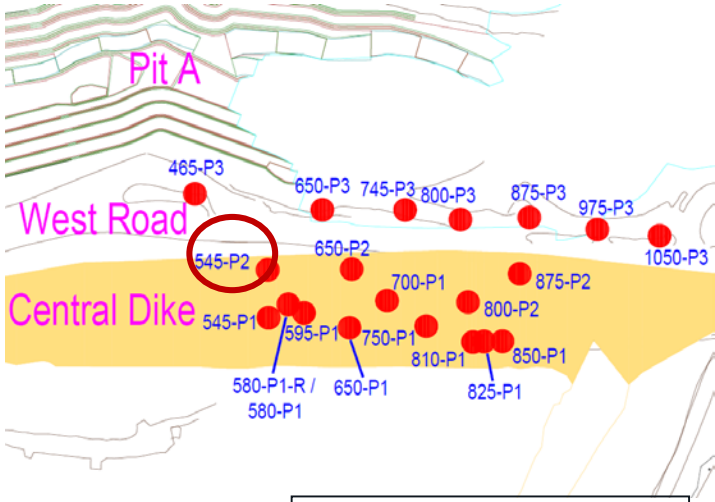
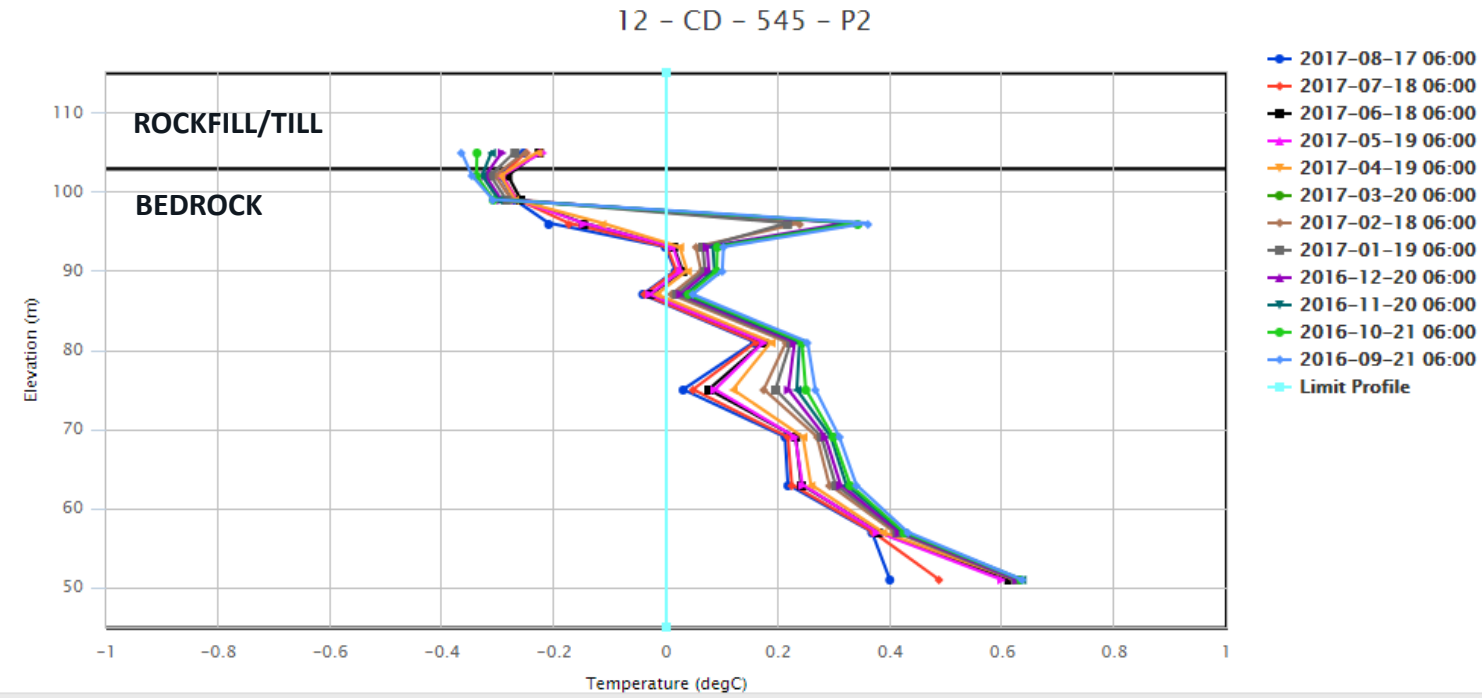
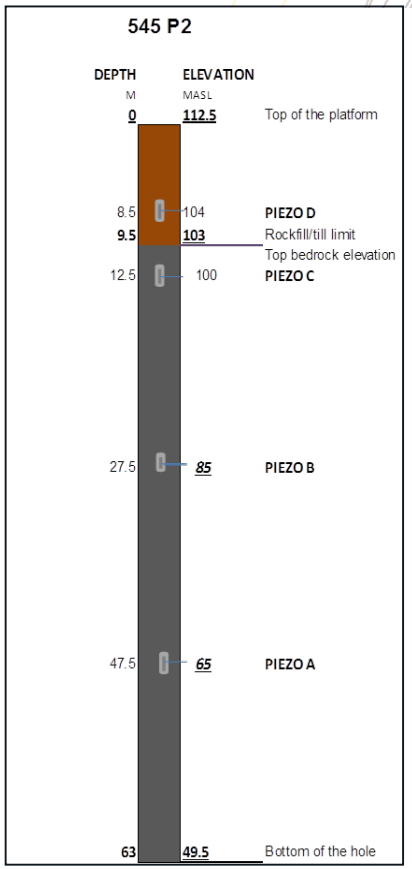
THERMISTOR 545-P2

- Temperature peak observed on the bead located at El. 96m from January 2015 to March 2017;
- In January 2015 readings was switched from manual to automatic;
- In March 2017, AVW multiplexer was changed and temperature profile was back to its original profile;
- Investigation still on going – interpretation of data must be done with precaution.

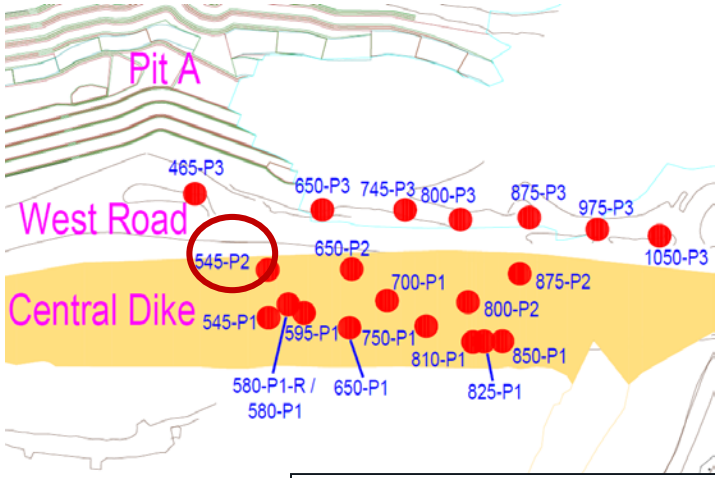
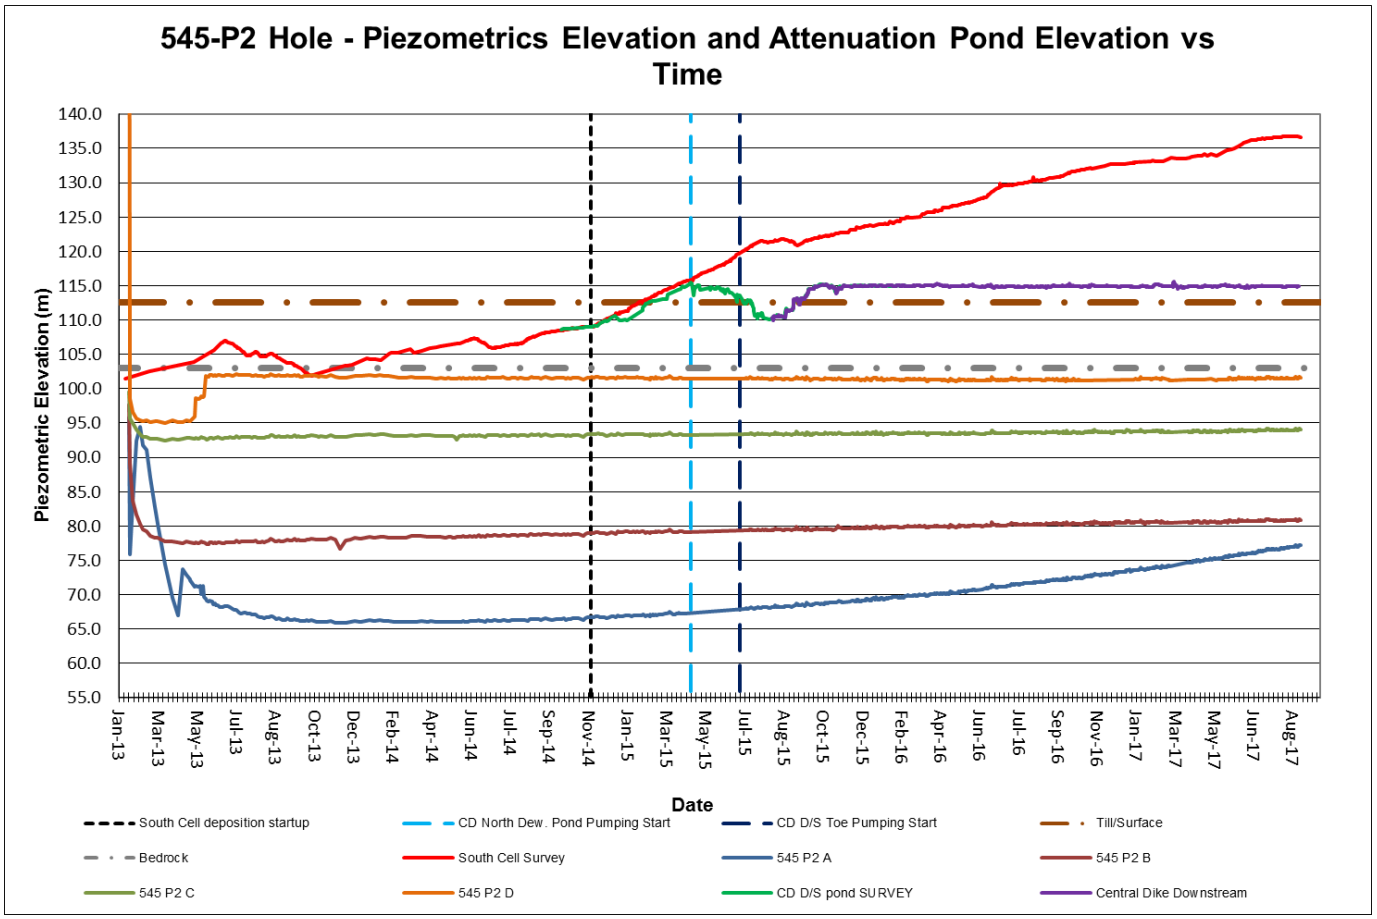
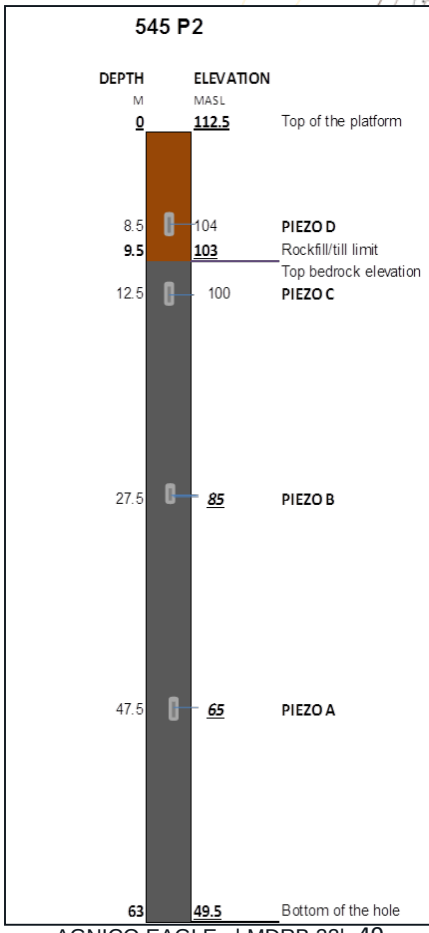
PIEZOMETER 545-P2

- Piezometer A reading is increasing with South Cell level
- Other piezometers are recording suction

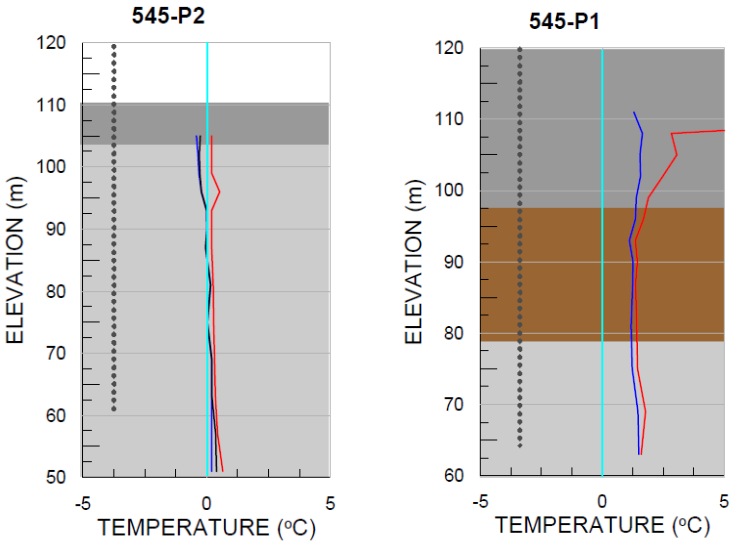
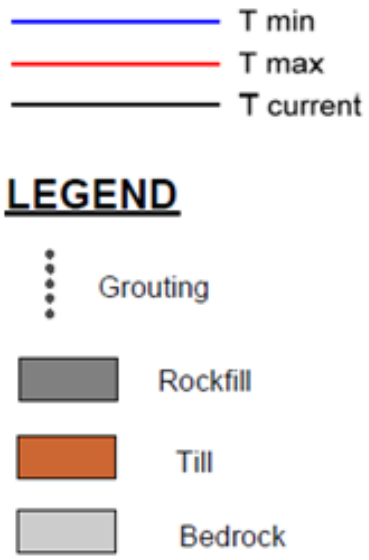
Max temperature in 2015-2016 was more around 2°C

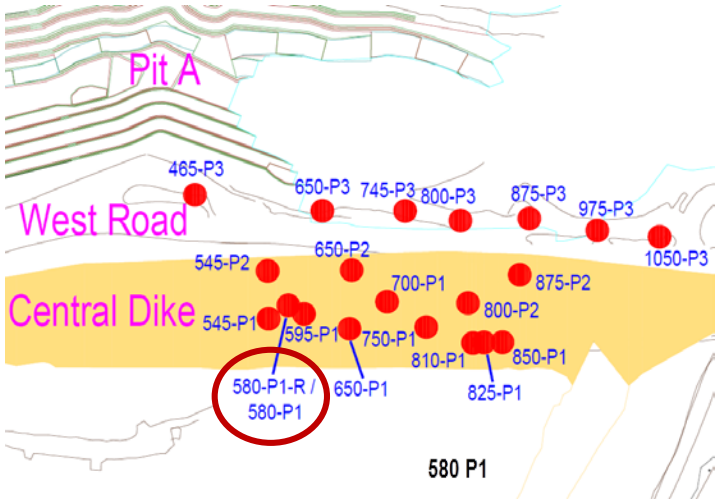
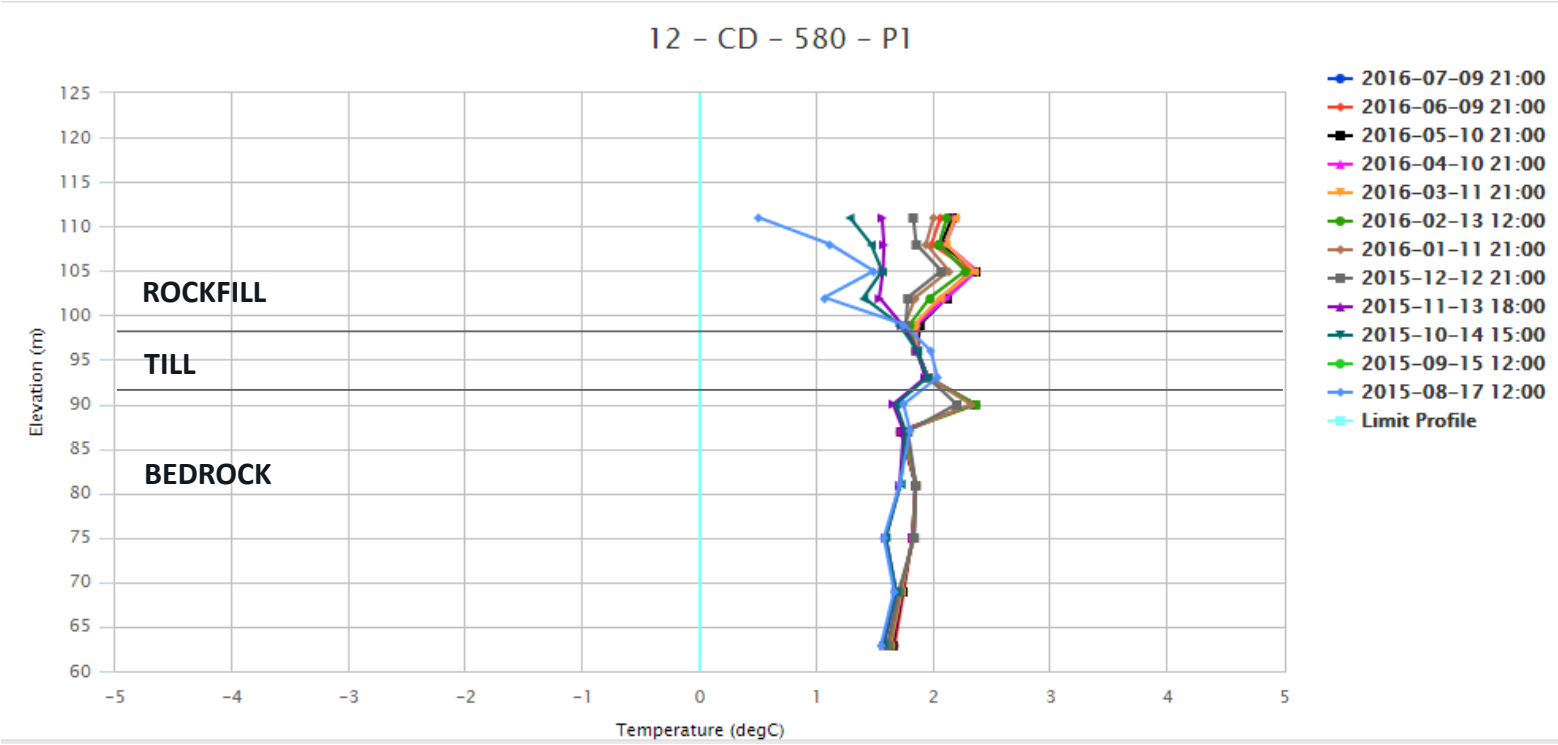
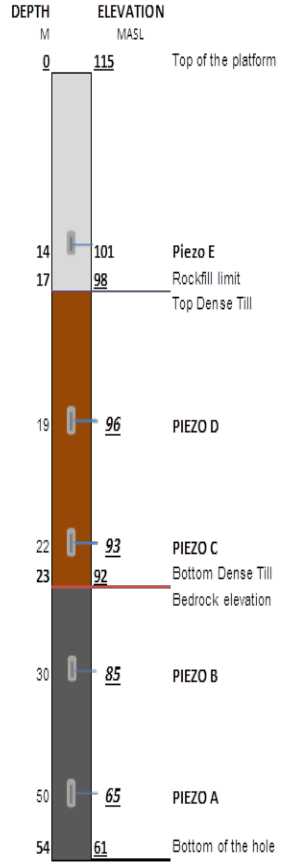
580-P1

- Piezometer and thermistance readings are not functional since July 2016
- Replacement hole 580-P1R drilled during 2017 campaign

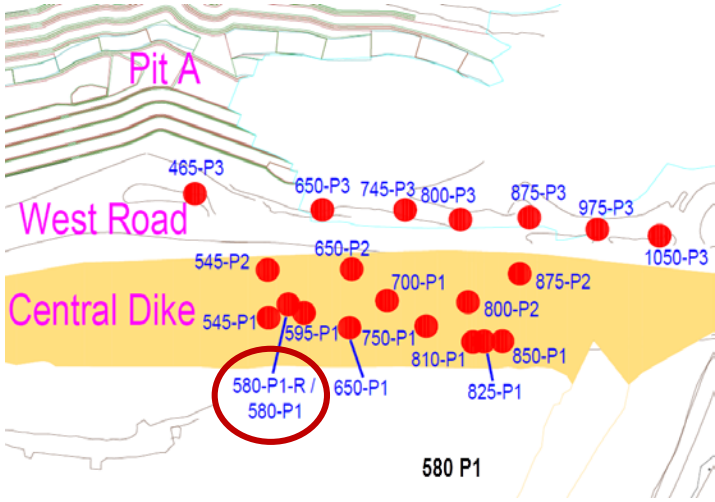
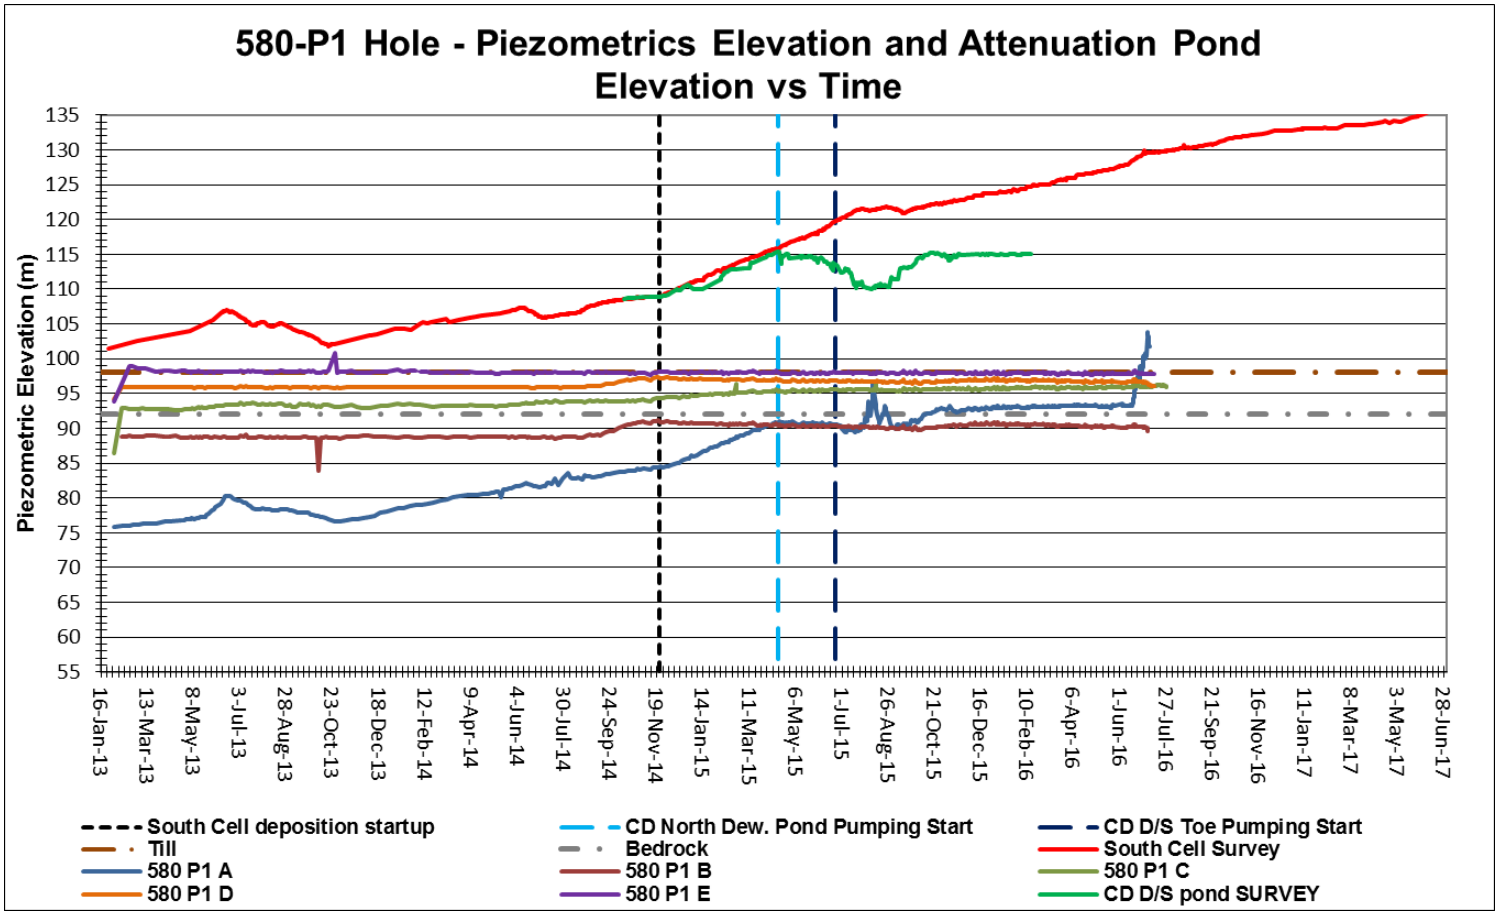
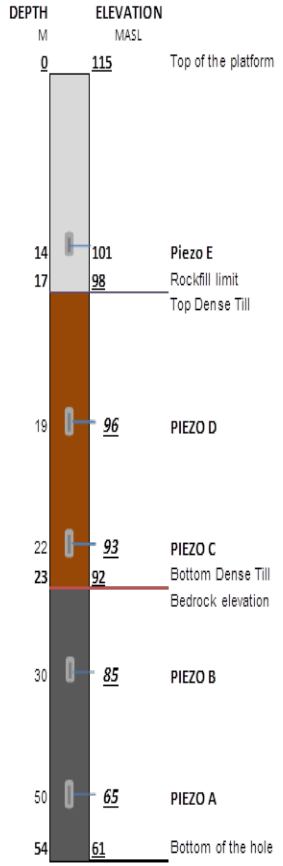
580-P1

- Piezometer and thermistor readings are not functional since July 2016
- Replacement hole 580-P1R drilled during 2017 campaign

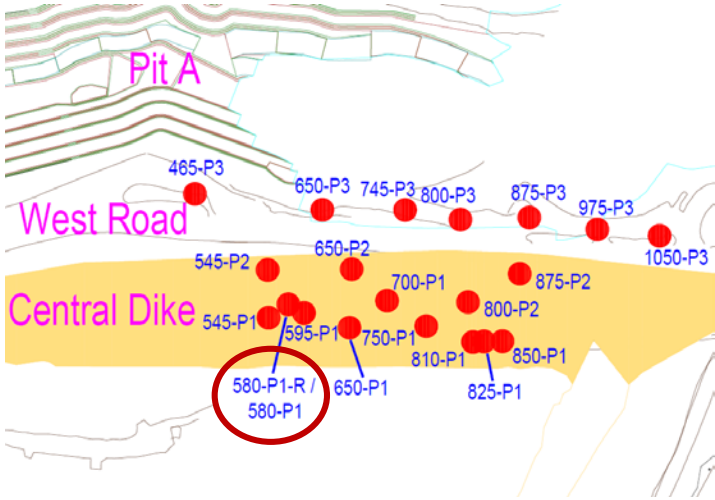
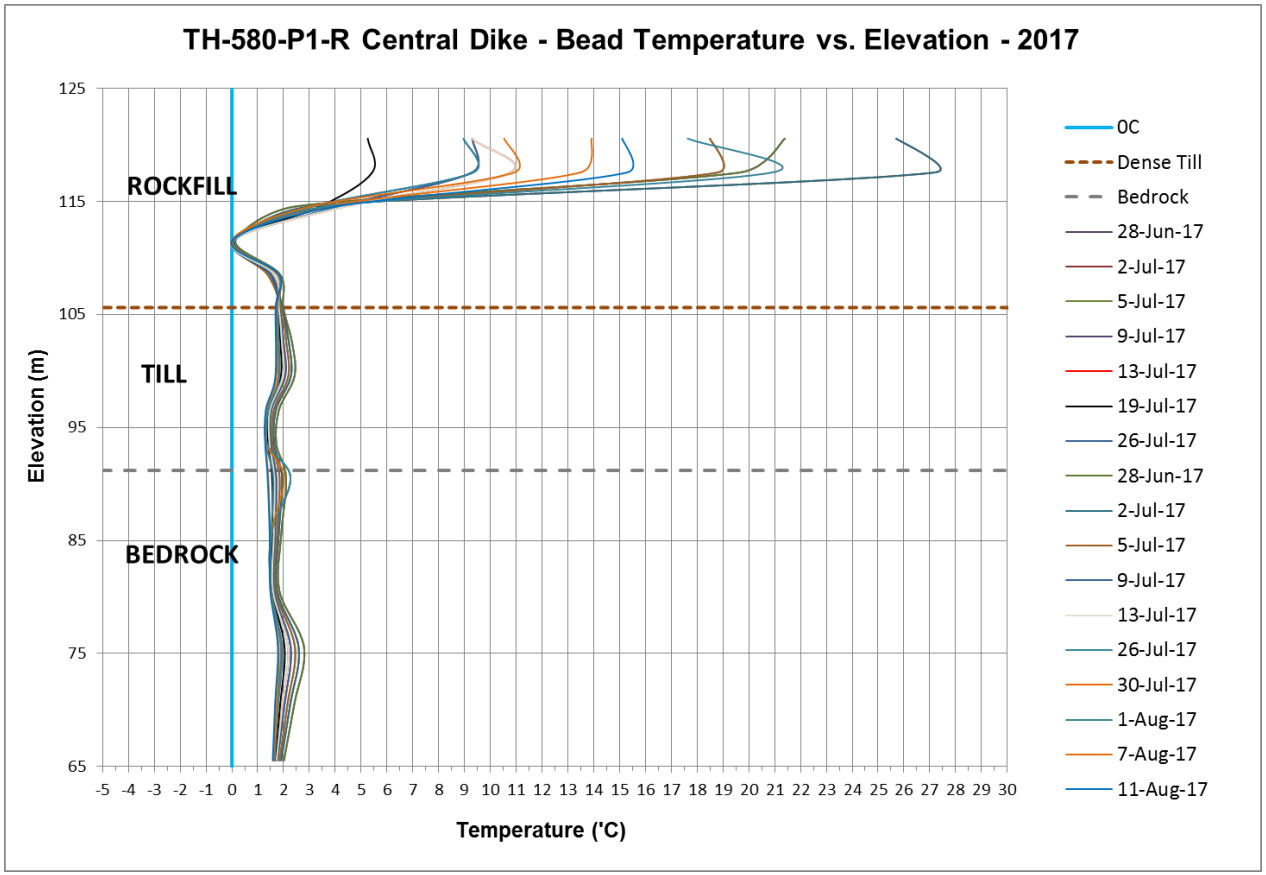
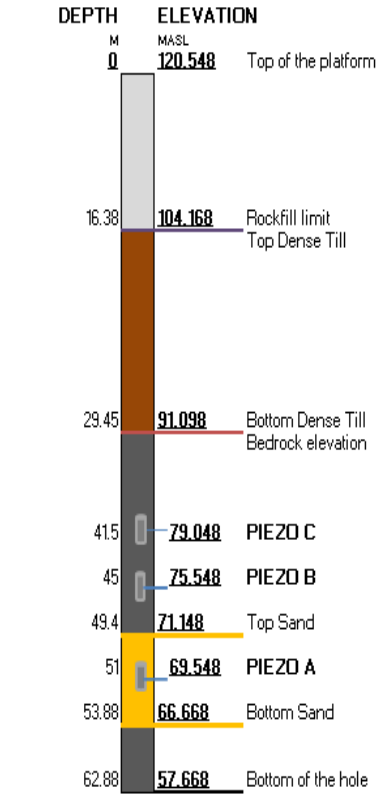
THERMISTOR 580-P1R

- Stabilisation in progress
- Temperature readings above 0ºC
- Simillar temperature readings range than 580-P1

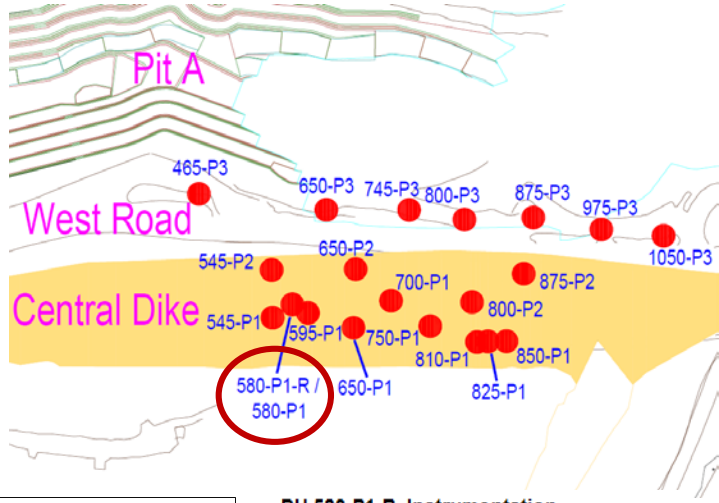
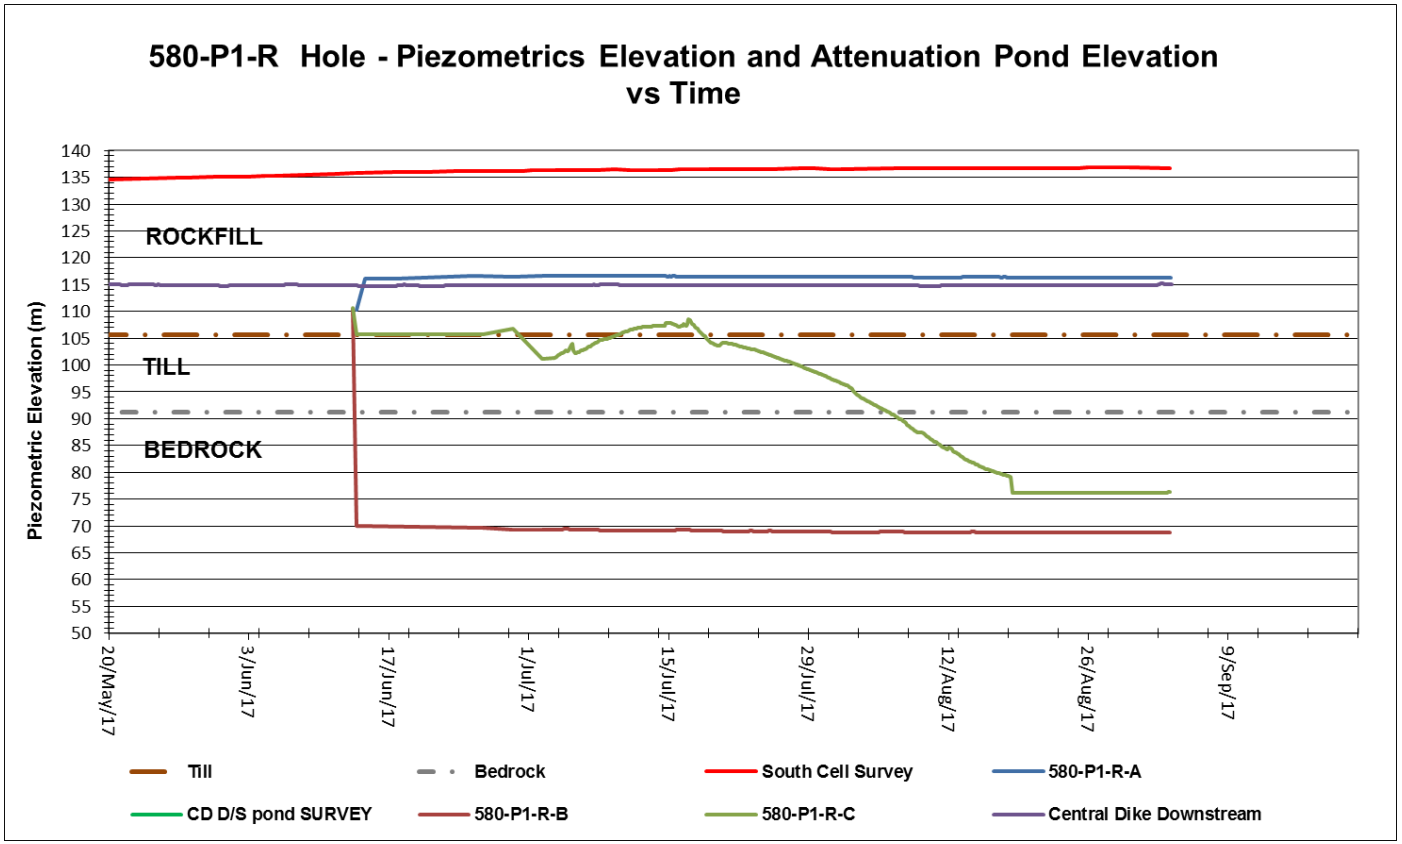
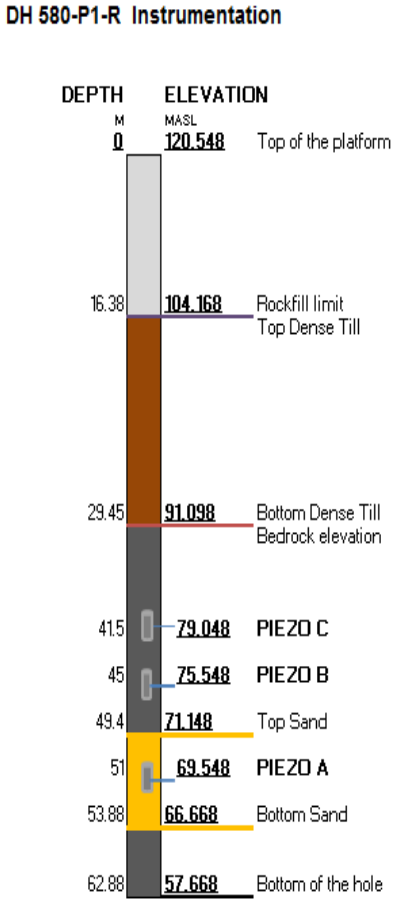
PIEZOMETER 580-P1R

- Piezo A is located in a sand layer and pressure readings are following the D/S pond regime
- Decrease in piezometric elevation ongoing for Piezo B
- Small data GAP

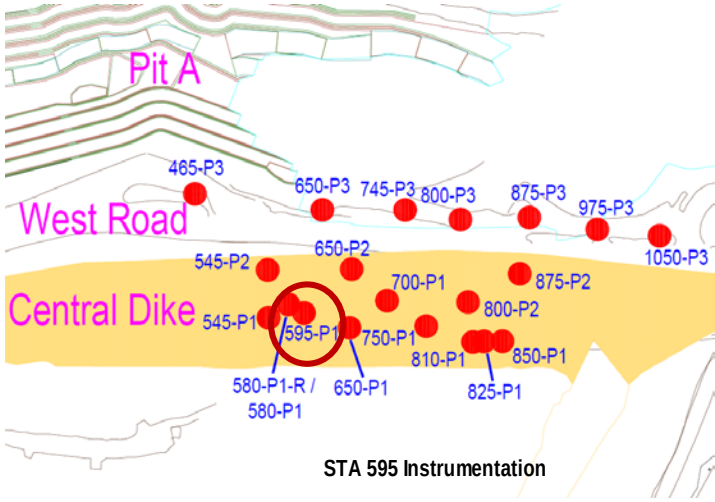
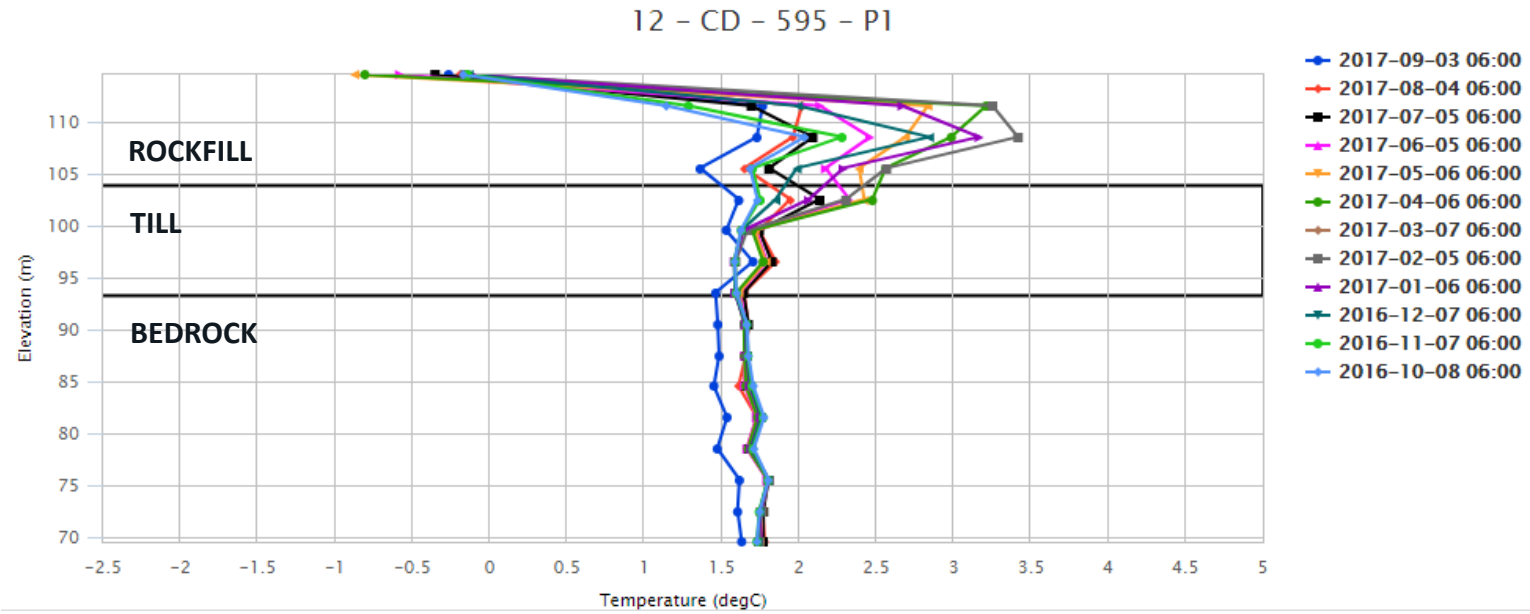
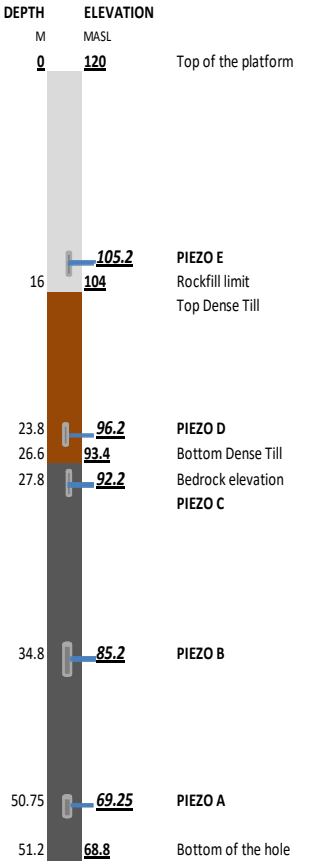
THERMISTOR 595-P1

- Temperature in the bedrock/till unit is in between 1.5 and 1.75º C.
- Glitch of 0.25º C could be caused by the automatization works done in August 2017.

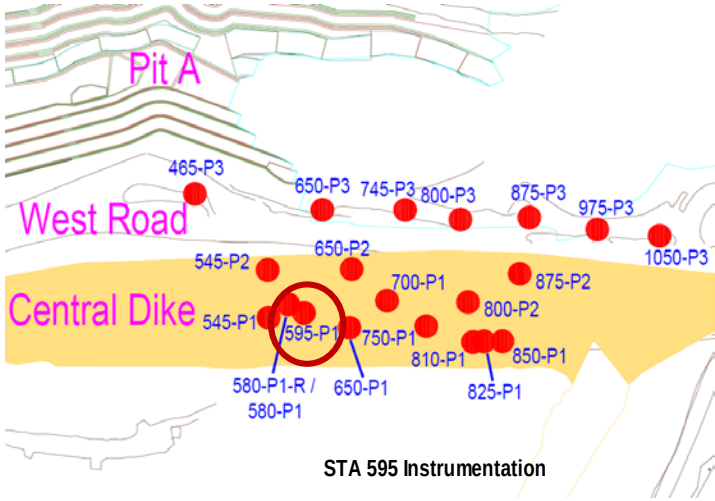
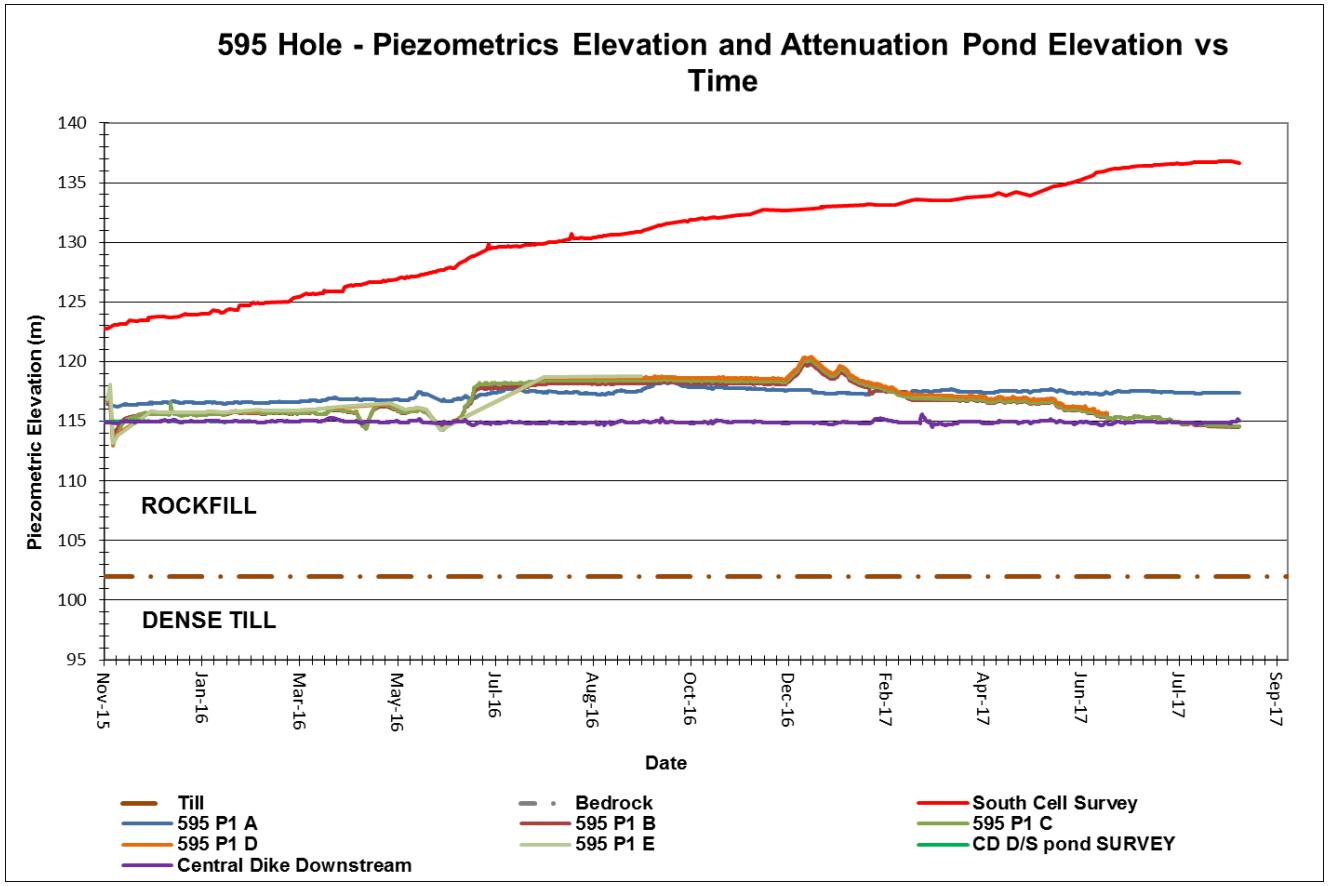
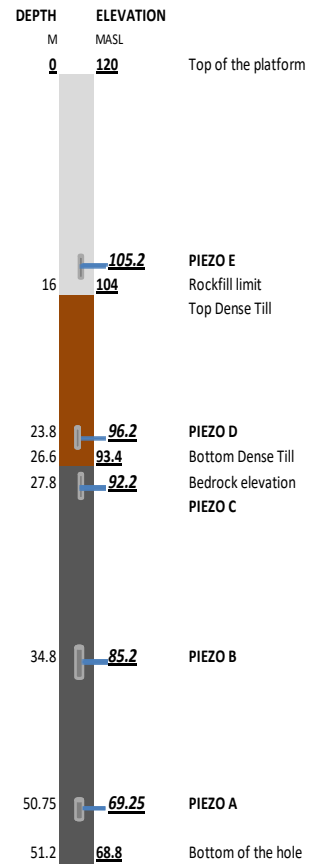
PIEZOMETER 595-P1

- Piezometric readings are fluctuating around D/S pond elevation since the installation.
- **Piezo C to E was installed in casing**

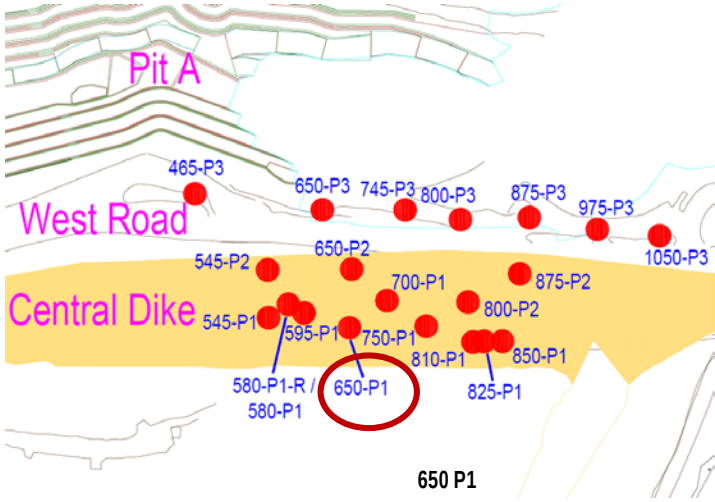
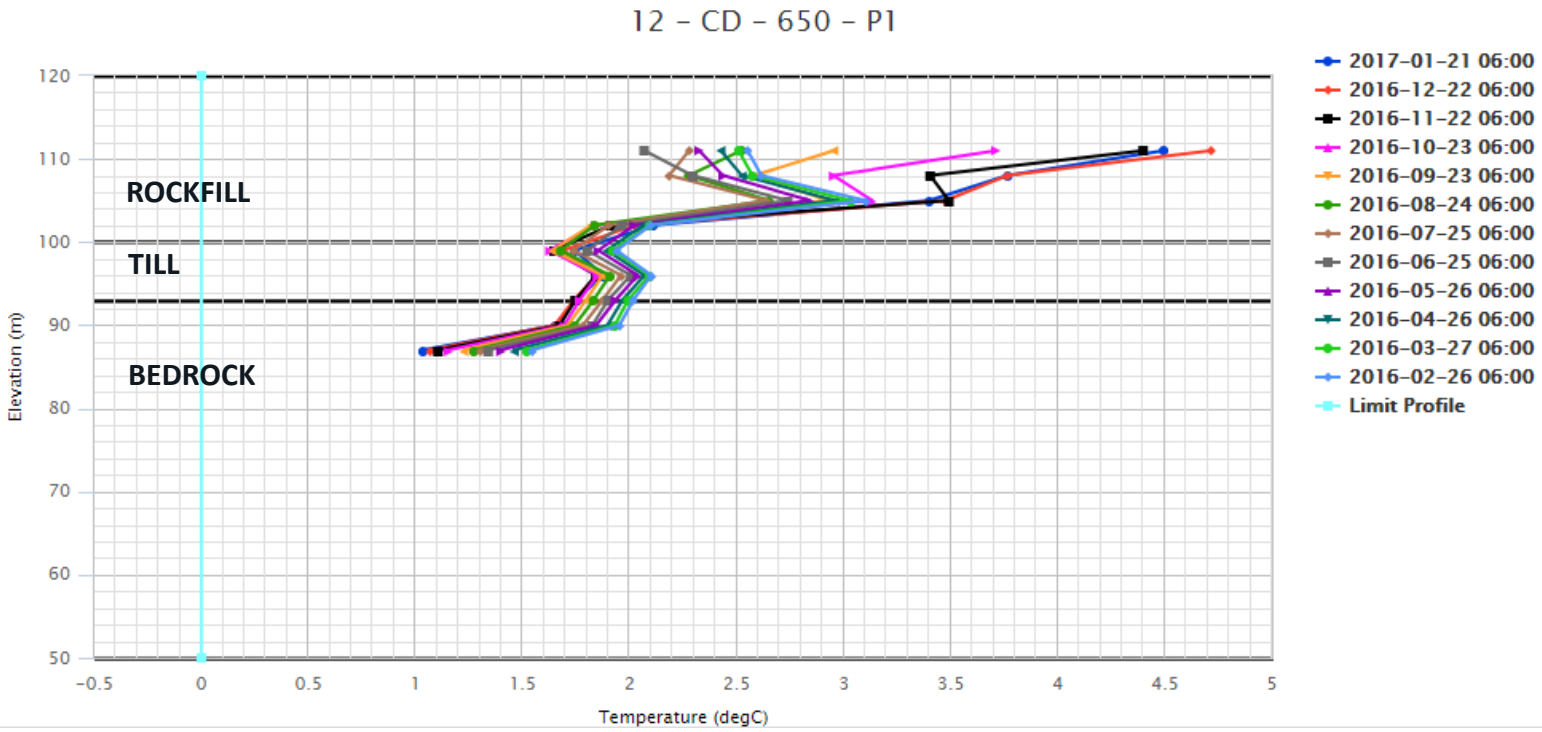
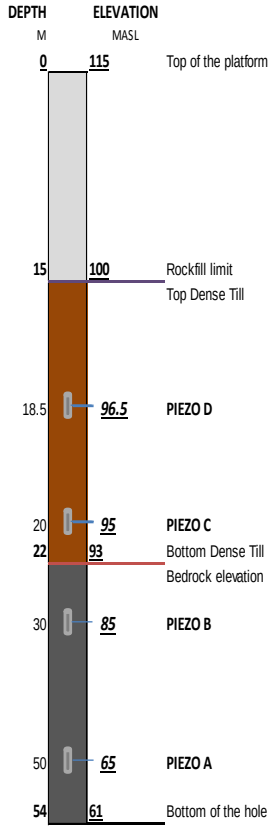
THERMISTOR 650-P1

- Thermistance reading not functional since January 2017
- Beads 10 to 12 are not functionning since August 2016
- Temperature of the bedrock/till units were in between 1.0 and 2.1º C.
