2017 Annual Geotechnical Inspection

2017 Annual Geotechnical Inspection Meadowbank Gold Mine, Nunavut

Report Number: 1784282-1574-RPT-Rev0

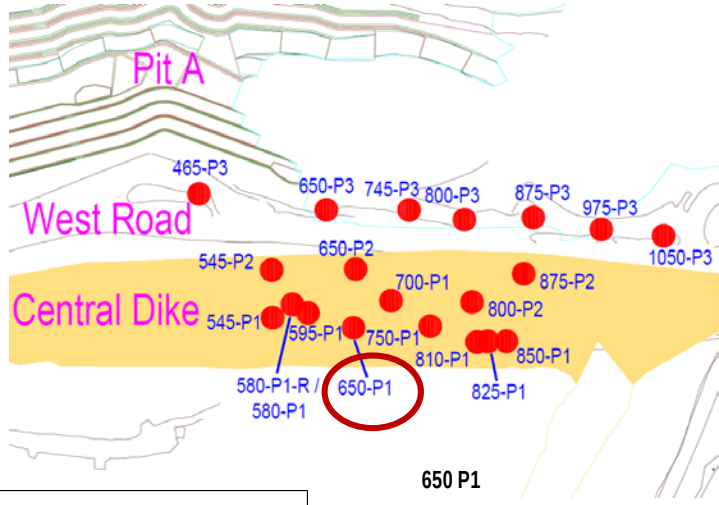
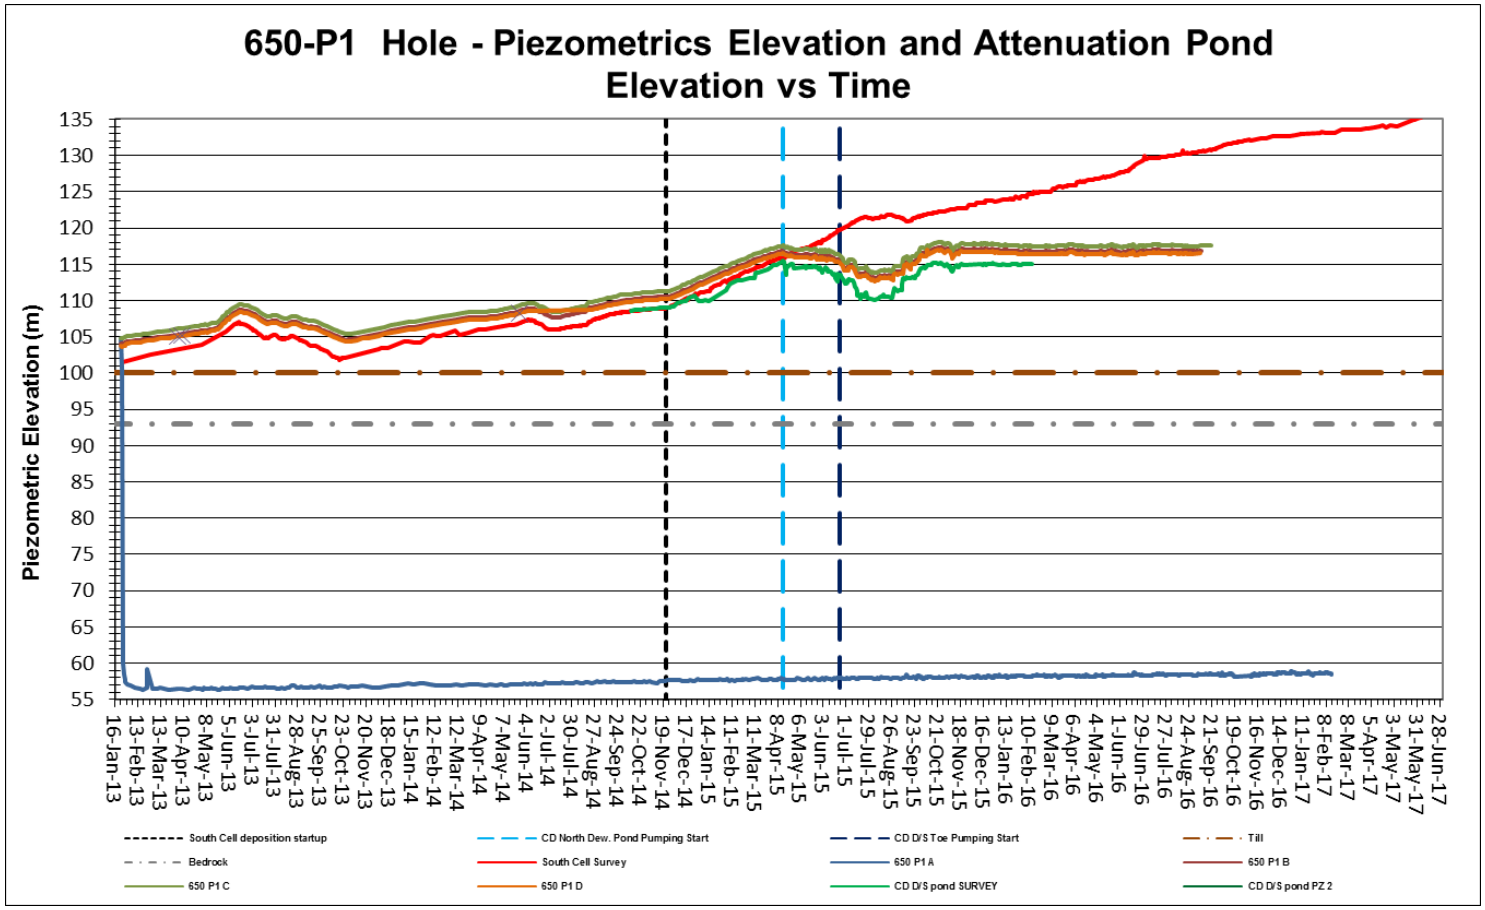
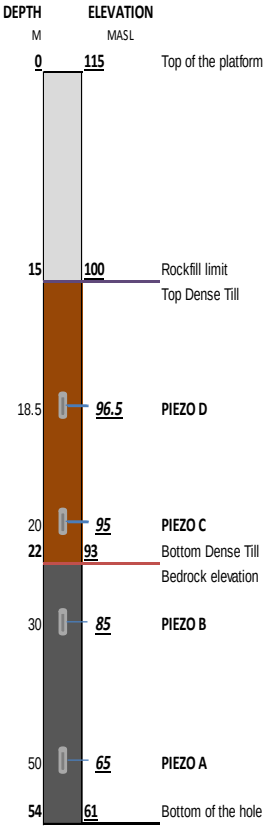
650-P1

- Piezometer reading not functional since February 2017
- Piezo A was in suction and piezo B to D were following D/S pond regime with readings around 117m.

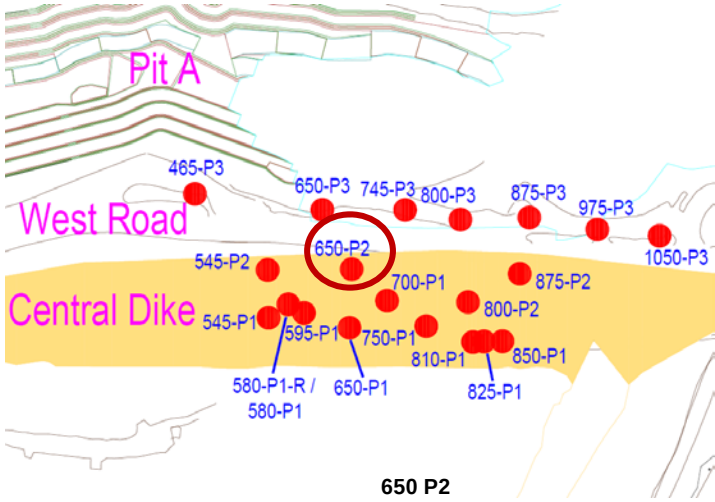
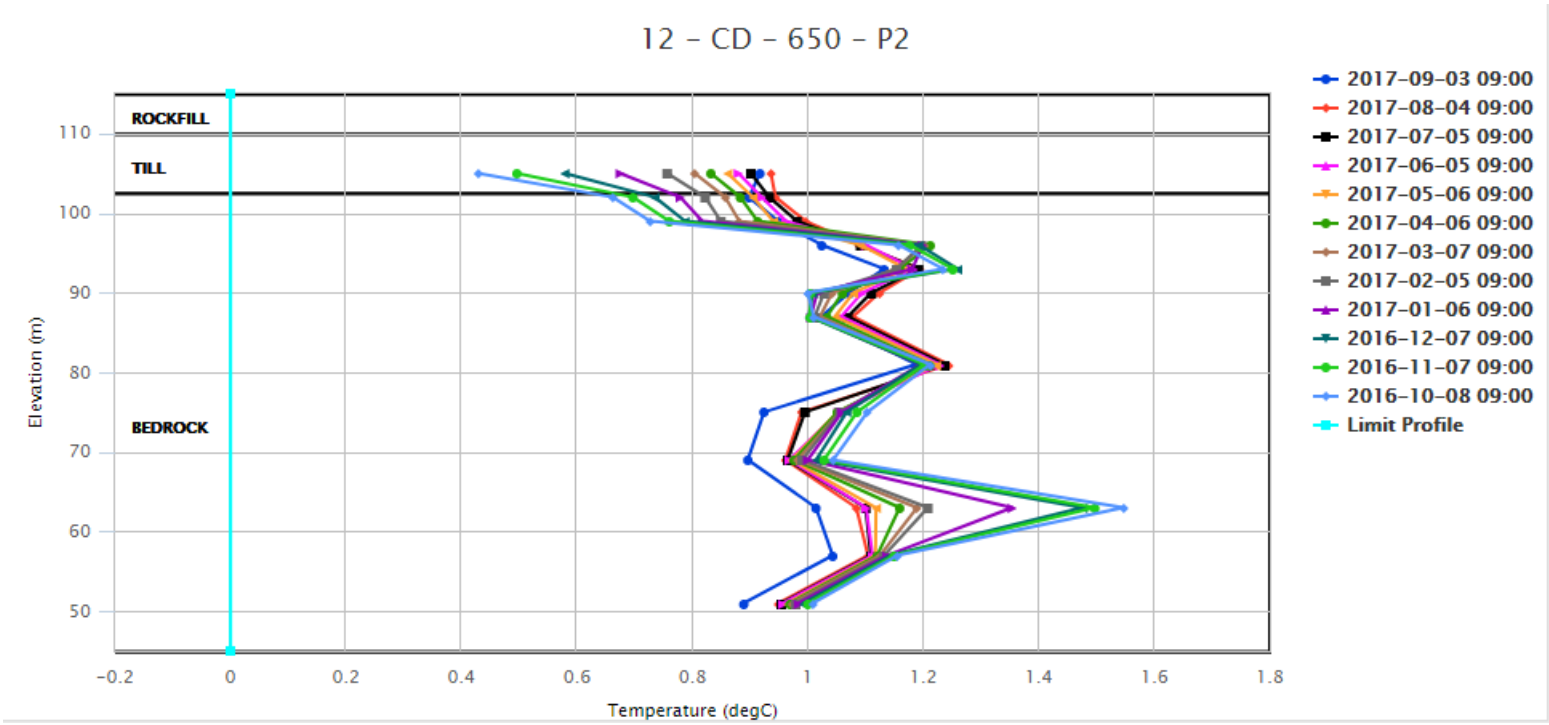
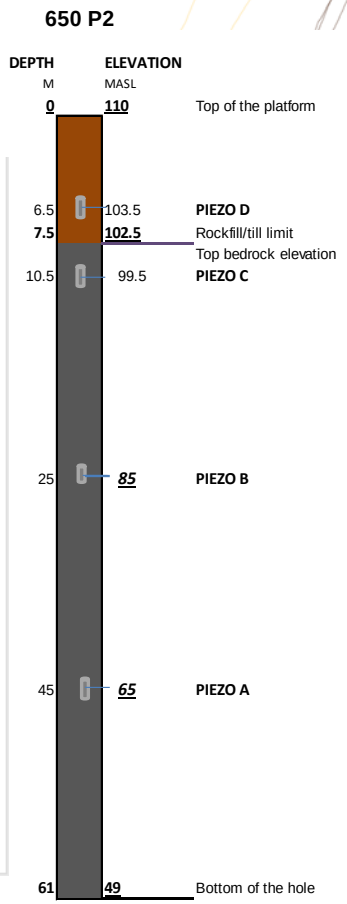
THERMISTOR 650-P2

- Cooling trend observed below El. 80 similar to 2016 readings.

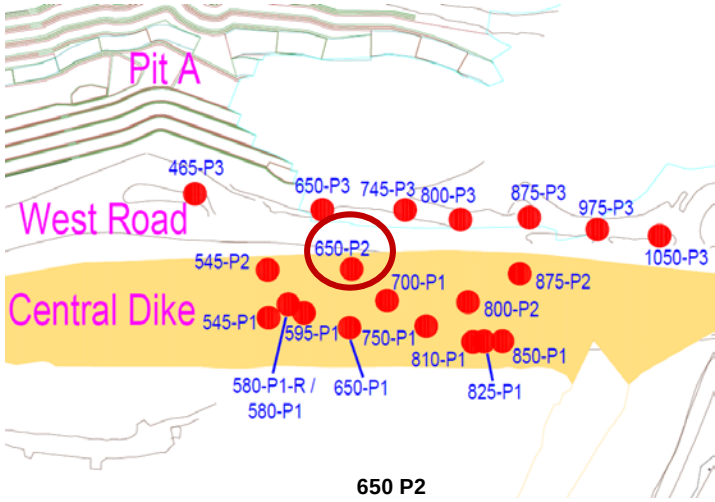
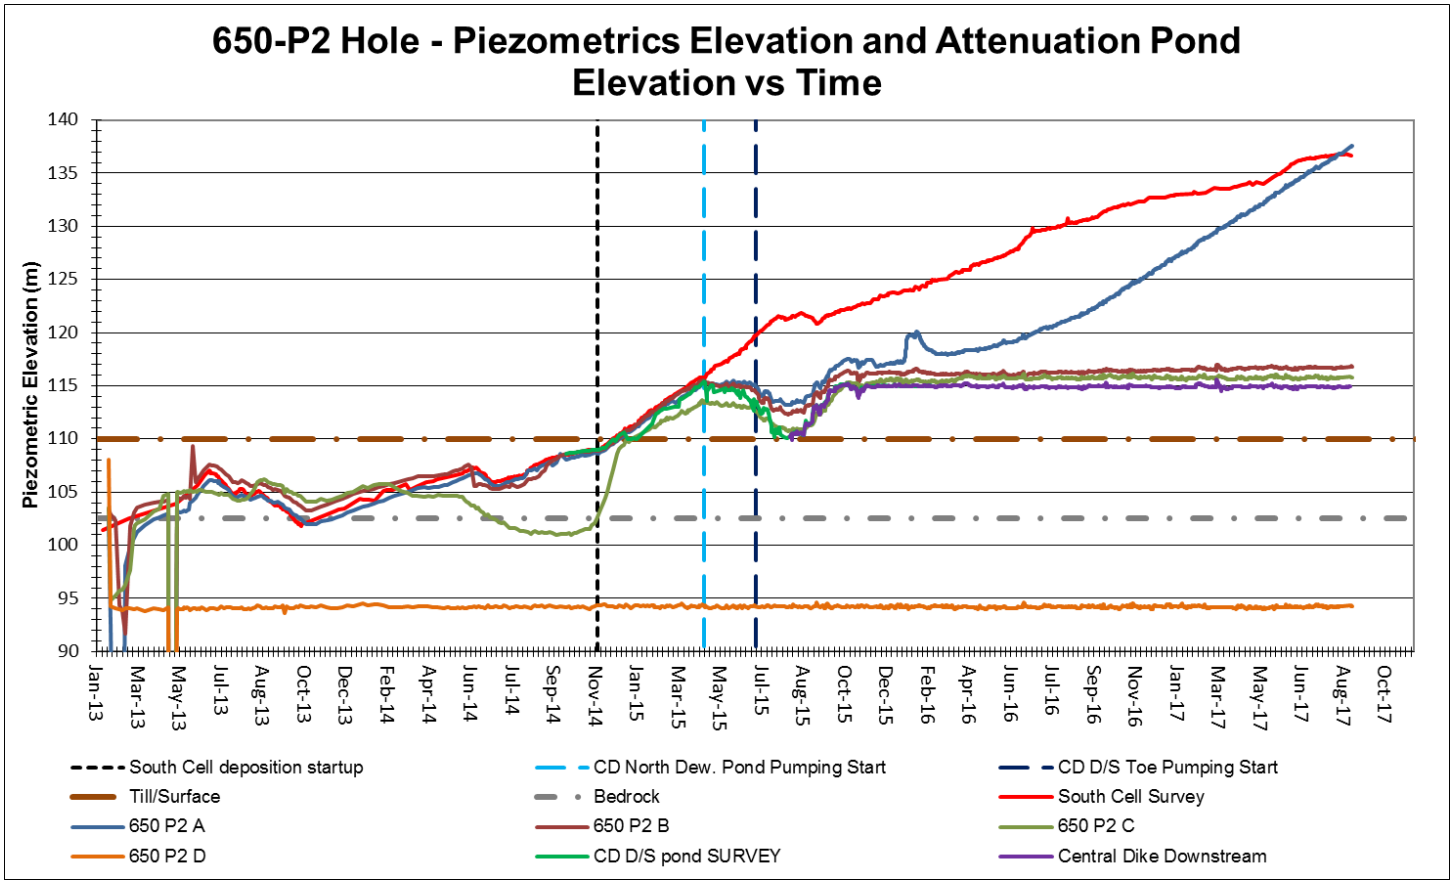
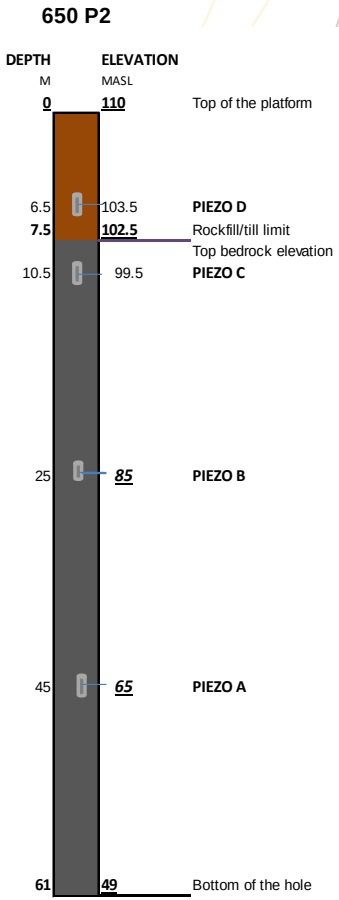
PIEZOMETER 650-P2

- Piezometer A in bedrock continue its rise and is now over the elevation of the South Cell
- Piezo B-C are following the piezometric regime of the D/S pond
- Piezo D is in suction

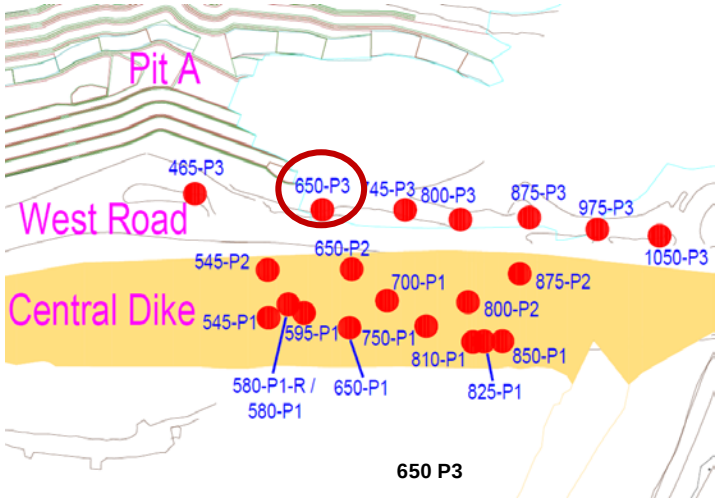
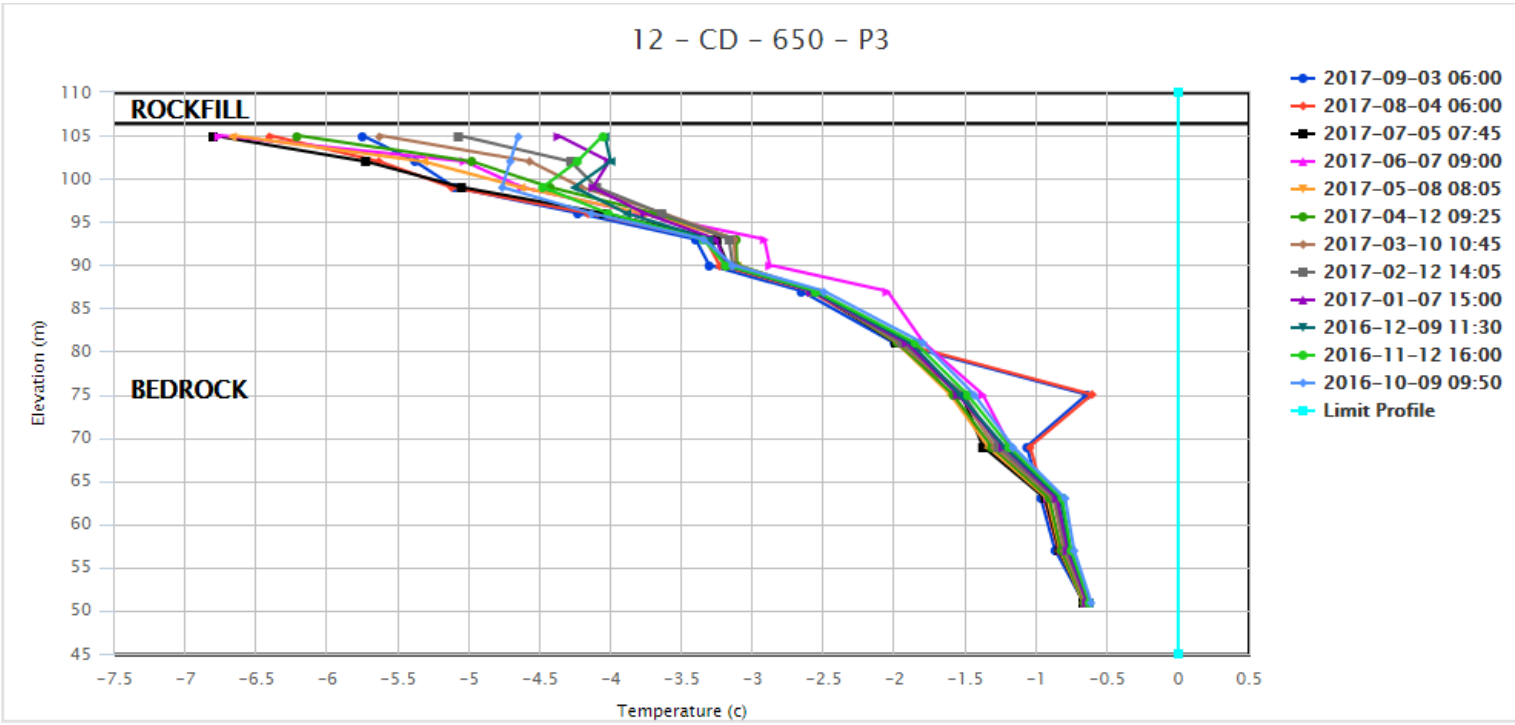
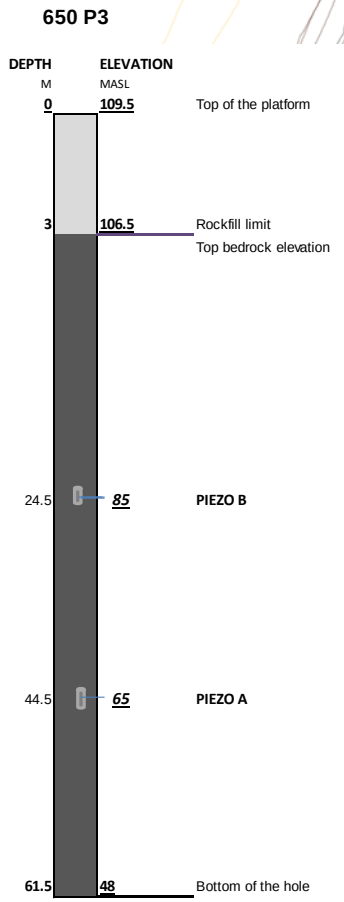
THERMISTOR 650-P3

- Bedrock Below 0º C at 650-P3
- Temperature spike at El. 75 m is related to capacitance effect on this specific bead.

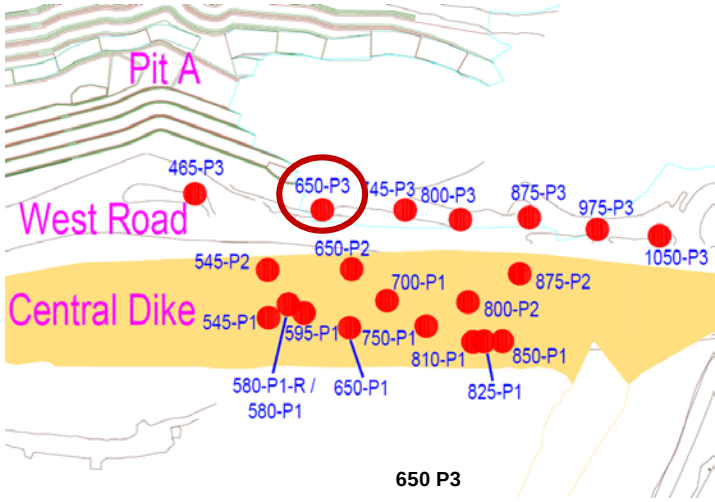
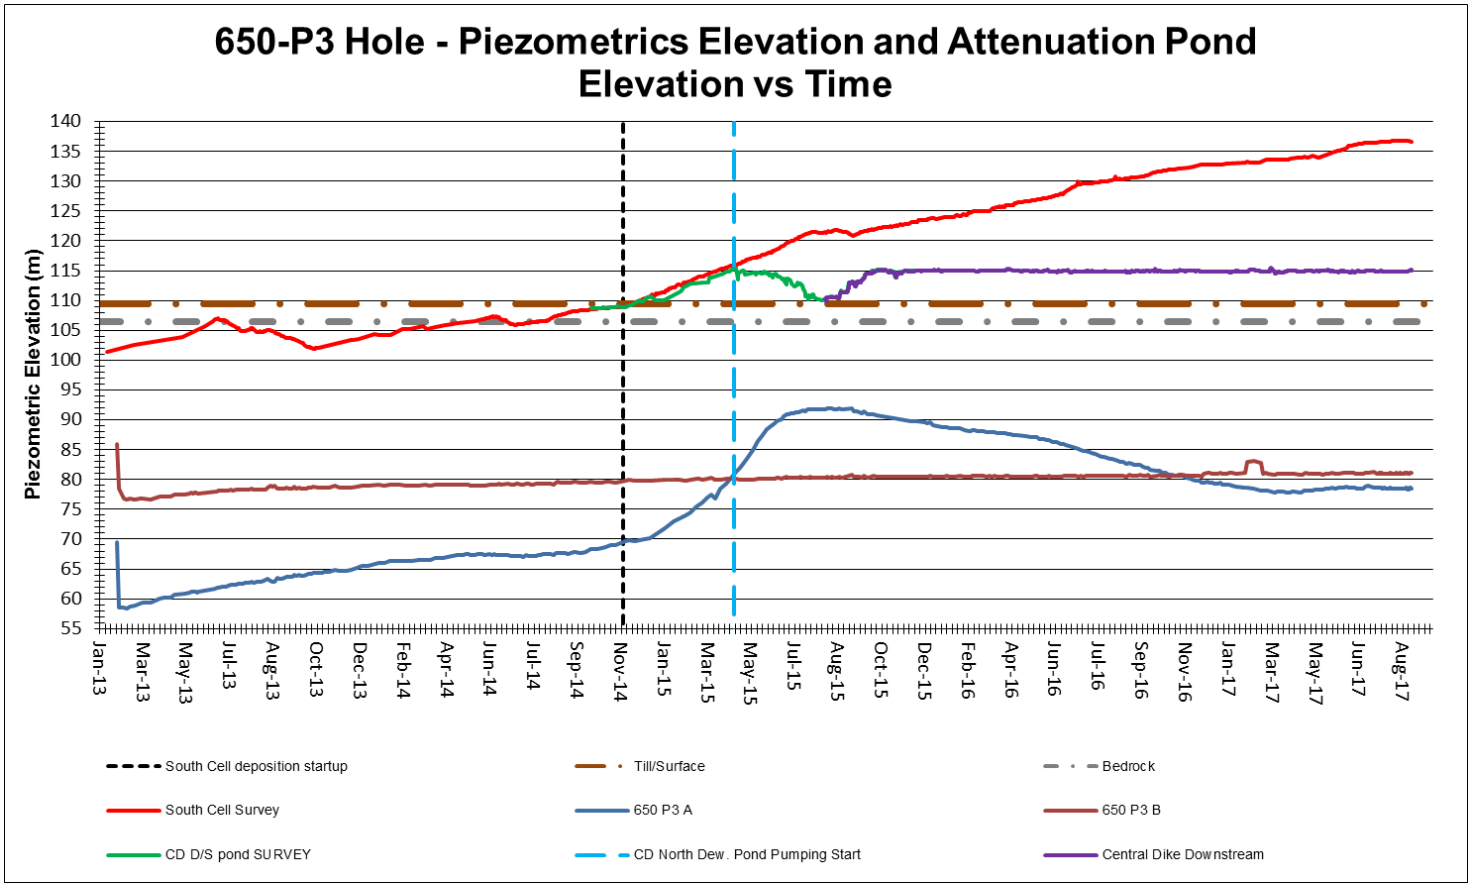
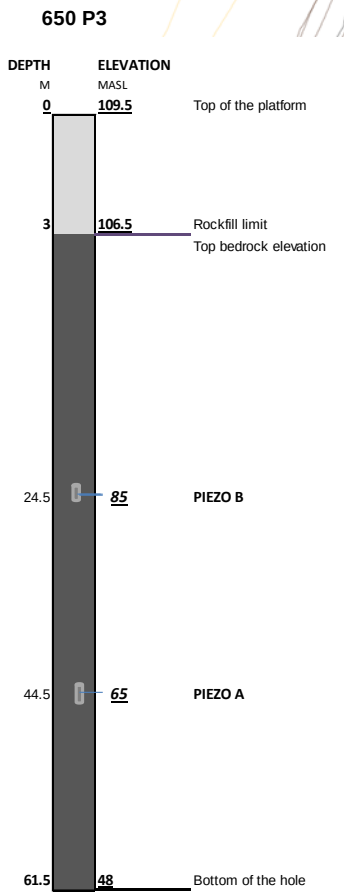
PIEZOMETERS 650-P3

Frozen Piezometers

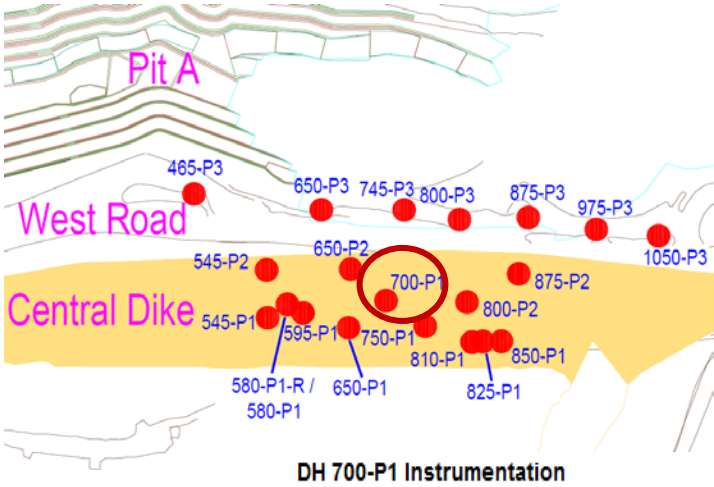
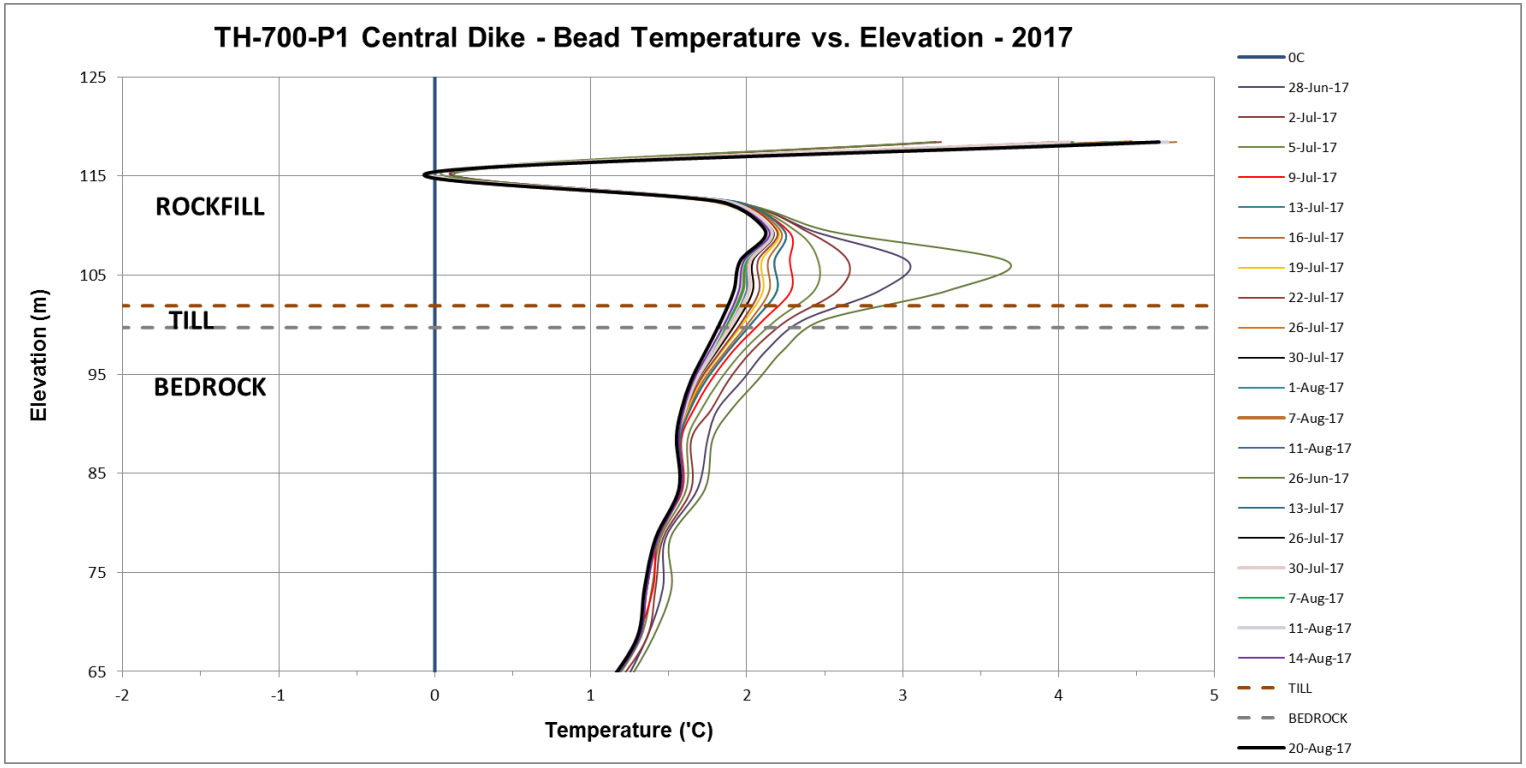
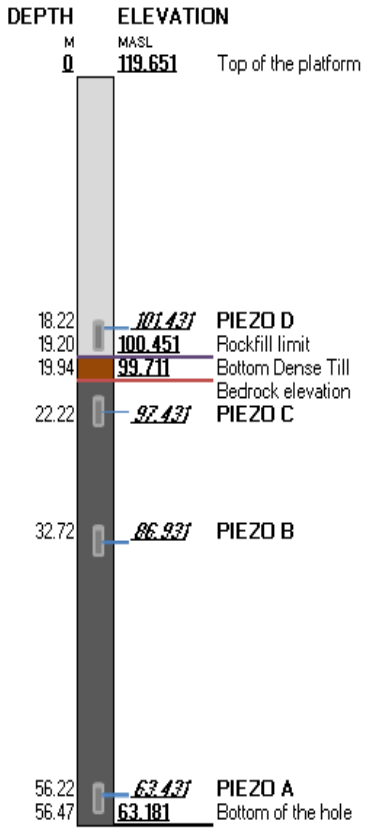
THERMISTOR 700-P1

- New instrument installed in 2017
- Stabilisation of temperature ongoing
- Till and bedrock temperature readings above 0º C

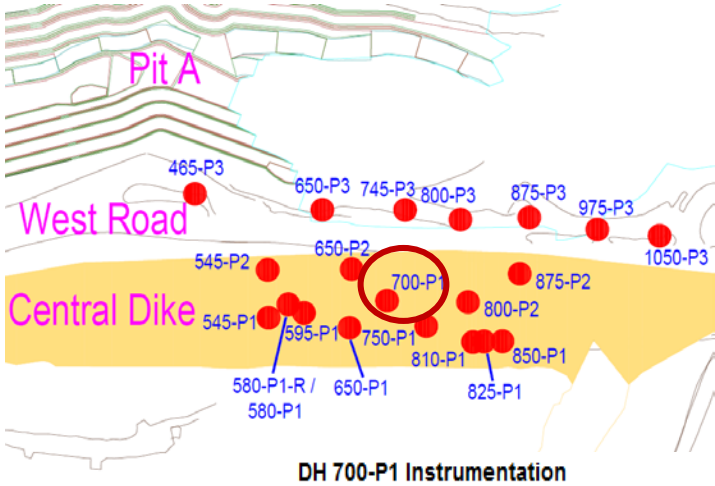
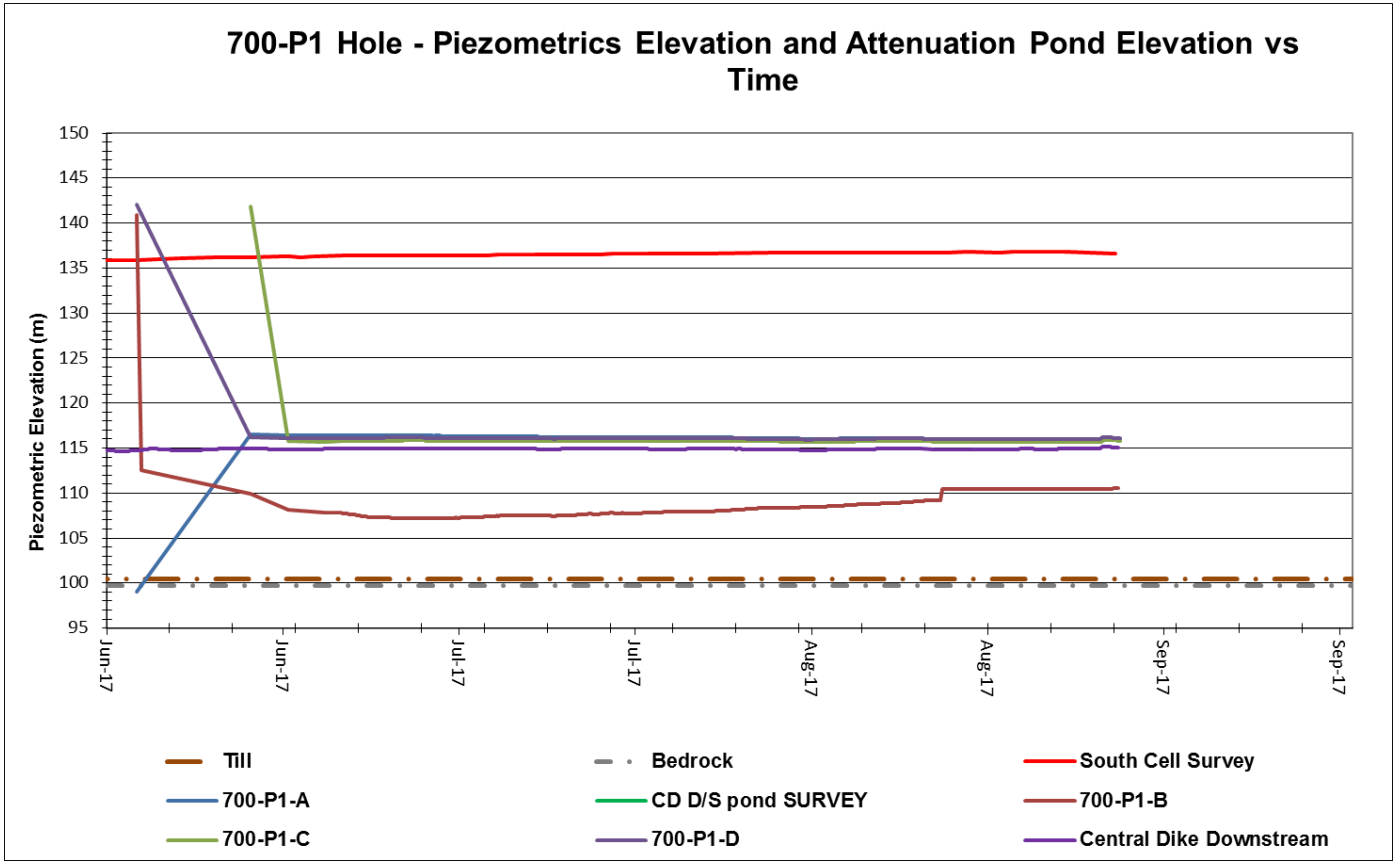
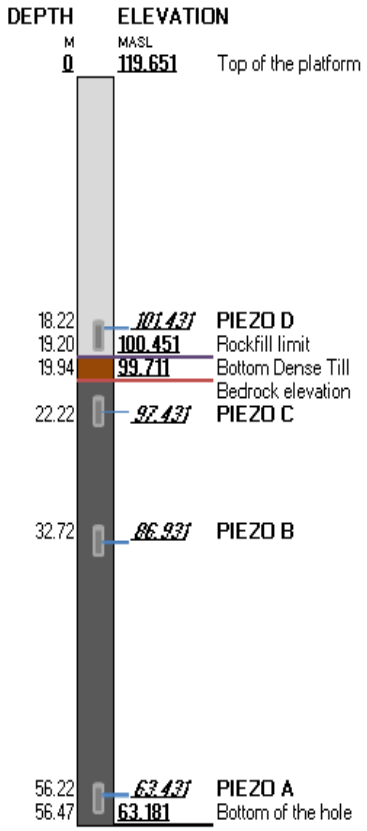
PIEZOMETER 700-P1

- New instrument installed in 2017
- Stabilization of temperature ongoing
- Reading automatization occurred on the date of the small bump observed on the piezo B
- Piezo A.C and D are showing reading similar to the D/S pond.

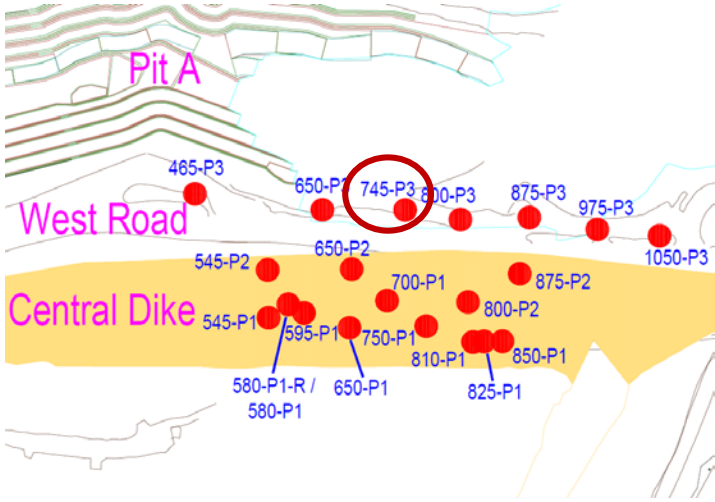
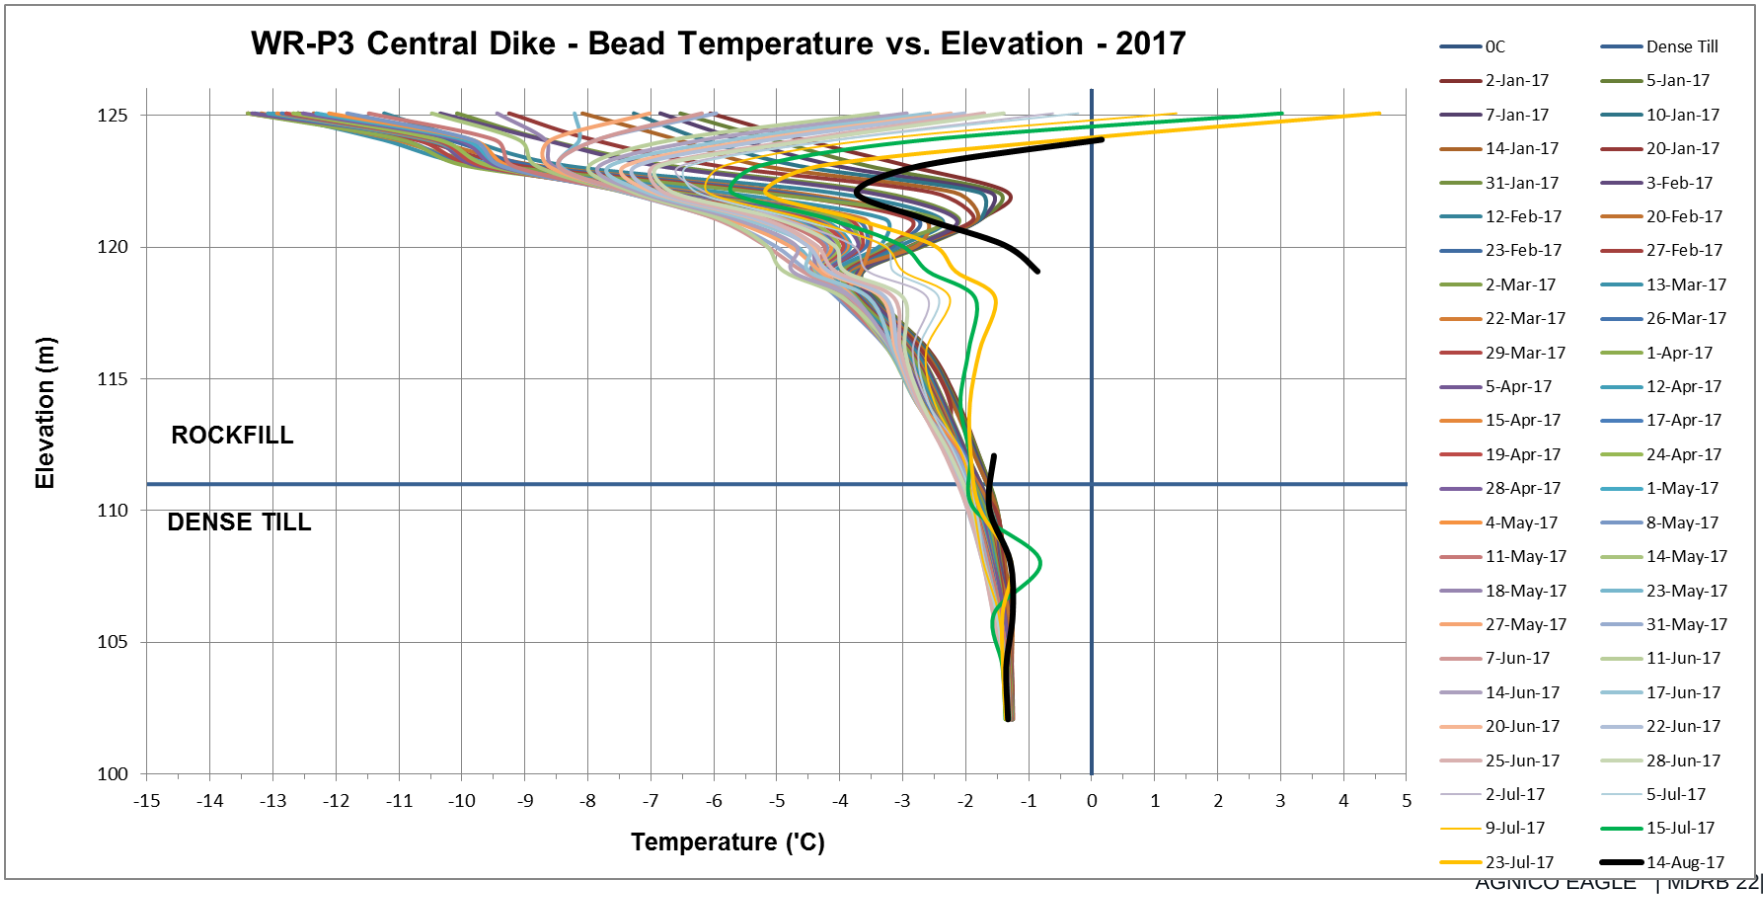
THERMISTOR 745-P3

- Thermistor installed to monitor freeze back of the West Road. This thermistor do not reach bedrock
- Rockfill and till below 0º C at 745-P3
- Frozen limit of the northen section of the P3 line

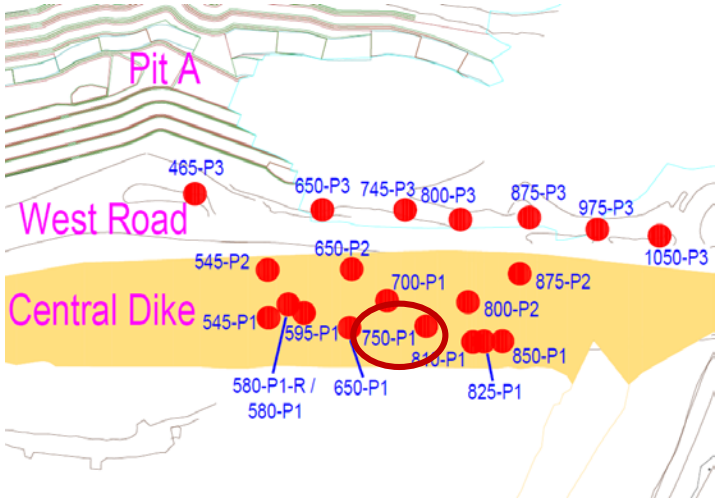
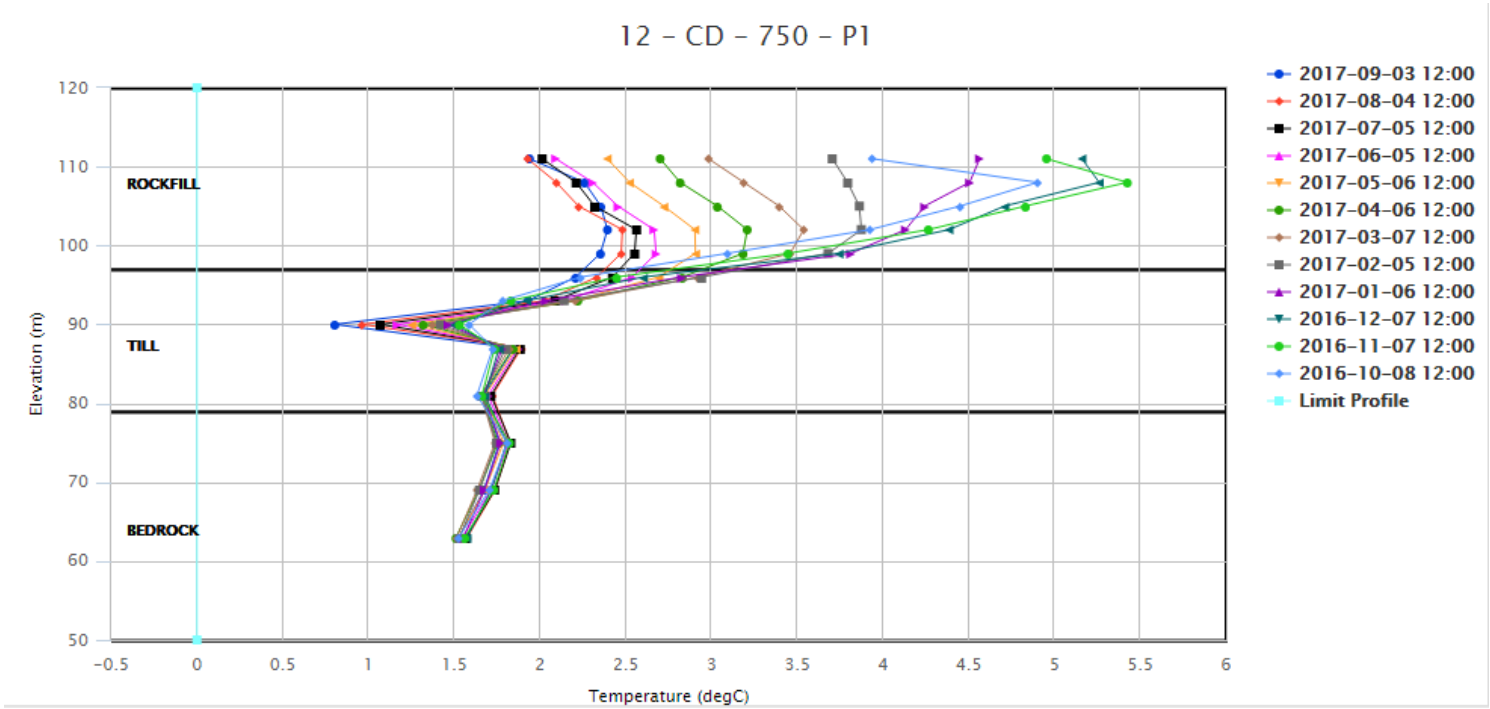
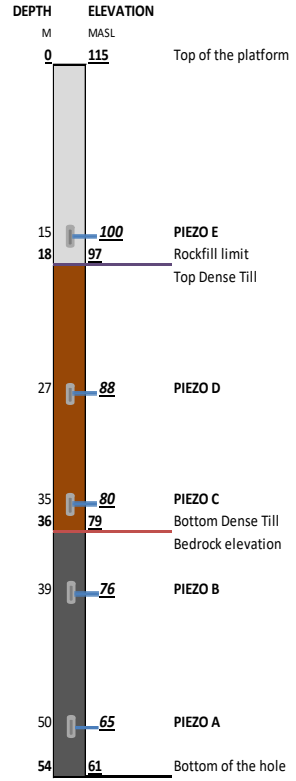
THERMISTOR 750-P1

- Cooling trend in till layer. The bead located at elevation 90m is in average 1º C cooler than in 2016.

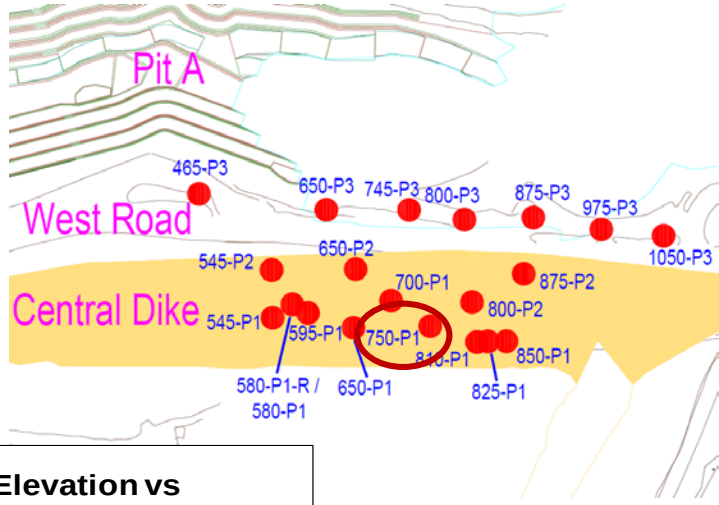
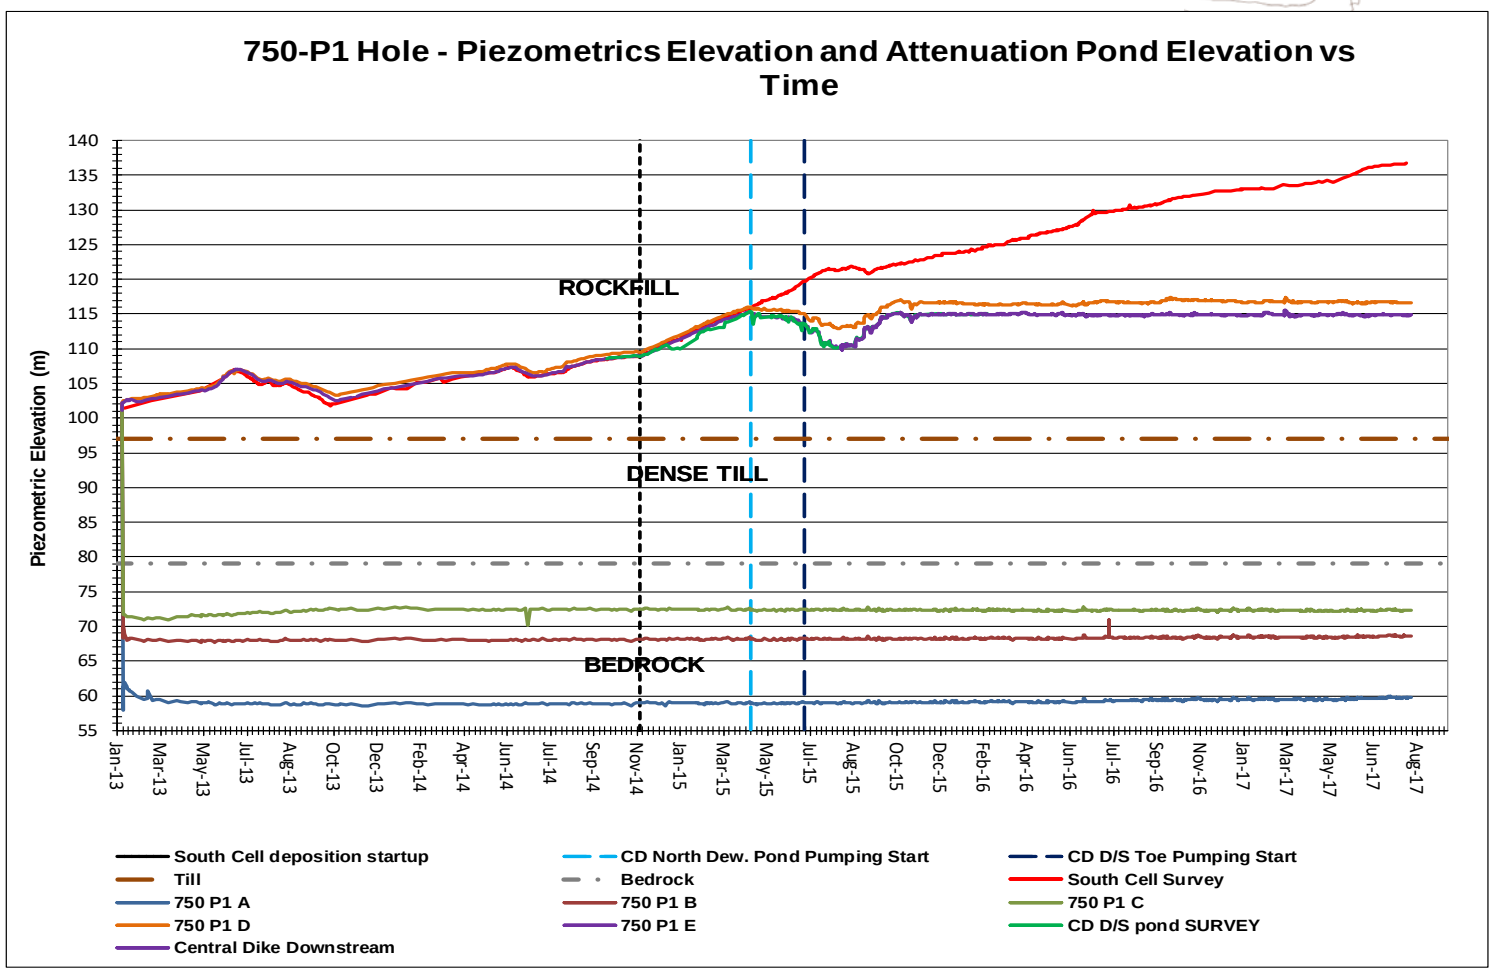
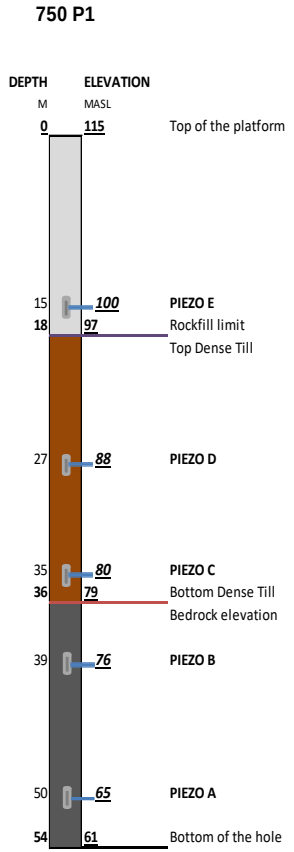
PIEZOMETER 750-P1

- Piezo A, B and C are in suction
- Piezo D is have a direct reaction to any variation in elevation observe in the D/S pond.

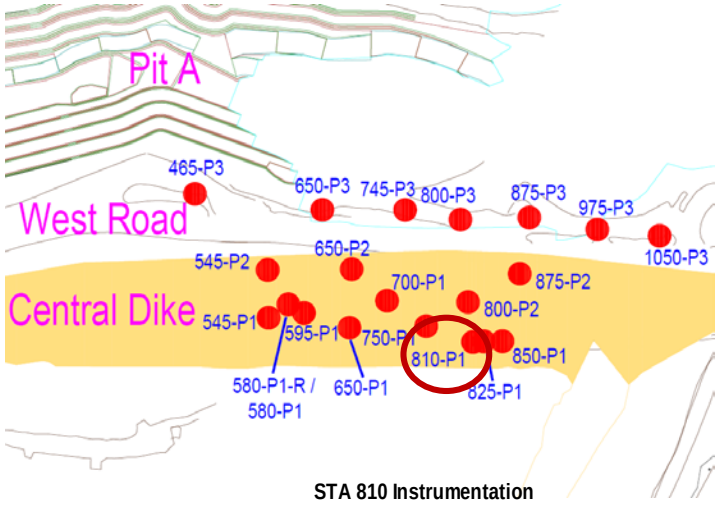
THERMISTOR 810-P1

- Bead below El. 114.84 m stop working in February 2017
- Higher temperature observed in this hole (might be the instrument progressively failing)

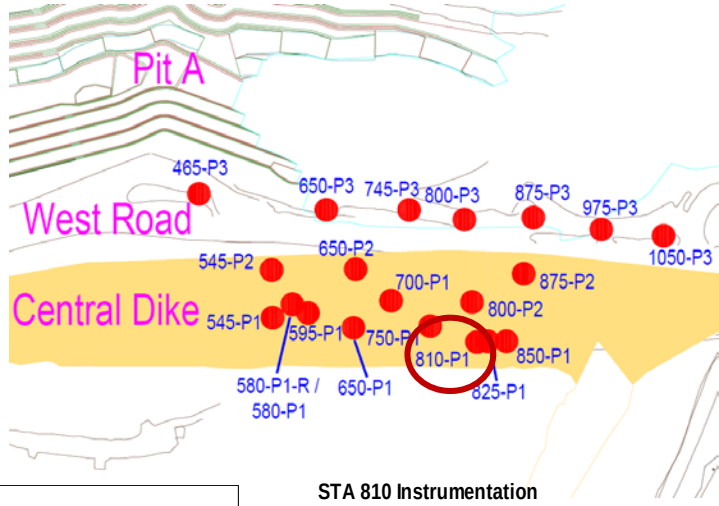
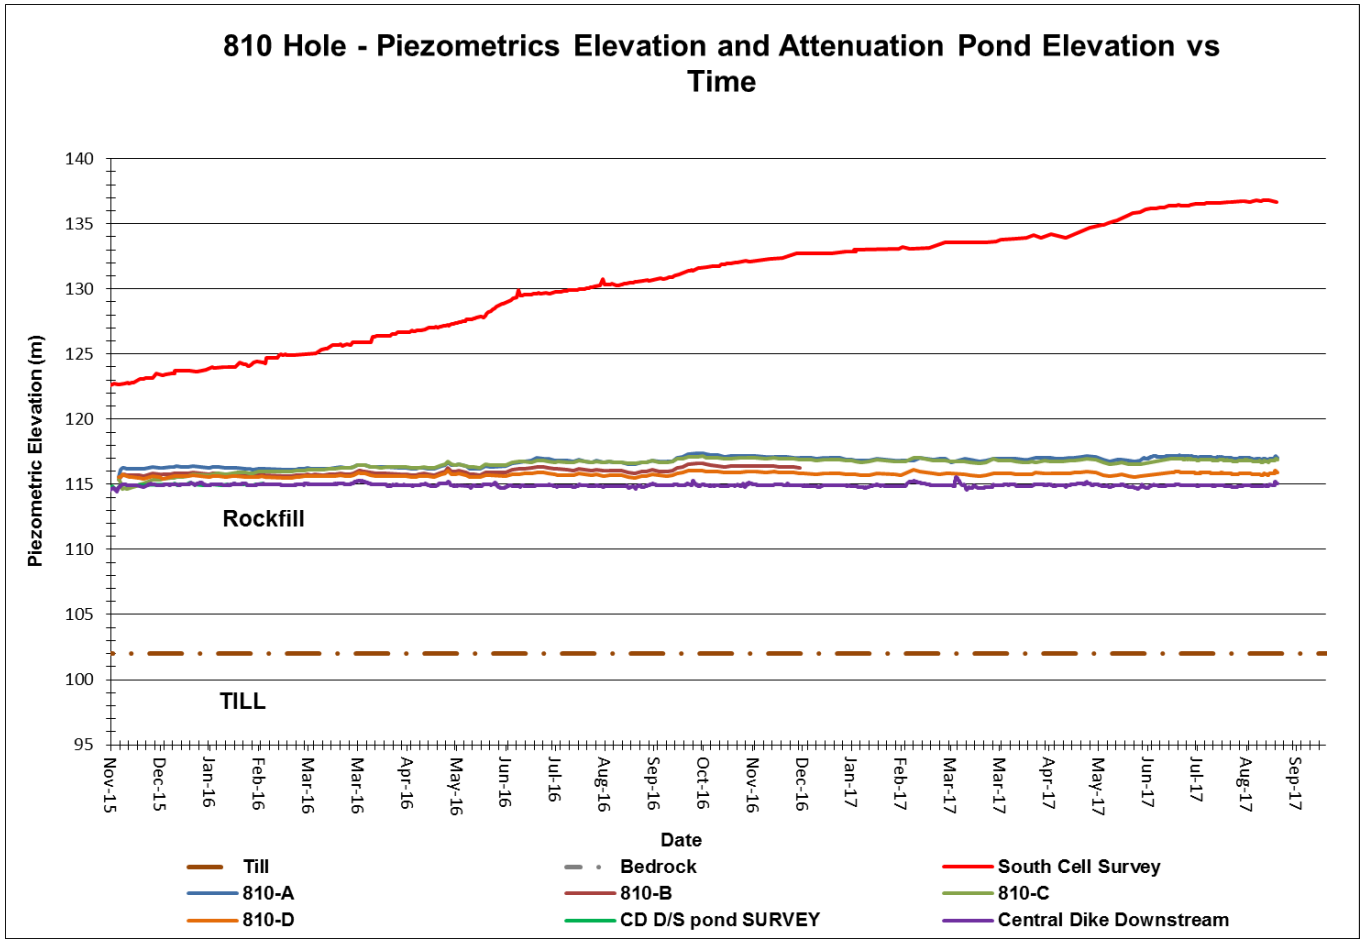
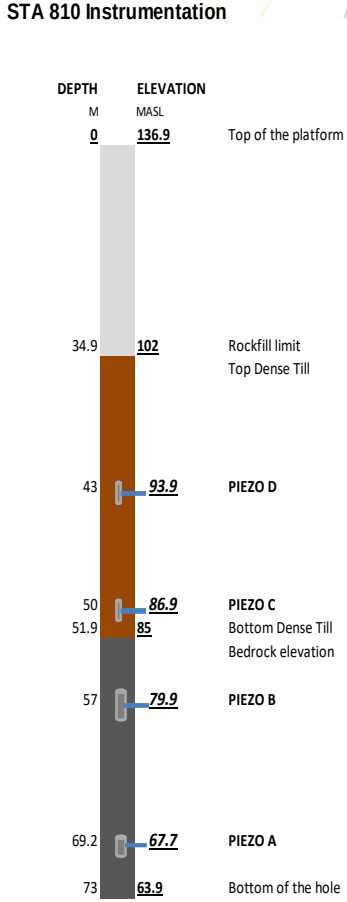
PIEZOMETER 810-P1

- Piezo B stop working in January 2017
- Piezo A, C & D are following the elevation change of the D/S pond

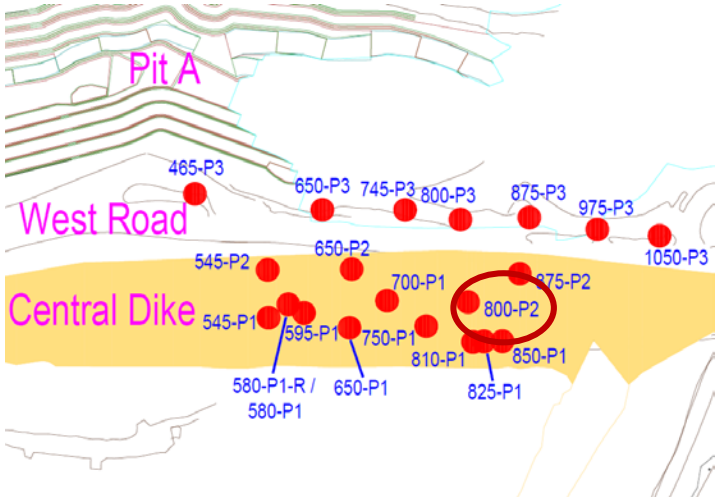
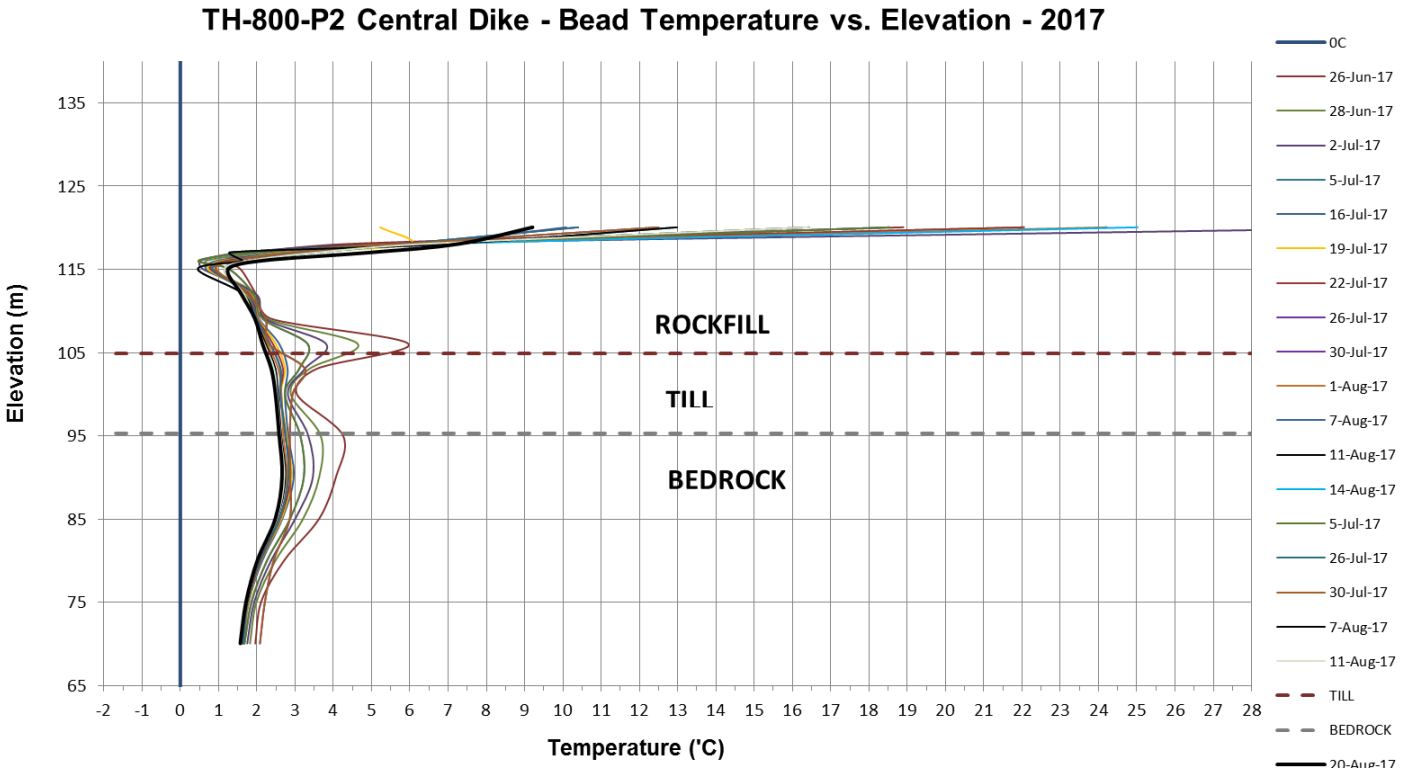
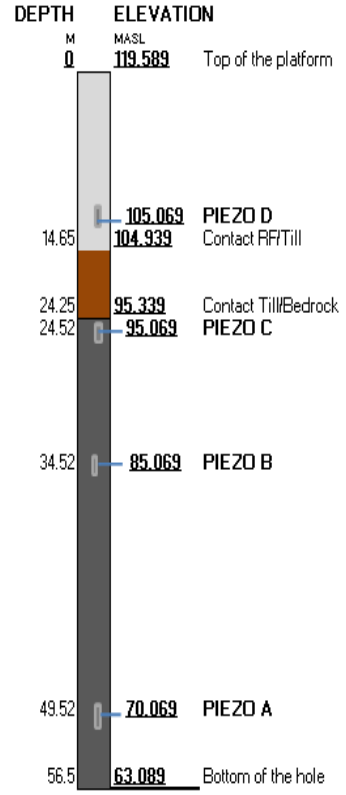
THERMISTOR 800-P2

- New instrument installed in 2017
- Stabilisation of temperature ongoing
- Temperature above 0 ºC
