2017 Annual Geotechnical Inspection

2017 Annual Geotechnical Inspection Meadowbank Gold Mine, Nunavut

Report Number: 1784282-1574-RPT-Rev0

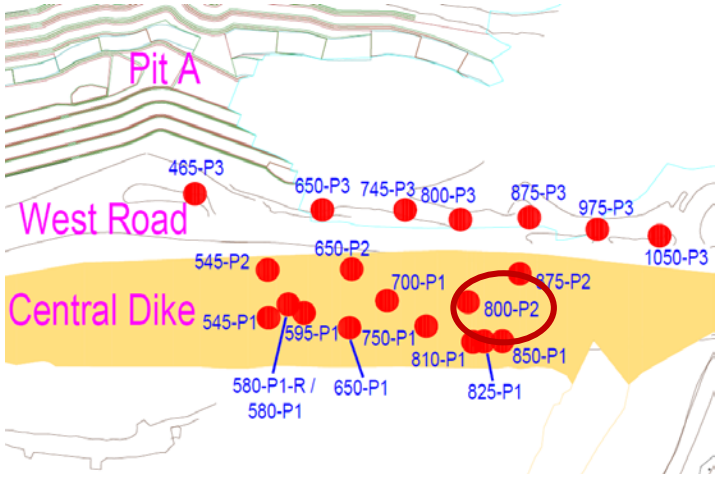
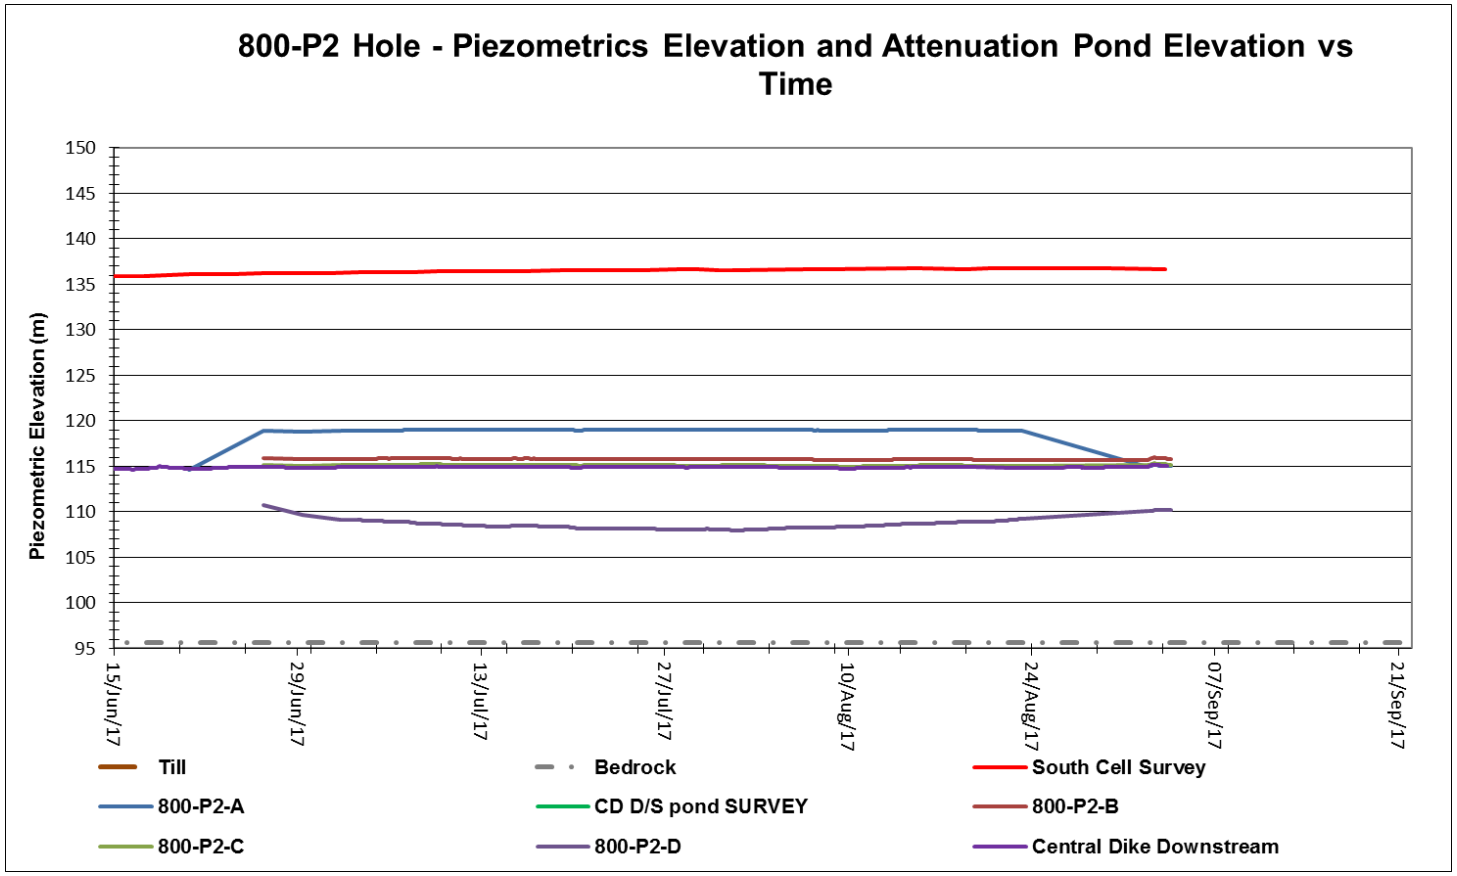
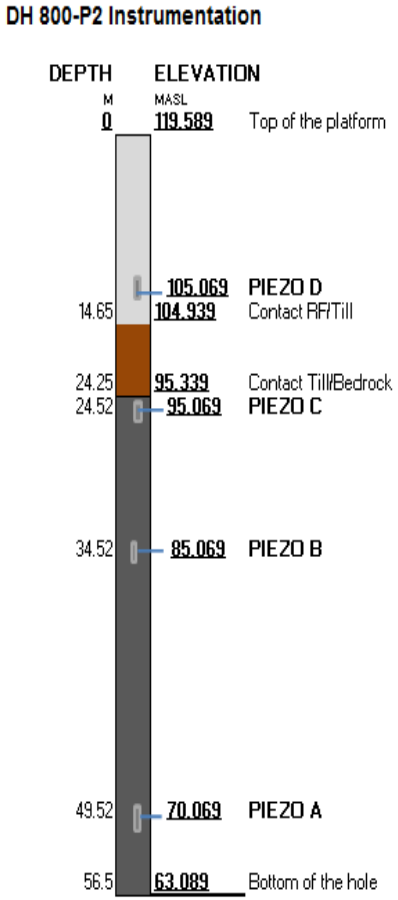
PIEZOMETER 800-P2

- New instrument installed in 2017
- Stabilisation ongoing
- Piezo A,B and C are showing pressure readings similar to the elevation of the D/S pond.

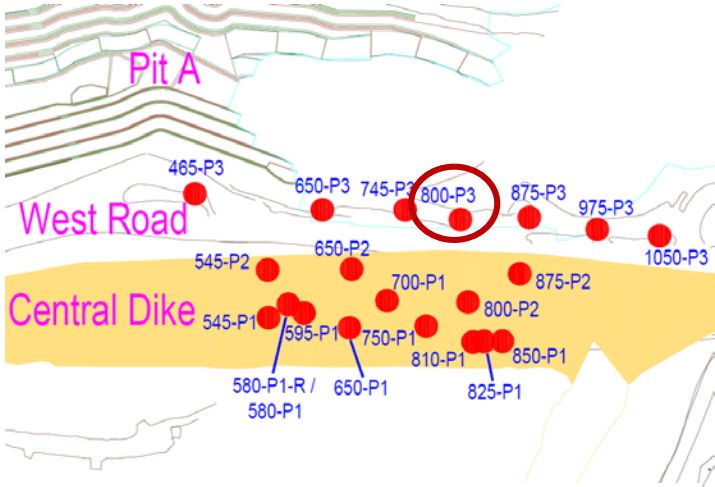
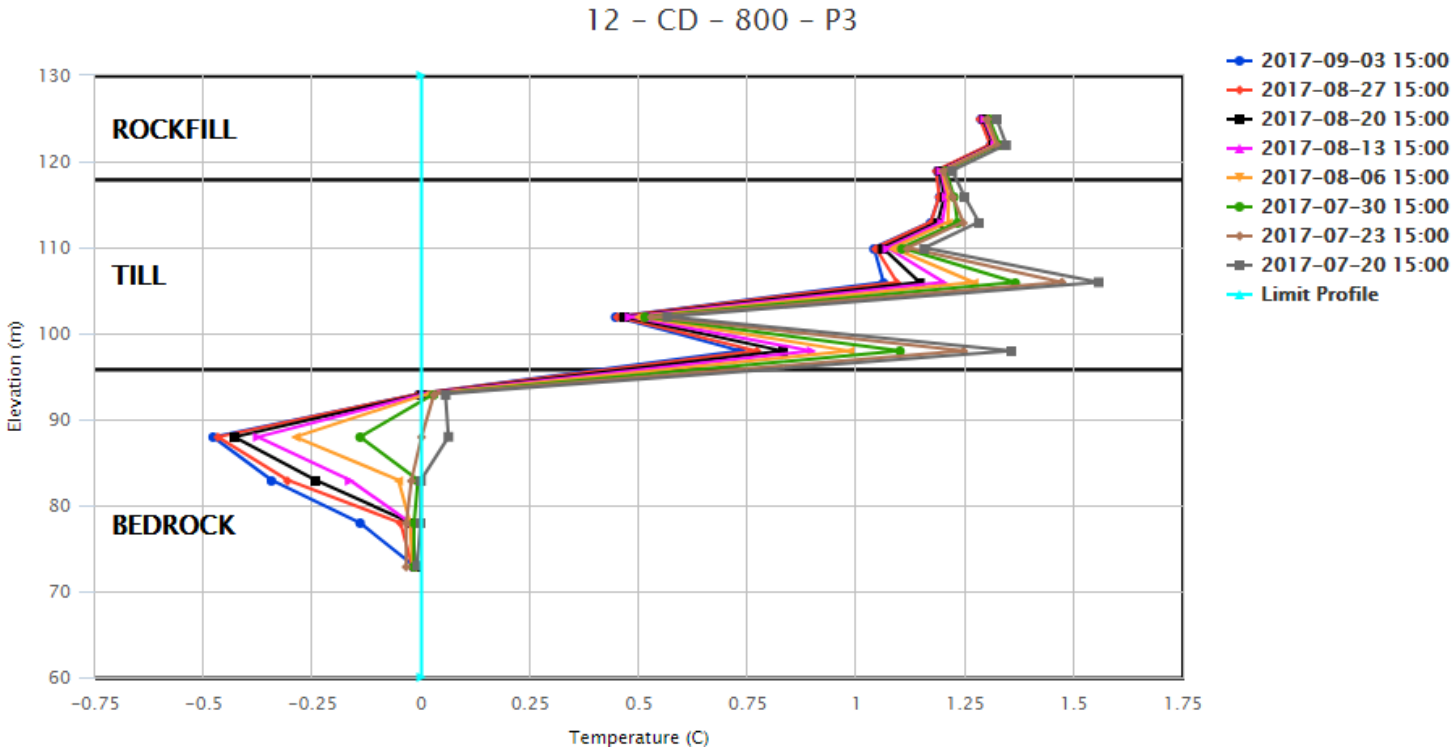
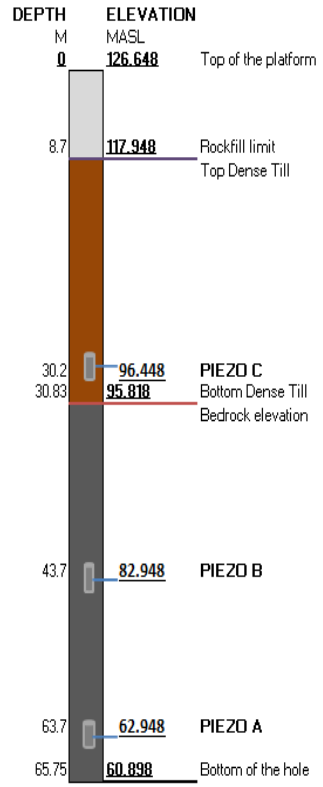
THERMISTOR 800-P3

- New instrument installed in 2017
- Stabilisation in progress
- Temperature under 0º C below El. 93 m

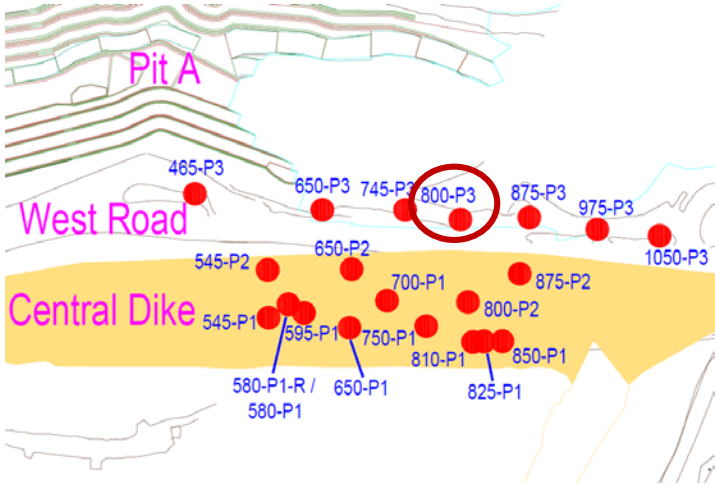
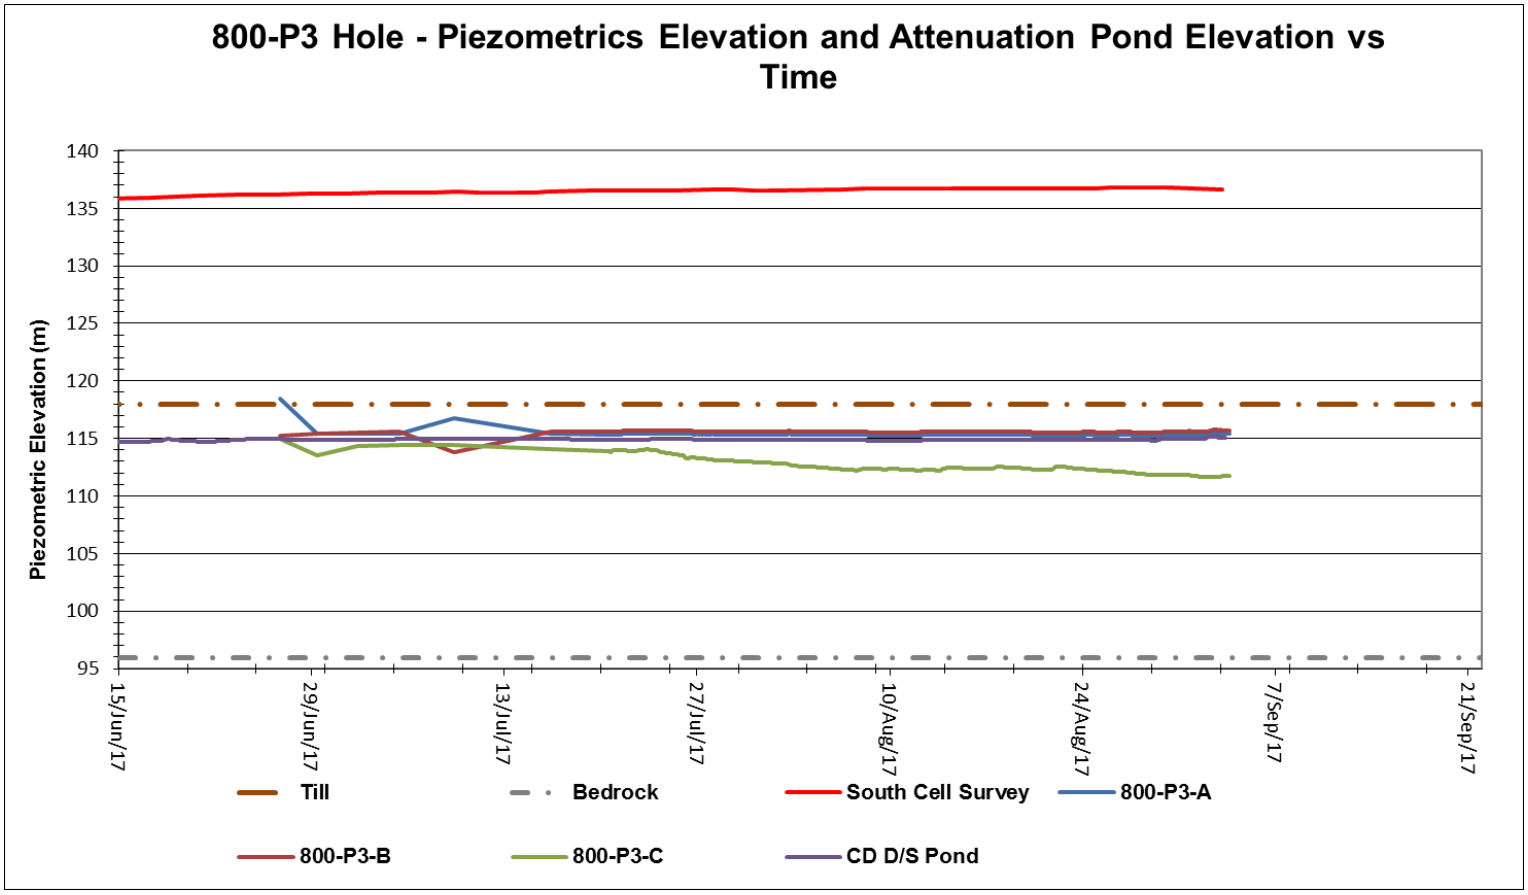
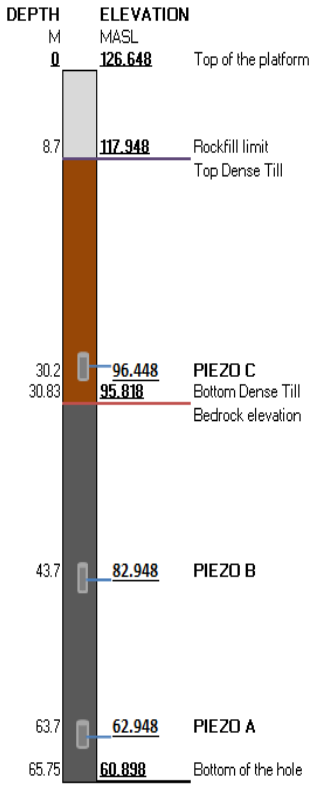
PIEZOMETERS 800-P3

- New instrument installed in 2017
- Stabilization in progress
- Piezo A & B readings are similar to the D/S pond elevation readings
- Piezo C readings is slowly decreasing

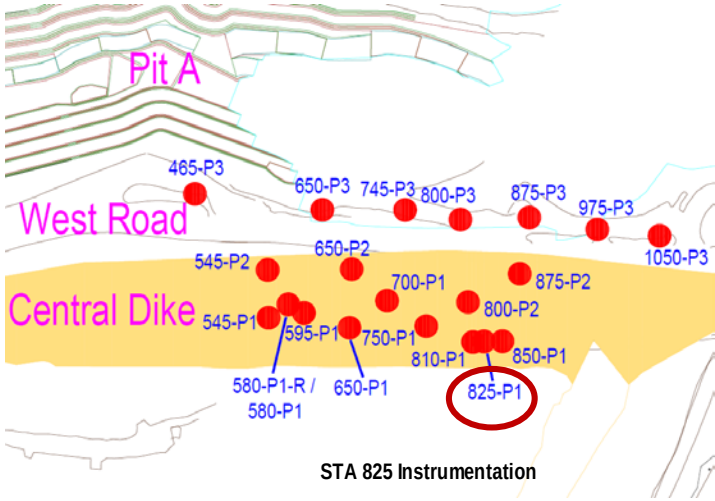
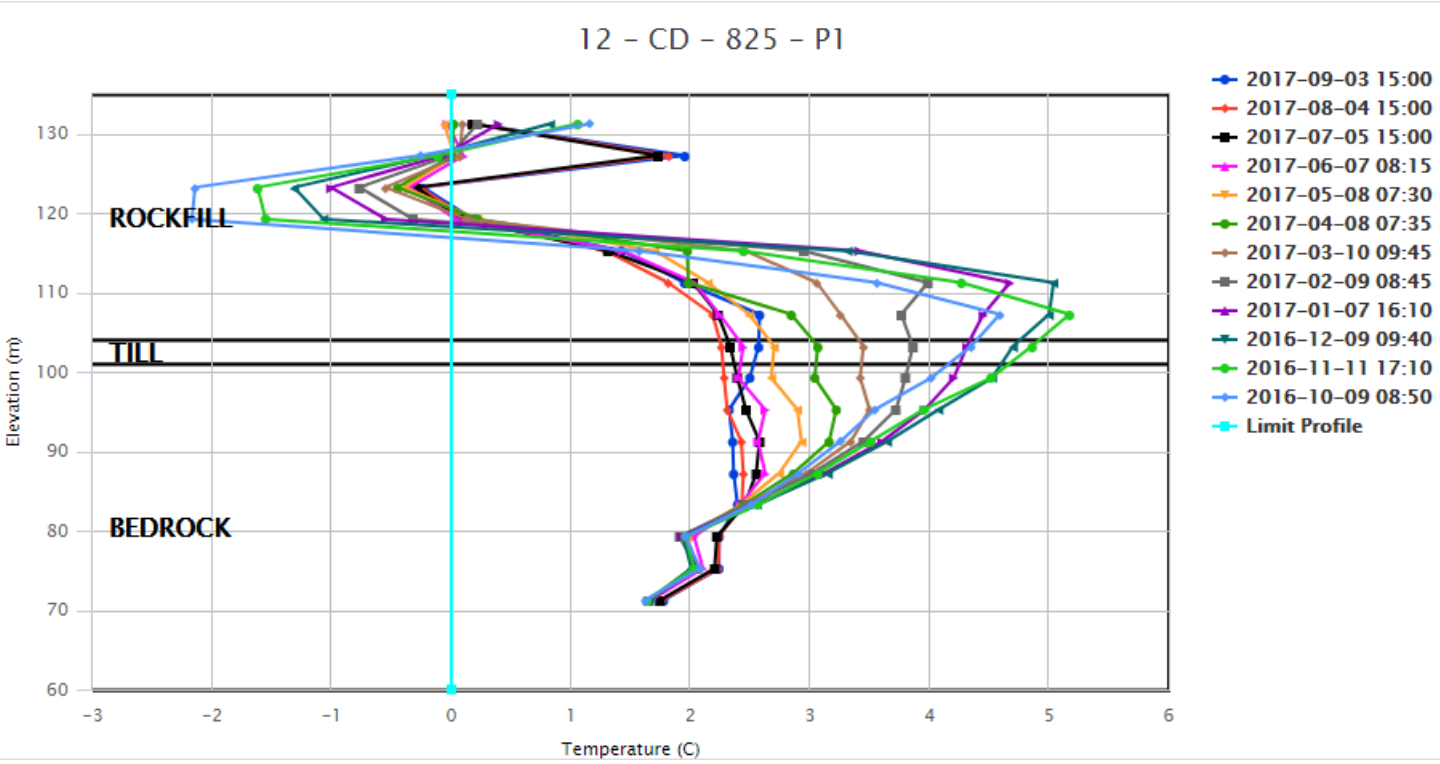
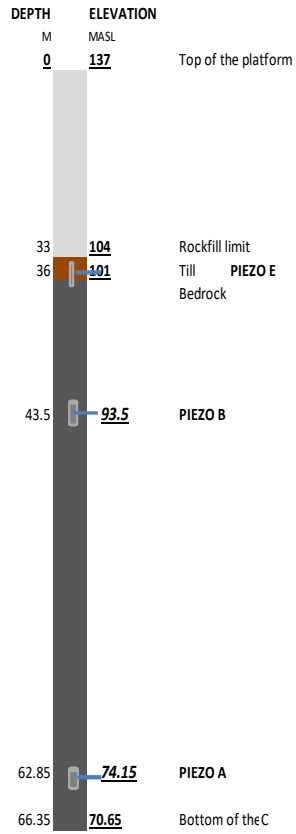
THERMISTOR 825-P1

- Temperature variation over the year inside the bedrock/till units is higher than in the previous year:
- 2016: [1.5, 3.2]
- 2017: [1.6, 4.5]
- Generally warmer readings recorded over the last year.

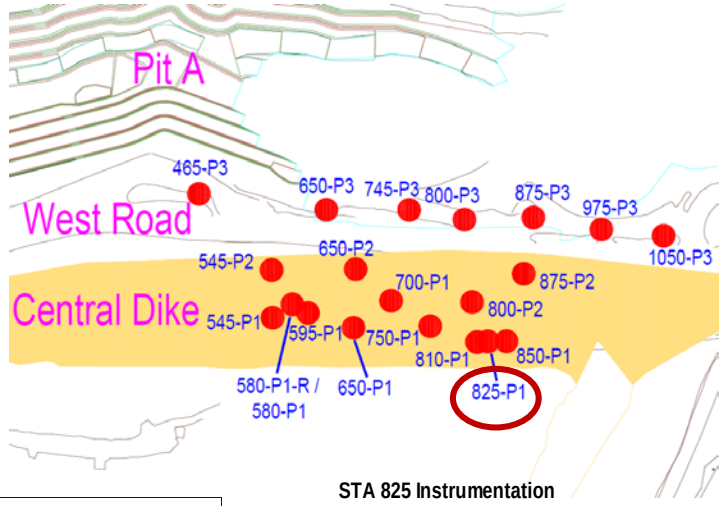
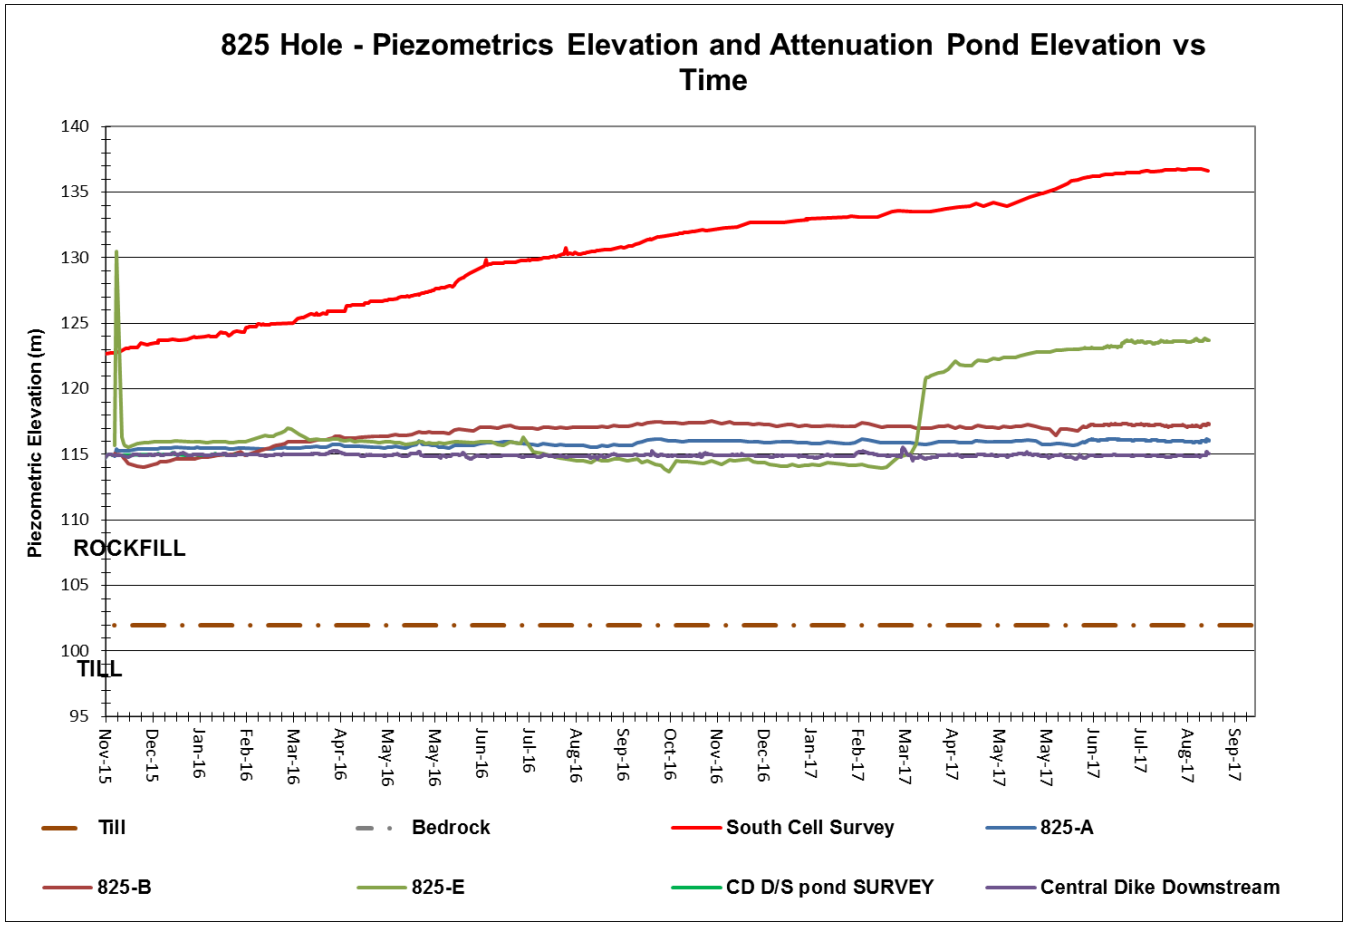
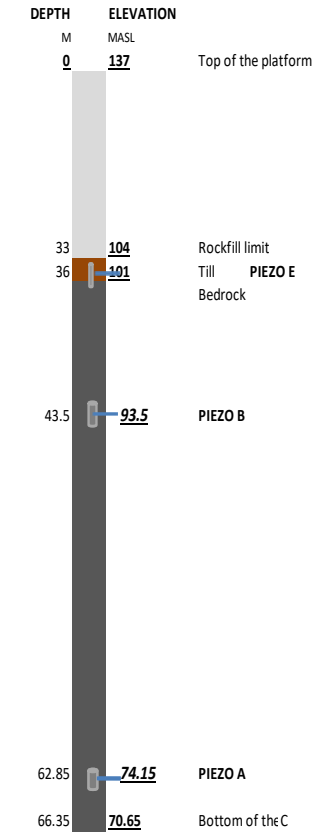
PIEZOMETER 825-P1

- Increased in piezometric elevation of Piezo E since April 2017. Seem to be connected now with South Cell.
- Piezo A and B showing readings similar to the D/S pond and are reacting directly with elevation change.

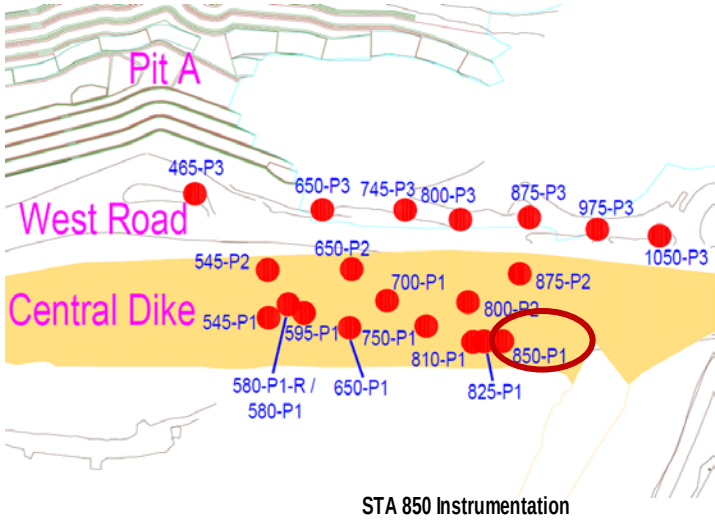
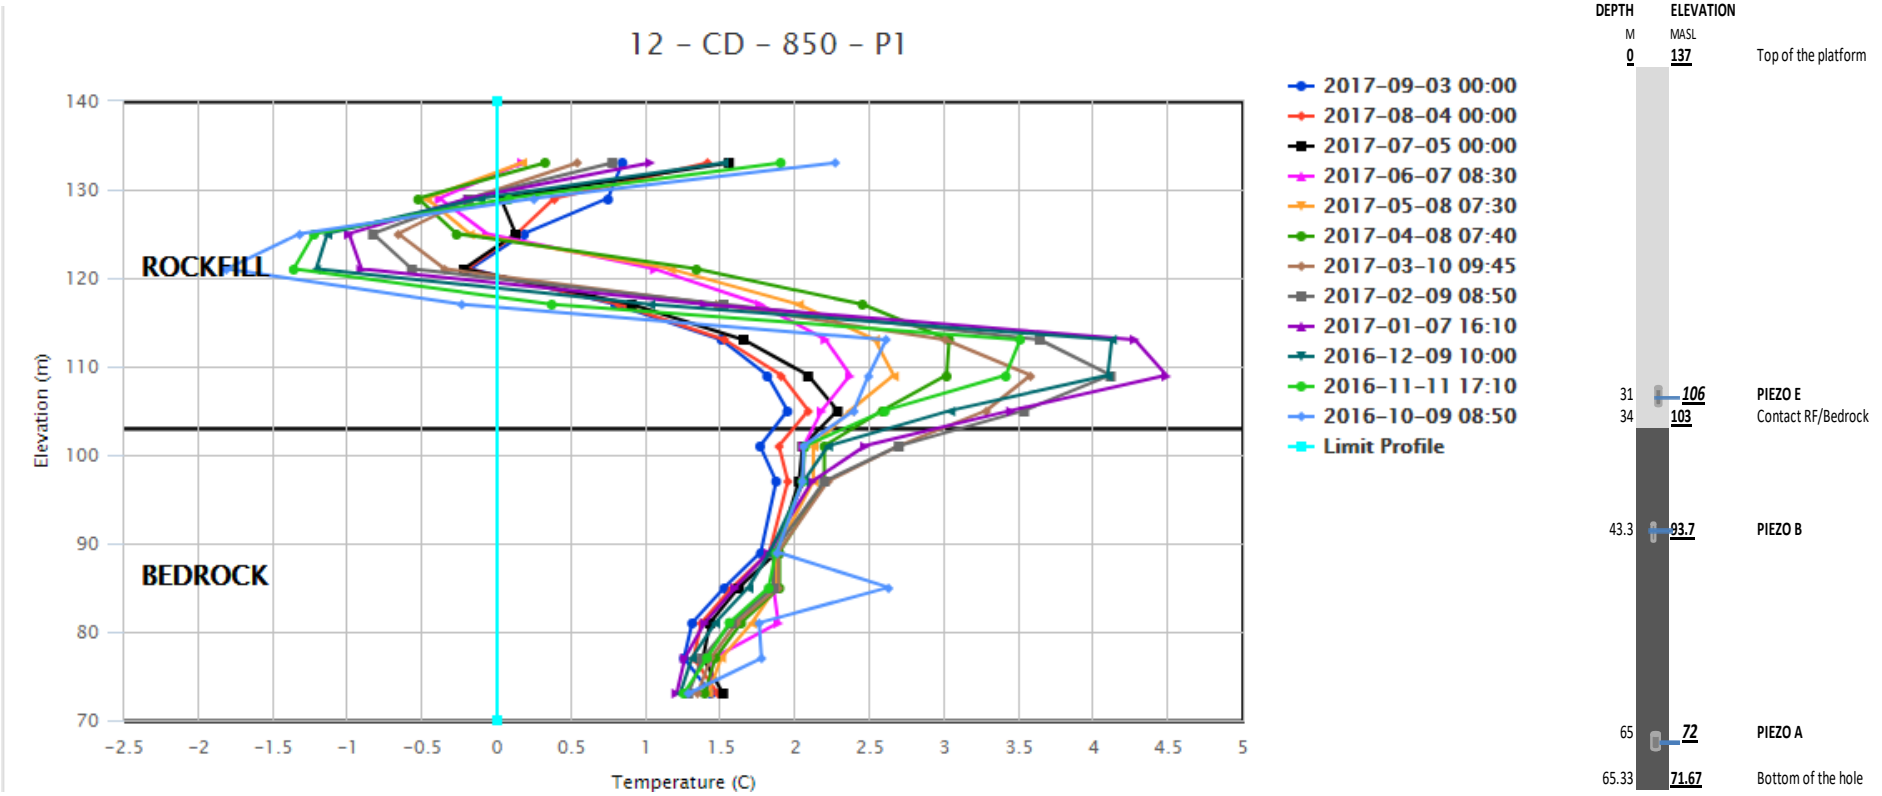
THERMISTOR 850-P1

- Temperature above 0º C in bedrock at 850-P1
- Similar profile than in 2016

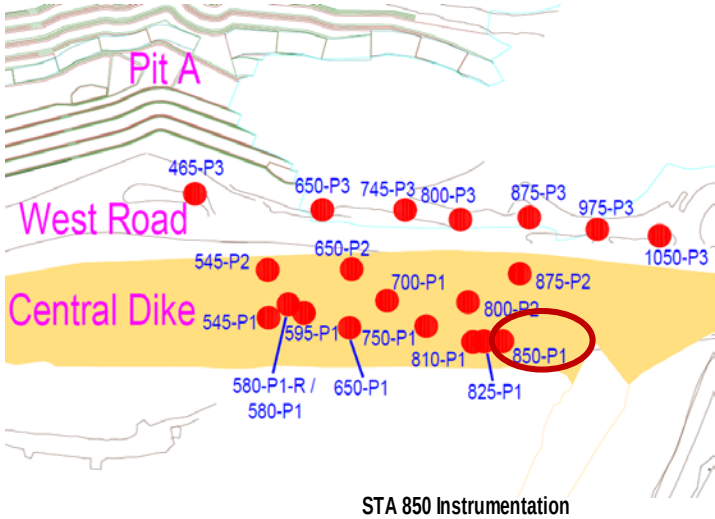
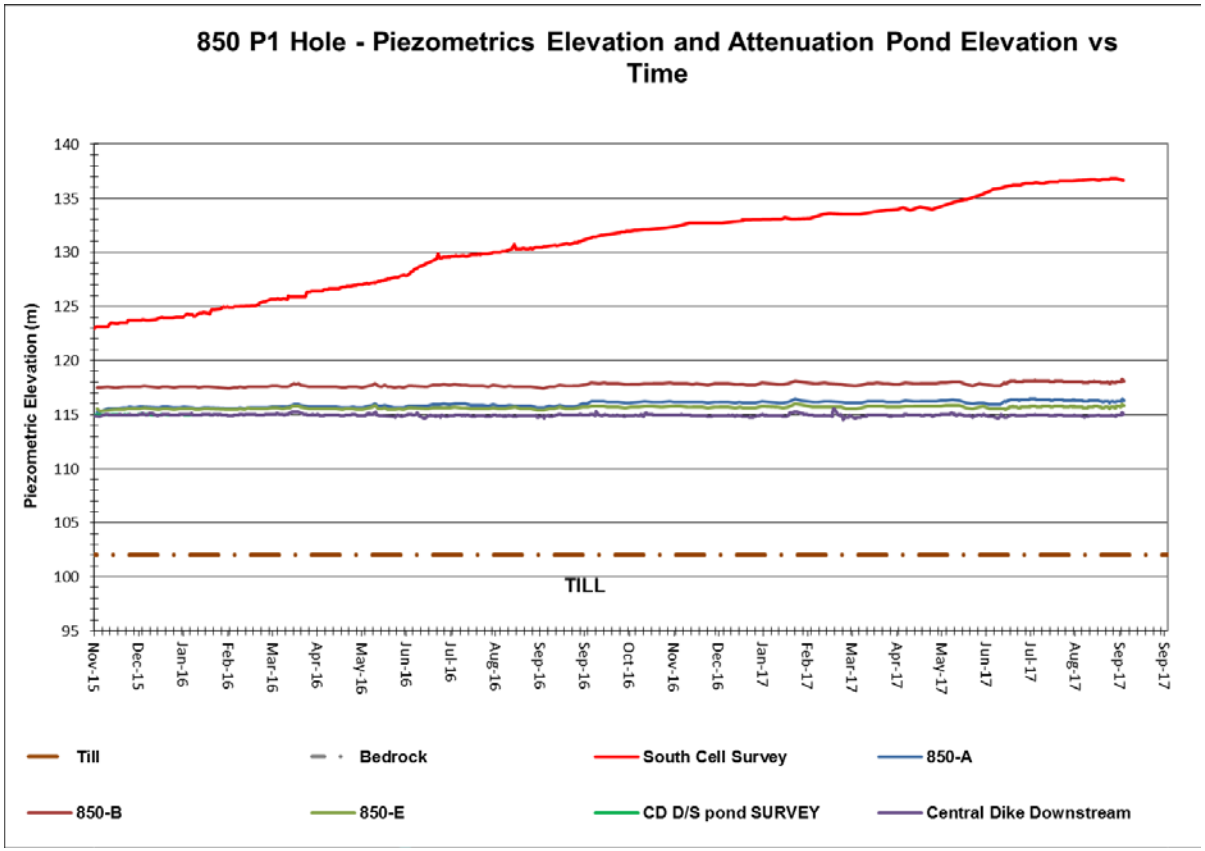
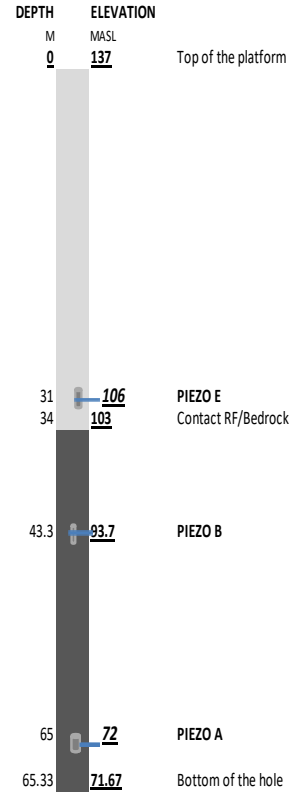
PIEZOMETER 850-P1

- All piezometer are following the trend of the D/S pond regime
- However piezo B is one of the highest in the piezometer readings that have stable reading (117.5m)

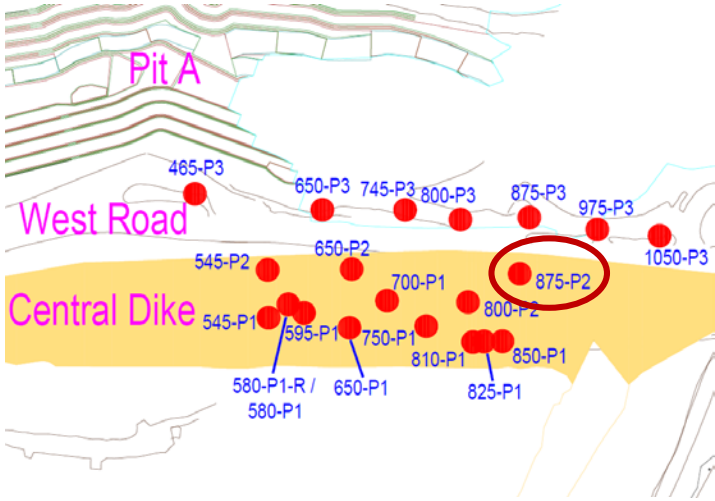
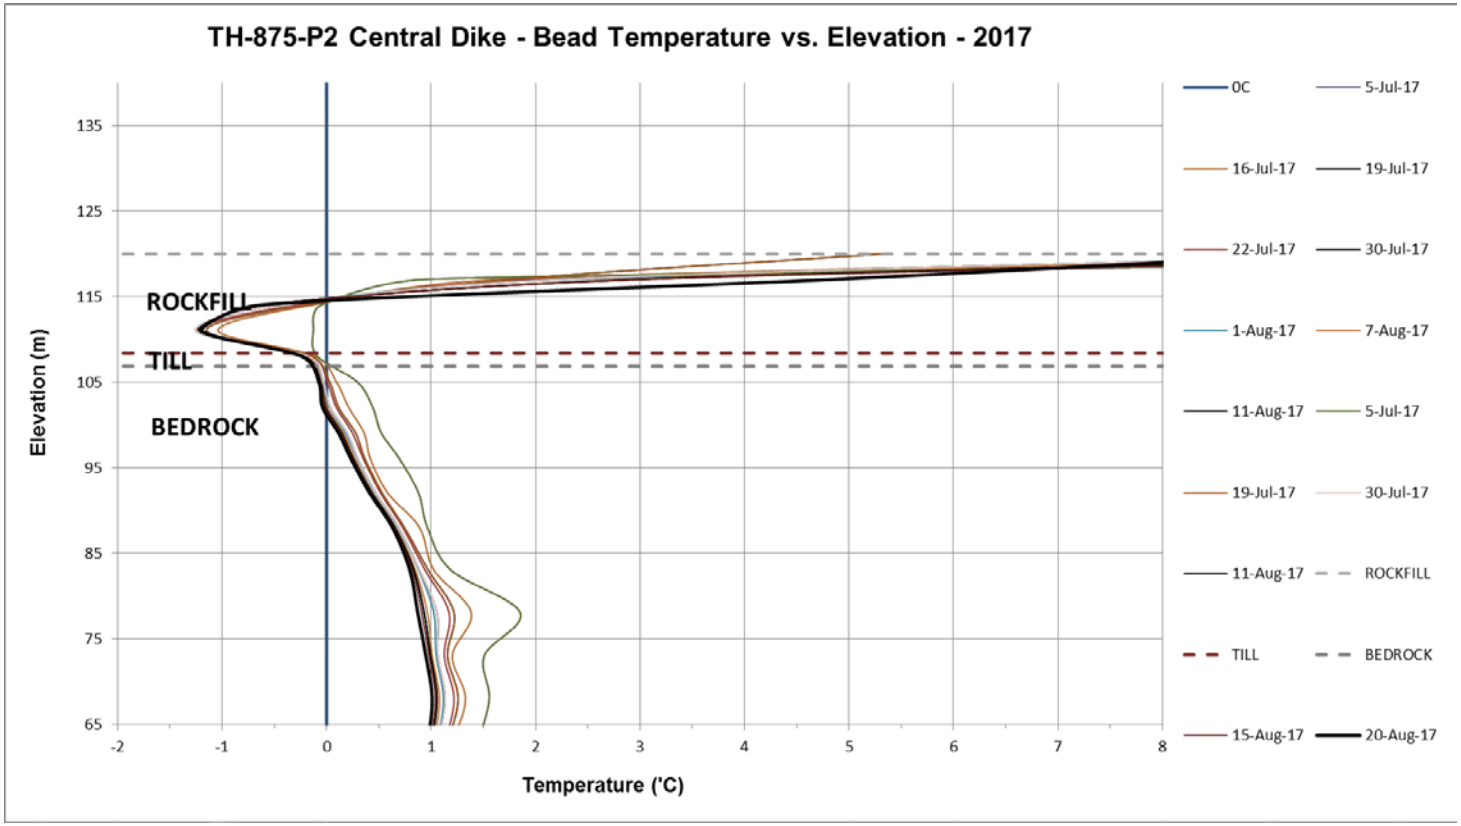
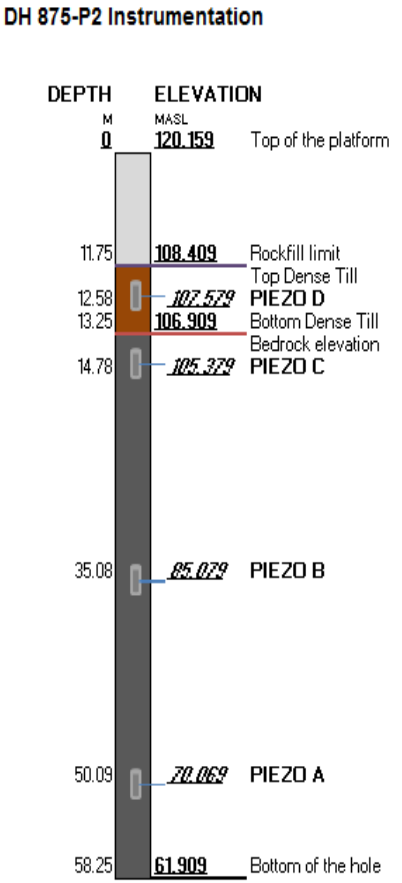
THERMISTOR 875-P2

- New thermistor installed in 2017
- Stabilisation of temperature ongoing
- Bedrock temperature above 0º C

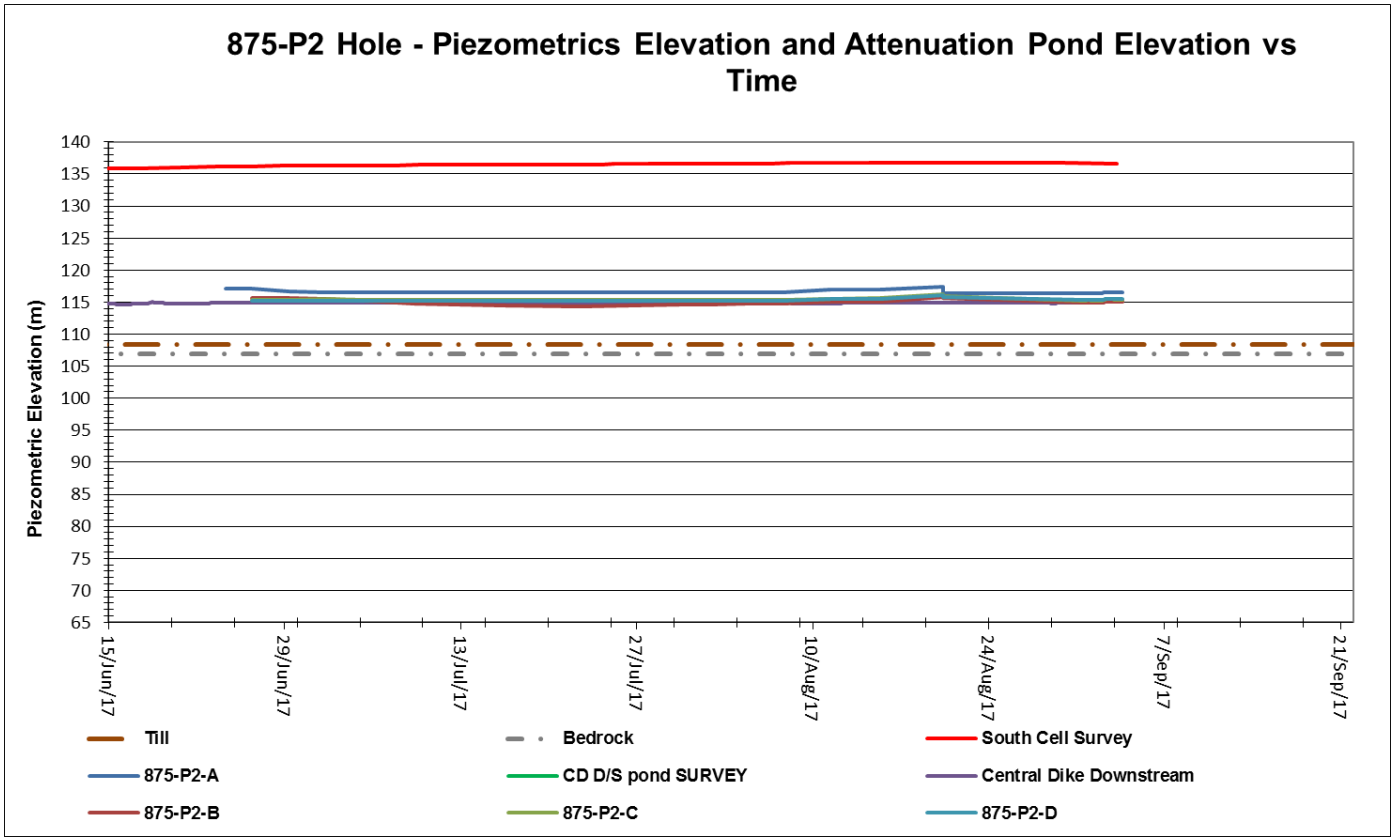
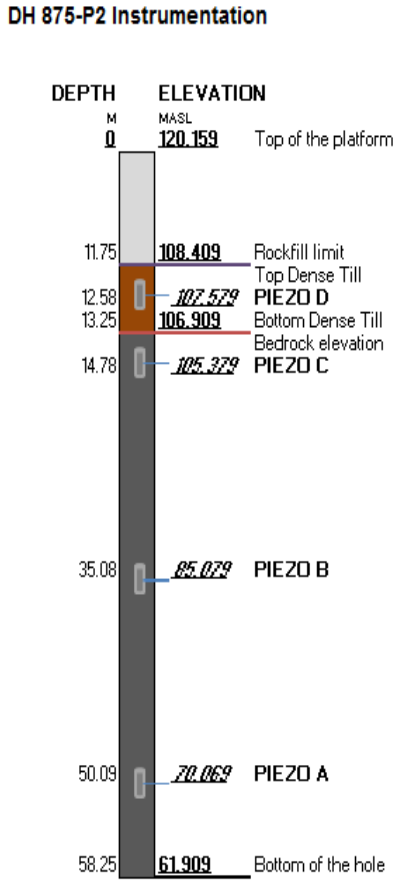
PIEZOMETER 875-P2

- All piezometer are following the trend of the D/S pond regime
- Small glitch in the data was observed when automatization of the system was completed

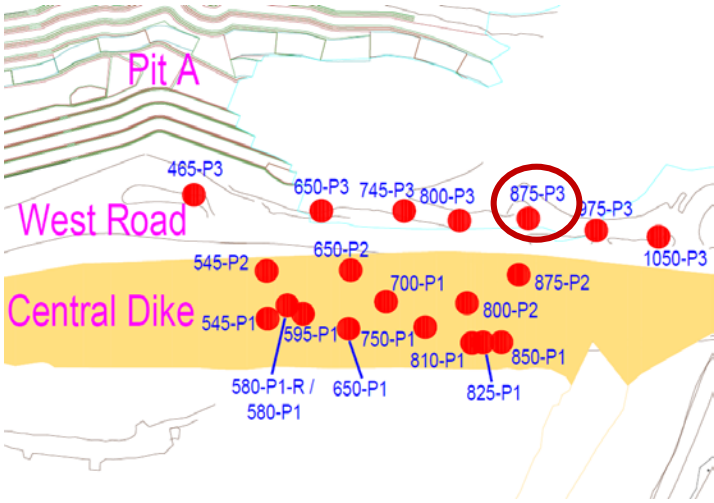
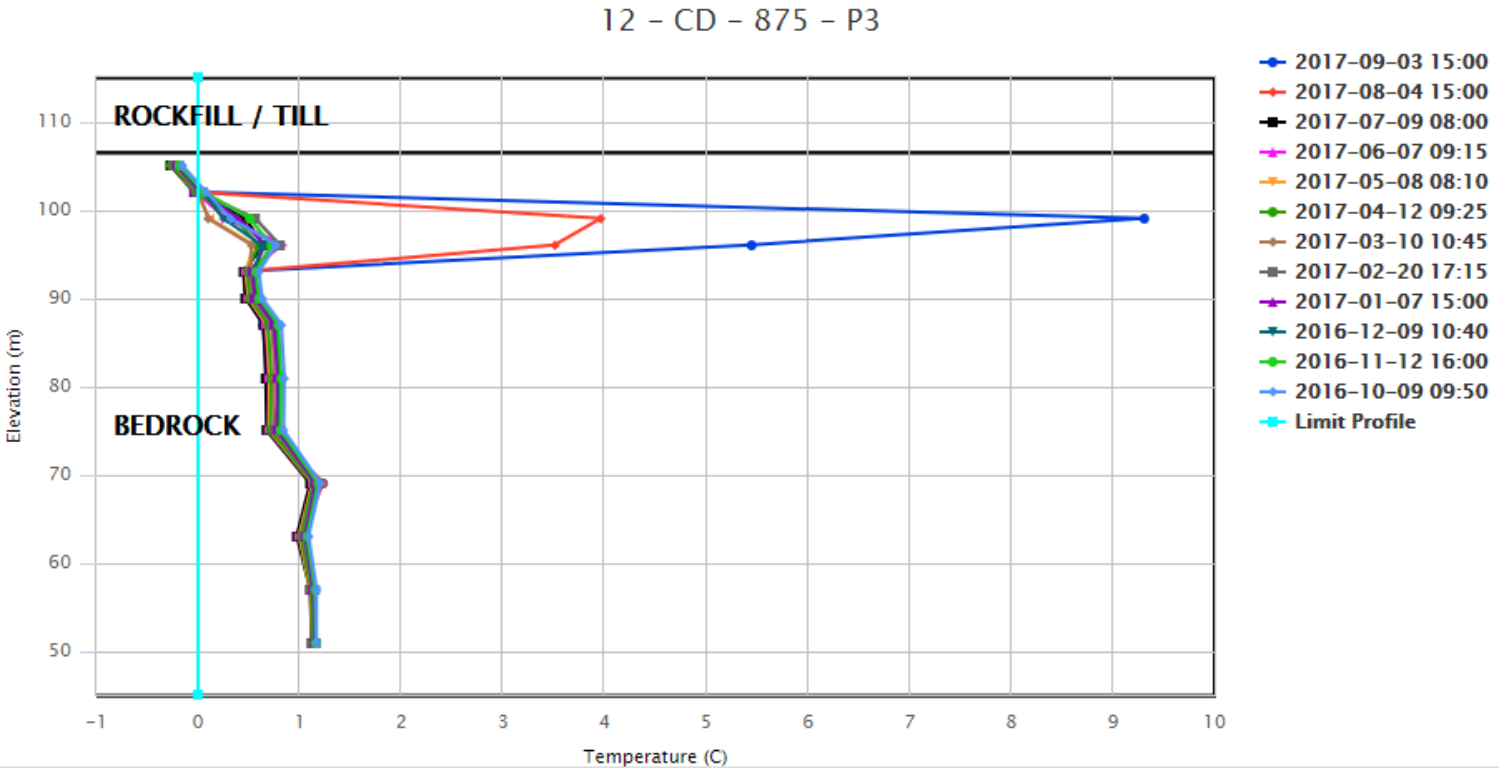
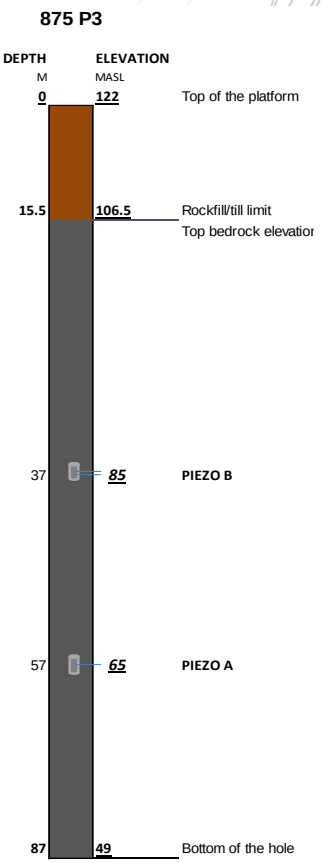
THERMISTOR 875-P3

- Temperature above 0º C in bedrock at 875-P3
- Temperature spike at El.96 m and 99 m are realted to capicitance effect.

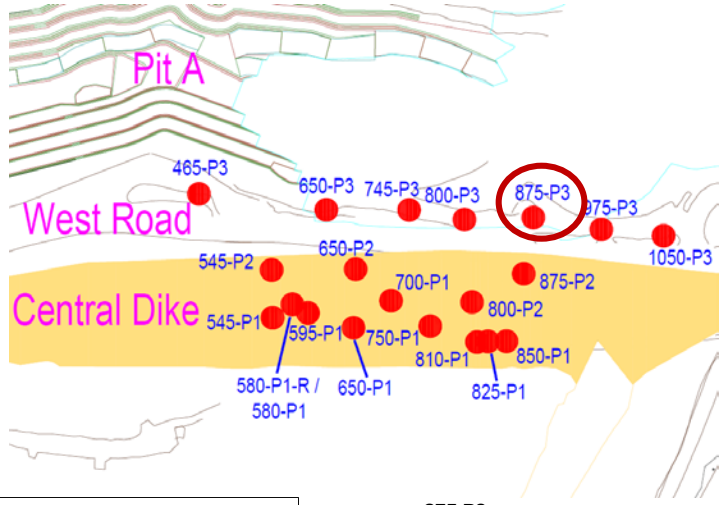
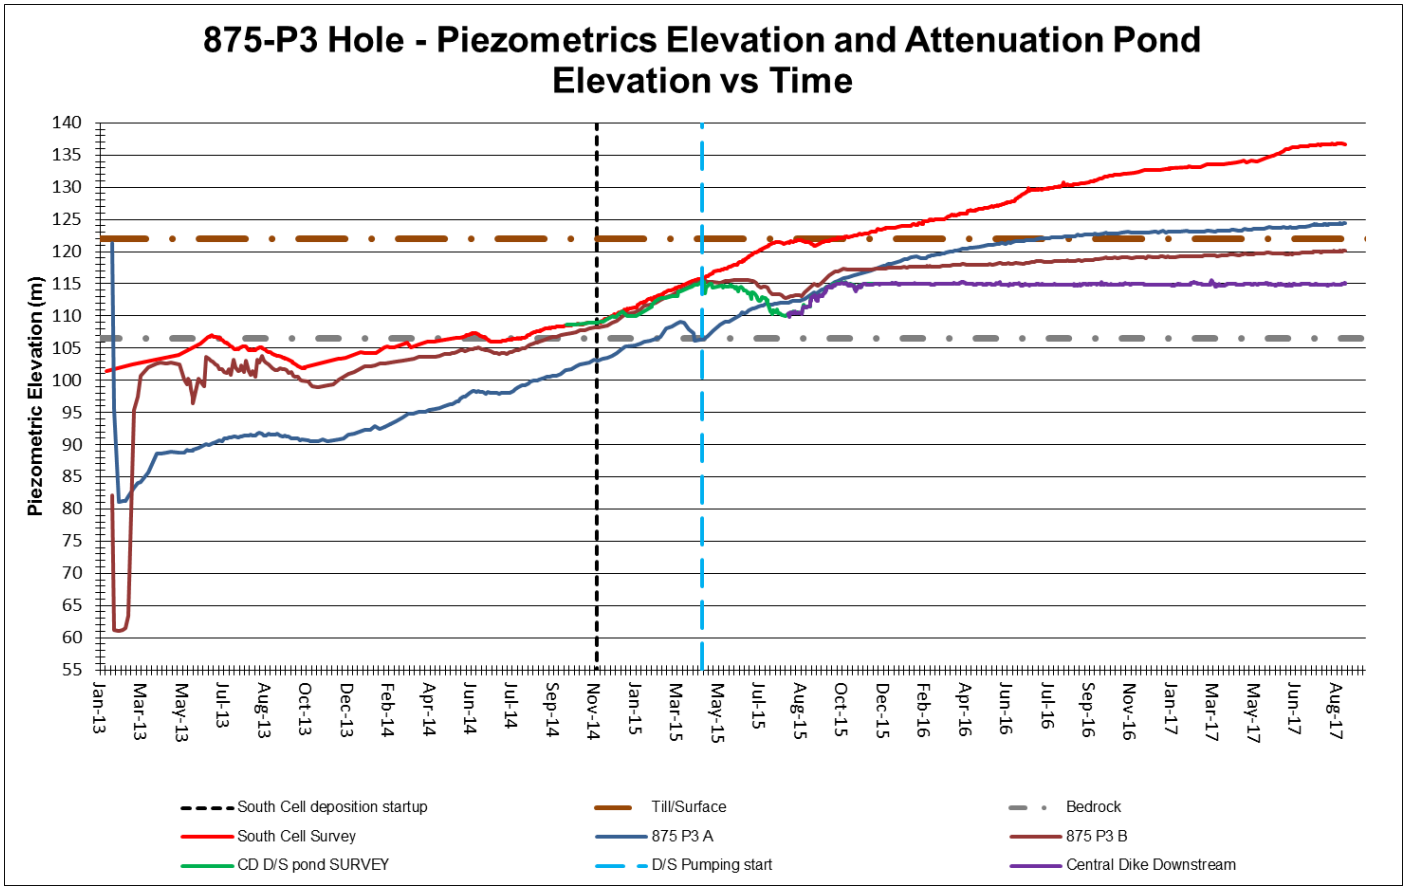
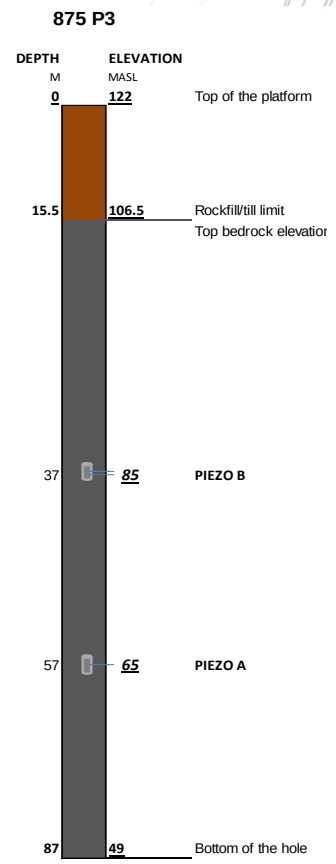
PIEZOMETER 875-P3

- Piezometer at 875-P3 are in bedrock and are impacted by increase in South Cell head

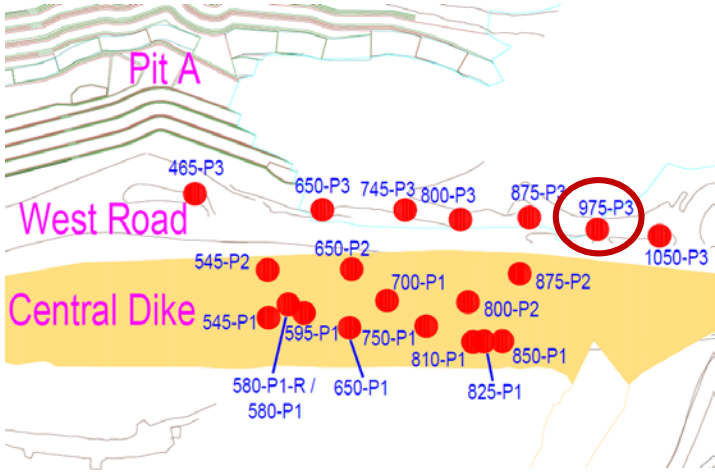
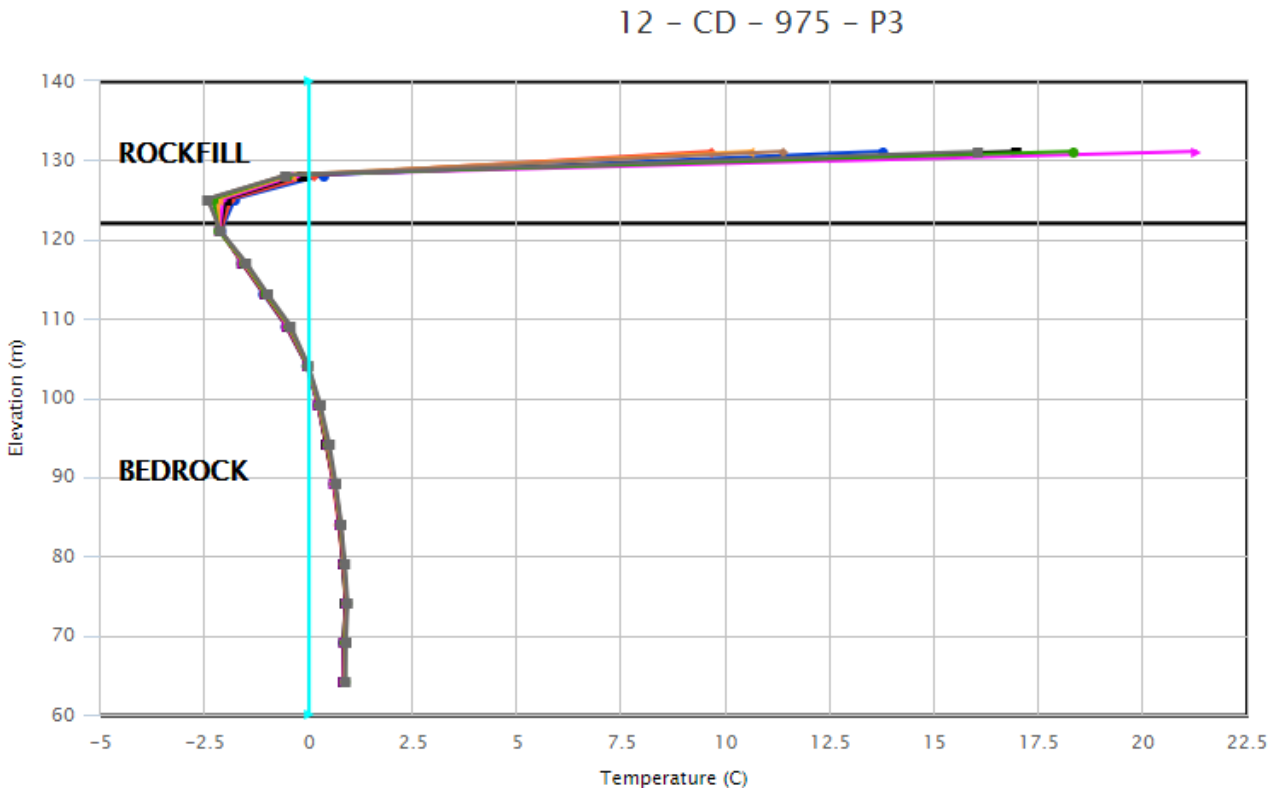
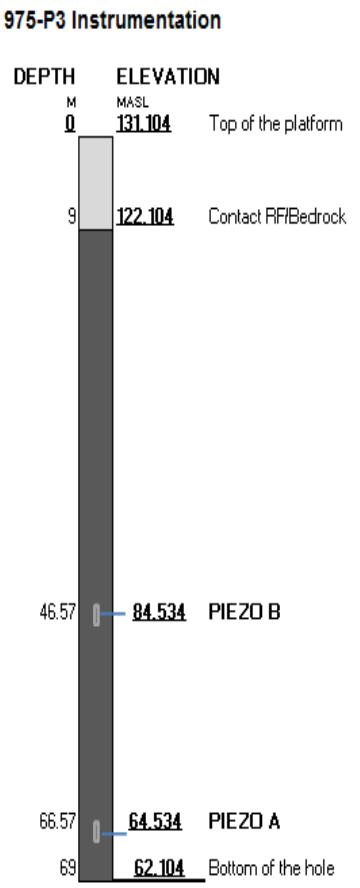
THERMISTOR 975-P3

- New instrument installed in 2017
- Stabilization of the thermistor mostly done
- Temperature above 0º C in bedrock below El. 105 m
