2017 Annual Geotechnical Inspection

2017 Annual Geotechnical Inspection Meadowbank Gold Mine, Nunavut

Report Number: 1784282-1574-RPT-Rev0

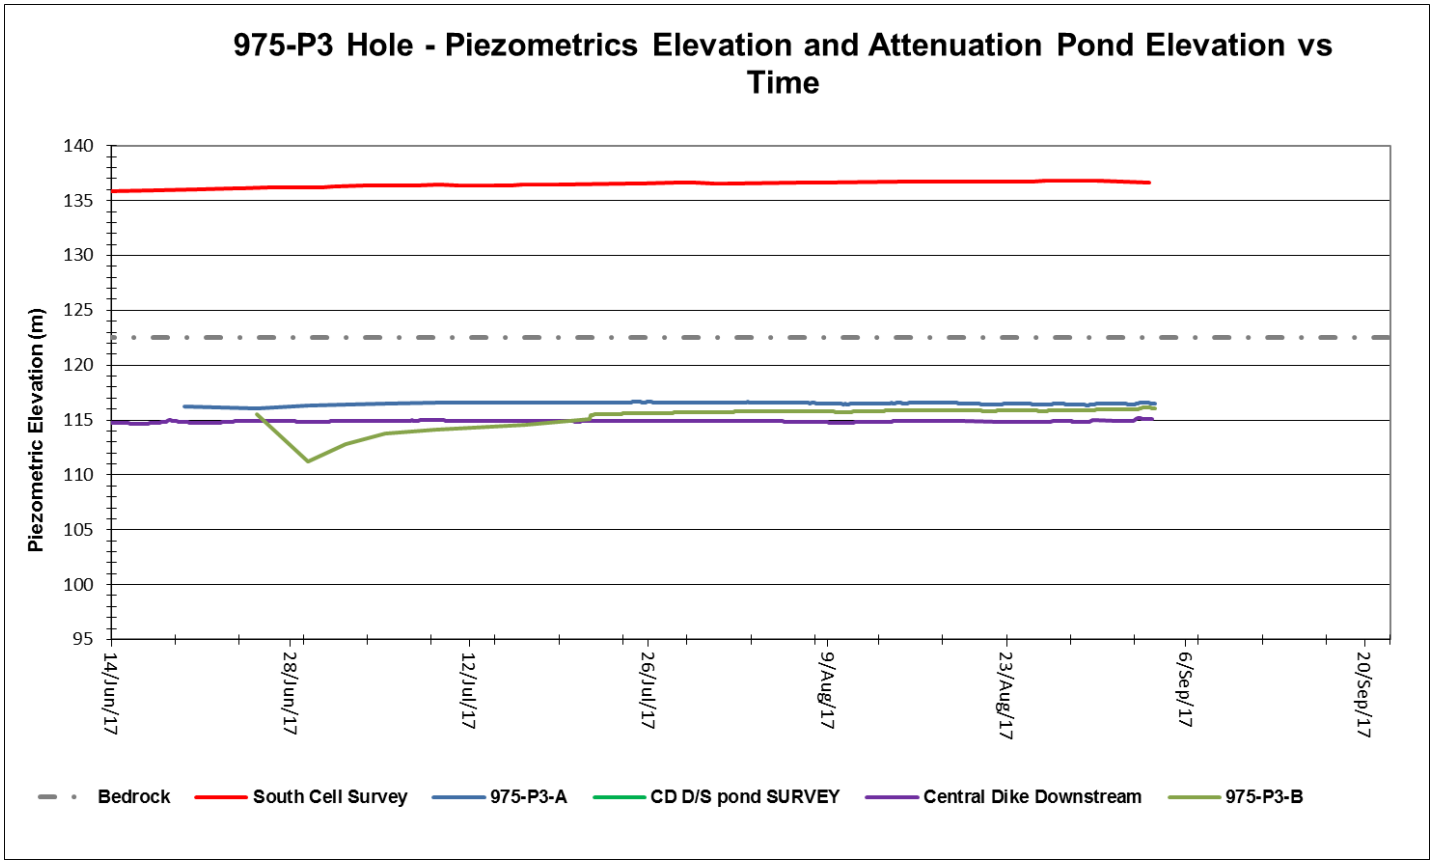
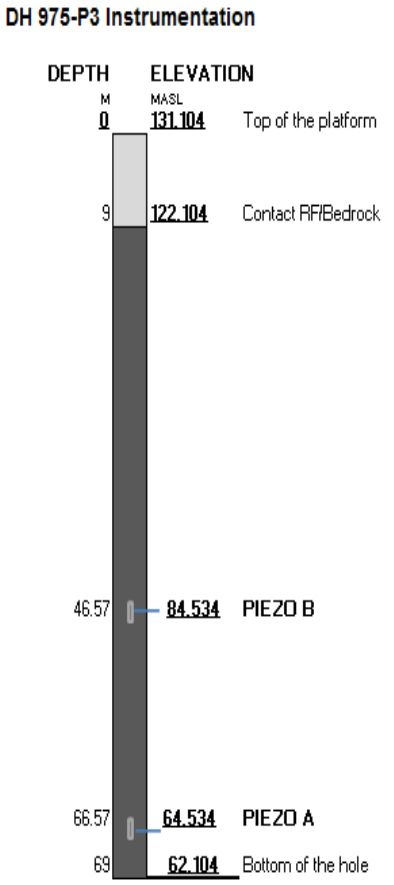
PIEZOMETER 975-P3

- New instrument installed in 2017
- All piezometer are following the trend of the D/S pond regime

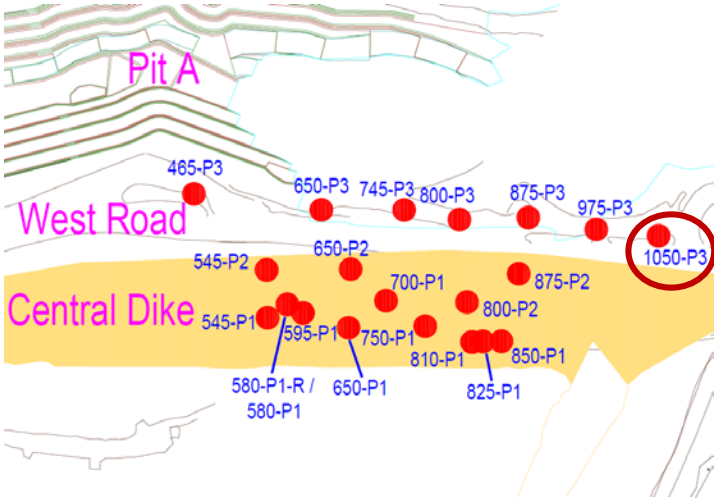
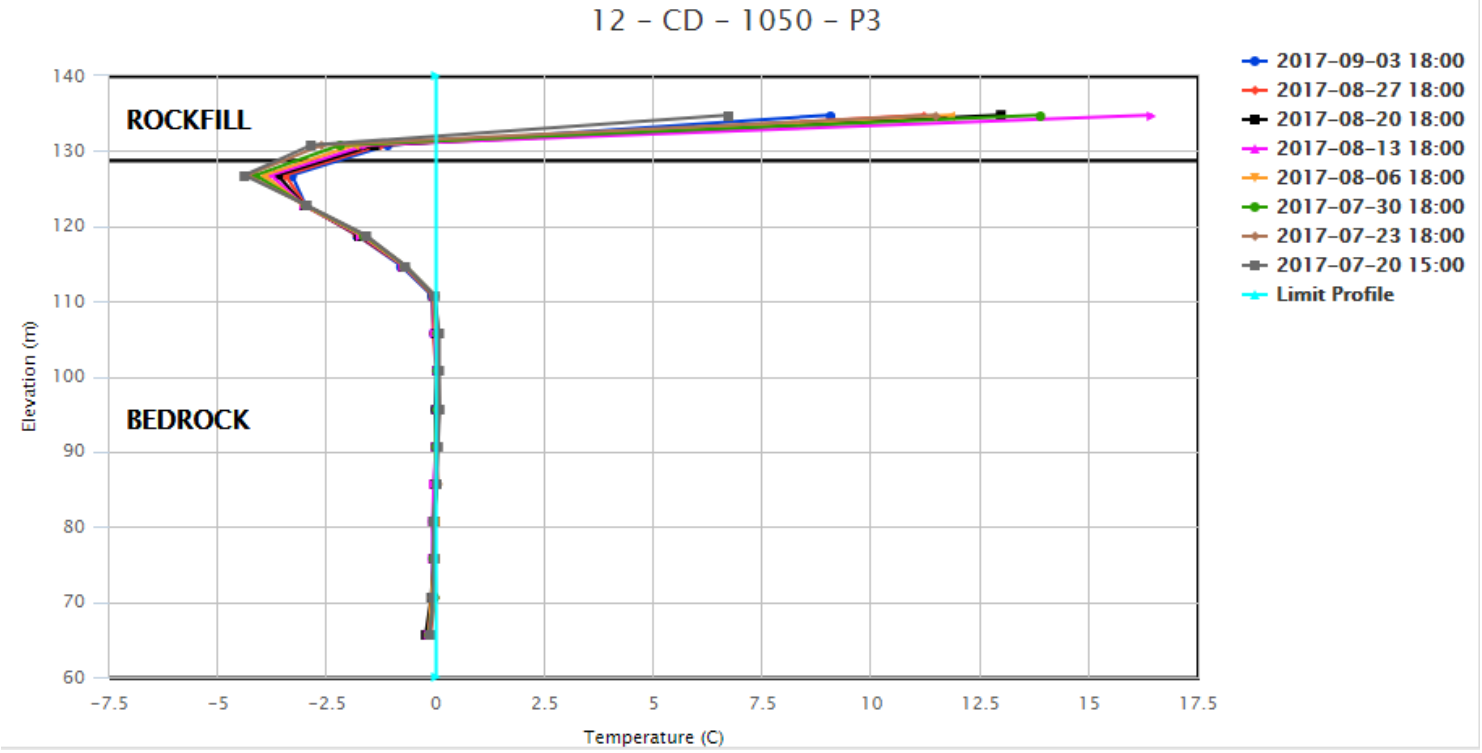
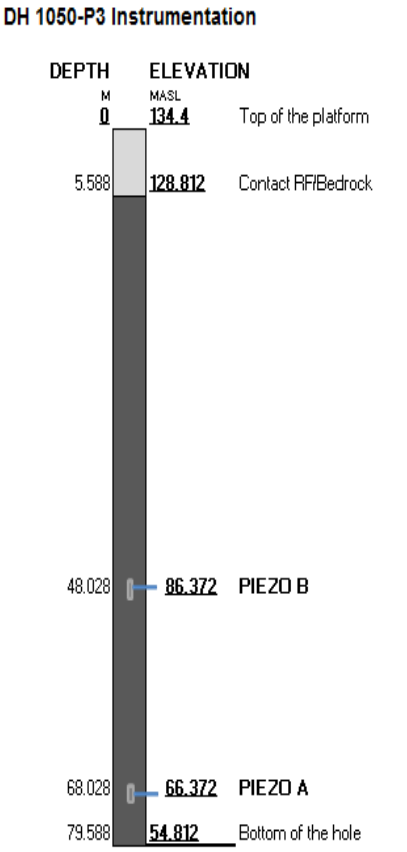
THERMISTOR 1050-P3

- Temperature at 0º C in bedrock

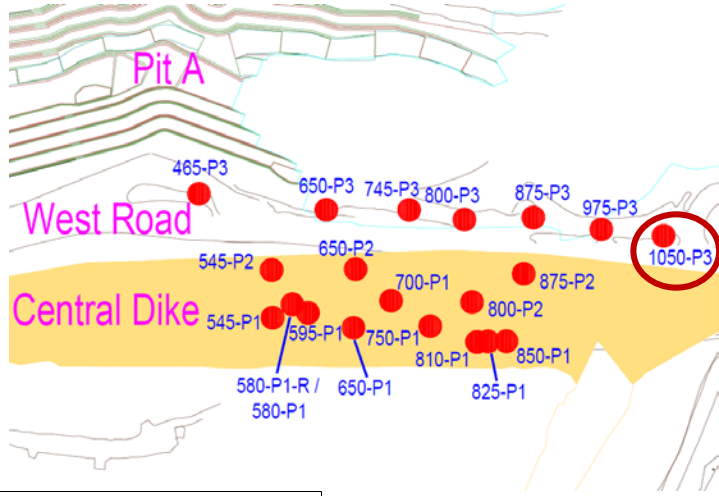
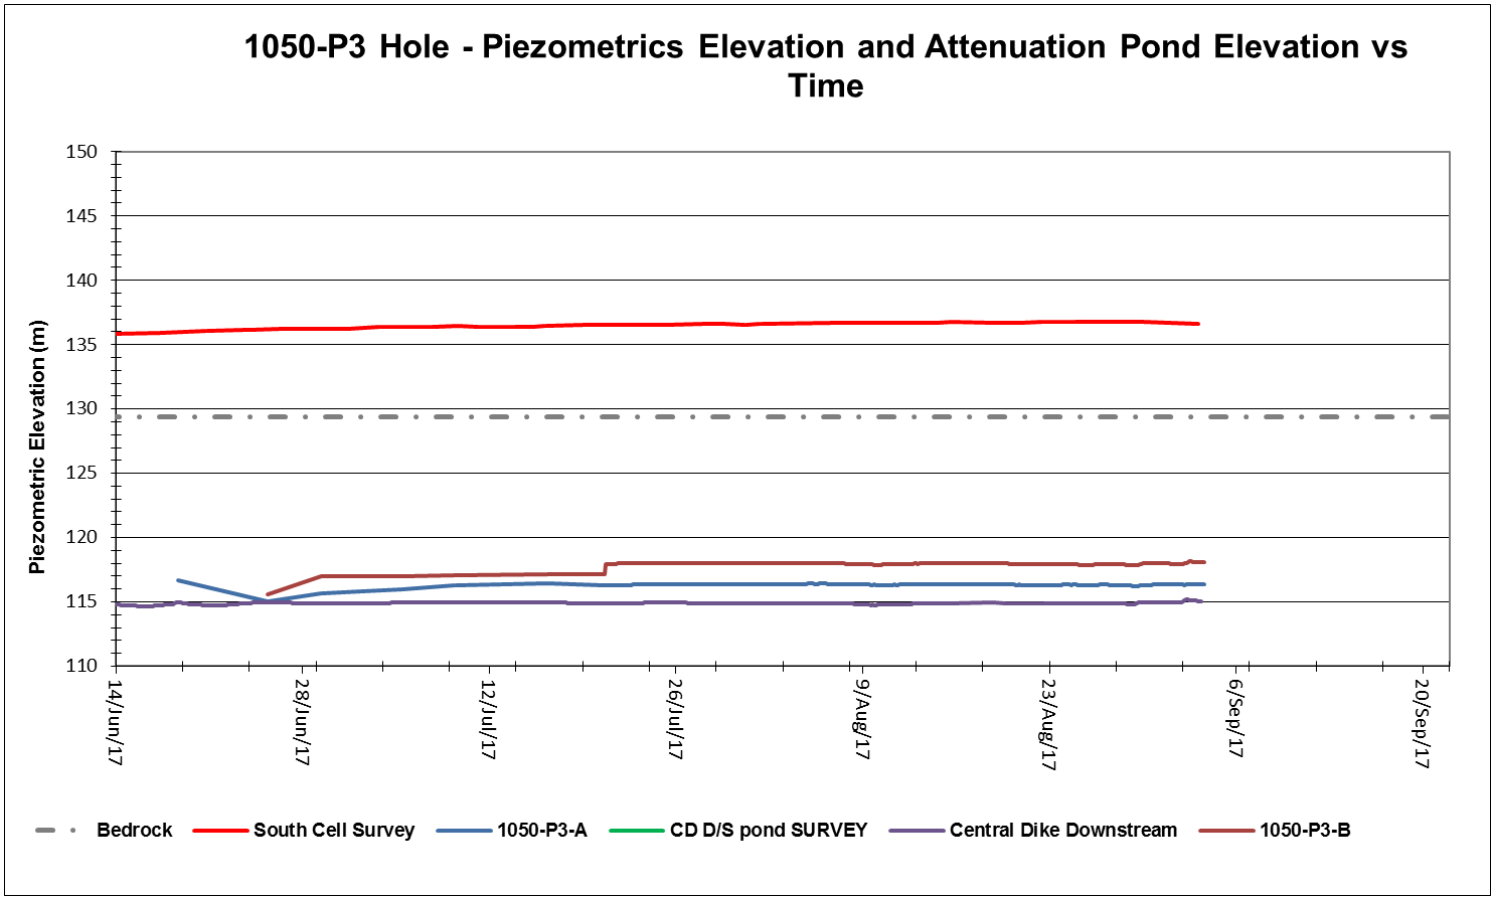
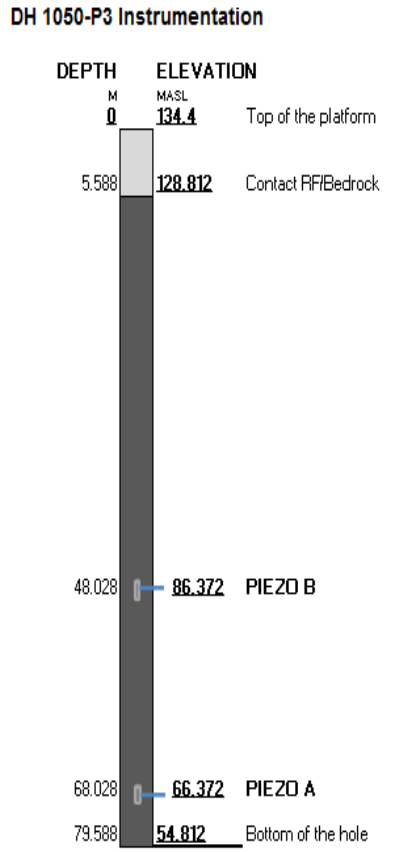
PIEZOMETER 1050-P3

- Piezometers temperature just below the freezing point
- Piezometers are following the trend of the D/S pond elevation.

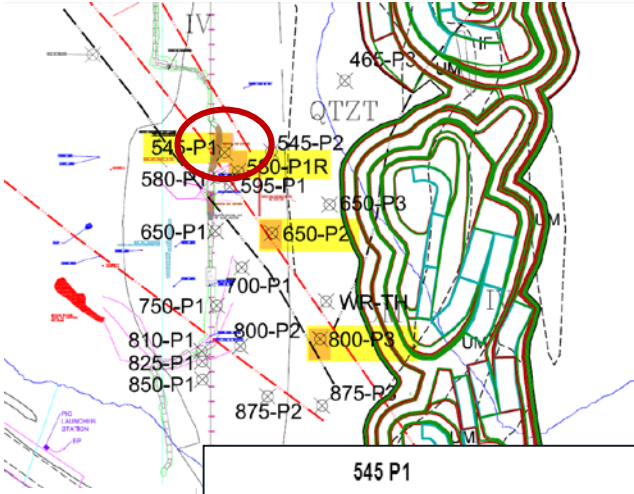
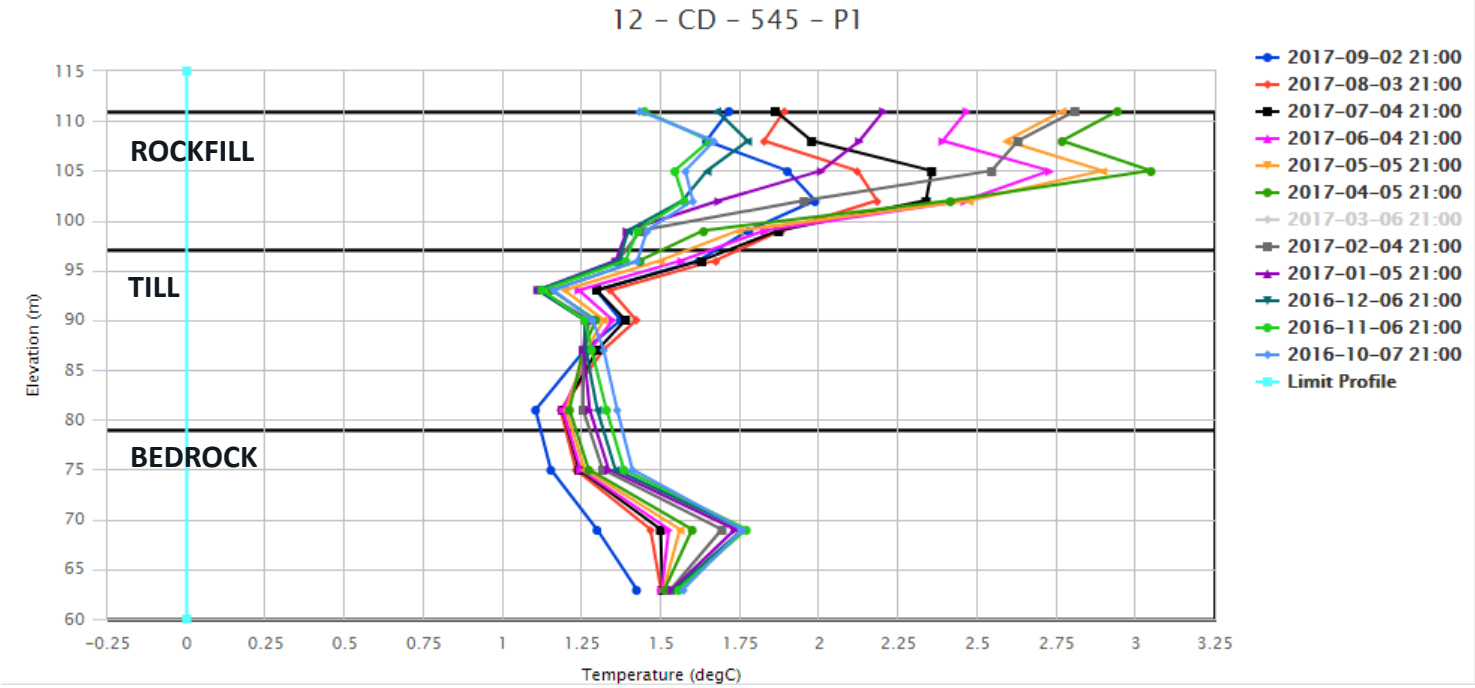
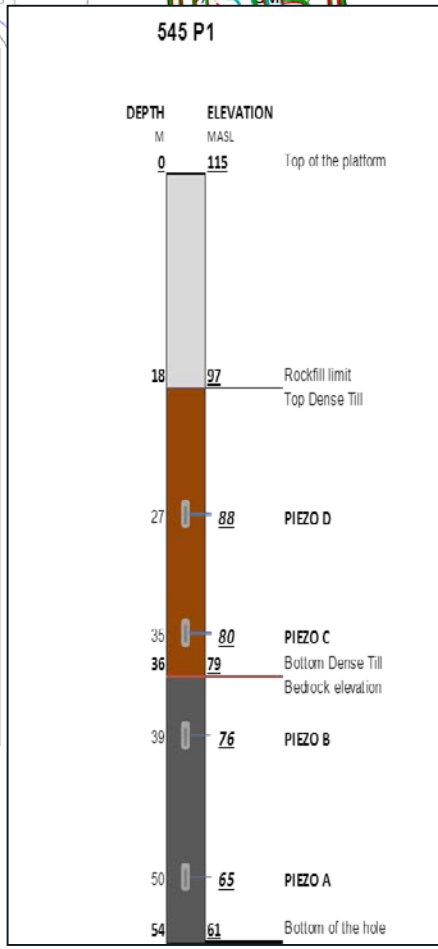
THERMISTOR 545-P1

- 545-P1 thermistor is showing the same temperature profile than last year. Warmer peak observed at elevation 70m since the installation.
- Temperature in the bedrock/till unit is in between 1.1 and 1.75º C.

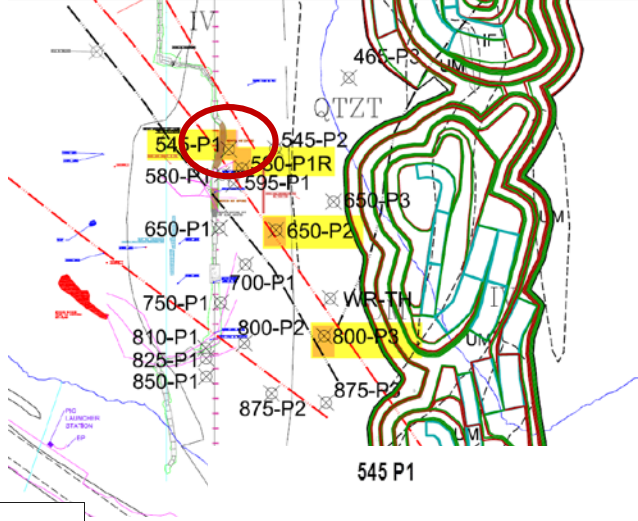
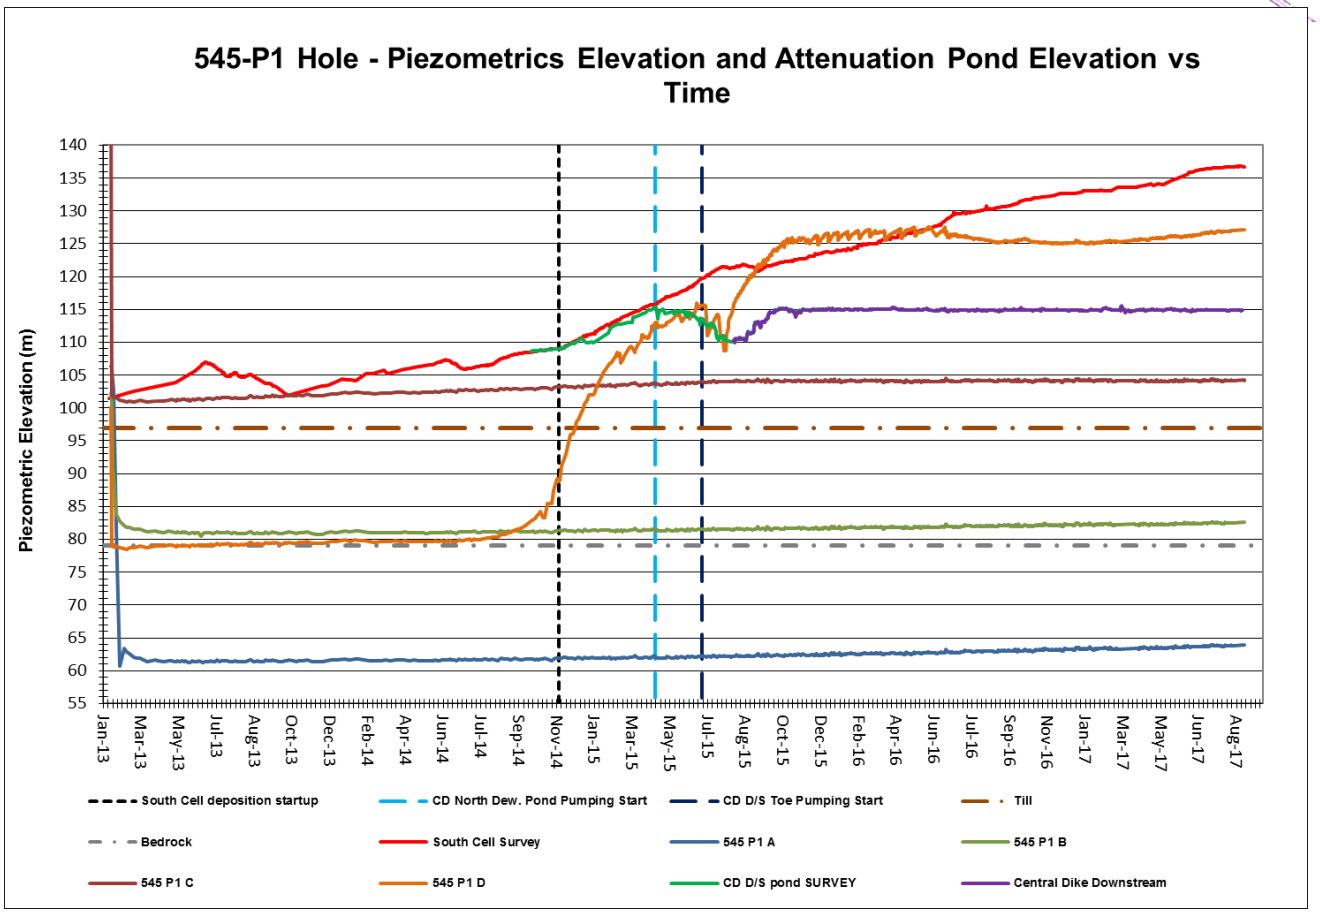
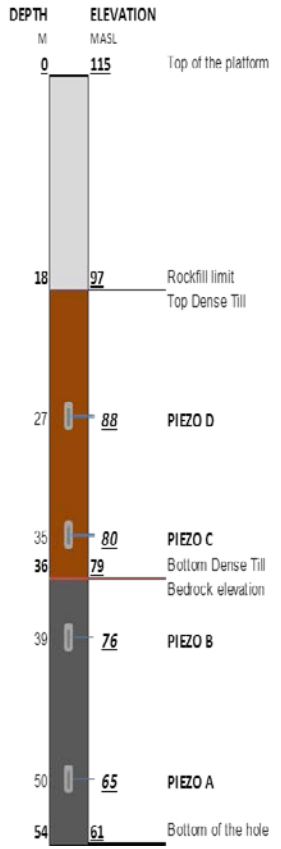
PIEZOMETER 545-P1

- Piezometer D still constant, no change since August 2015
- Piezometer A is recording suction since its installation
- Identification of the piezo on the field is confusing. Interpretation of the readings must be done with precaution.

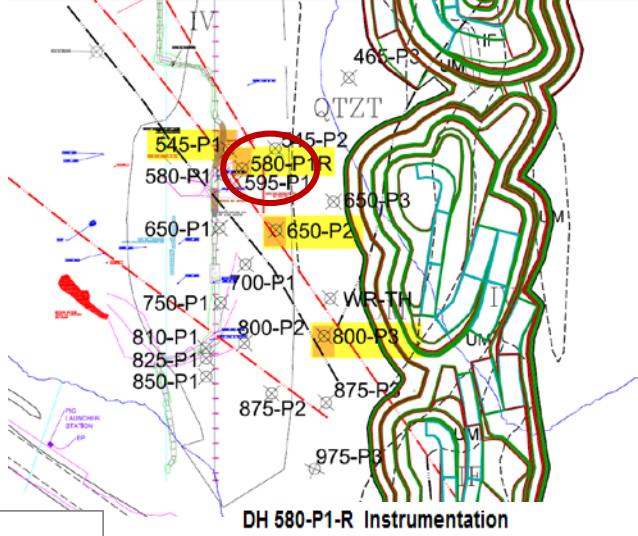
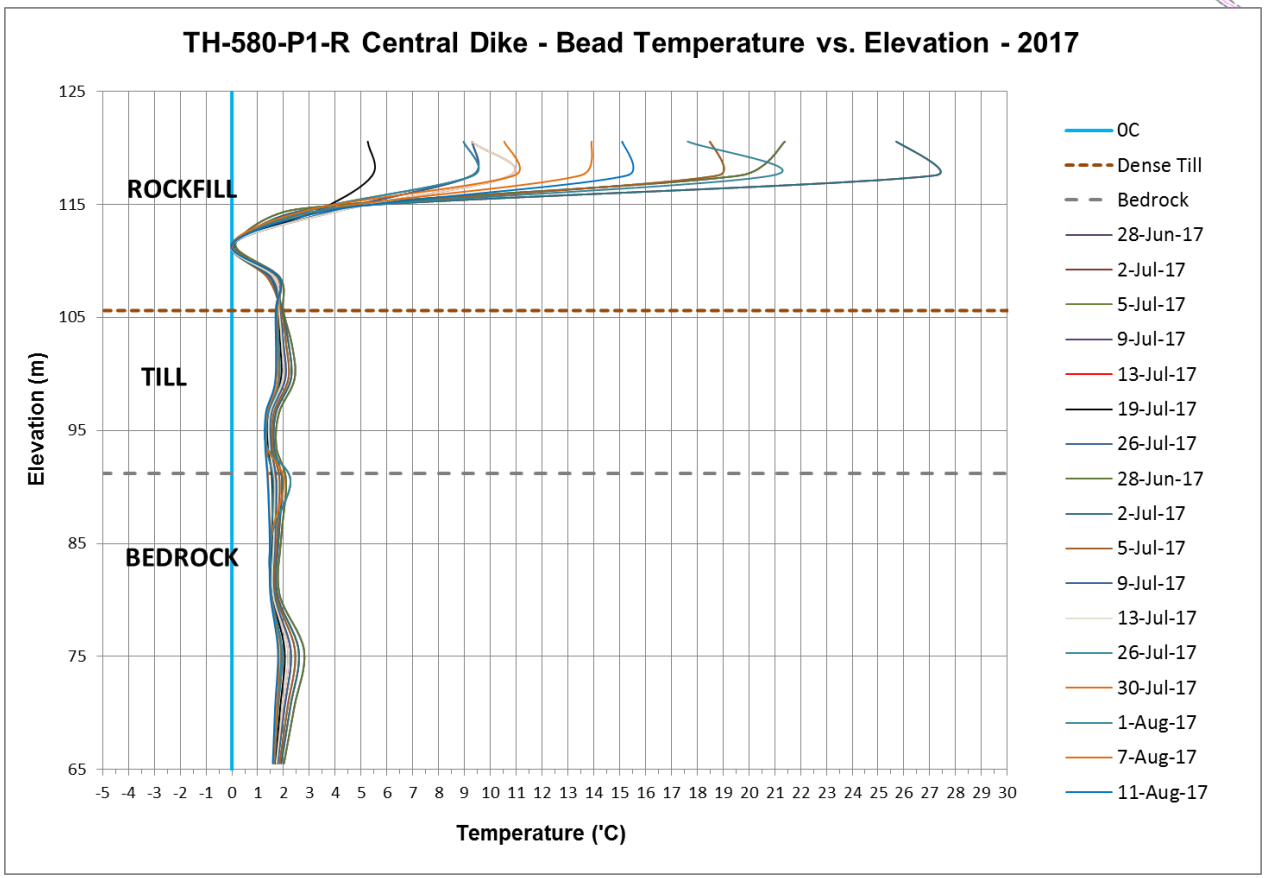
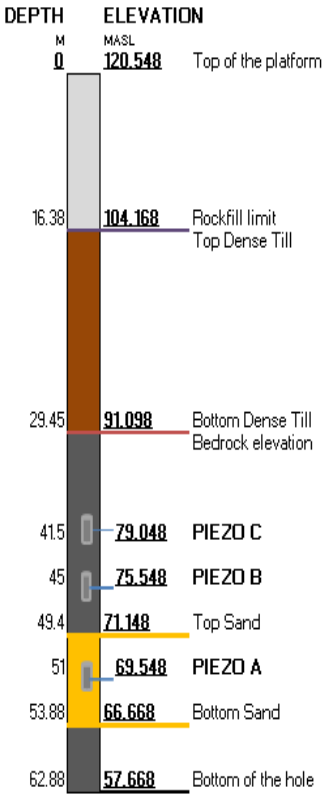
THERMISTOR 580-P1R

- Stabilisation in progress
- Temperature readings above 0ºC
- Simillar temperature readings range than 580-P1

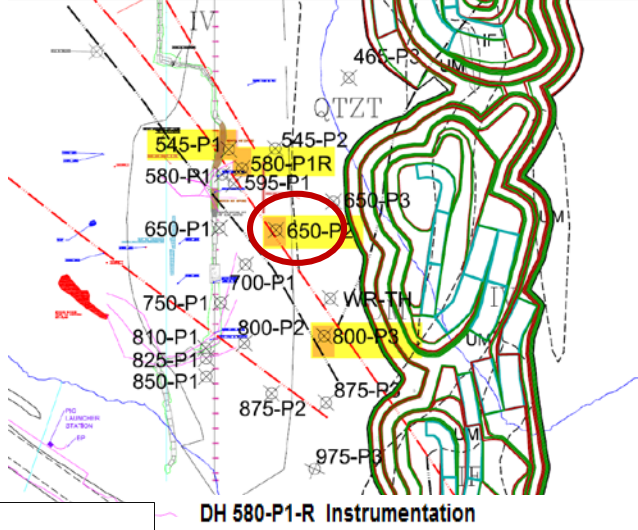
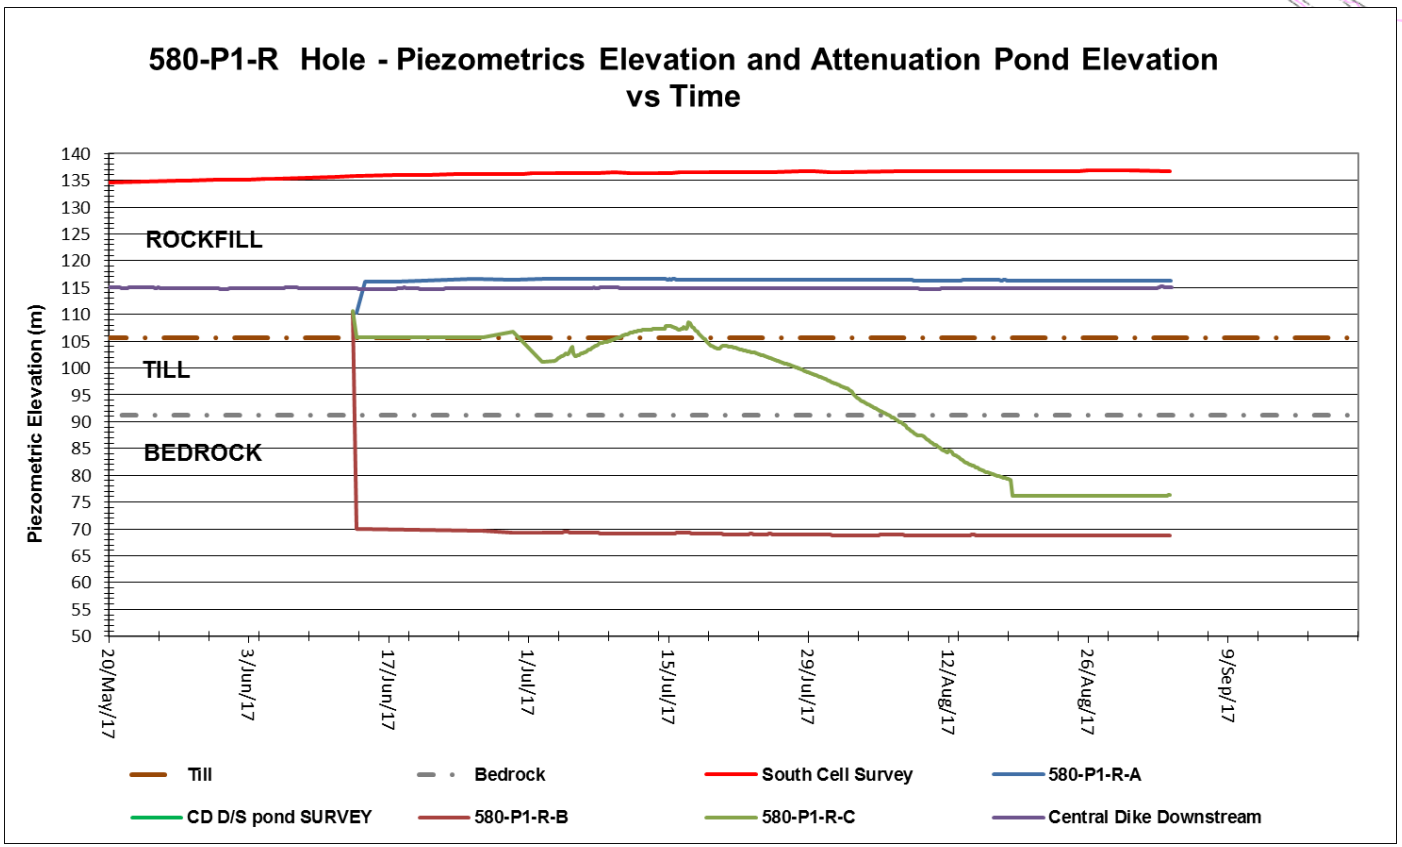
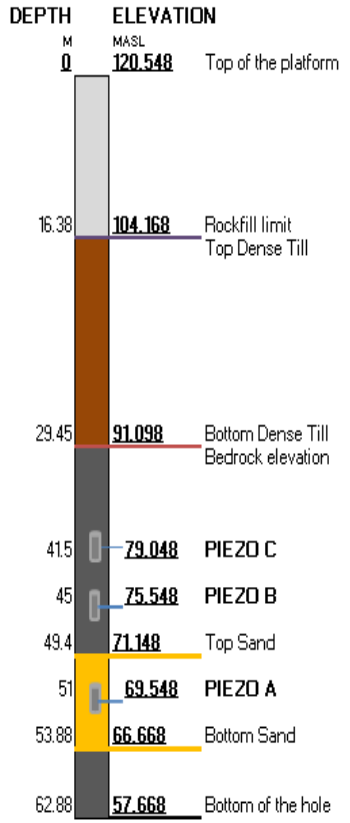
PIEZOMETER 580-P1R

- Piezo A is located in a sand layer and pressure readings are following the D/S pond regime
- Decrease in piezometric elevation ongoing for Piezo B
- Small data GAP

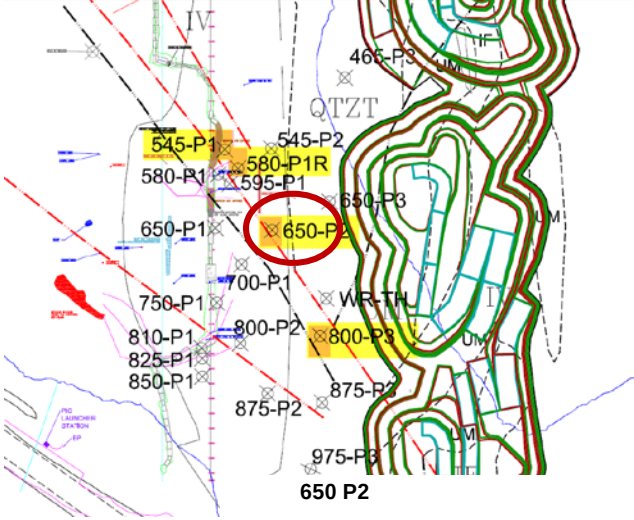
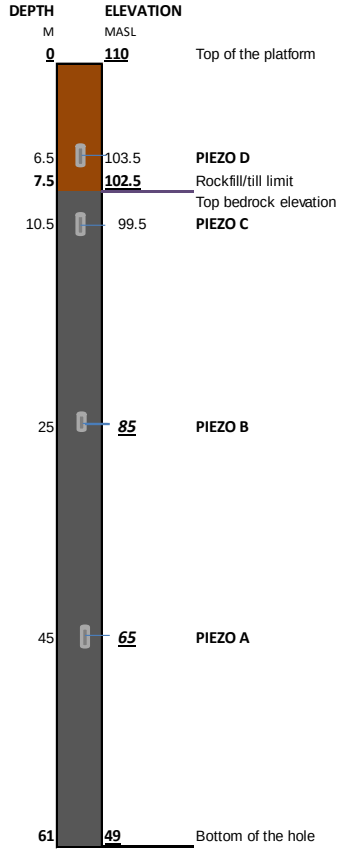
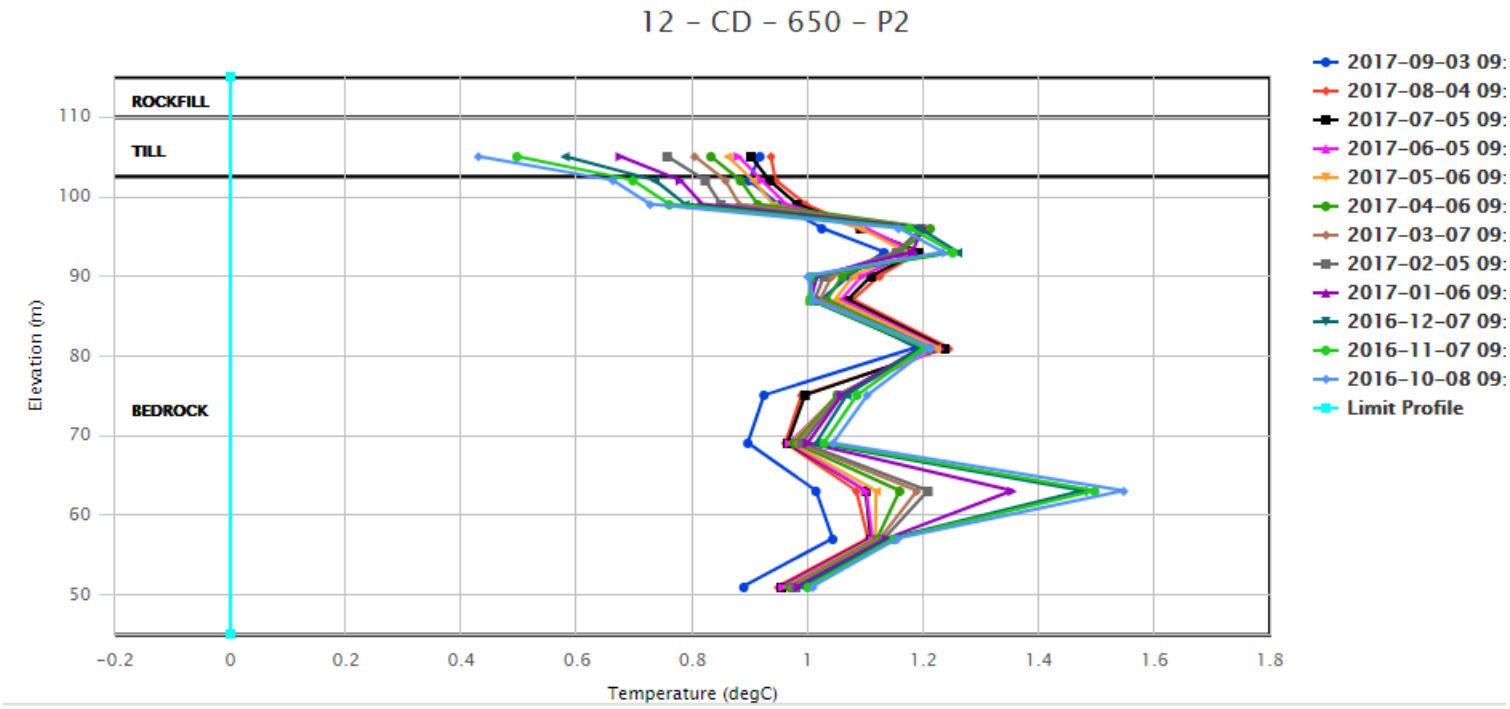
THERMISTOR 650-P2

- Cooling trend observed below El. 80 similar to 2016 readings.

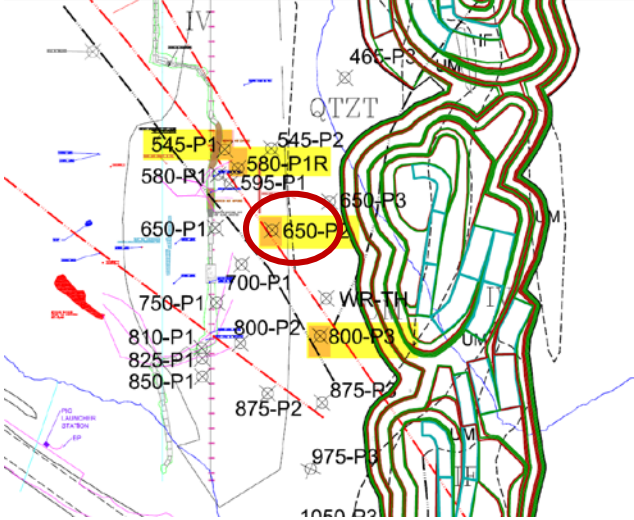
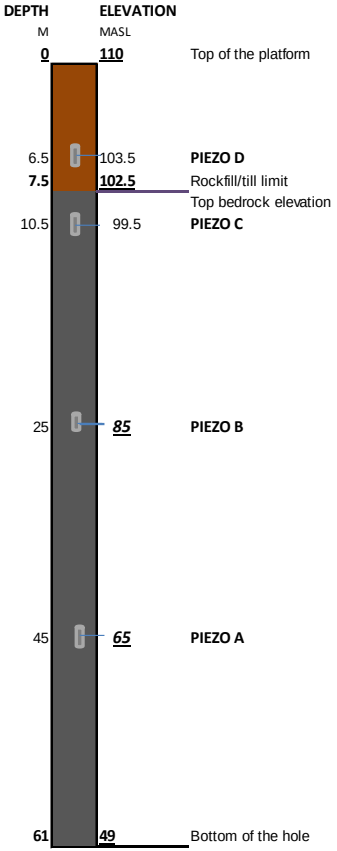
PIEZOMETER 650-P2

- Piezometer A in bedrock continue its rise and is now over the elevation of the South Cell
- Piezo B-C are following the piezometric regime of the D/S pond
- Piezo D is in suction

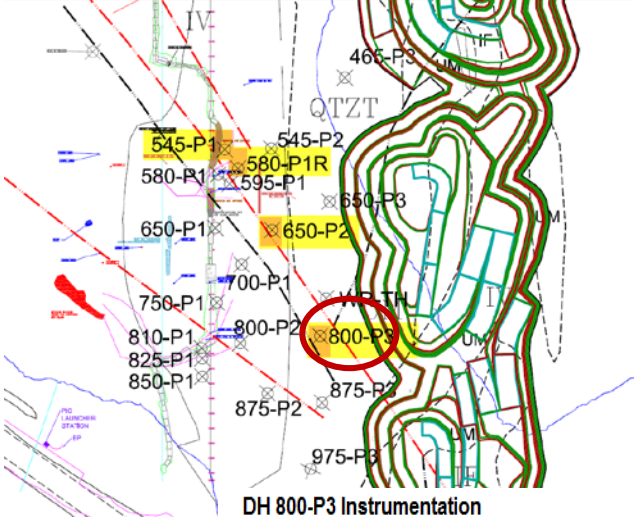
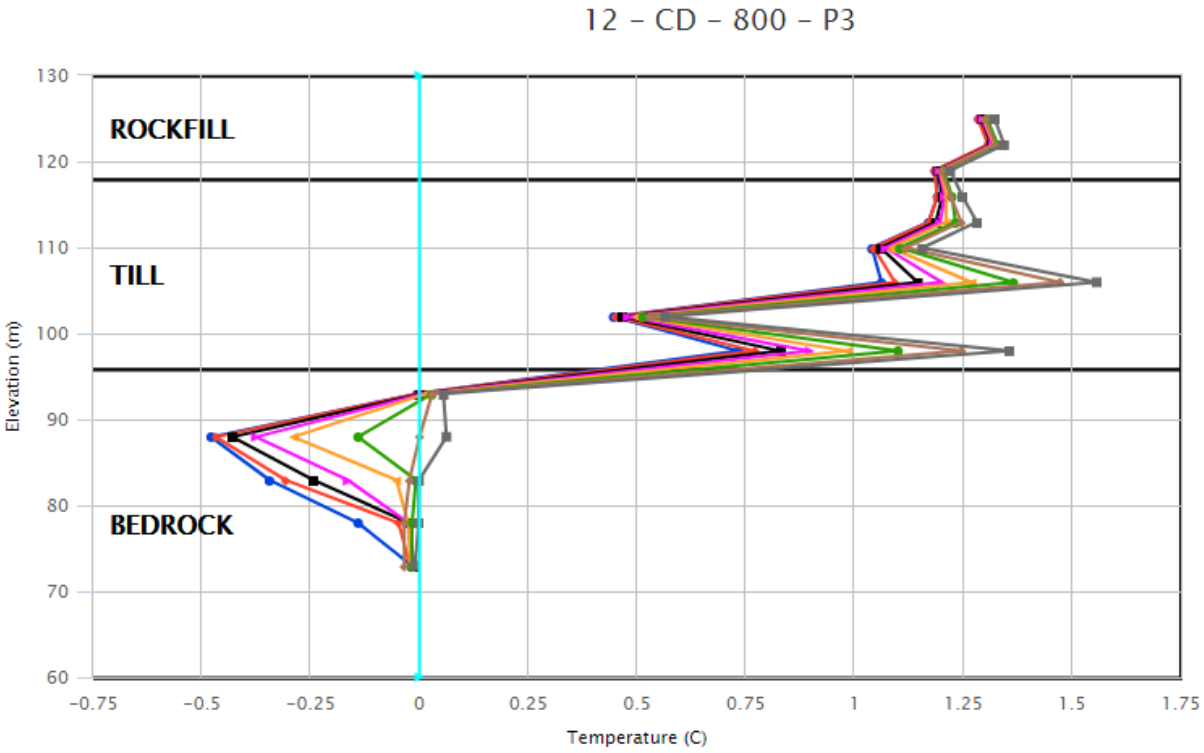
THERMISTOR 800-P3

- New instrument installed in 2017
- Stabilisation in progress
- Temperature under 0º C below El. 93 m

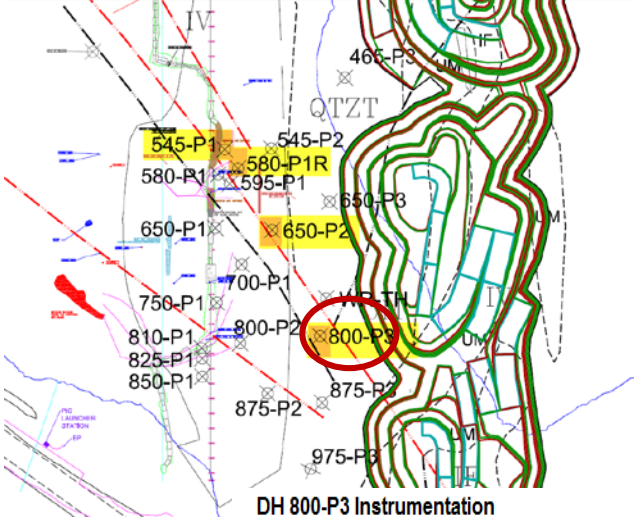
PIEZOMETERS 800-P3

- New instrument installed in 2017
- Stabilization in progress
- Piezo A & B readings are similar to the D/S pond elevation readings
- Piezo C readings is slowly decreasing

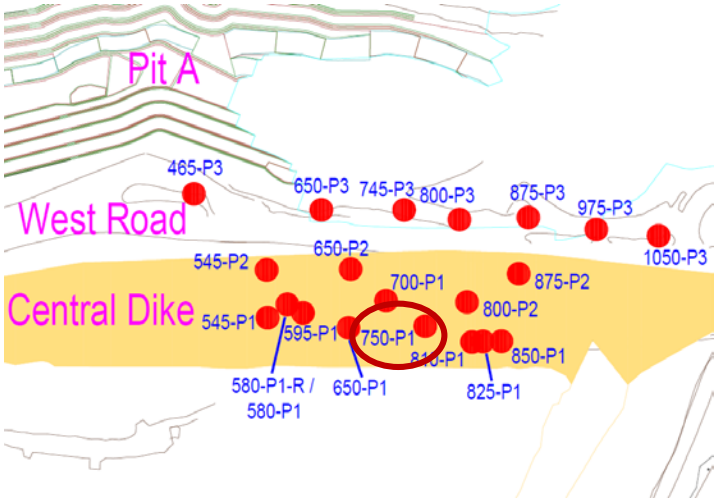
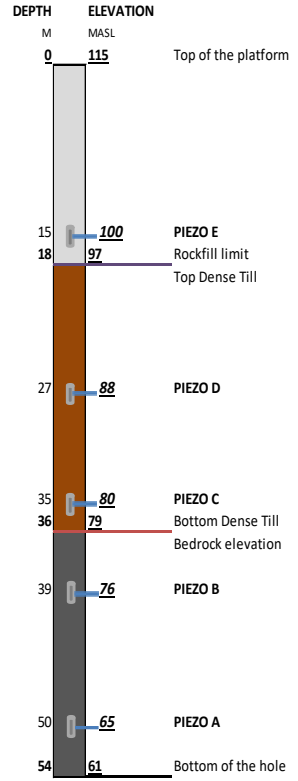
THERMISTOR 750-P1

- Cooling trend in till layer. The bead located at elevation 90m is in average 1º C cooler than in 2016.

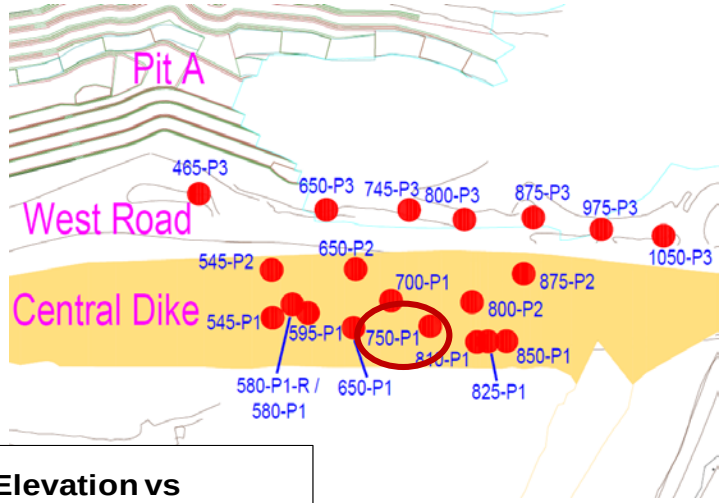
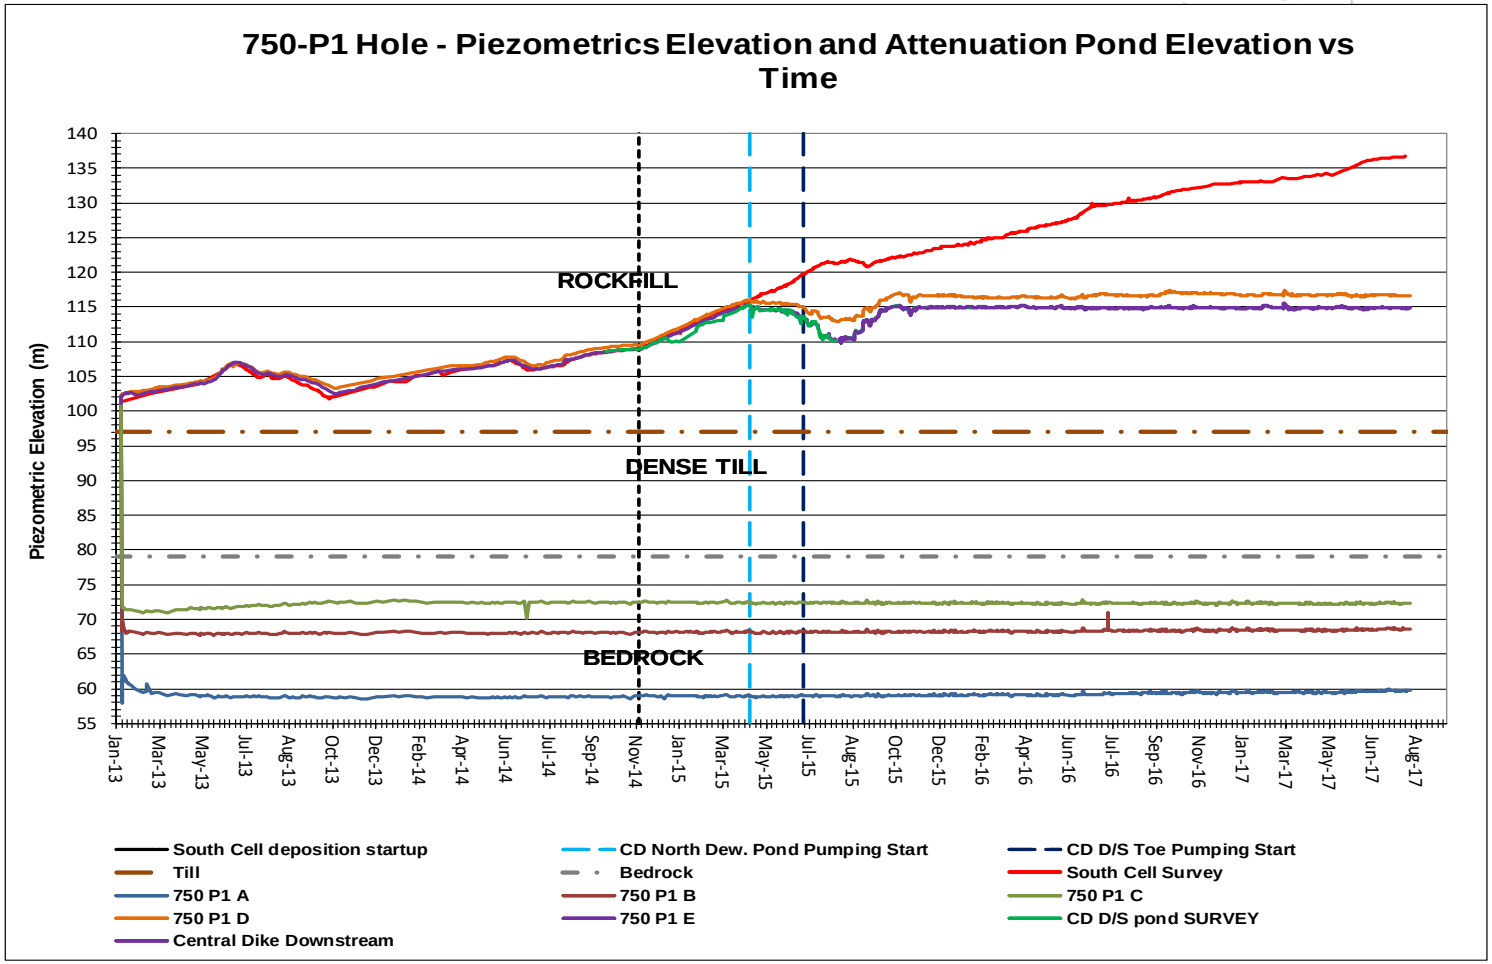
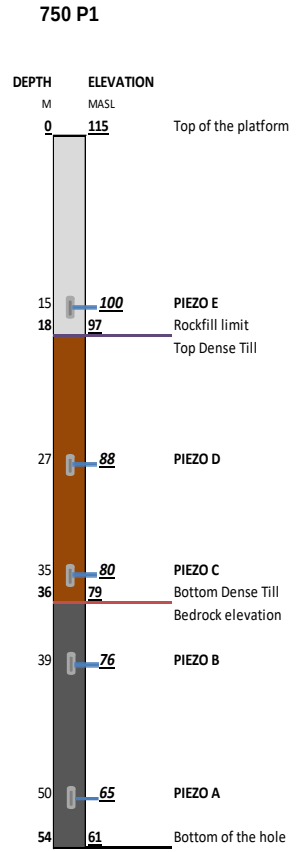
PIEZOMETER 750-P1

- Piezo A, B and C are in suction
- Piezo D is have a direct reaction to any variation in elevation observe in the D/S pond.

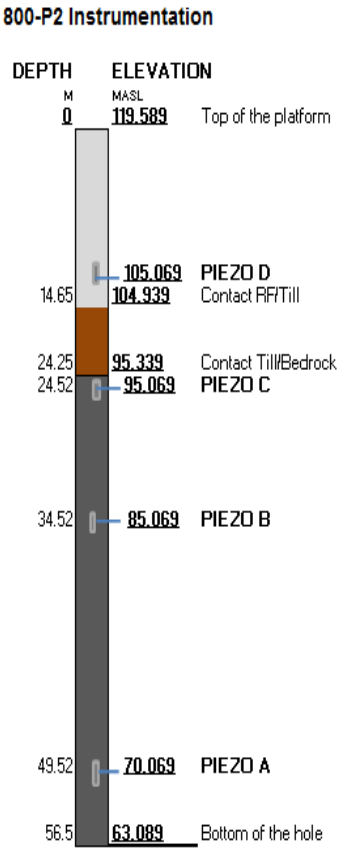
THERMISTOR 800-P2

- New instrument installed in 2017
- Stabilisation of temperature ongoing
- Temperature above 0 ºC

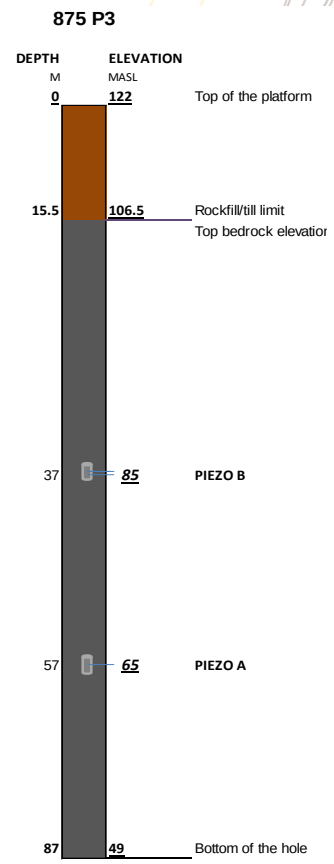
PIEZOMETER 875-P3

- Piezometer at 875-P3 are in bedrock and are impacted by increase in South Cell head

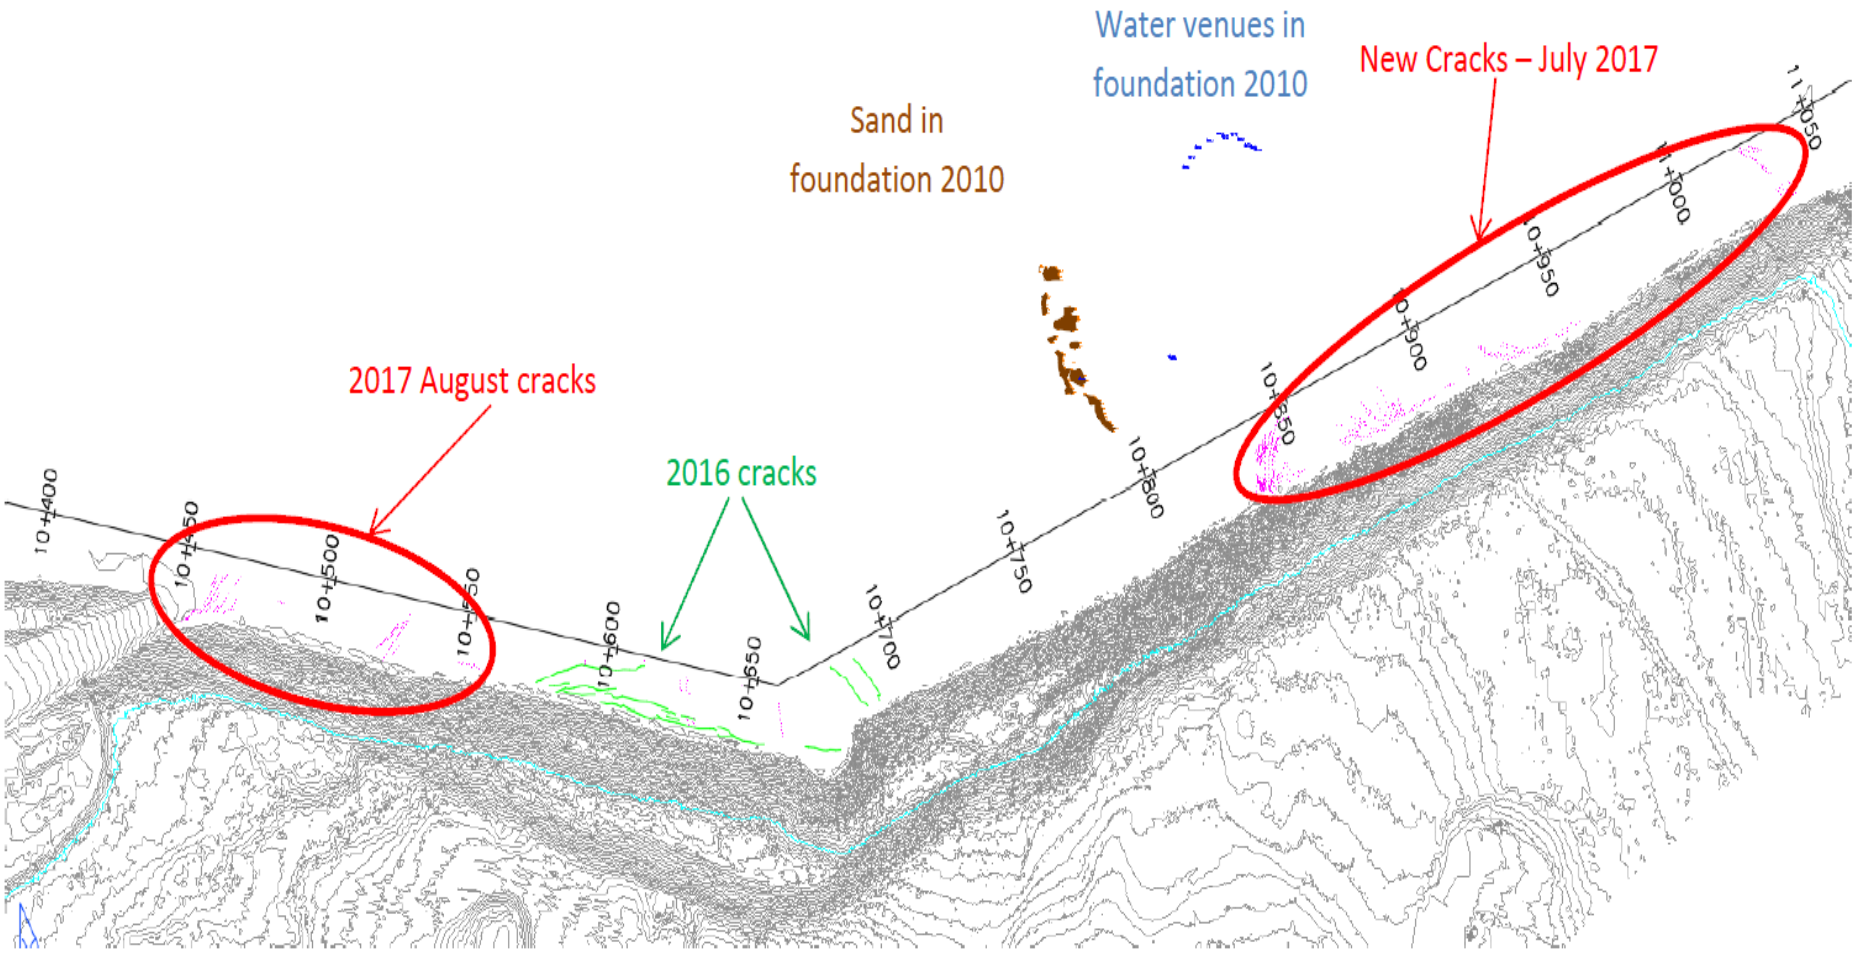
STORMWATER DIKE 2017 HIGHLIGHT

July 5 - Observation of settlement of 70cm deep and cracks from 10+840 and 10+925

July 15 - Observation of new cracks at 10+425 and 11+050 (corresponding to limit of South Cell water)

- Daily visual inspection of Stormwater Dike increased to 1 per day
- Increased frequency of prisms reading to 1 per day
- Weekly/ bi-weekly update to AEM Management and Dike designer
- Installation of additional instrumentation on the crest (3 prisms and 2 extensometers)

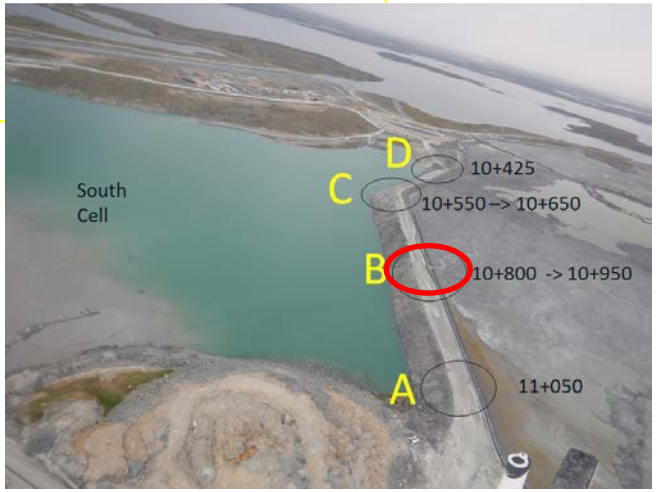
AREA OF MOVEMENT-10+800 TO 10+950

- Observed initially on July 5th 2017
- Depression present in previous year but deeper and larger amplitude this year
- Cracks were not present before

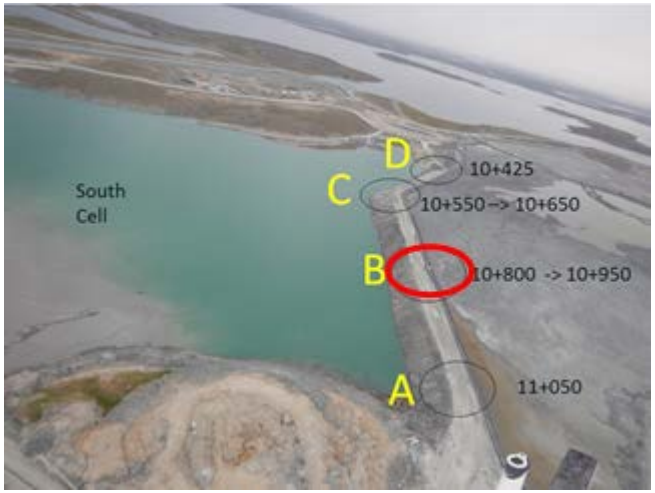
PICTURE OF MOVEMENT – 10+800 TO 10+950

- Cracks crossing the crest at 40º from CL
  - Did not progressed much during summer
- Longitudinal cracks along the crest
  - Constantly opened to up to 5cm wide

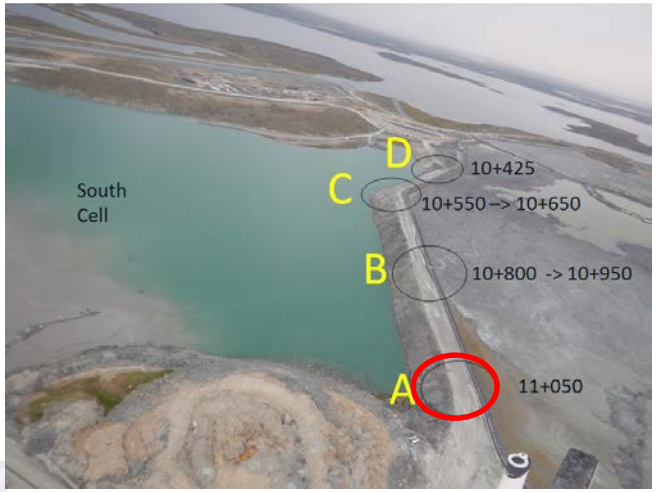
PICTURE OF MOVEMENT – 11+050

- Observed initially on July 15th 2017
- Appeared when water reached the toe in the area
- Crack width relatively small (<1cm)
- Cracks did not progressed
