2017 Annual Geotechnical Inspection

2017 Annual Geotechnical Inspection Meadowbank Gold Mine, Nunavut

Report Number: 1784282-1574-RPT-Rev0

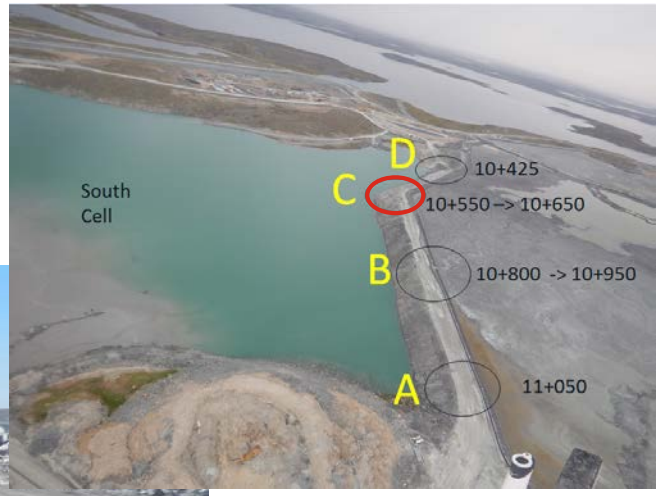
PICTURE OF MOVEMENT – 10+550 TO 10+750

- Cracks crossing the crest at 40º from CL
  - Did not progressed much during summer
- Longitudinal cracks along the crest
  - Constantly opened to up to 5cm wide

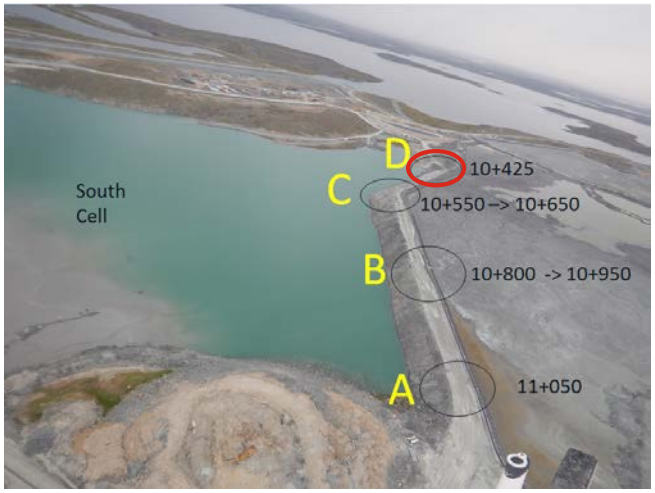
PICTURE OF MOVEMENT – 10+425

- Observed initially on July 15th 2017
- Appeared when water reached the toe in the area
- Crack width relatively small (<1cm)
- Cracks did not progressed

- The new cracks found at 10+425 and 11+050 happened when the South Cell water elevation reached the toe of the structure in these areas, same process as last year.
  - The observed cracks in those zones are smaller in amplitude compared to last year observation from 10+500 to 10+750
- The instrumentation data still shows movement but in a stabilizing trend since freshet as confirmed by the visual inspection. Creep is expected to continue to be visible until the crest of the structure freezes.
- Tailings in the North Cell are frozen for 18m.
- The structure is still in yellow tarp level and the situation is considered moving towards stability.
- Monitoring of the prisms will continue on a reduced frequency.
- Frequent visual inspection of the structure are planned for freshet 2018.
- New cracks will be filled with bentonite before temperature falls below 0ºC.

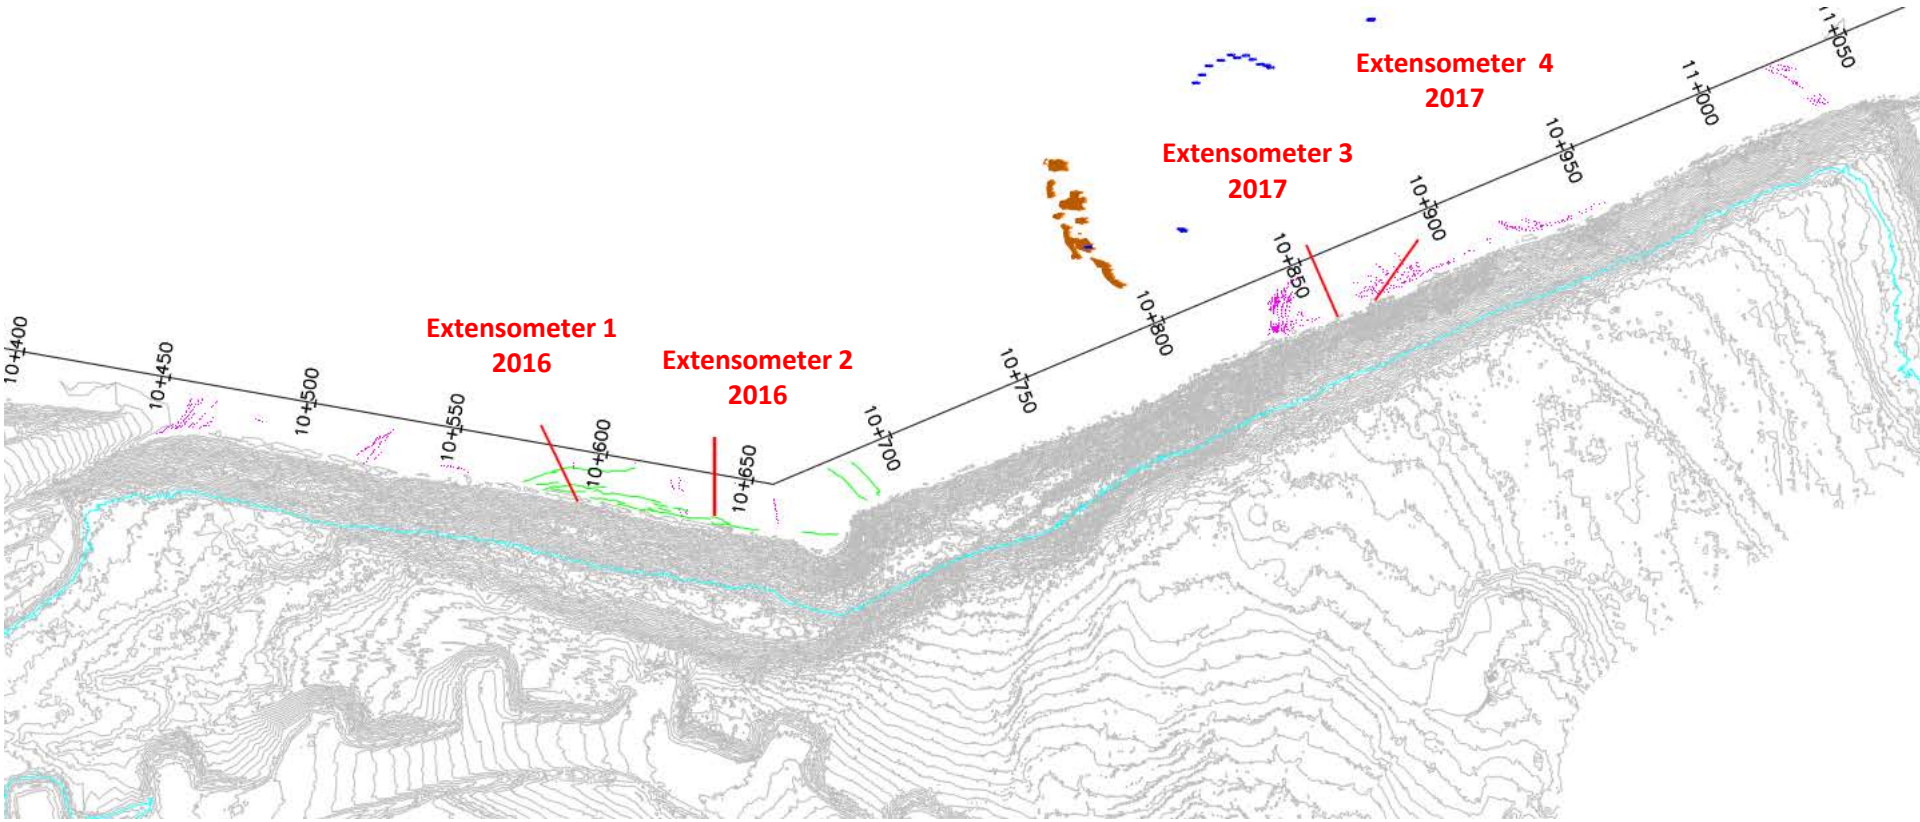
HOMEMADE EXTENSOMETERS (4X)

- No movements were recorded on any of the 4 extensometers installed in 2017

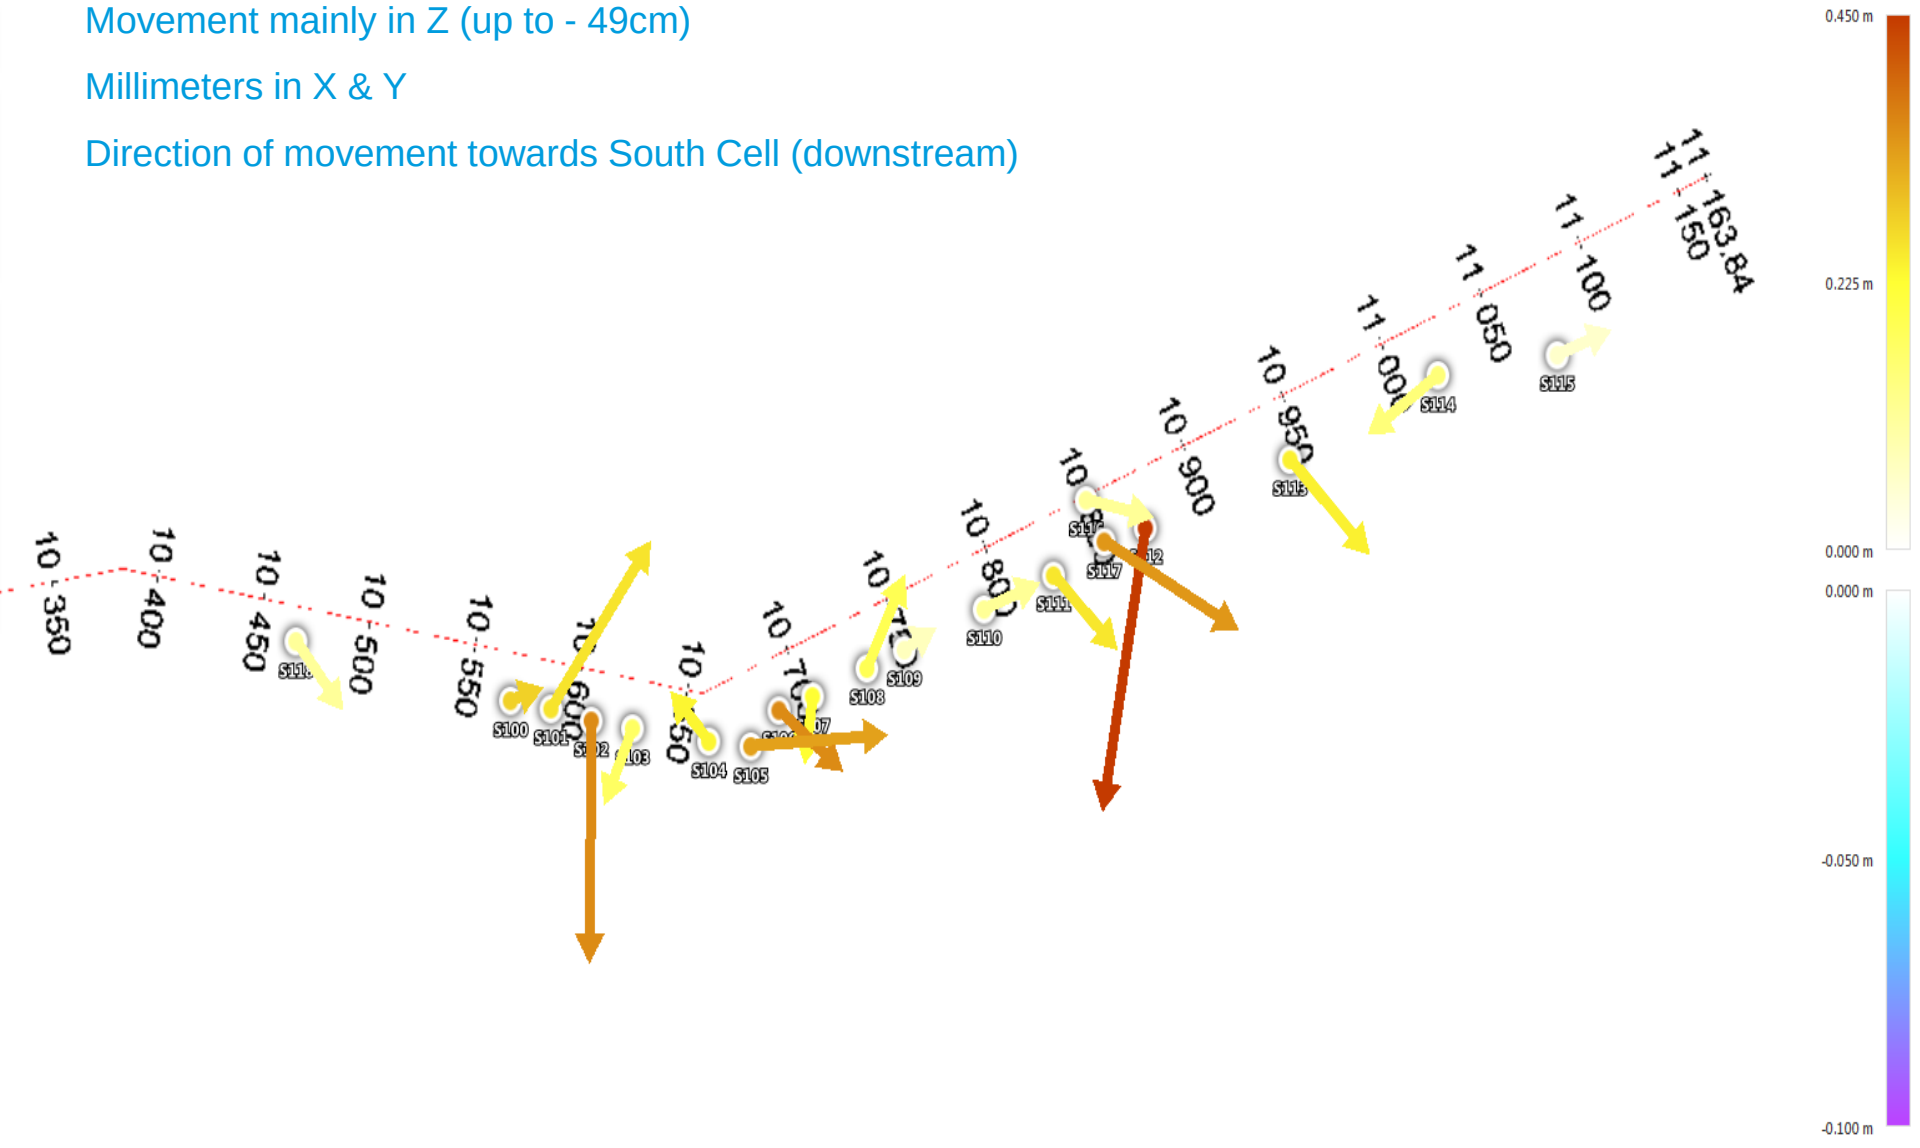
Movement mainly in Z (up to - 49cm)

Millimeters in X & Y

Direction of movement towards South Cell (downstream)

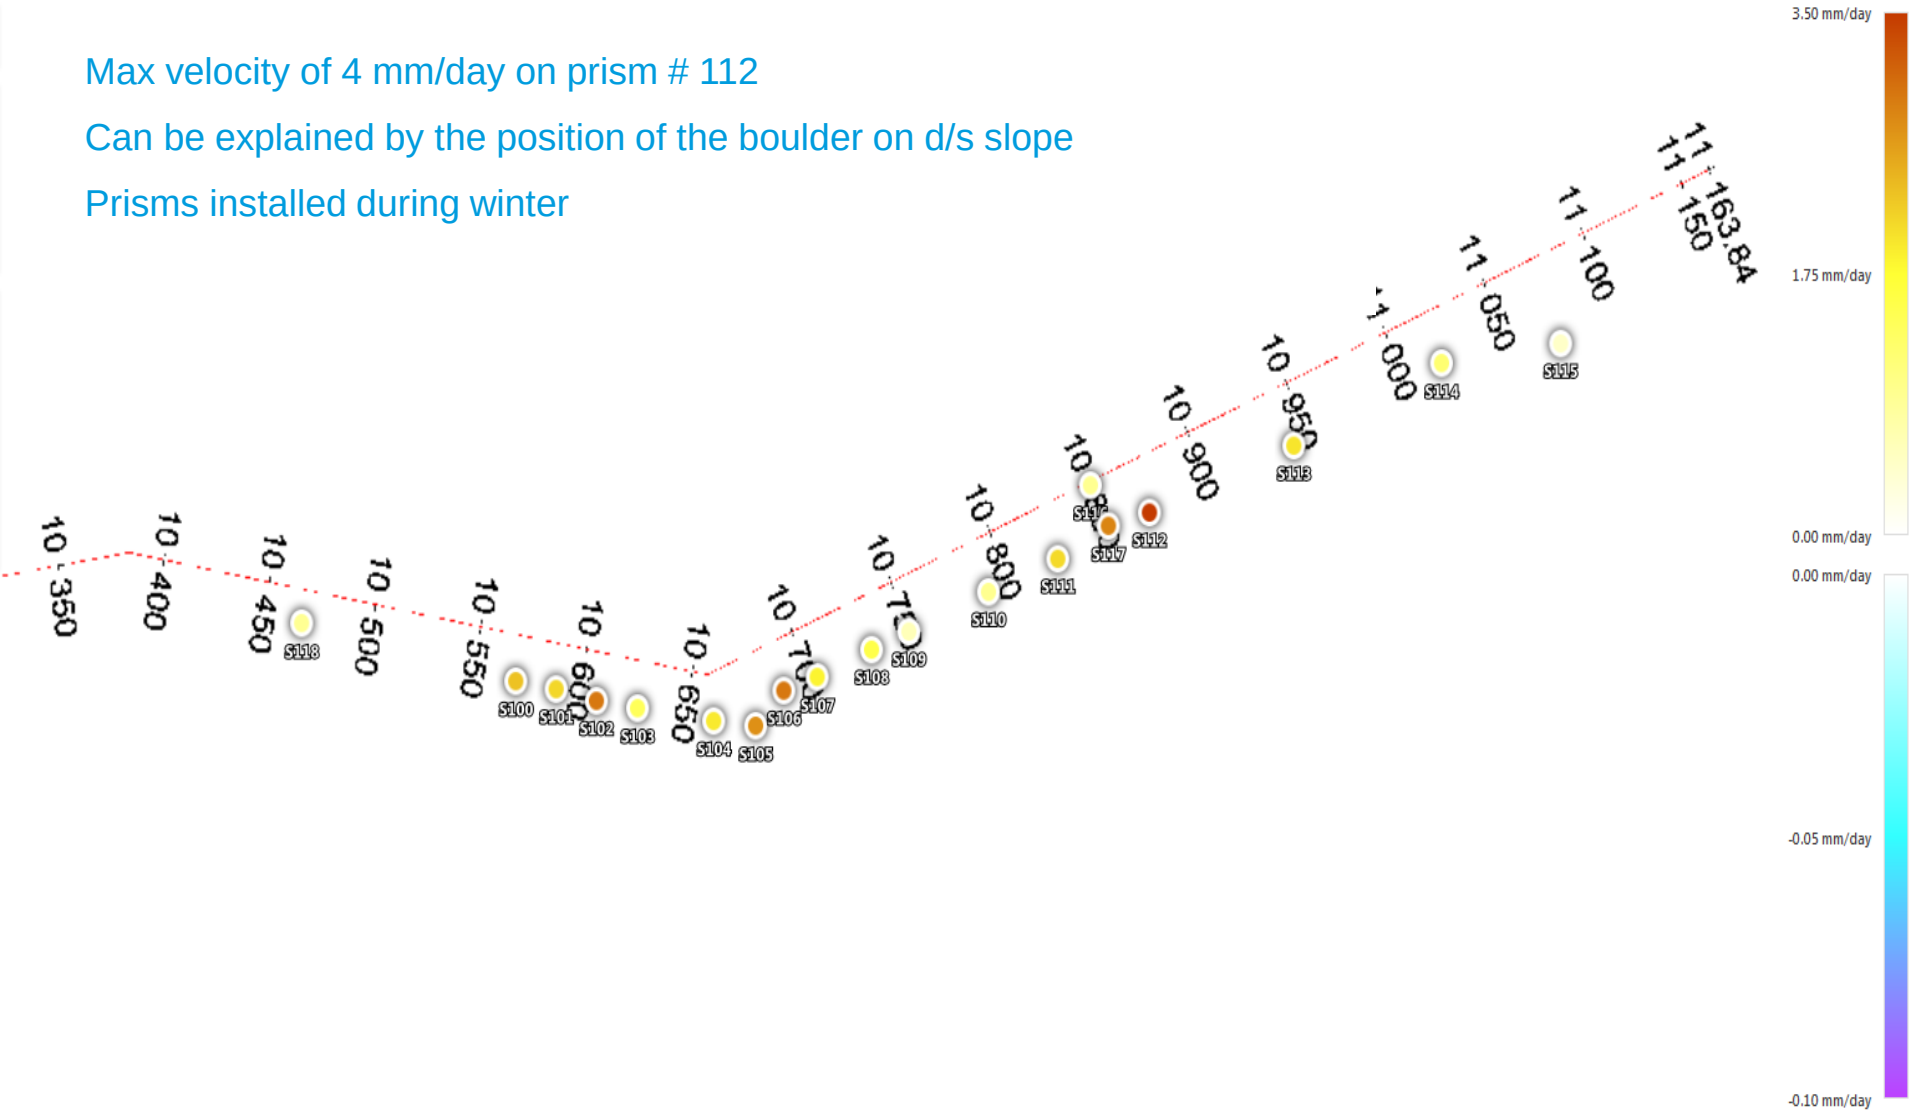
Max velocity of 4 mm/day on prism # 112

Can be explained by the position of the boulder on d/s slope

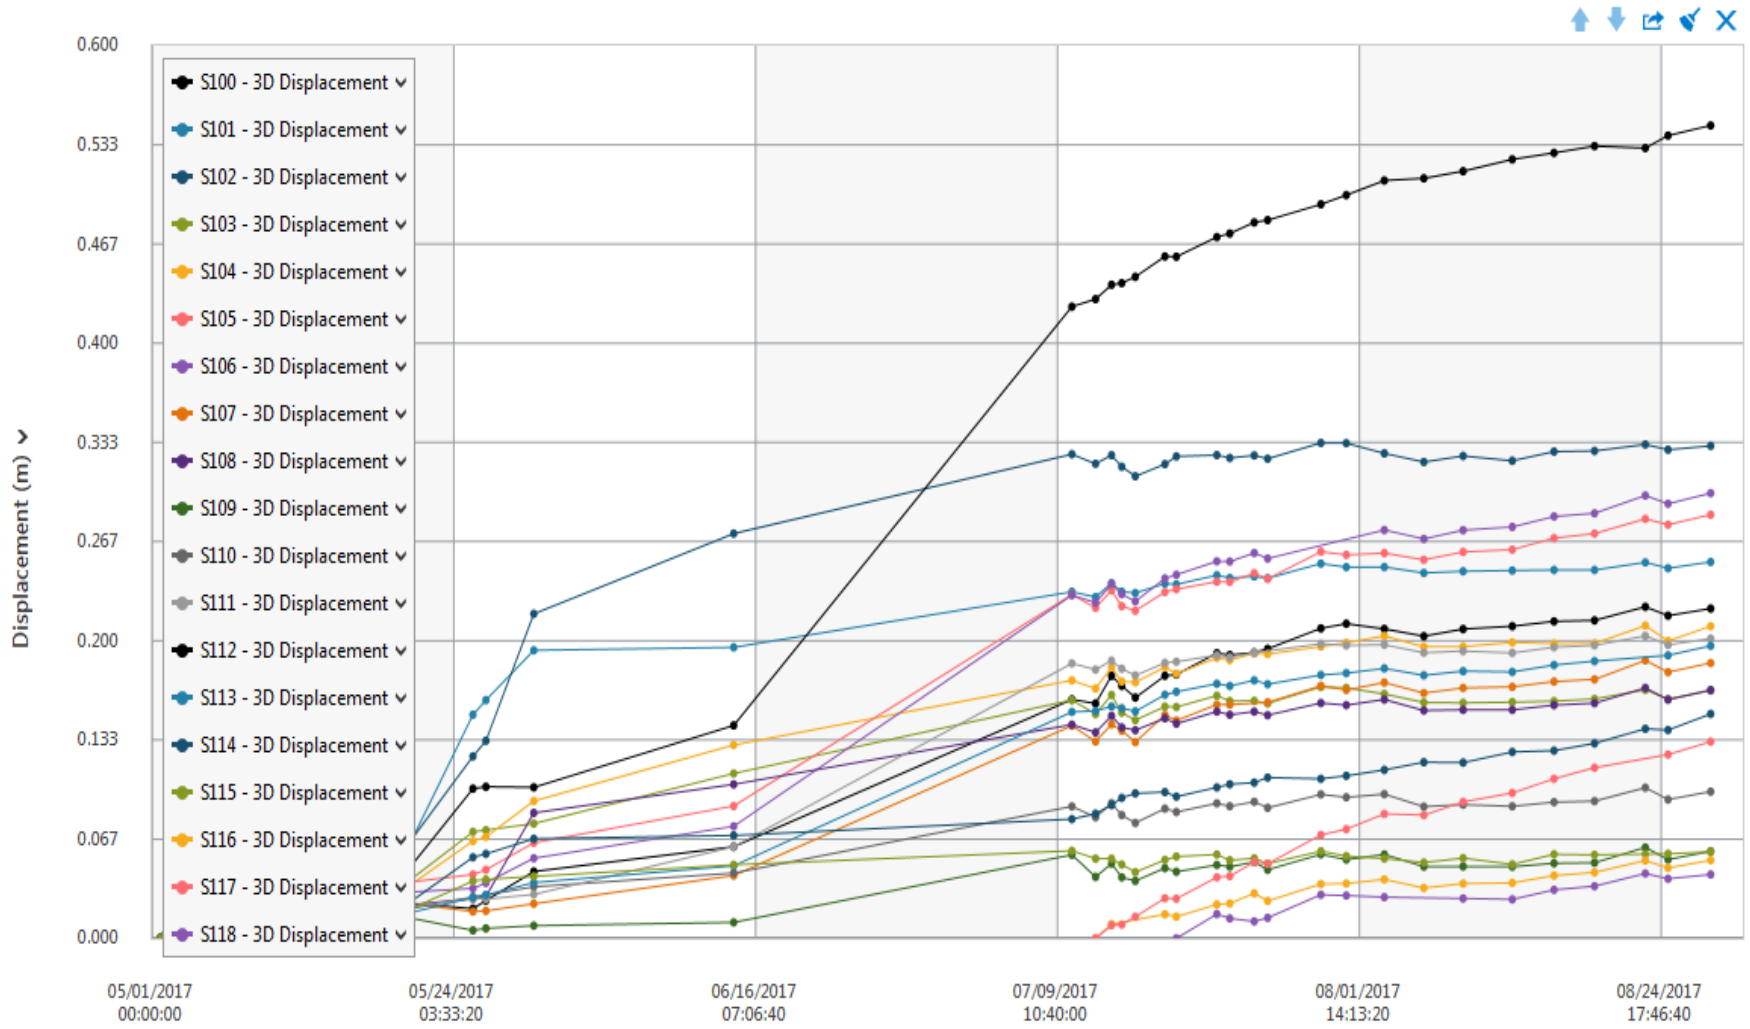
Cumulative Displacement (3D) since May 2017

Max movement of 55cm

Most of the movement happened at freshet

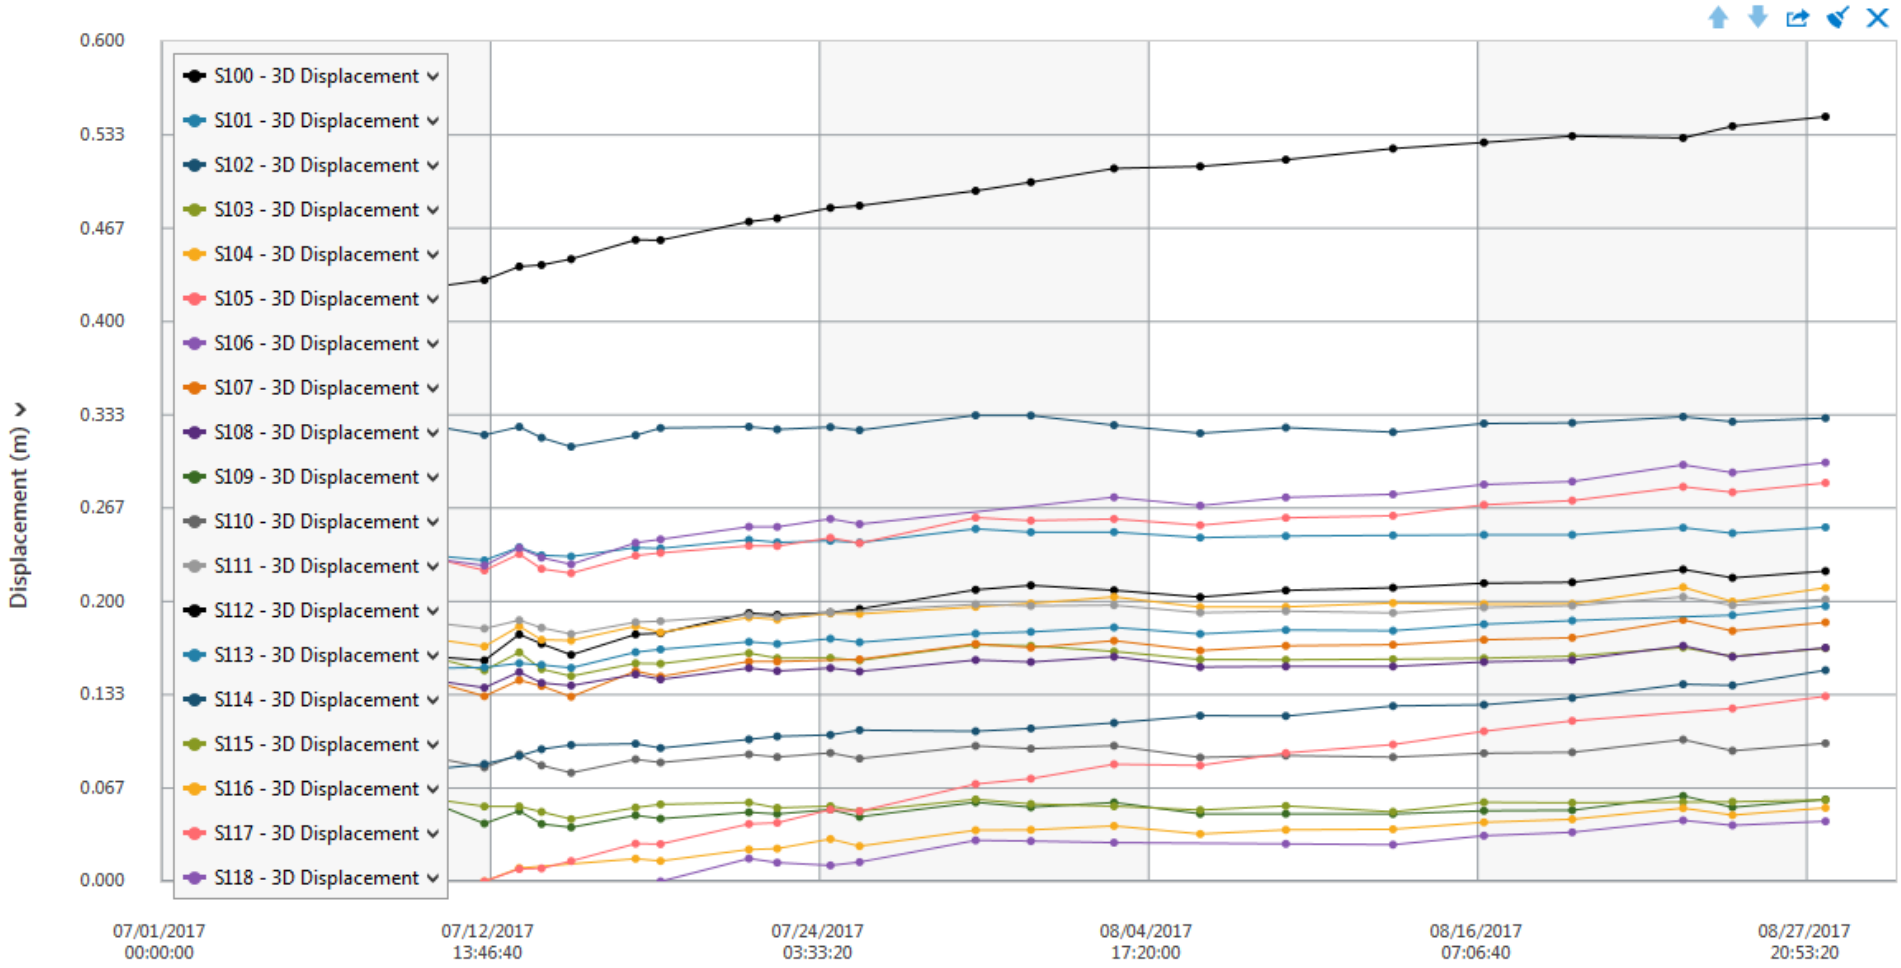
Cumulative displacement (3D) since freshet

Still displacement but lower amplitude than considering thawing period

Max movement for the post-freshet period is ~5-6 cm

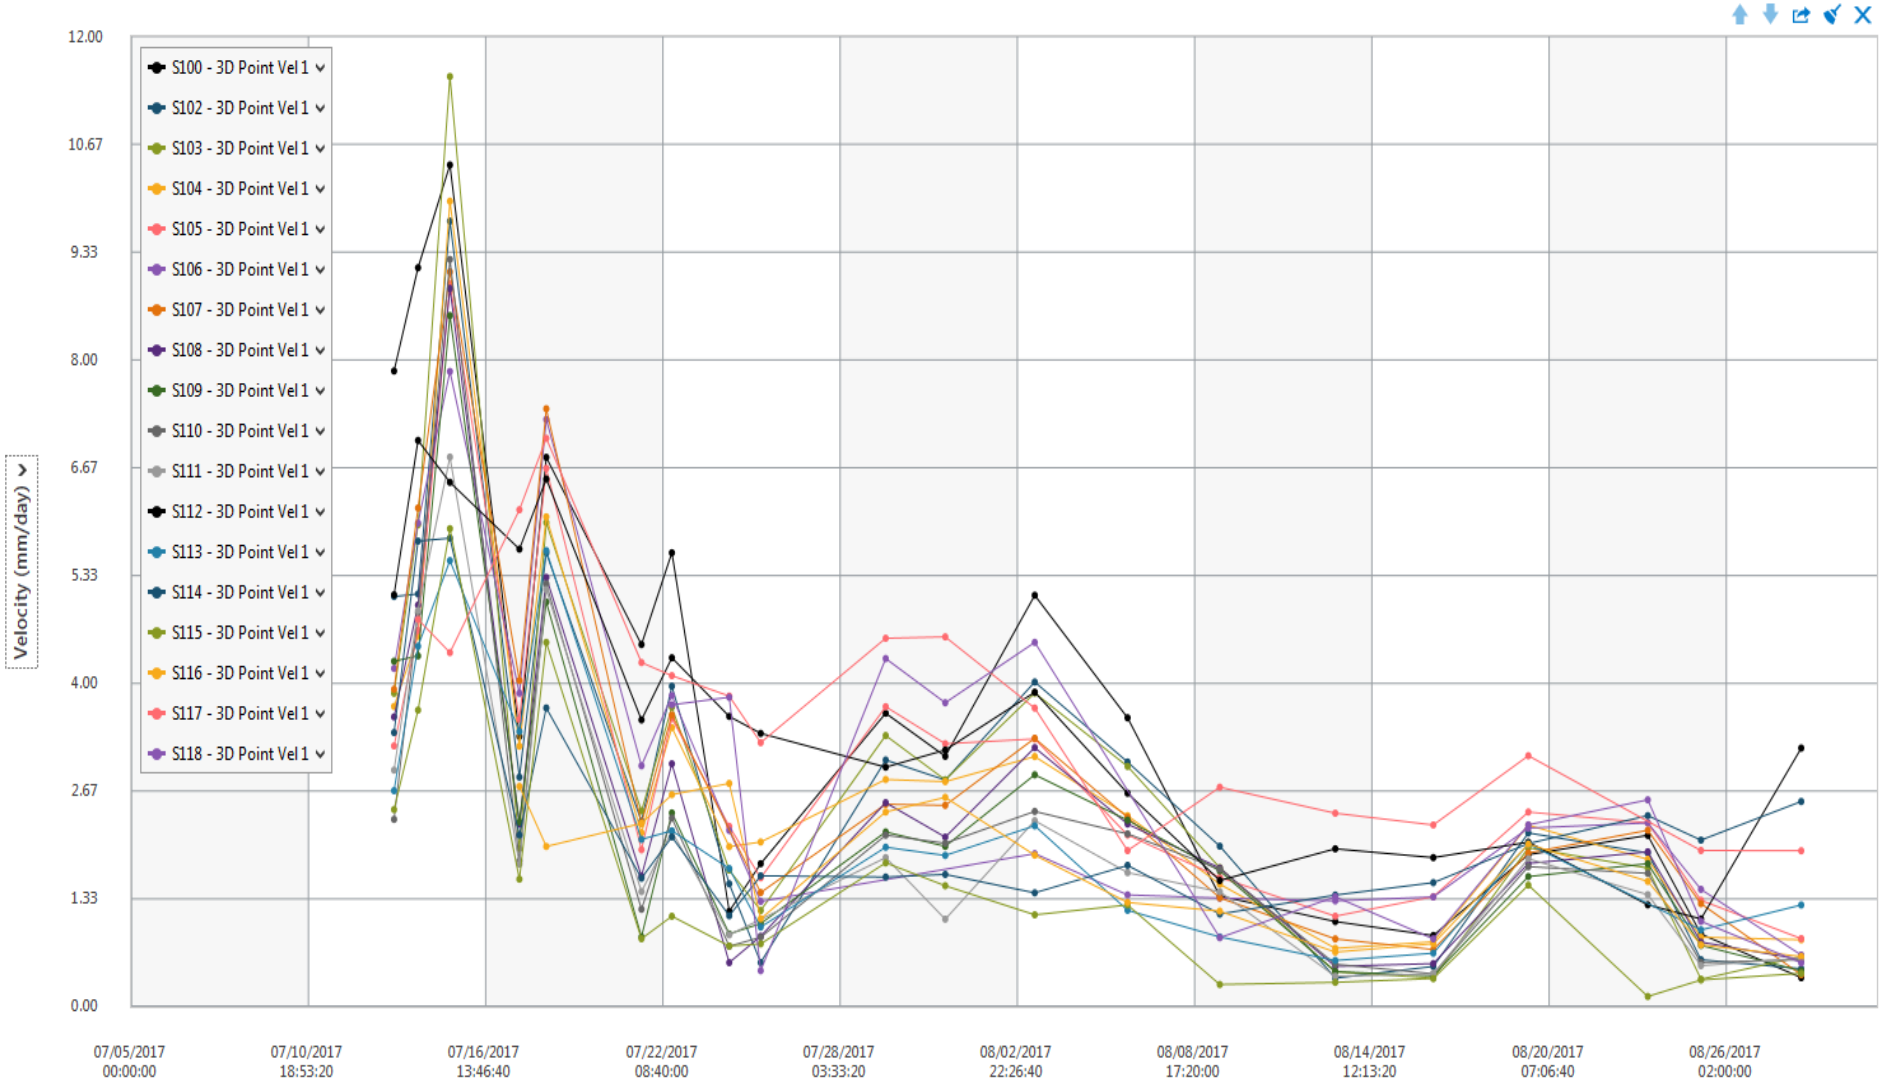
3D velocity since freshet

Decreasing velocity from average 5mm/day to 1.5mm/day

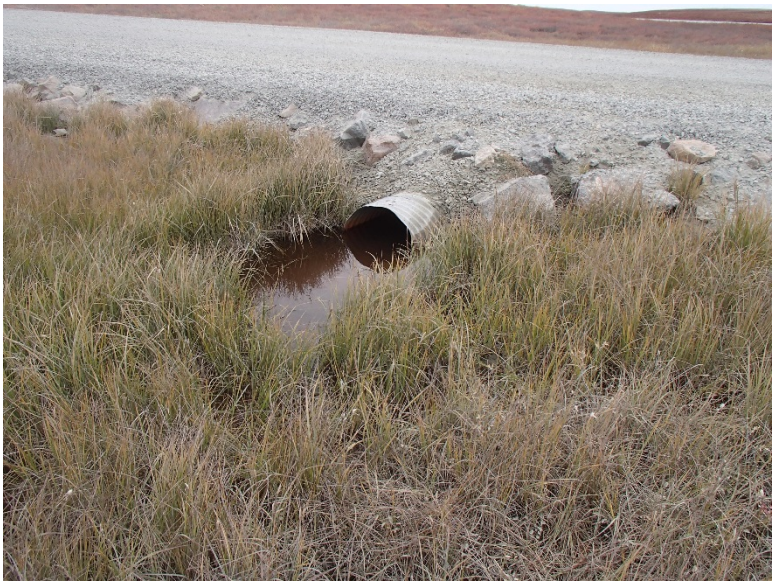
Photograph D1-49: PC-11 km 39+552

Description: View of the culvert inlet. The inlet is too high and water is flowing underneath.

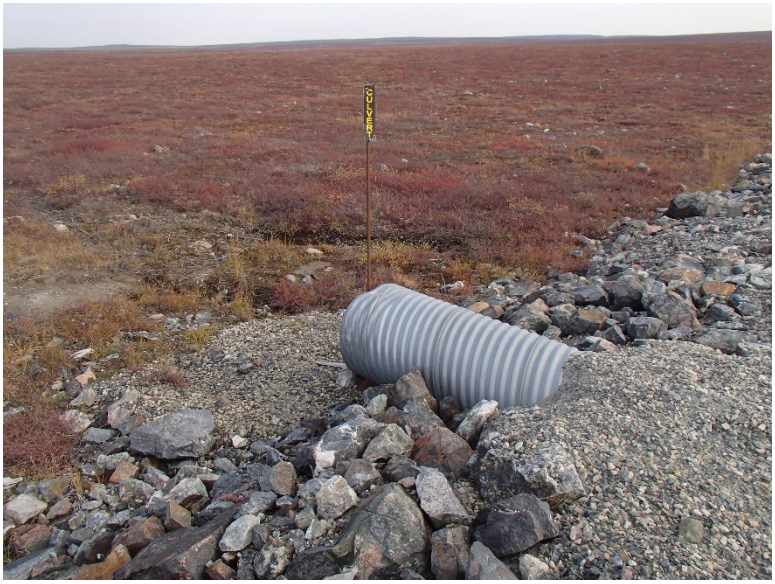
Photograph D1-58: R-18A km 80+950

Description: View of the culverts inlet. In good condition. The southern culvert inlet is partially buried.

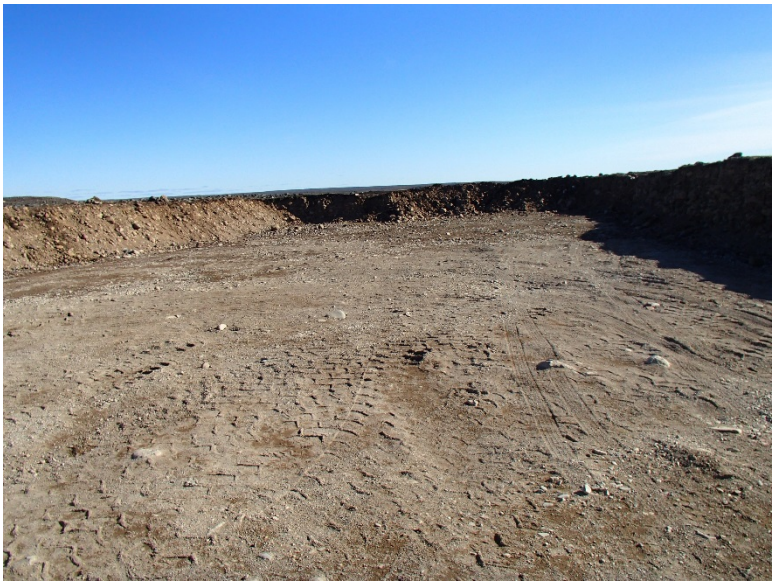
Photograph F2-13 Eskers and Quarries 5 – km 52+000

Description: View of the rock quarry at km 52. In good conditions with loose blocks on the north wall.

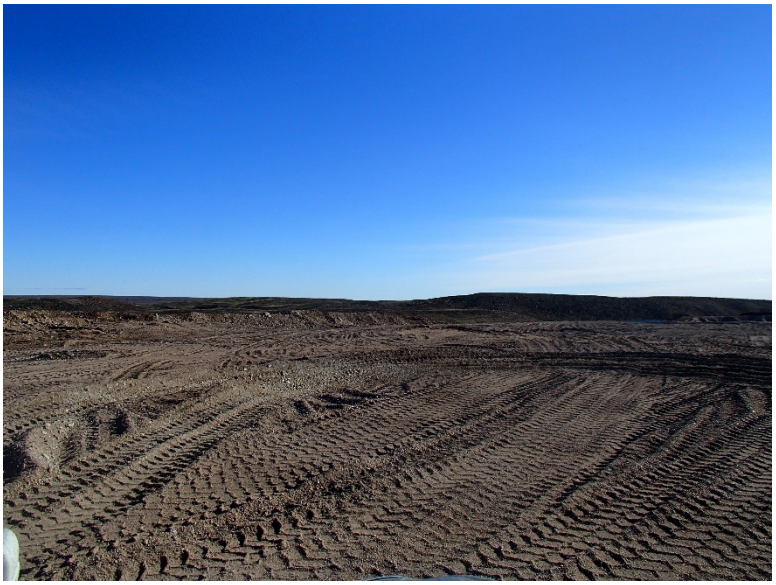
Photograph F2-15 Eskers and Quarries 6 – km 62+000

Description: View of esker #6C (north borrow pit). The 2-m high steep soil slopes are unstable.

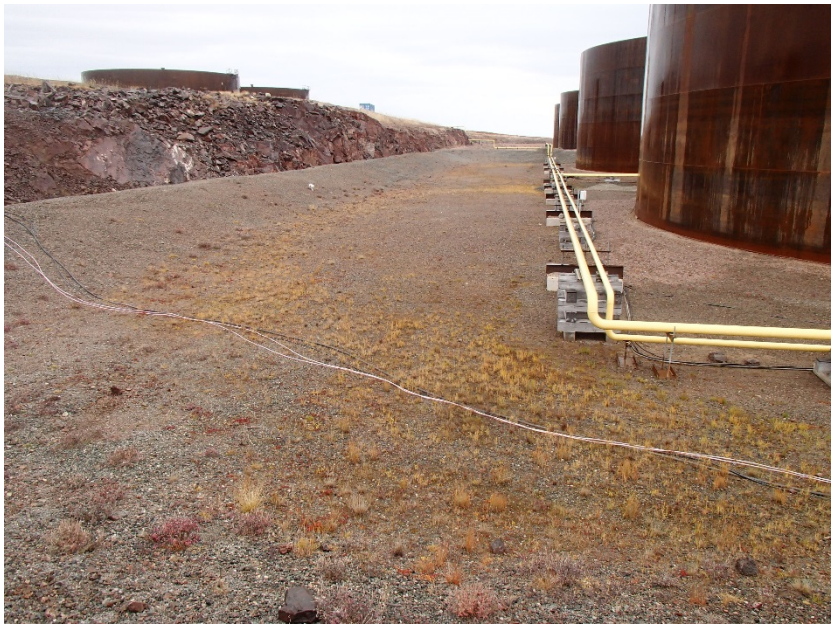
Photograph G1-1 Baker Lake Tank Farm

Description: From the south side of Tank 1, looking southeast at Tanks 1, 2, 3, and 4. Presence of water ponding.

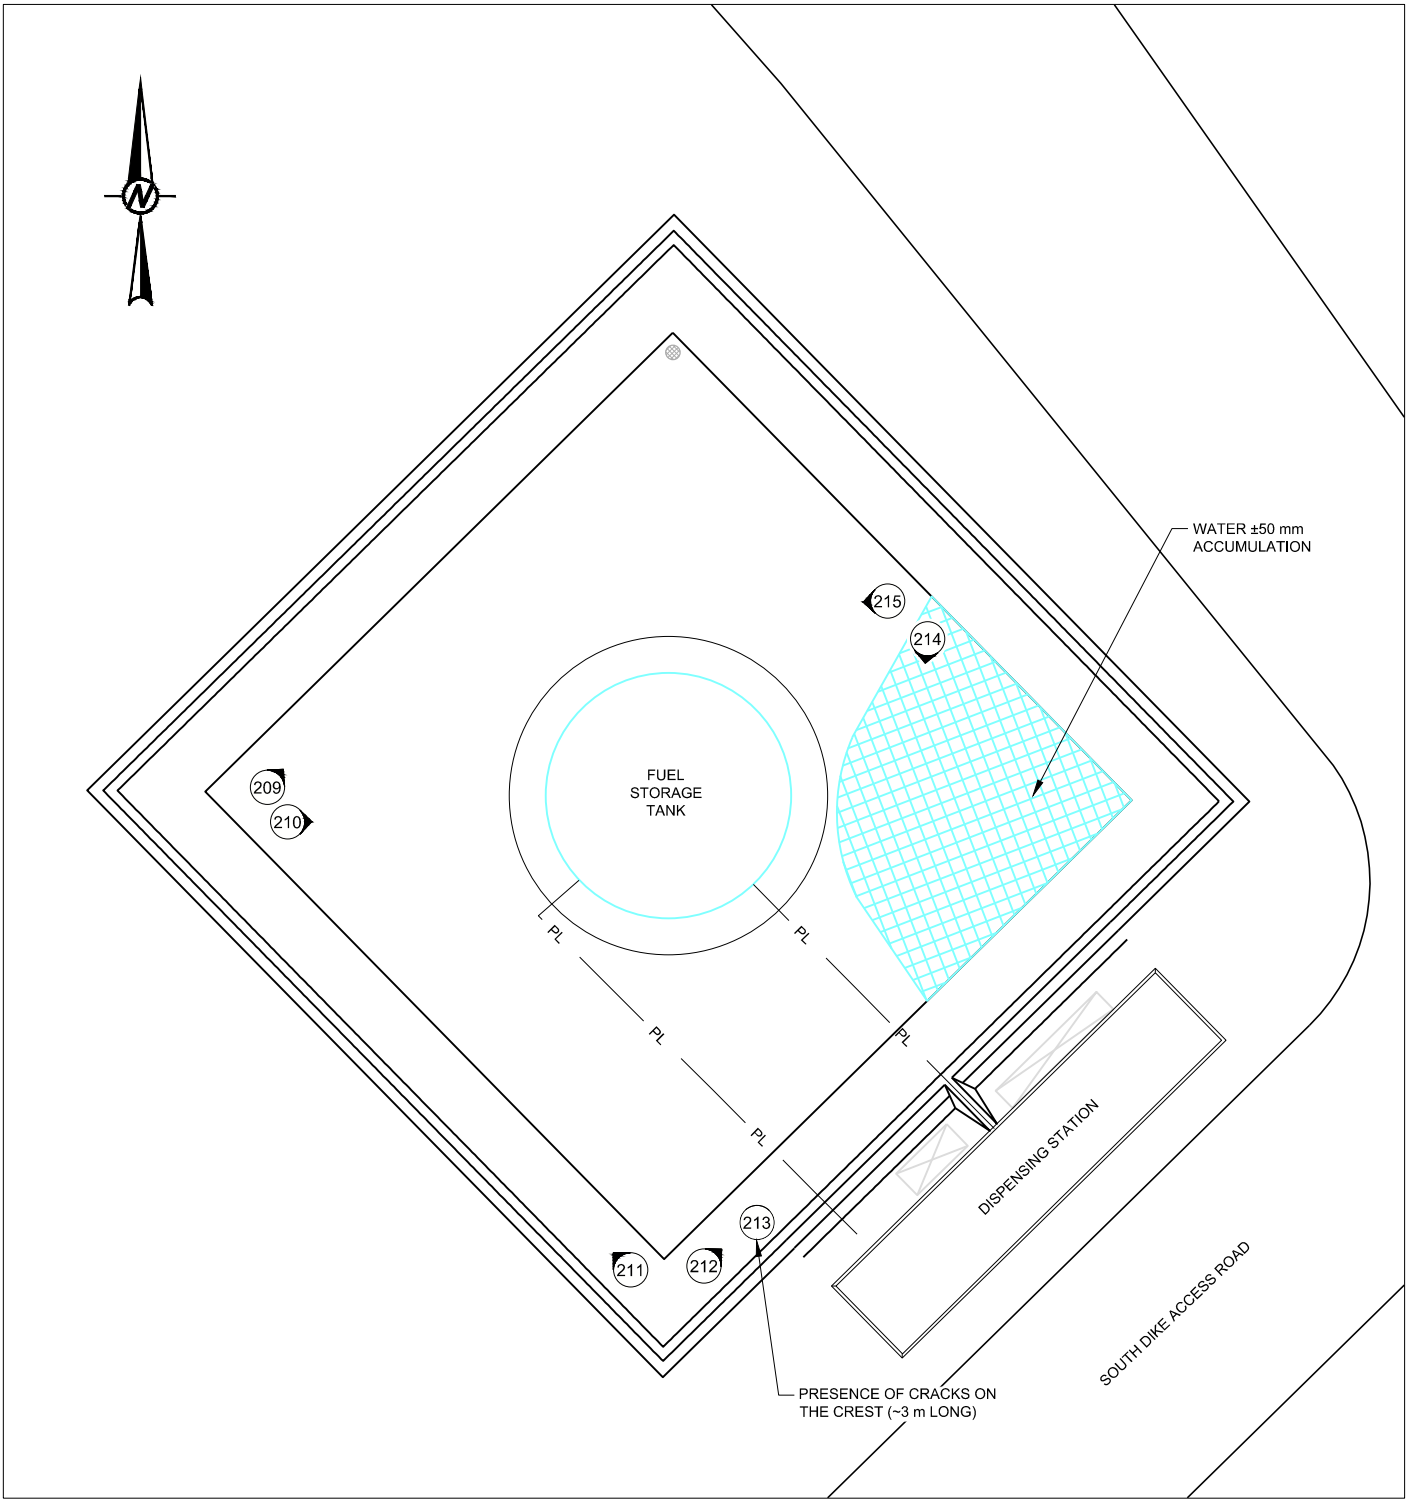
Description: From the southwestern corner of the Jet A fuel tanks looking east. Presence of exposed geomembrane and water ponding.
