## **NYRSTAR**

### **NANISIVIK MINE, NUNAVUT**

## **2013 ANNUAL GEOTECHNICAL INSPECTION**

PROJECT NO.: 0255-023  
DATE: February 27, 2014  
DOCUMENT NO.:

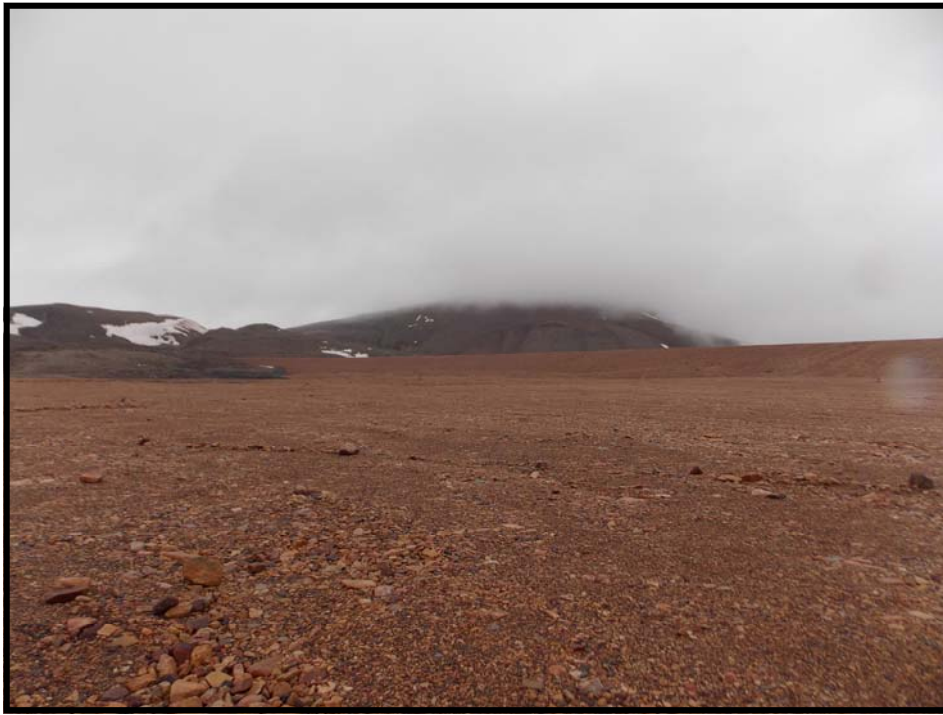
Photo 21. Test Cell—Surface of Test Cell cover.

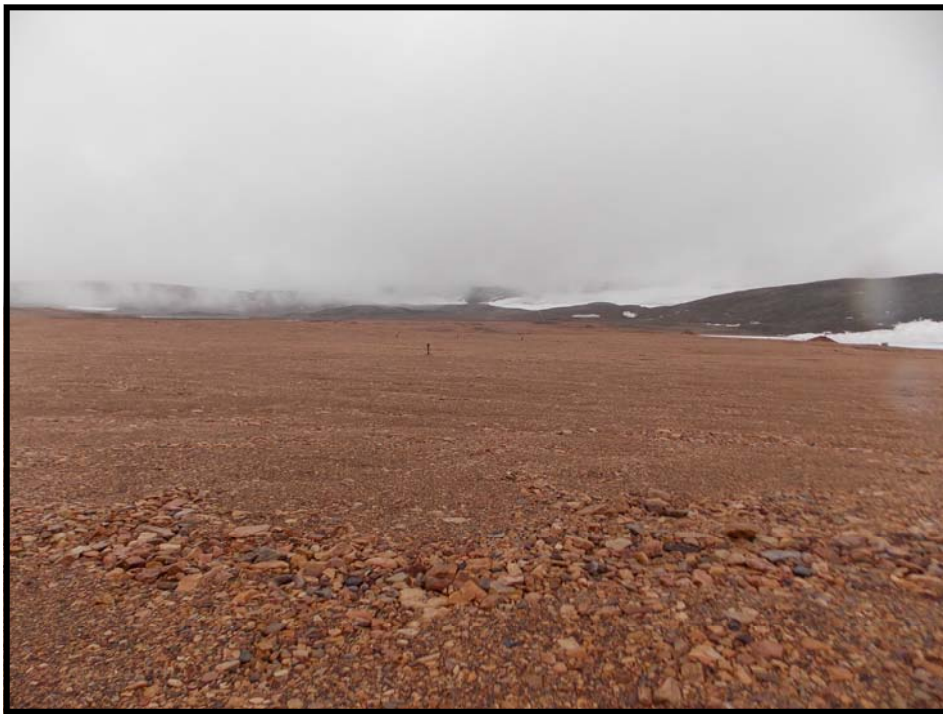
Photo 22. Test Cell—Surface of Test Cell cover.

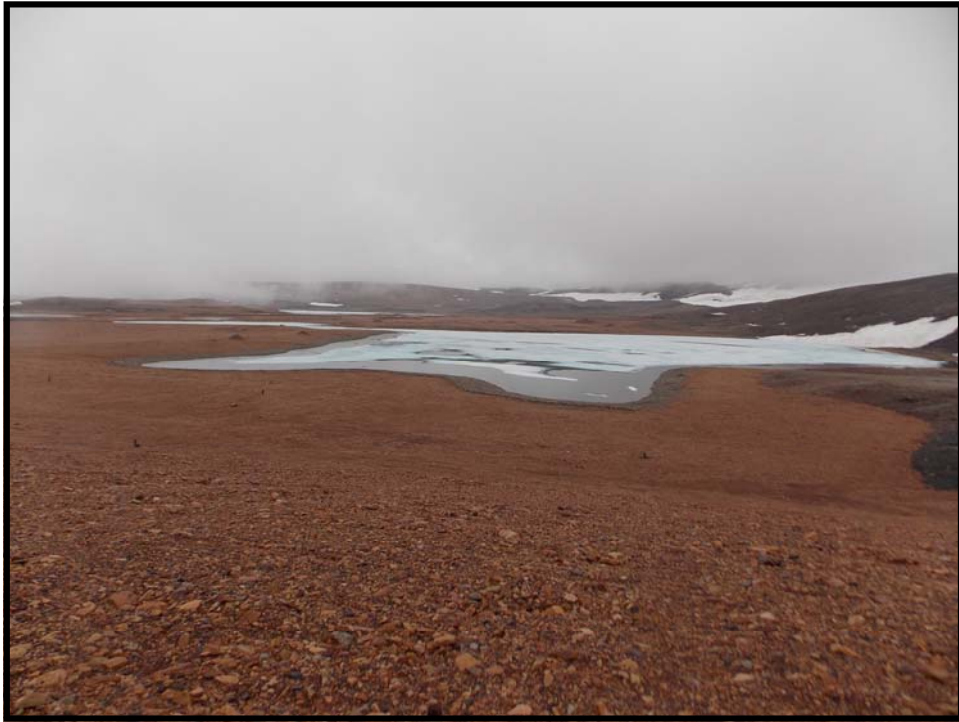
Photo 27. Toe of West Twin Dyke.

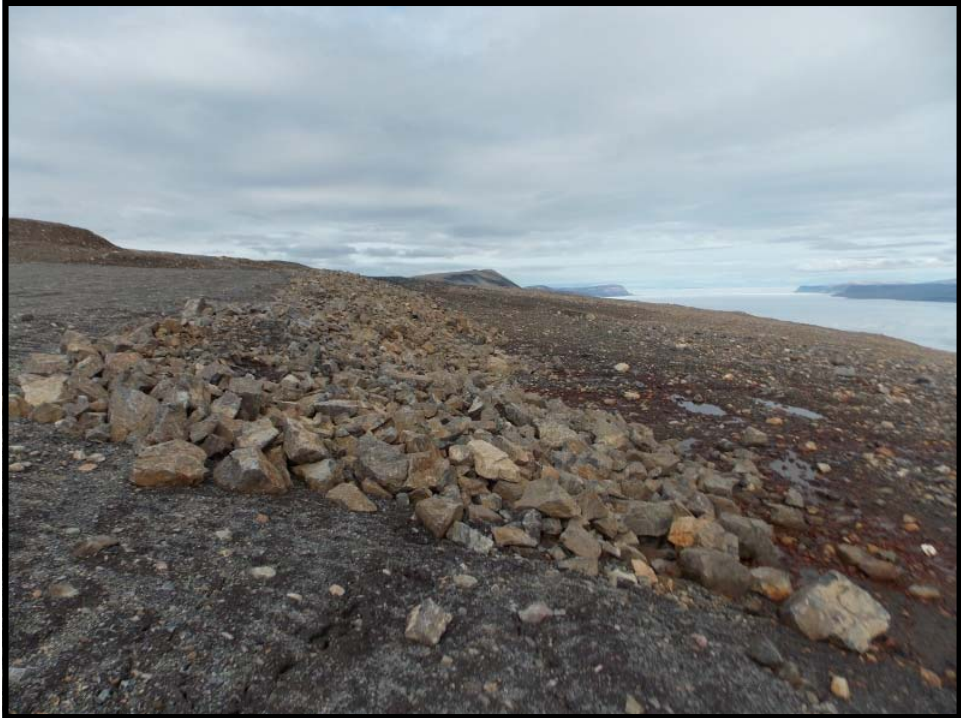
Photo 41. Oceanview Open Pit—Toe area.

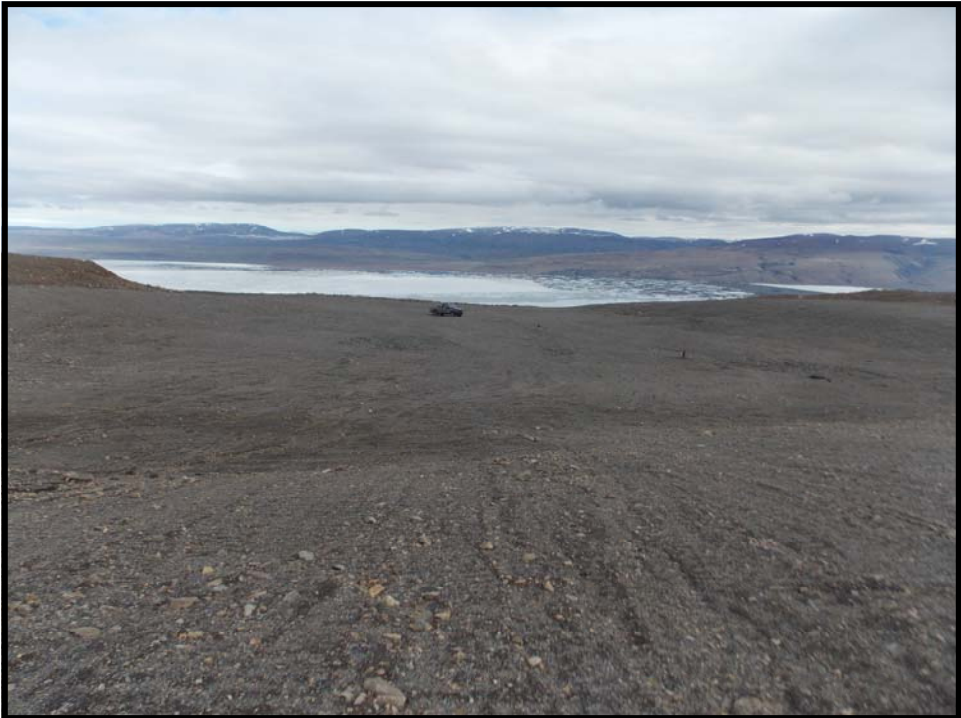
Photo 44. Oceanview Open Pit—Note minor rill erosion.

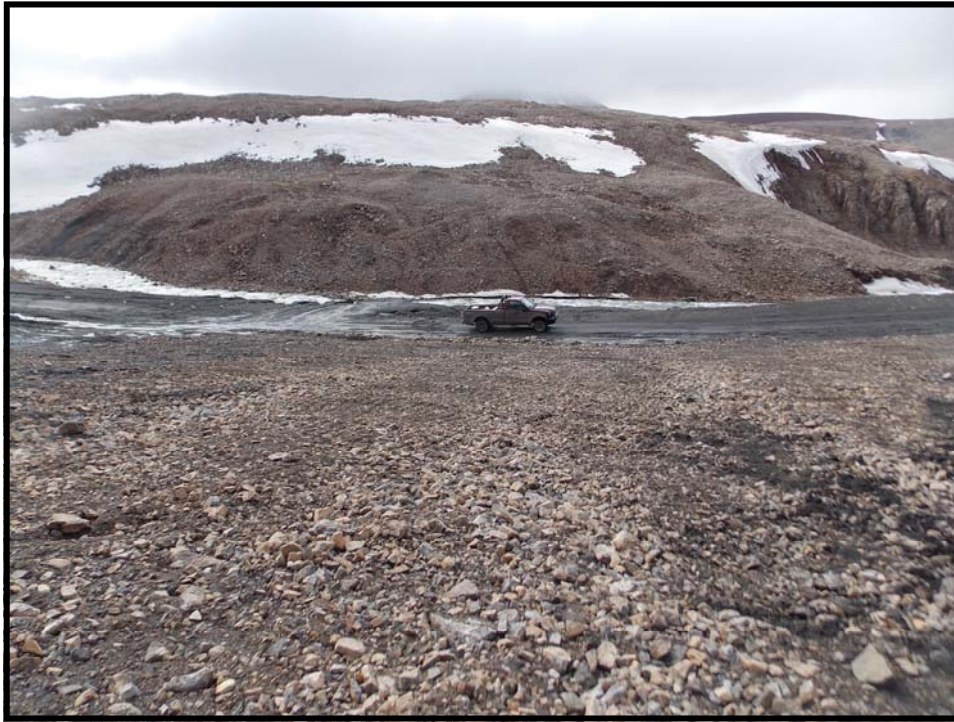
Photo 58. 09S Portal—Looking downslope along surface of cover.

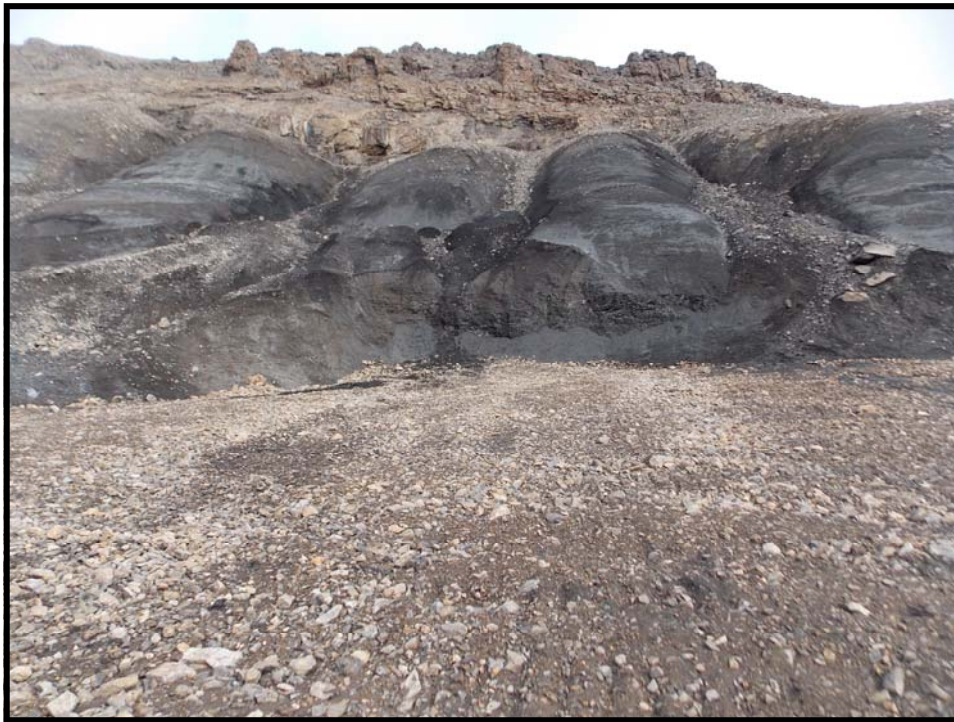
Photo 59. 09S Portal—Looking upslope along surface of cover.
