NANISIVIK MINE RECLAMATION PROJECT COMPLETION REPORT

PROJECT NUMBER: 0255-017-05

DATE: JANUARY 30, 2009

PROJECT COMPLETION REPORT

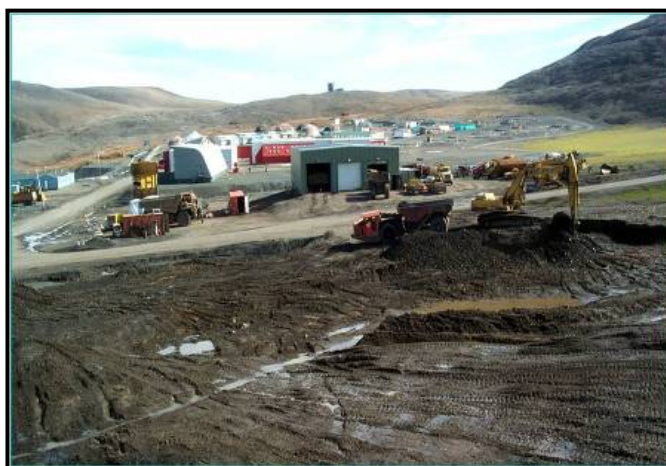
Figure 35 – Reclamation of Hydrocarbon Contaminated Soils, Nanisivik Townsite (2005)

The reclamation of the hydrocarbon contaminated soils located at the various end user tank locations is documented in detail in GLL (2008b) and SRK (2009). The reclamation of the end user tank areas is summarized by the following:

- All tanks were emptied of any free phase product and subsequently relocated to the underground mine workings.
- All secondary containment structures were removed and the liners were relocated to the underground mine workings.
- Any hydrocarbon contaminated soils encountered at each location were excavated and relocated to the underground mine workings.
- All excavations associated with reclamation of the end user tanks were backfilled and/or recontoured to provide positive drainage and prevent ponding of surface water.

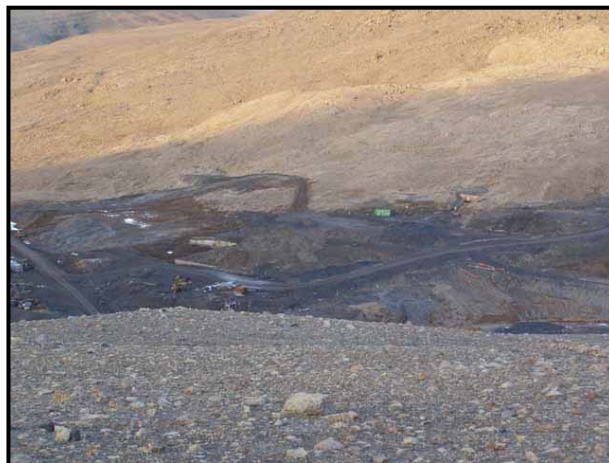
Figure 37 – Industrial Complex Yard during Reclamation (2007)

The reclamation of the hydrocarbon and metals contaminated soils in the Industrial Complex Yard Area is documented in SRK (2009). The main elements of the reclamation of the Industrial Complex Yard Area are summarized by the following:

- The hydrocarbon contaminated soils excavated from the Industrial Complex Yard Area were excavated and relocated to the underground mine workings.
- The metals contaminated soils from the Industrial Complex Yard Area were excavated and relocated within the footprint of the Industrial Complex foundation. The metals contaminated soils were subsequently covered with a thermal cover as previously documented in Section 3.6.
- All remaining equipment in the bone yard was decontaminated and either transported off site or disposed of into the underground mine workings.
- A roadway capable of providing safe passage of vehicular traffic through the Industrial Complex area was preserved.
- Water quality monitoring stations are established in Twin Lakes Creek both up and downstream of the area.

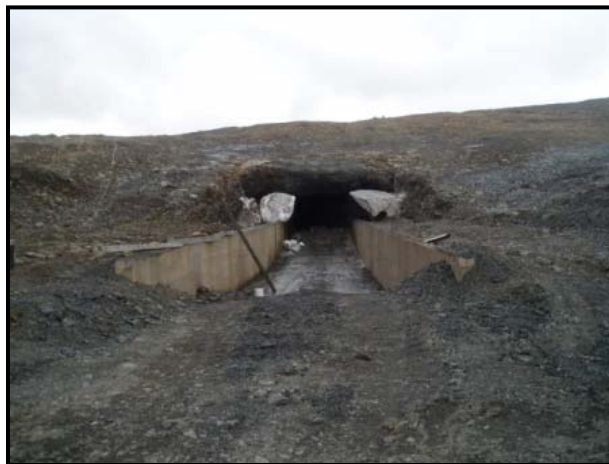
Several openings to both the main underground mine and satellite mining areas existed throughout the life of the mine in the form of both portals and raises. Openings to the main underground mine workings included the Lower Adit, the 00 and 01 Portals at the West Adit Area, the 09S Portal, the 17N Portal, the 39S and 88 Portals in the East Adit area and the Shale Hill raise. Openings to the satellite mining areas included the Area 14 portal and raise, the K-Baseline portal and the portal and two raises at Oceanview. The pre-reclamation condition of each of these openings is further described in detail in BGC (2005).

Figure 41 – 17N Portal Pre-reclamation (2005)

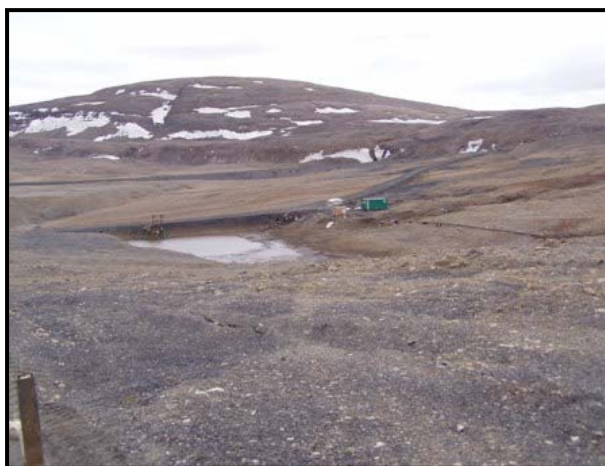
1. The EATF contains residual metals contaminated soil related to the lime treatment of runoff water. A soil volume of 600 m³ was identified in the ESA investigations (GLL 2004d). This soil was to be excavated and relocated into the underground mine workings.
2. The two dikes that form the treatment ponds were to be breached such that natural drainage patterns are restored to the area.

Figure 43 – EATF Pre-reclamation (2004)

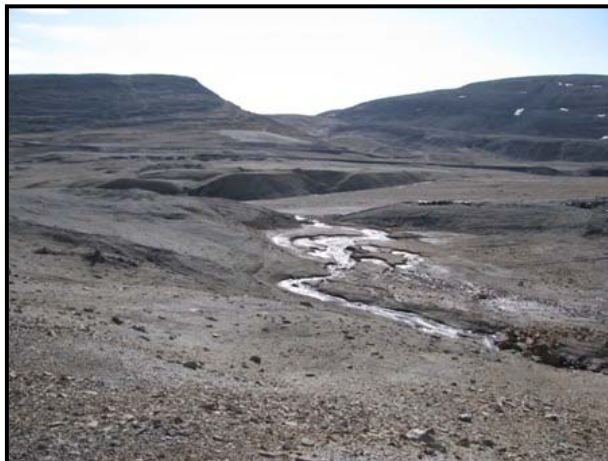
Figure 44 – EATF Post-Reclamation (2007)

The reclamation of the metals contaminated soils in the EATF is documented in SRK (2009). The reclamation of the EATF is summarized by the following:

- According to site staff, some of the sediments retained in the bottom of the Treatment Pond were removed prior to 2004 as part of progressive mine reclamation activities. In 2006, the remnant sediments retained in the bottom of the EATF ponds were sampled to provide additional geochemical characterization. Following the sampling program, it was determined that sediments met the SQRO's for metals contaminated soils, as such no further reclamation activities were considered necessary (SRK 2009).
- The dikes were breached, restoring natural drainage patterns to the area.
