## **NANISIVIK MINE, A DIVISION OF CANZINCO LTD.**

### **2009 ANNUAL GEOTECHNICAL INSPECTION**

### **NANISIVIK MINE, NUNAVUT**

PROJECT NO.: 0255-019-03  
DATE: MARCH 26, 2010

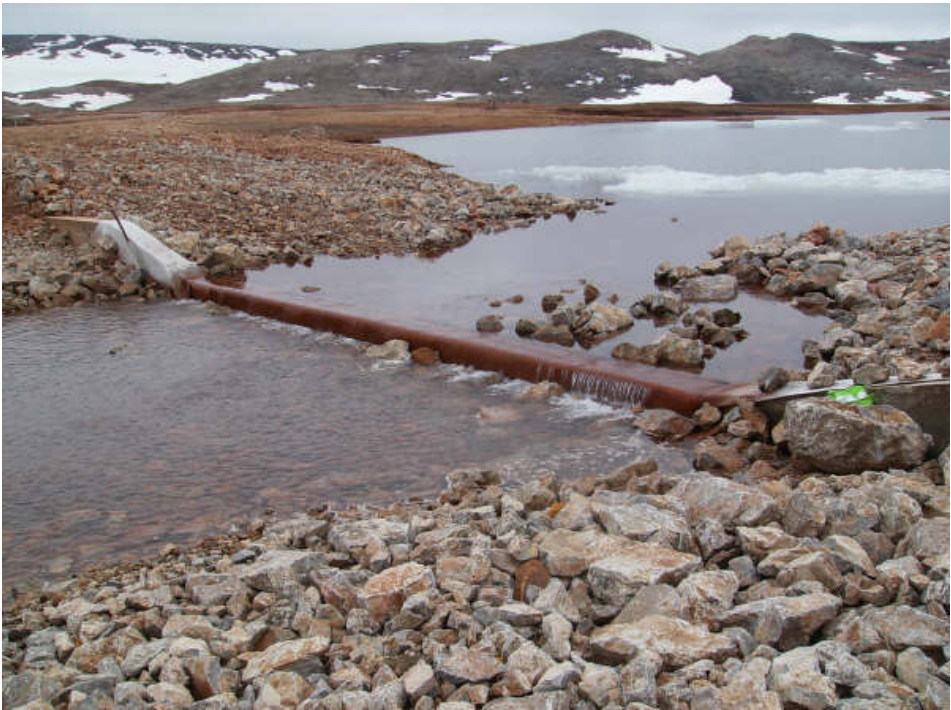
Photo 12 West Twin Outlet Wall in mid-August 2009.
