### **INSPECTION MEMO OF SEPTEMBER 11, 2003**

## **PROJECT MEMORANDUM**

| <b>Subject:</b> | <b>Inspection Visit relative to Waste Containment Dikes and Berms<br/>Summary of Site Observations and Commentary</b> | | |

Nanisivik Mine - Annual Geotechnical Inspection of Dikes  
Nanisivik Mine, a division of Canzinc

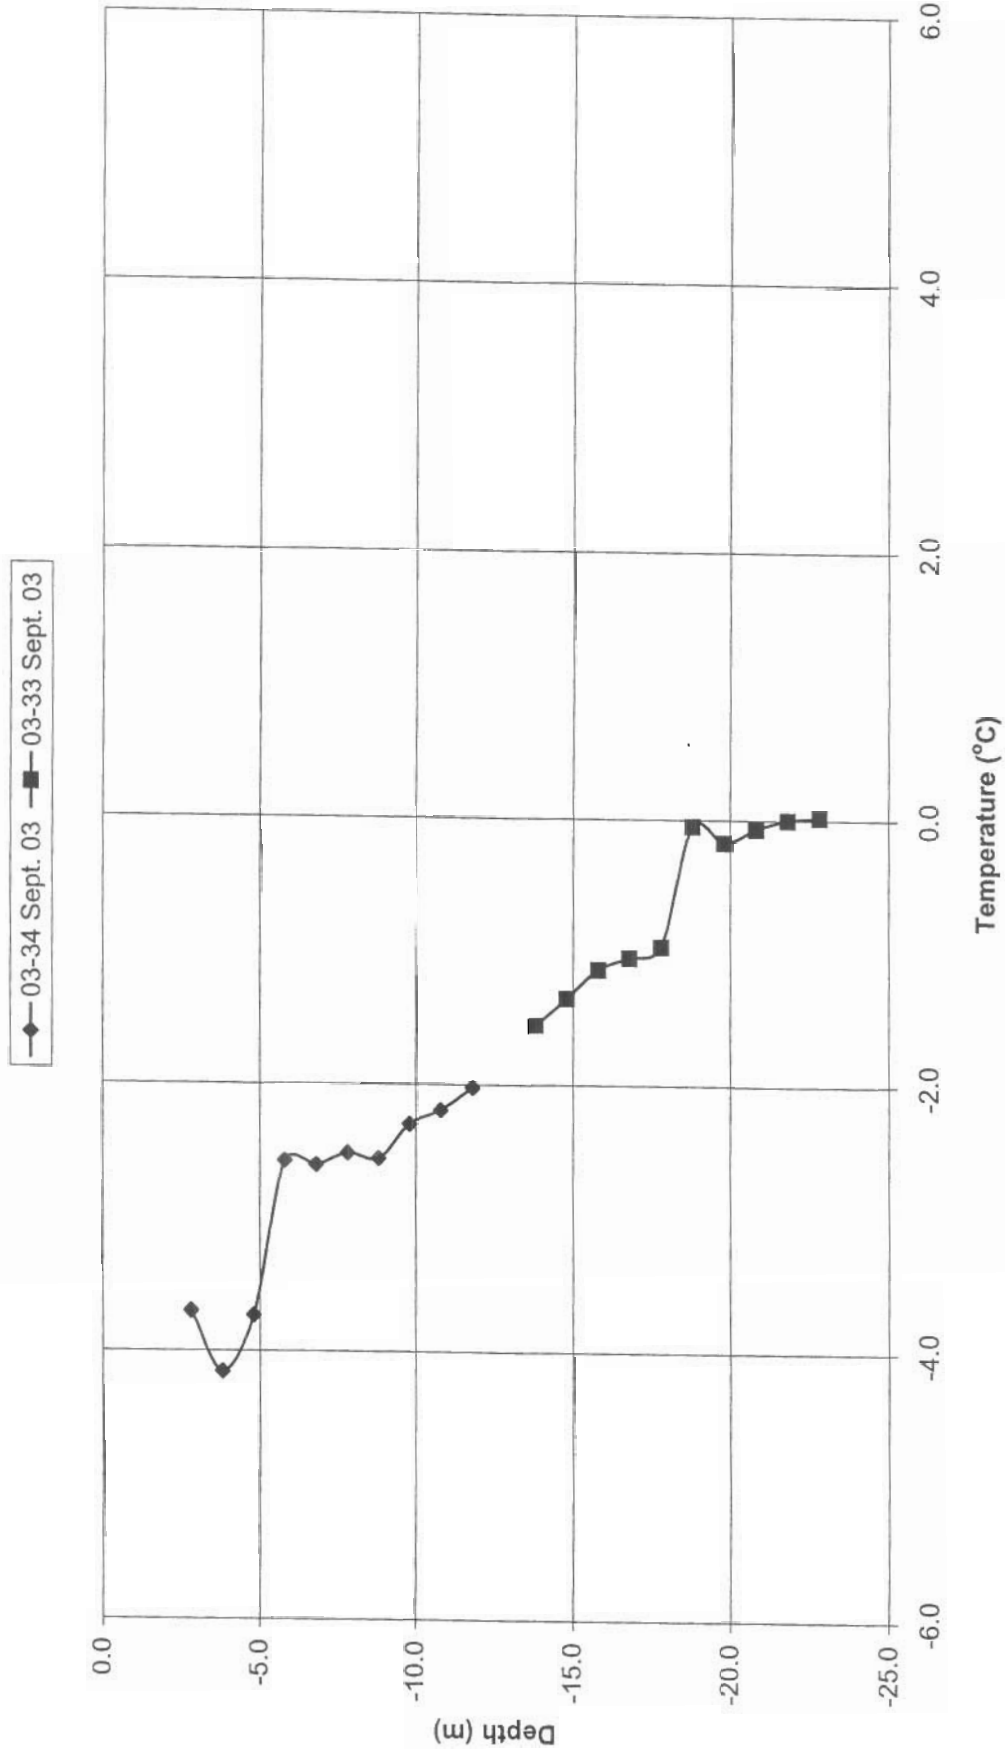
**Geothermal Monitoring  
Surface Cell  
Thermistor BGC03-33/34**

| BGC03-33 | TM | Dike Crest | | 388 m | 18 to 23 m | Thawed conditions below 18 m to the end of the hole. 1 reading in 2003. |
