ZOSTRICH GEOTECHNICAL

RE: REVIEW OF NANISIVIK MINE OPENINGS CLOSURE PLAN (JANUARY 27, 2005)

PROJECT: NANISIVIK ROCK MECHANICS REVIEW - III

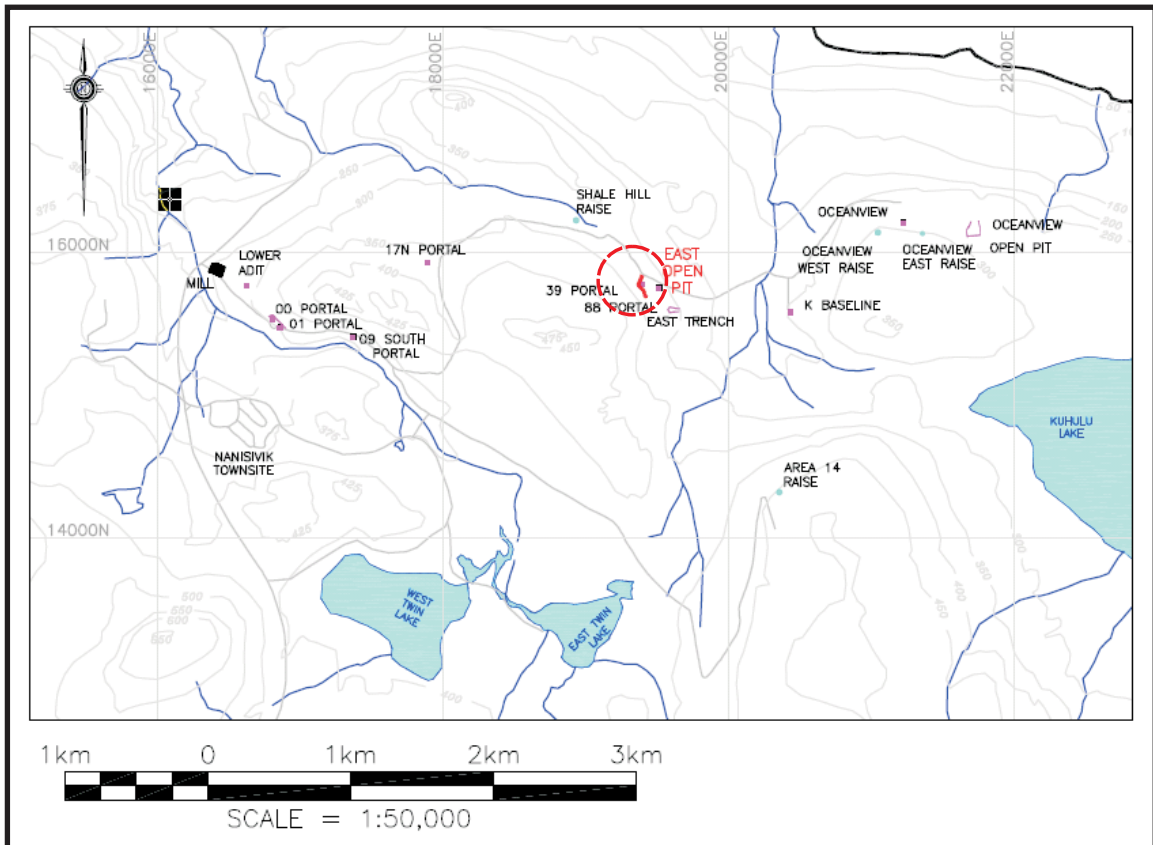
From Figure 22, East pit highwall (showing East adit area)

Notes:
It is unclear from the provided information if the right noted situations have been analyzed for the respective open pits.

Oceanview:
Has the stability of the rock fil, given the shown profile, been analyzed, including pore pressure conditions present during melt. Has the potential complex failure geometry of bedding joints combined with a circular type failure been analyzed?

East pit area:
Have the joints in the bench shown on the schematic section been mapped? If the joint pattern follows that obtained from the West pit area, then bedding joints may create a potential long term failure geometry (frost action driven) as shown. Has this been analyzed and taken into account?

Both geometries assume that the pit walls are north to northeast facing. The lack of a detailed map view and section locations on plan makes this assumption necessary.
