# Polaris 2010 Geotechnical Inspection

## FORMER POLARIS MINE, NUNAVUT

**Submitted to:**  
Teck Resources Ltd.

**Report Number:** 10-1118-0019

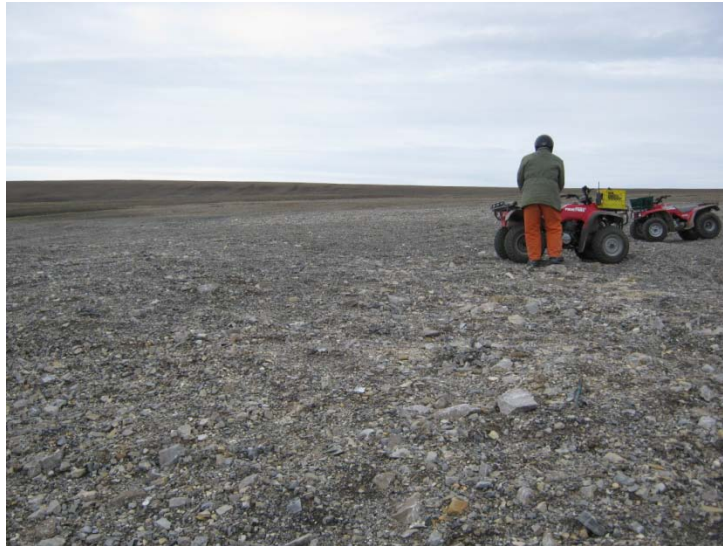
The sideslopes of the Garrow Lake Dam breach were observed to be free of erosion or indications of slope instability during the July 2010 inspection. Photographs 8, 9, 10 create a panoramic view of the dam breach and channel facing upstream towards Garrow Lake. Rip-rap at the base of the breach slopes appears to be in good condition and effectively protecting the breach slopes from channel erosion (Photographs 11 and 12). The condition of the dam crest and breach slopes during the July 2010 inspection is documented in Photographs 11 through 15.

Photo 15, Garrow Lake Dam, West Dam Crest

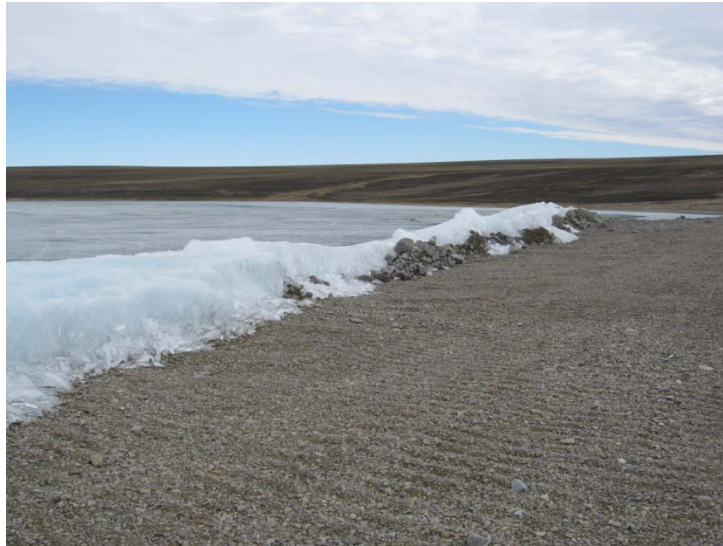
To support mine operations, a rockfill jetty was constructed out into Frustration Lake for the freshwater supply pump station. The pump house and associated water lines were removed during site decommissioning but the jetty remains. Displacement of some jetty rockfill due to ice being pushed up onto the end of the jetty was observed during the July 2010 inspection (Photograph 16). Photographs 17 and 18 document the condition of the jetty crest and edges at the time of the inspection. Lake water around the jetty was observed to be clear during the July 2010 inspection (Photograph 19). Photograph 20 is a view of the jetty from the access road to Frustration Lake. Erosion and displacement of jetty rockfill due to wave and ice action is a natural process and does not appear to be negatively impacting water quality in Frustration Lake.

Photo 17, Frustration Lake, Ice Pushed up onto Northeast Side of Jetty Facing Shore

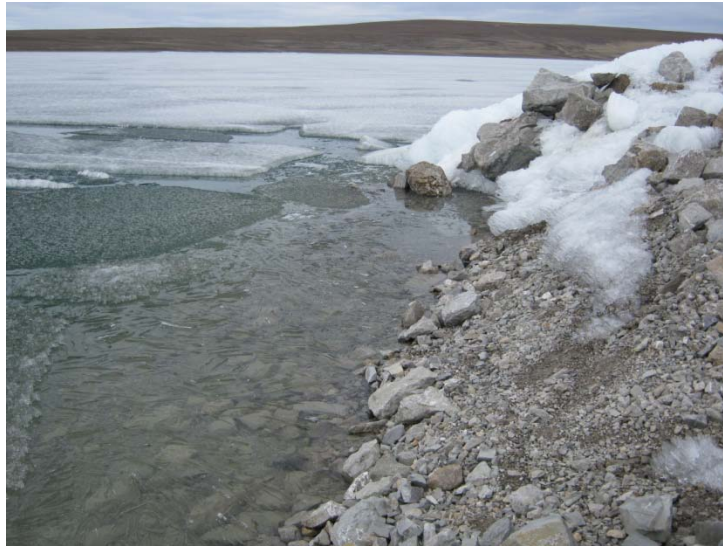
Photo 19, Frustration Lake, Clear Lake Water Beside Jetty

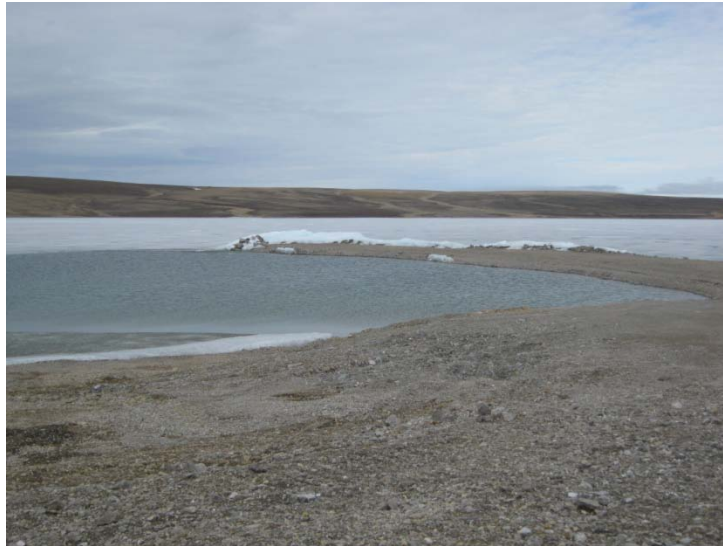
Photograph 21 is a view of the access road down to the jetty at Frustration Lake. The Frustration Lake access road remains in good condition, with some localised erosion at drainage crossings that appear to be self-armouring and stable. Erosion gullies that were repaired in 2006 by regrading slopes, placing gravel/rip-rap and constructing water bars were all observed to be stable during the July 2010 inspection and should not require further attention. Photograph 22 illustrates a typical road drainage crossing that has been resistant to erosion since improvements were made in 2006.

Photo 21, Frustration Lake, Facing Jetty from Road to Frustration Lake

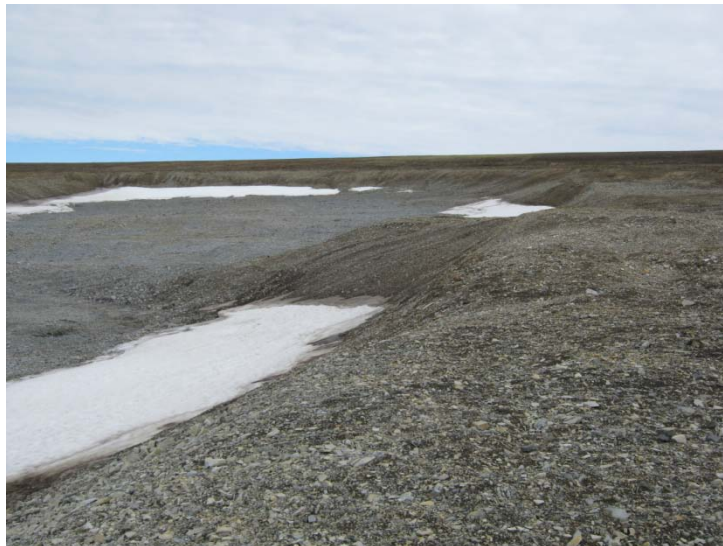
A panoramic view of the New Quarry (Photographs 23, 24 and 25) illustrates the observed condition of the New Quarry area during the July 2010 inspection. Backfilled perimeter sideslopes have not changed significantly from previous post-closure inspections (Photographs 26 through 30). Previously observed settlement and sink holes on backfilled slopes were generally unchanged from previous inspections. Settlement of backfilled slopes is likely the result of buried snow and ice that has melted and is not considered problematic. Photograph 31 illustrates a typical slope tension crack in the New Quarry that may progress into a slump. Photographs 32 and 33 illustrate typical erosion gully development on perimeter sideslopes of the New Quarry. Photograph 34 is a previously observed slump at the south end of the New Quarry (Photograph 56 in 2009 Geotechnical Inspection Report). Minor erosion and slumping of slopes is a normal process in the arctic as slopes reach a state of equilibrium. Minor slumping of the backfilled sideslopes around the perimeter of the New Quarry is not considered problematic and does not pose a safety hazard to humans or wildlife.

Photo 26, New Quarry, East Sideslopes Facing North

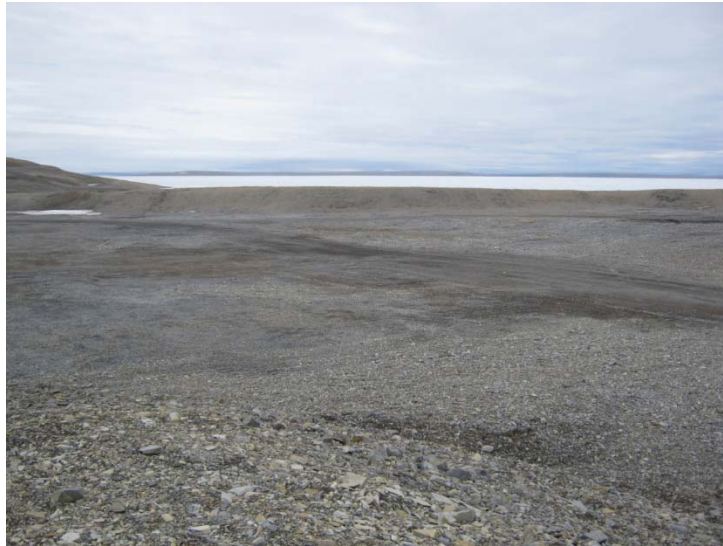
Photo 29, New Quarry, West Sideslopes Facing Southwest

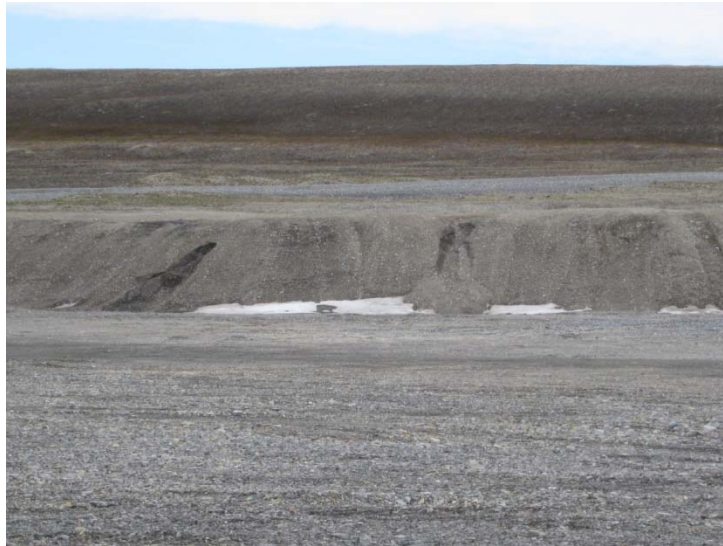
Photo 33, New Quarry, Minor Erosion and Slumping on East Slope

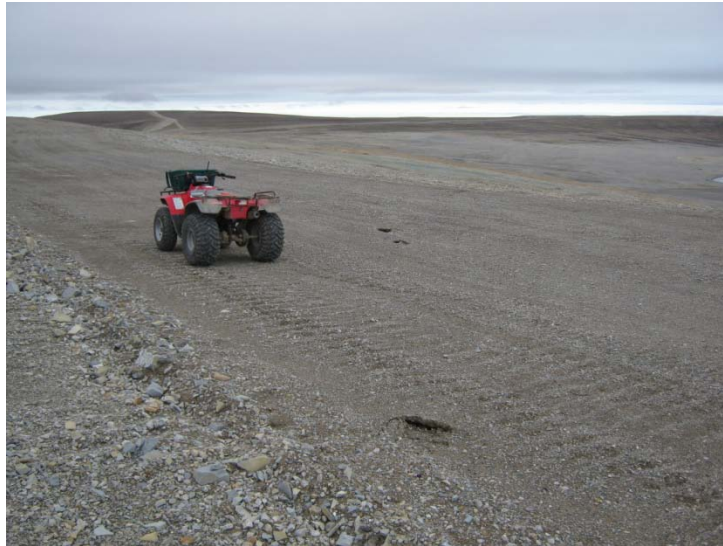
A small (i.e., 0.3 m diameter) thaw settlement area was observed on the access road above the Operational Landfill (Photograph 35). The thaw settlement may have been caused by melting of frozen ice or snow or alternatively a concentration of drainage across the road and is not considered problematic.

Photo 35, Access Road, Small Thaw Sinkhole on Road Above Operational Landfill
