**POLARIS MINE CLOSURE AND RECLAMATION
PROJECT**

**JUNE 20 TO JUNE 22, 2004, INSPECTION TRIP
REPORT**

PROJECT NO.: 0131-013-01
DATE: JULY 21, 2004

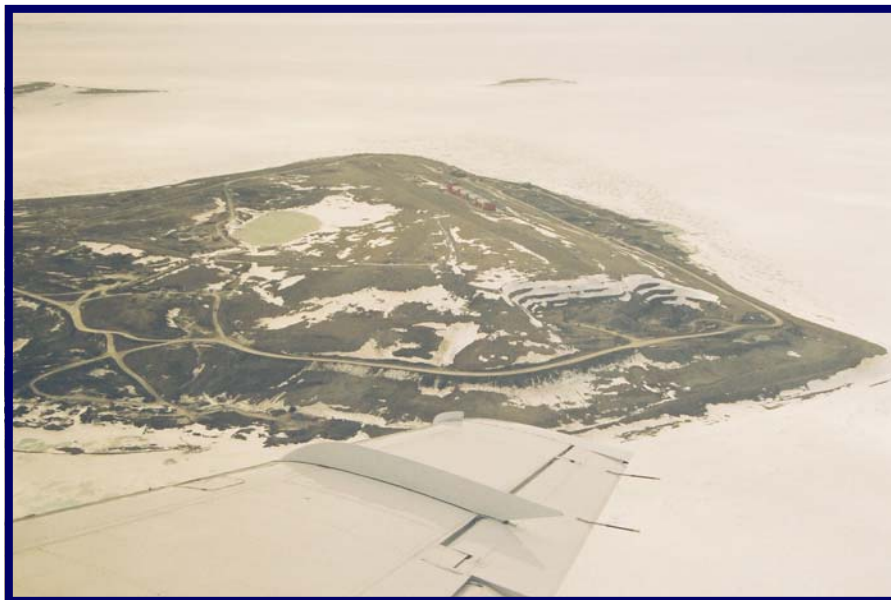
The subsidence area has been covered with shale rockfill and has been contoured into a gentle swale. Cracks were evident in the rockfill cover, indicating that subsidence movements are still occurring. TCL have hired Golder Associates to undertake a review of the historical subsidence data and to prepare an assessment report. In the meantime, TCL will conduct surface monitoring of subsidence movements using a locally based GPS system. The monitoring will take place over the rest of this summer and is planned to take place annually, during the snow free period, over the next 5 years. TCL believes that the subsidence movements are slowing down. The Golder review as well as the ongoing monitoring will provide information from which to assess the long-term management of this area.

Polaris Mine Site, re-contoured area around subsidence zone and North Portal.

- Excavate test pits to confirm cover thickness over debris placed into Subsidence Zone landfill.
- Operational Landfill- Replace fine-grained cover materials with materials meeting design specifications.

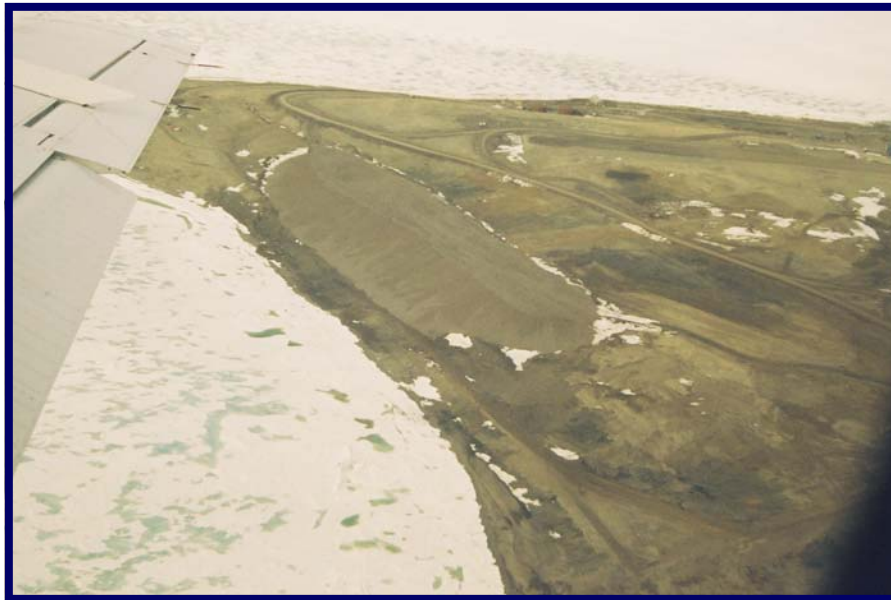
Several areas were noted where the cover consisted mainly of the segregated finer portion of the cover material. These areas were located on the side slopes of the cover and would be susceptible to erosion. TCL has indicated that some regrading will be carried out on the cover and that additional coarser grained cover material would be placed into those areas not meeting the cover material specifications.

View of Operational Landfill.

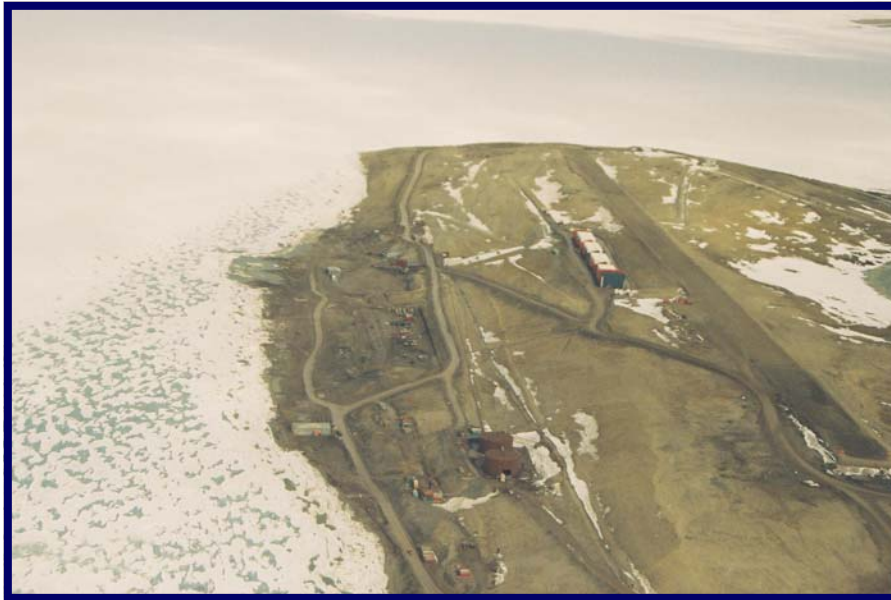
Foreshore area, looking north. Visible is backfilled area of product storage shed and mill barge.

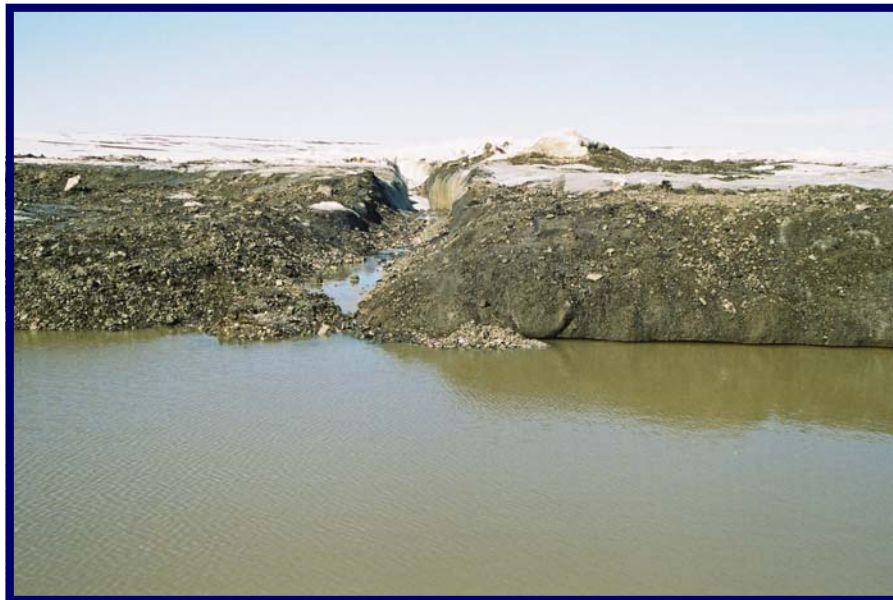
Channel cut into ice of Garrow Lake upstream of dam to channel flow towards breach.

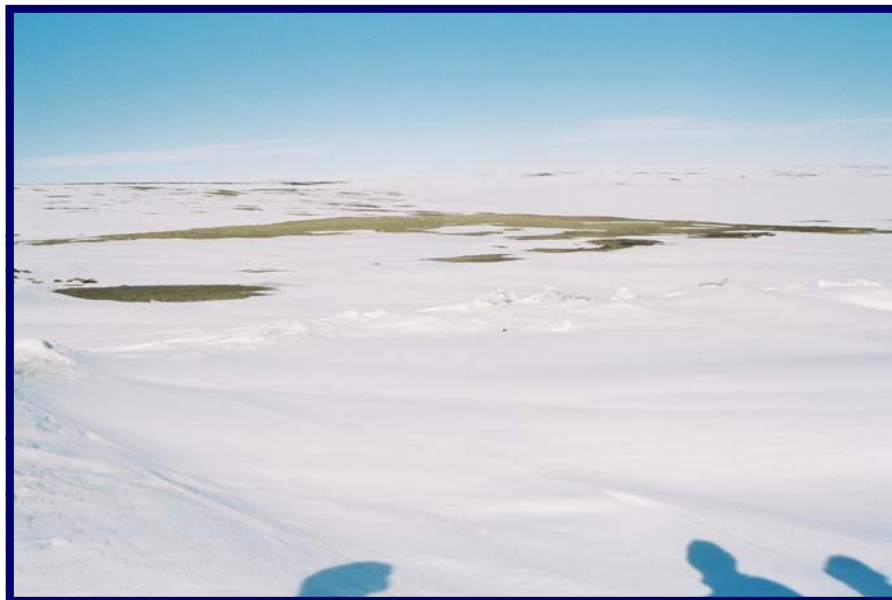
Tailings thickener area - reclaimed dump pond site, mostly covered in snow.

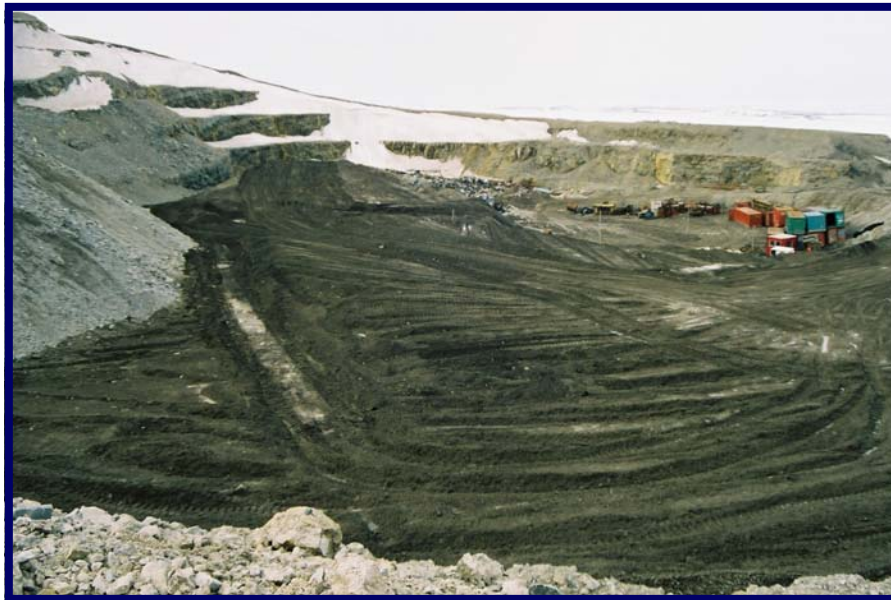
LRD quarry with cover of metals contaminated soils. Stockpiles of final cover consisting of blasted limestone visible on left.

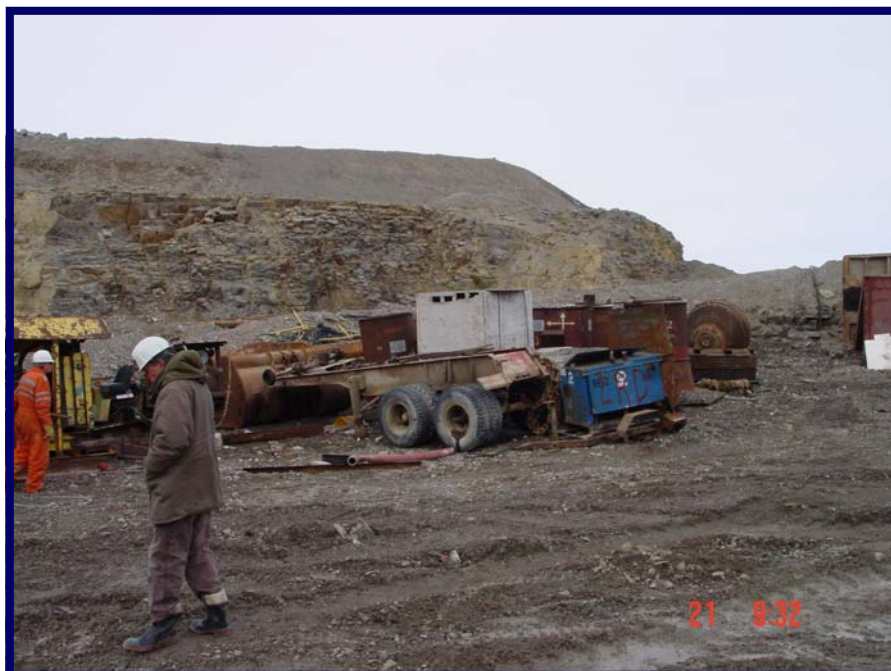
LRD quarry, materials that remain to be cut up prior to disposal into quarry.

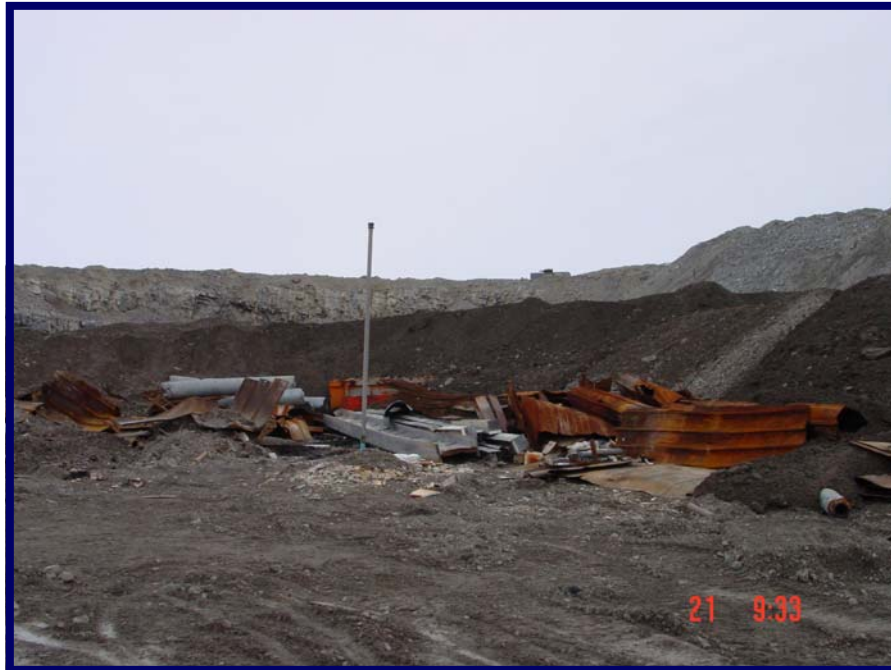
LRD quarry, large materials that remain to be cut up. Casing pipe is for installation of thermistor after quarry is closed.

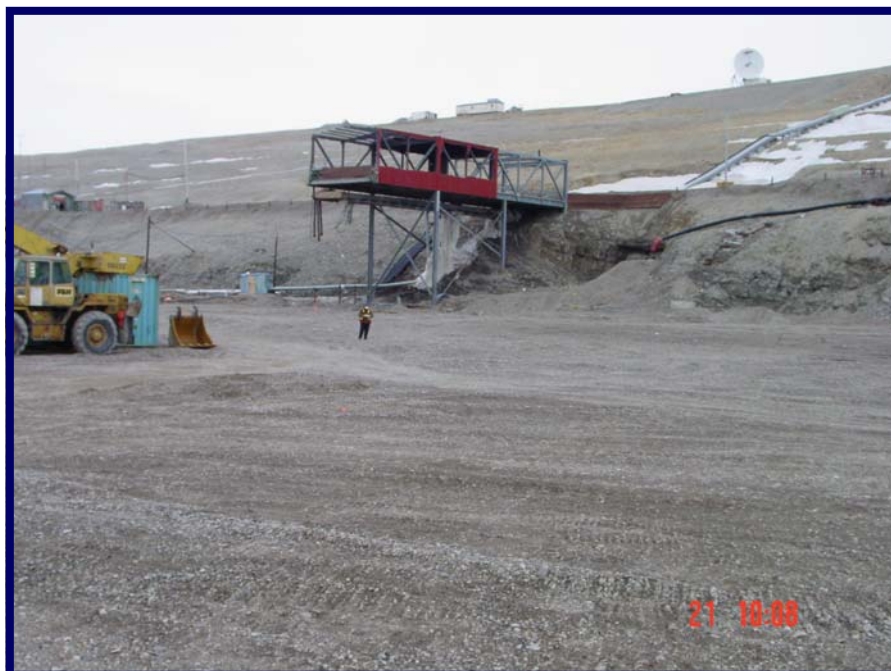
The footprint of the product storage building was excavated to bedrock and covered with a nominal 0.5 m of beach gravel. In bedrock depressions, TCL noted that the cover may be up to 1 m thick. The concrete and steel footings remain to be removed along the west side of the building. Some metals contaminated soils remain to be removed between the product storage building and the foreshore area. The final beach slope grading was being done in the reach south of the dock area.

Beach gravel backfill over mill/barge and product storage shed area.

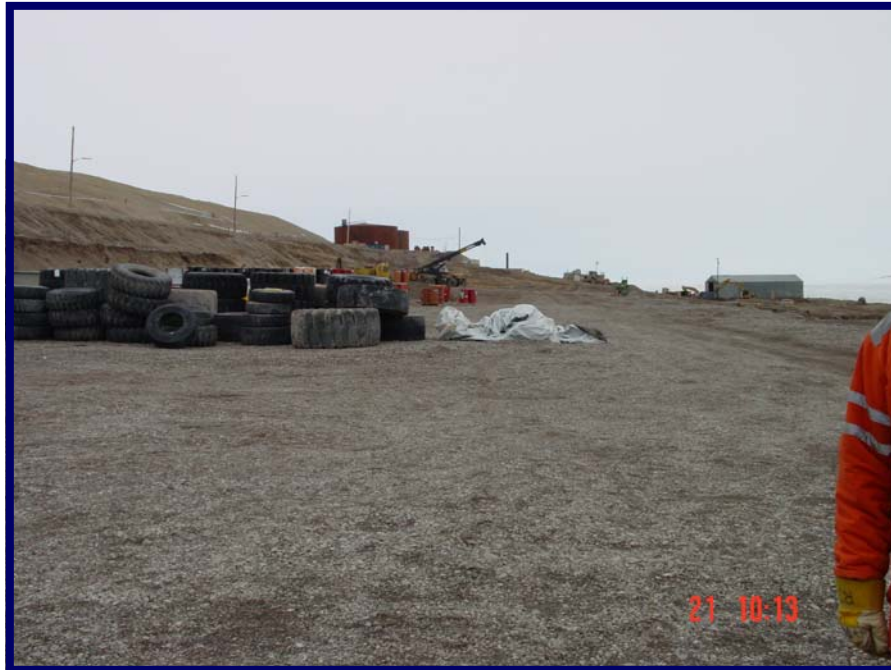
All metals contaminated soils were removed from the product storage area footprint, except for a localized area where some relict metals persisted within cracks in the bedrock surface. It was not possible to remove this material, despite over-excavating into the upper bedrock surface.

Beach gravel cover over product storage shed area.

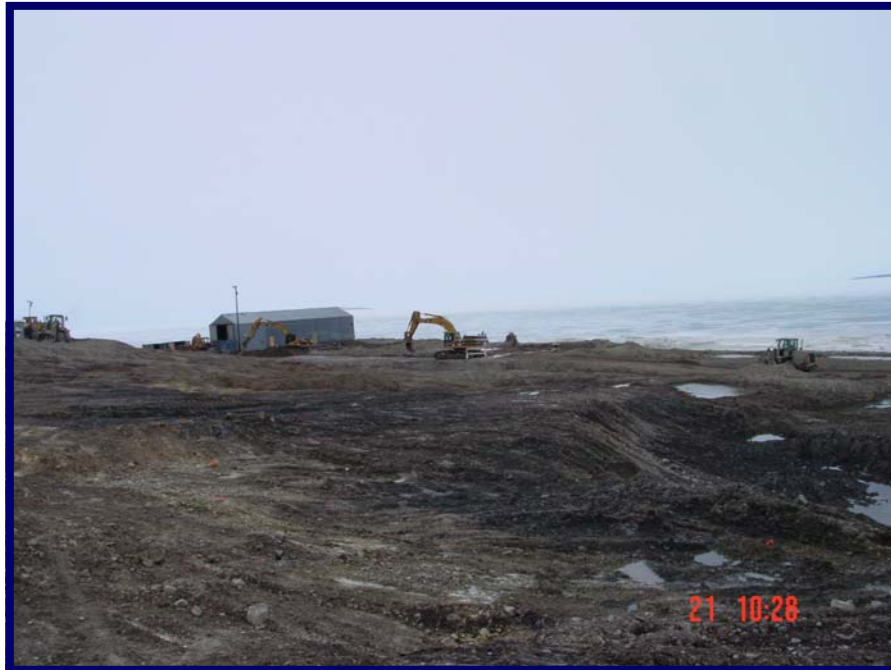
Foreshore area north of foldaway buildings.

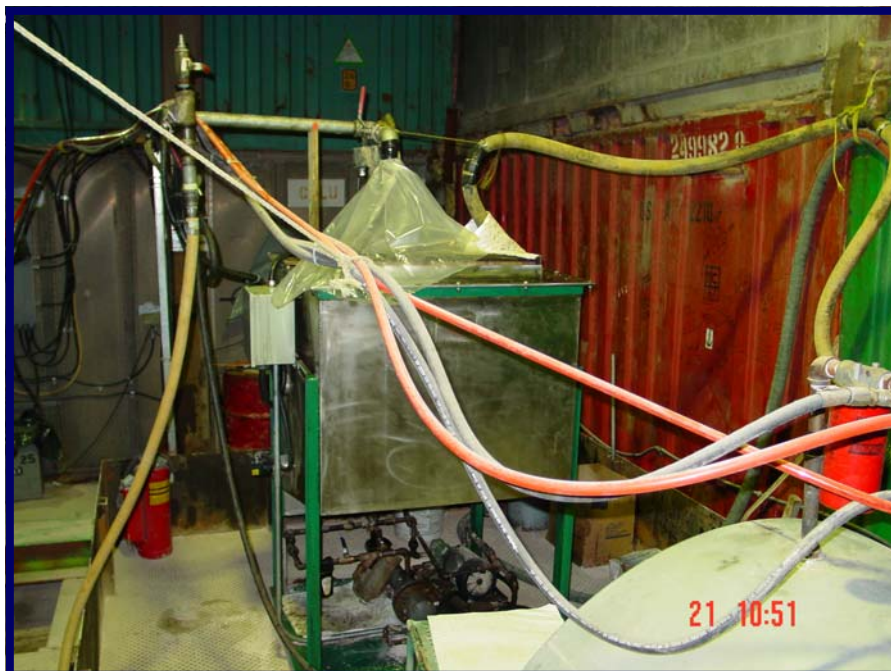
Waste oils and glycol are being burned at a rate of 500 gal/day. TCL noted that the incinerator was not operated during the winter period and that the schedule for incinerating the remaining products is very tight, now that the shipping window has been advanced. A tight balance must be met going into the final closure period to ensure that there are sufficient products to complete the required reclamation and decommissioning, yet minimize the material that remains to be barreled and shipped out after the incinerator is shutdown.

Inside of incinerator building.

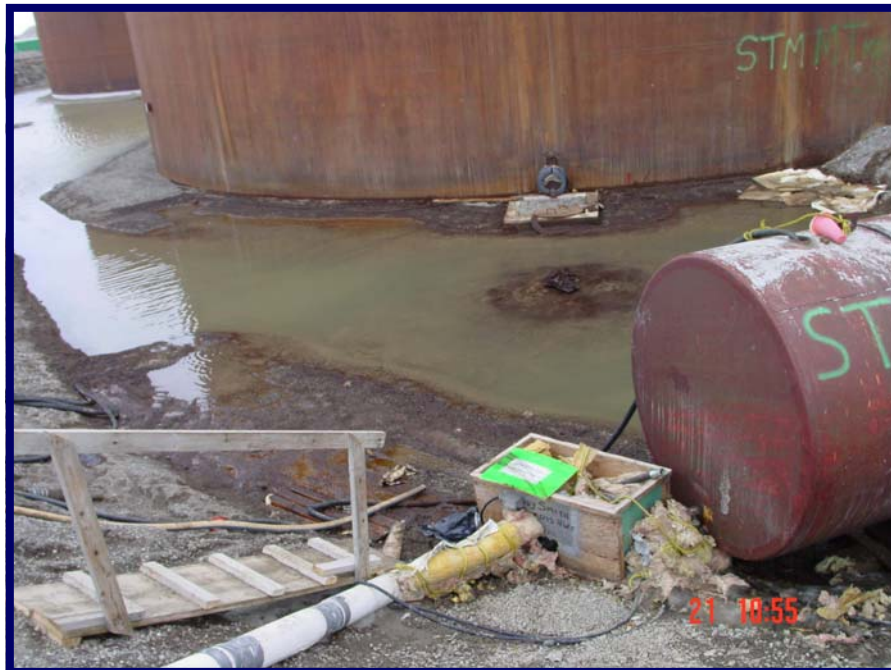
Inside bermed area at tank farm.
