<div>Block</div>		<h1>POLARIS MINE</h1>	
INDIAN RPT.		DB	GEOREFERENCED RPT.		<div>2150 SECTION THROUGH SINKHOLE AREA</div>		
STRIPPED RPT.		DATA	REVISION/REMARKS				
POLARIS M.T.S.				DATA

APPENDIX C

**SITE VISIT
TO
COMINCO LTD.'S
POLARIS MINE**

February 1994

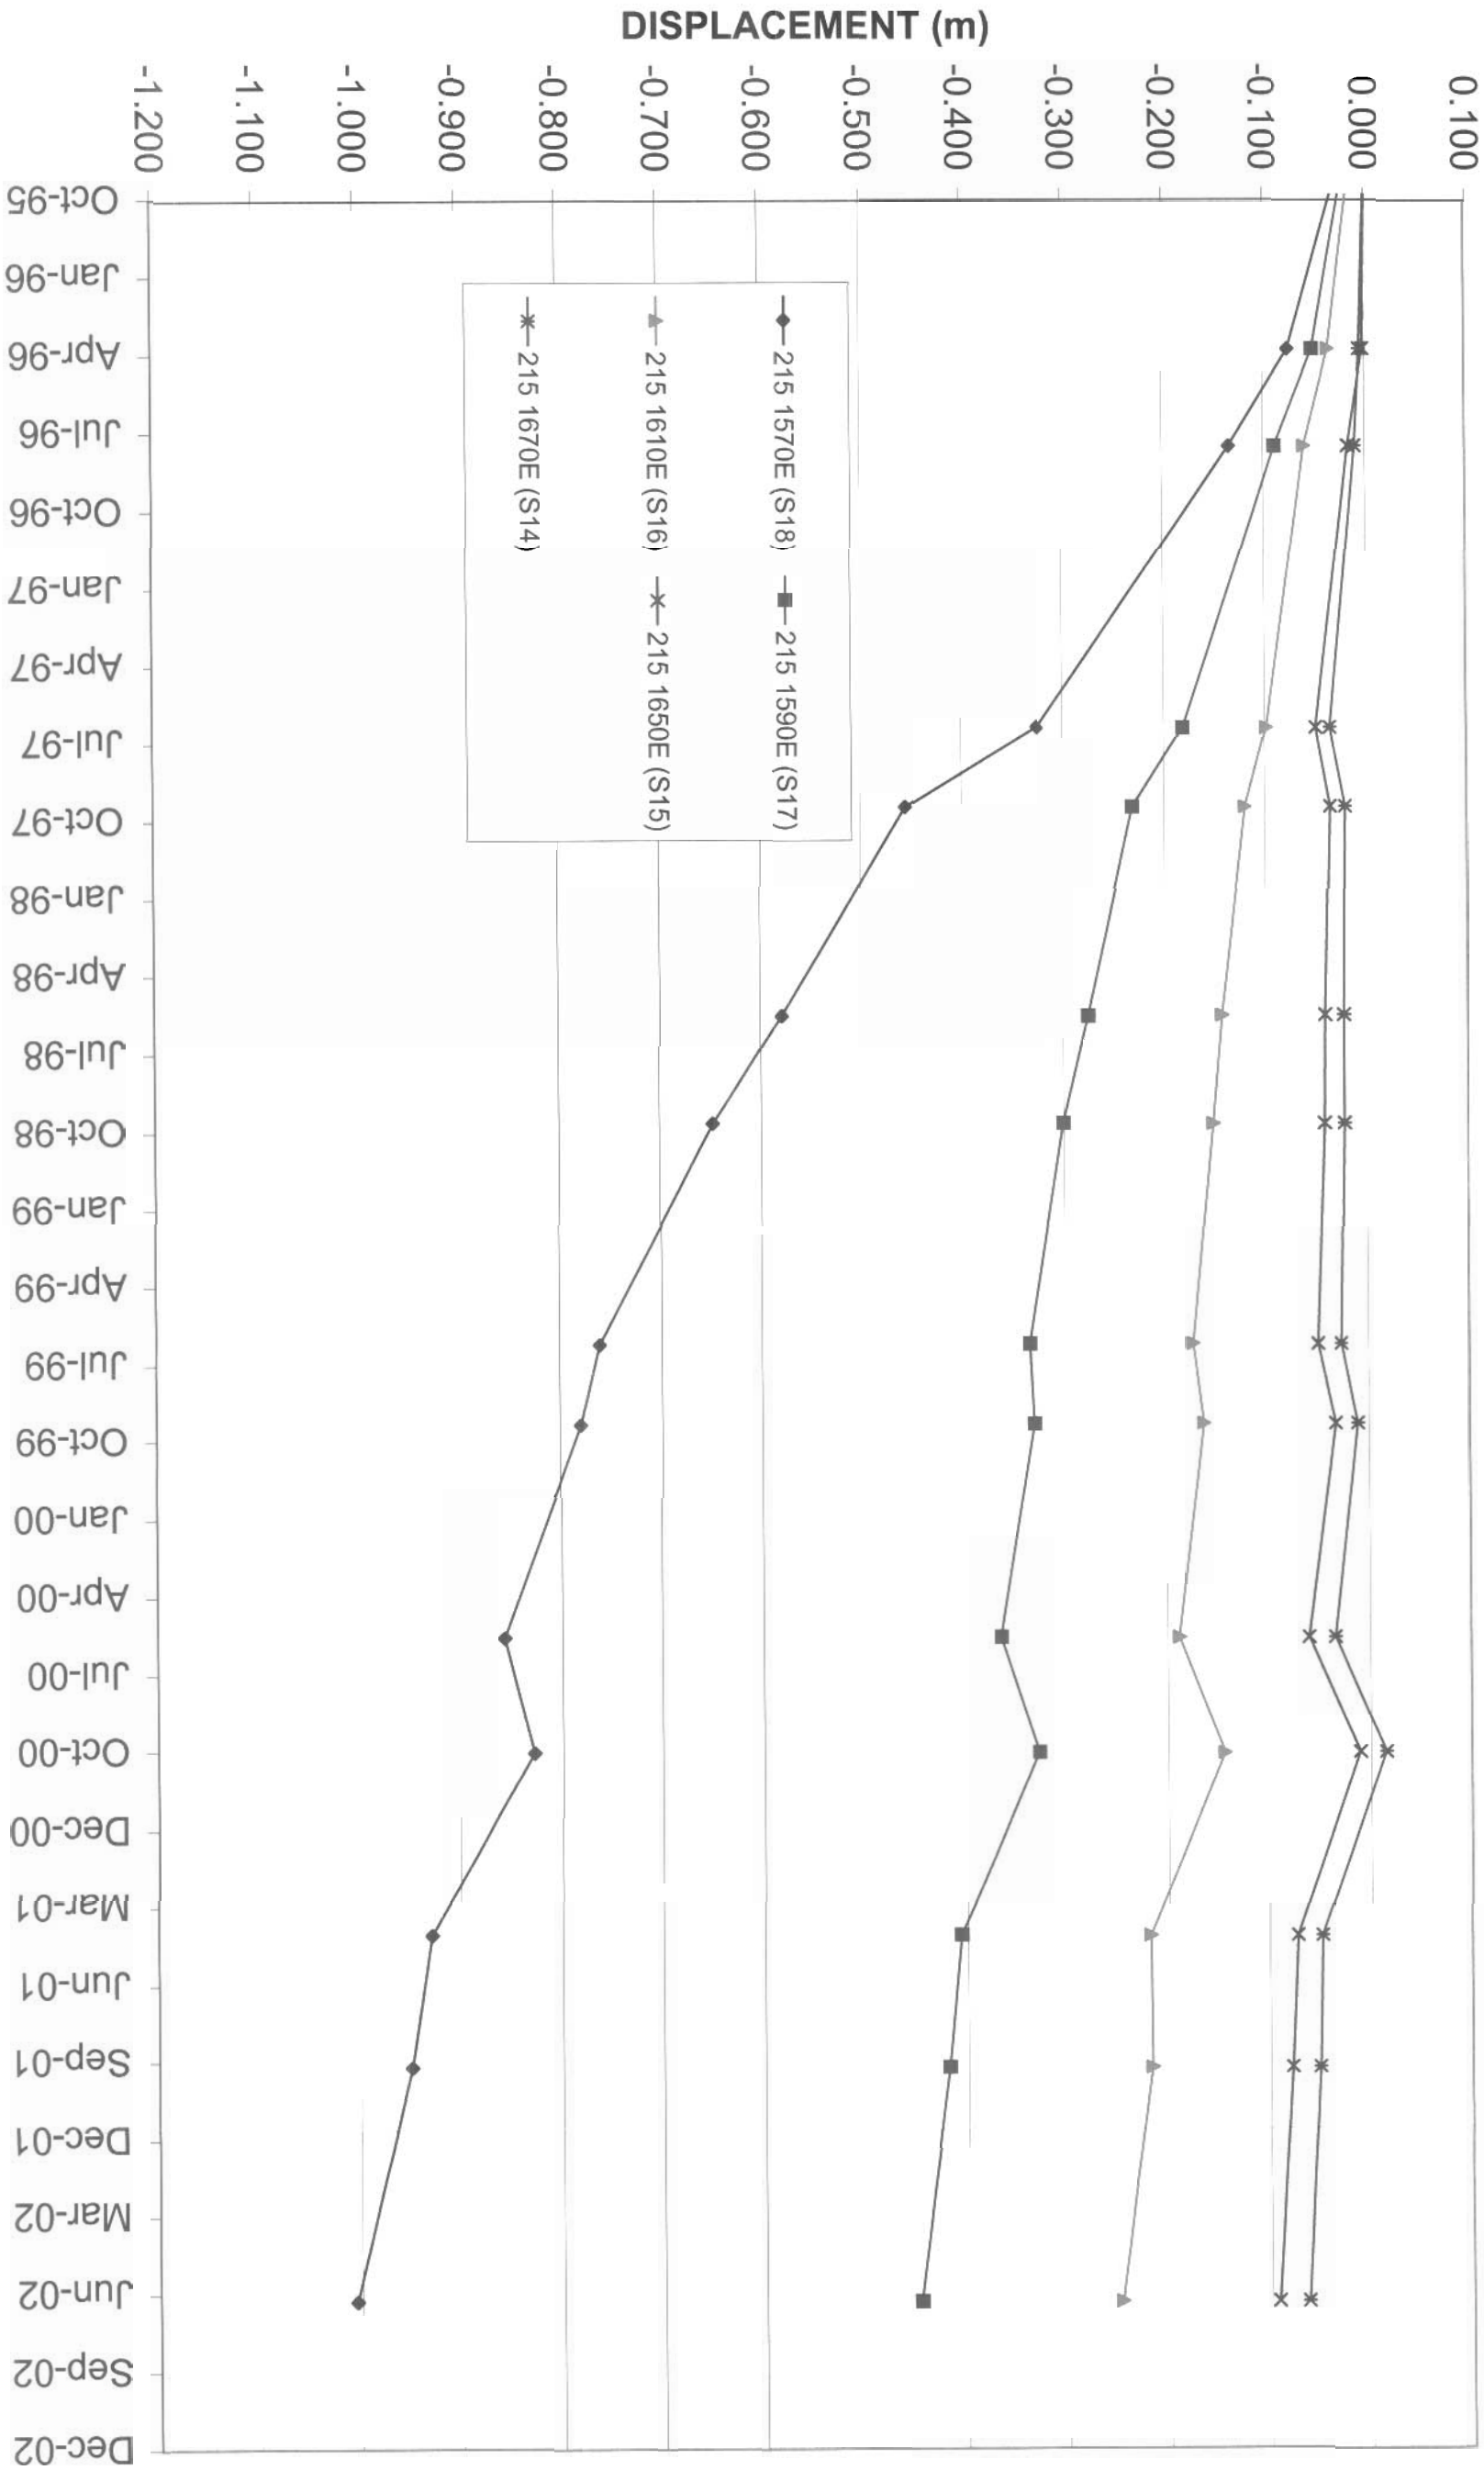
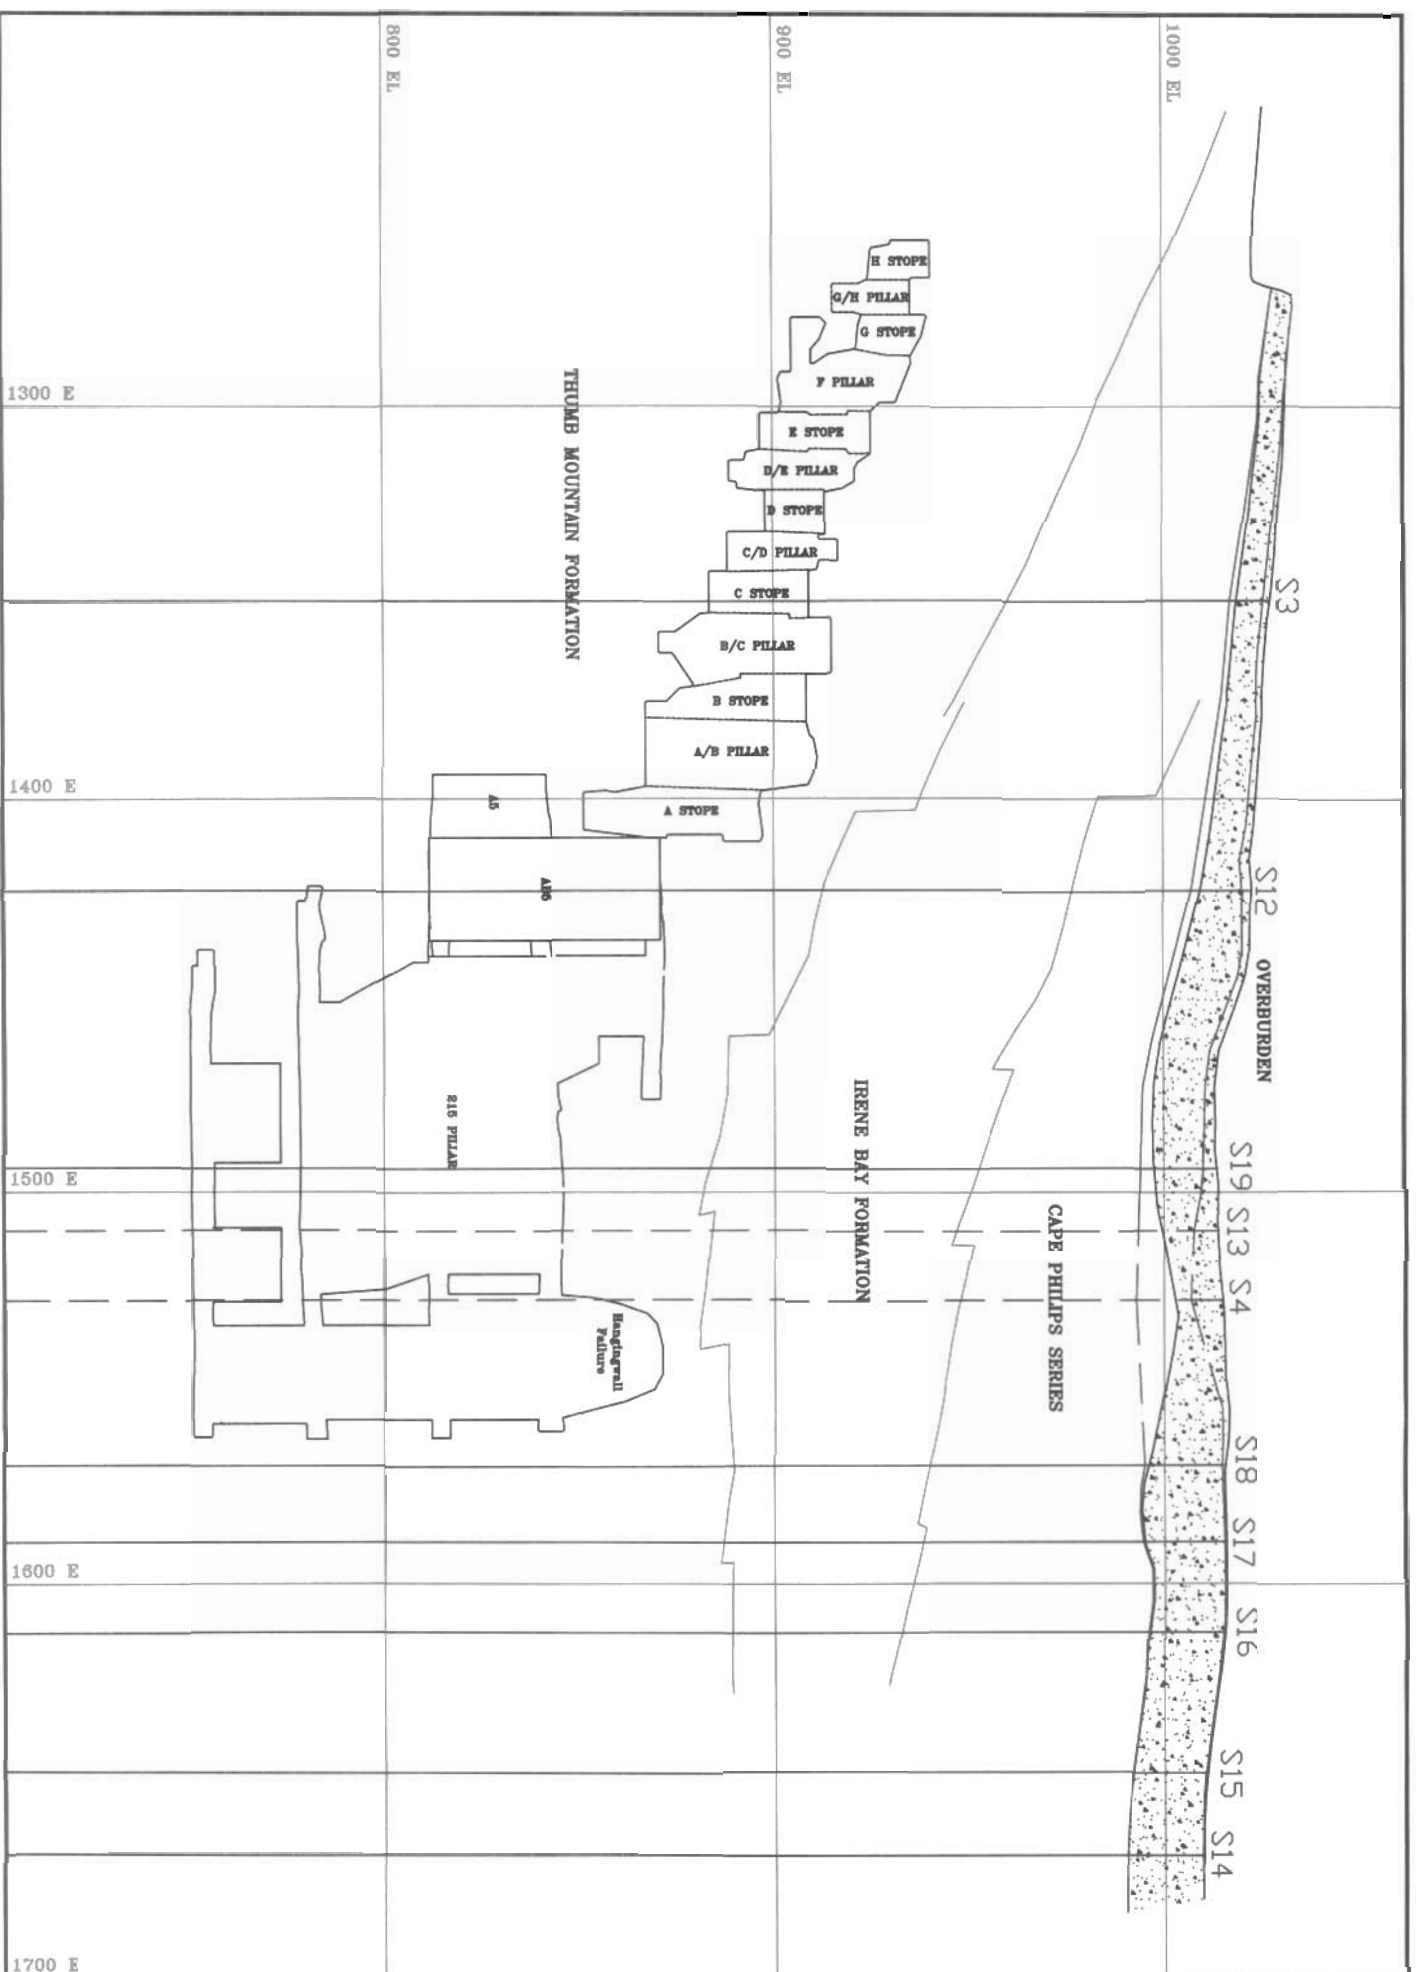
OUTLINE OF PILLARS & STOPES _____

SUBSIDENCE MONITORING STATION _____

MEASURED BEDROCK MOVEMENT _____
(Current to July 2002)

APPROXIMATE BEDROCK MOVEMENT _____
(Stations Destroyed By Subsidence)
