**REPORT ON**

**VISIT TO POLARIS MINE  
NOVEMBER AND DECEMBER 1995**

Cominco Ltd.  
Polaris Operation  
Polaris, NWT  
XOE 0Y0

May 31, 1996

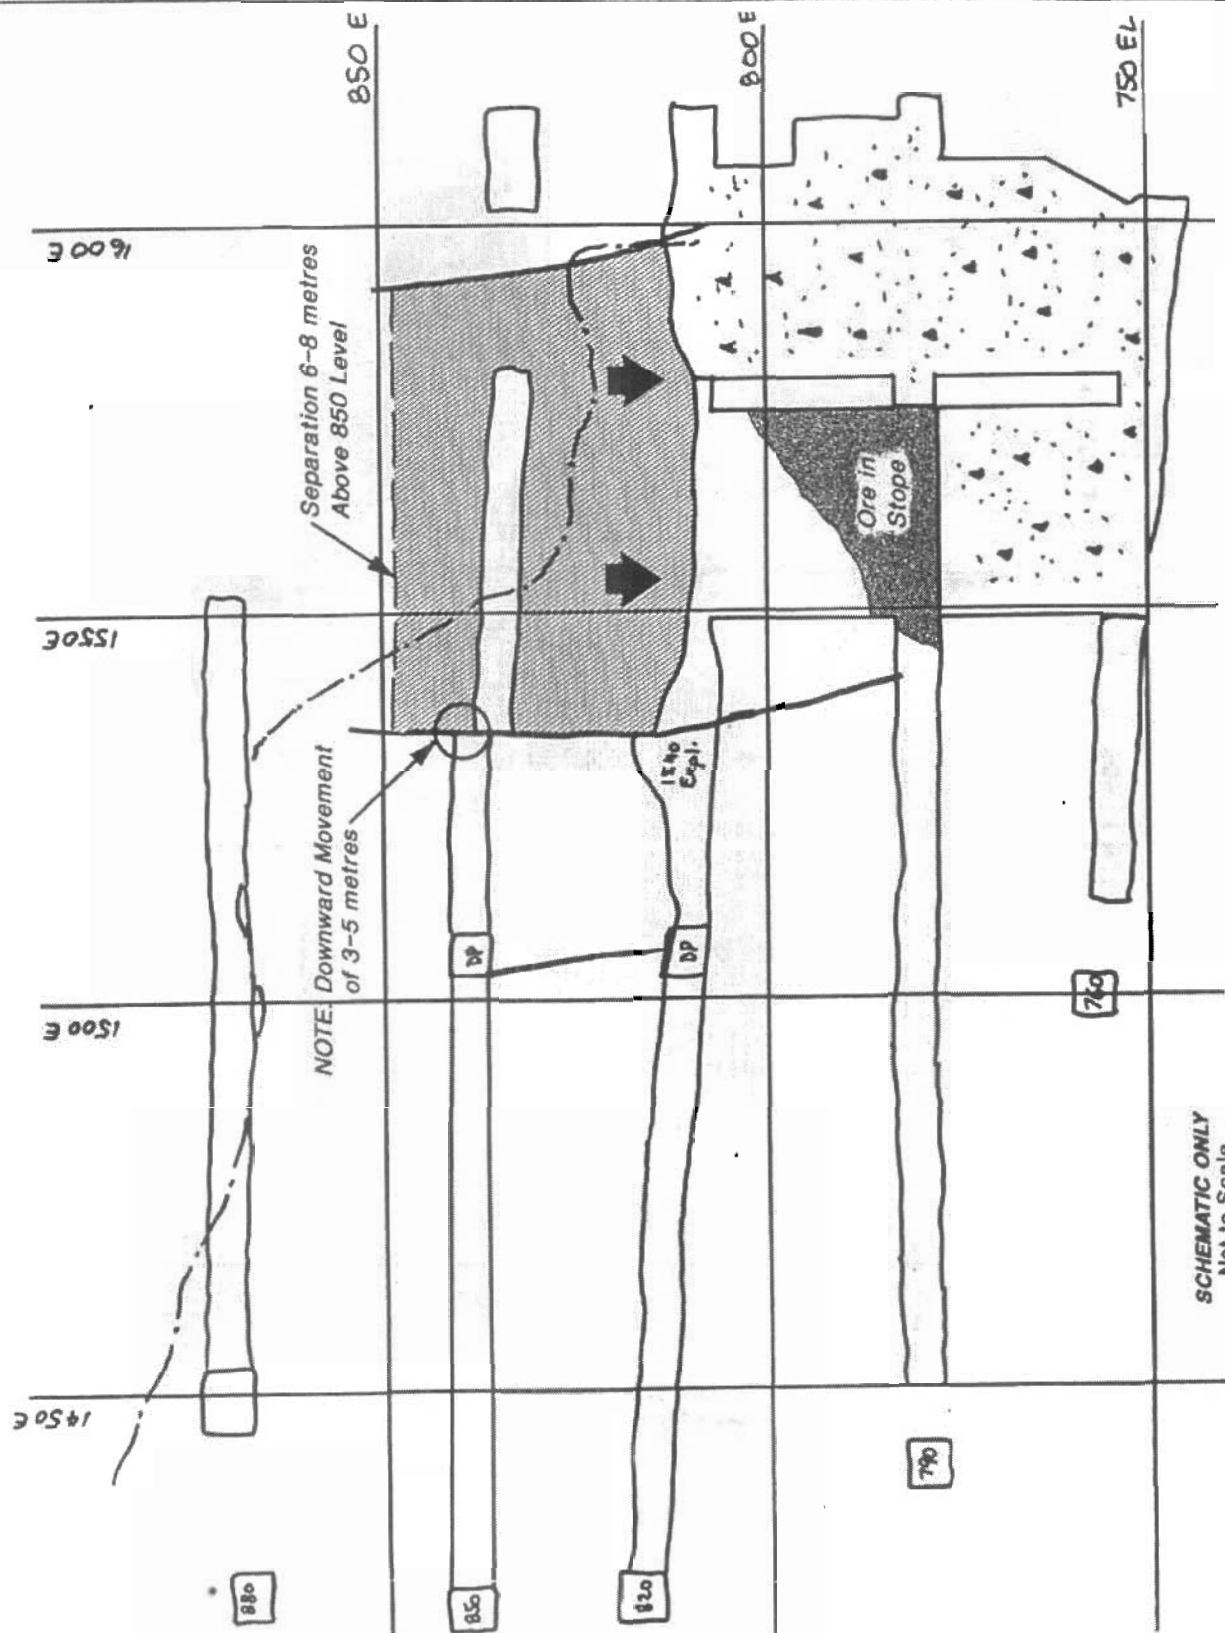
Figure 6

# 202 PILLAR SECTION

Surface monitoring shows continuing ground movement (see Figure 6). The maximum *measured* subsidence is approximately 1.25 m and is located over the 189 pillar area.

- Most subsidence monitors are maintaining constant velocity or de-accelerating.
- Analysis by mine staff of the monitoring data suggest an angle of draw of 40°.
- Given the location of the surface cracking, the angle of cave along the east and western sides of the orebody may be about 20° to 30°.
